Reinspection Survey

Swindon Borough Council

Survey Reference Number: A-17427

Clarence House
Civic Campus
Euclid Street
Swindon
Wiltshire
SN1 2JH

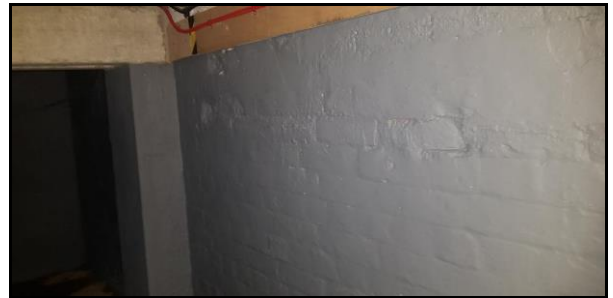
Area Title	Store - B03
Floor / Level	Basement
Product Type	Insulation
Sample Reference	Previously Sampled
Item Description	Insulation residue to walls: Insulation
Estimated Extent	1 m ²

Material Factor Rating	Result from Material Assessment (above)	7
Material Category	Potential for fibre release	Medium

Manage - Condition and surface treatment are adequate for the material to be left in place. Asbestos warning stickers may be applied.

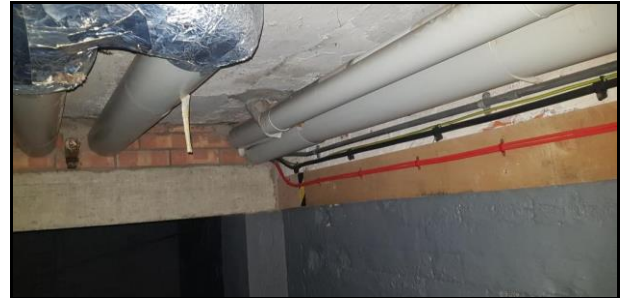
Area Title	Store - B03
Floor / Level	Basement
Product Type	Insulation
Sample Reference	Previously Sampled
Item Description	Insulation residue to pipes: Insulation
Estimated Extent	1 lin m

Material Factor Rating	Result from Material Assessment (above)	8
Material Category	Potential for fibre release	Medium

Manage - Condition and surface treatment are adequate for the material to be left in place. Asbestos warning stickers may be applied.

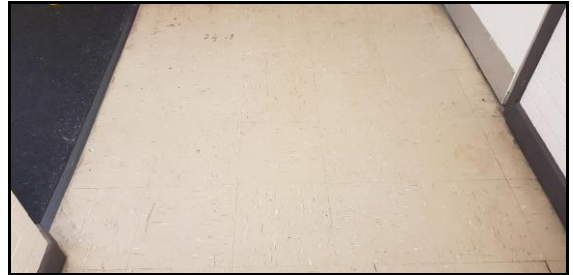
Area Title	Lobby - 019
Floor / Level	Ground Floor
Product Type	Floor Tile + Adhesive
Sample Reference	Previously Sampled
Item Description	Floor tiles & Adhesive: Floor Tile + Adhesive
Estimated Extent	6 m ²

Material Factor Rating	Result from Material Assessment (above)	3
Material Category	Potential for fibre release	Very Low

Manage - Condition and surface treatment are adequate for the material to be left in place. Asbestos warning stickers may be applied.

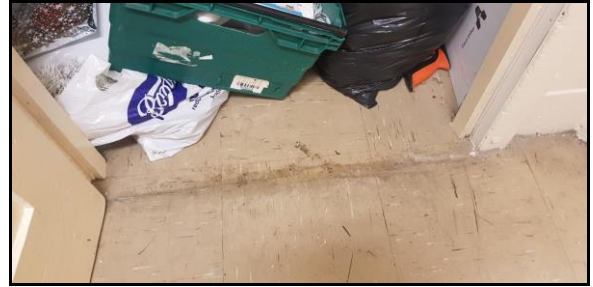
Area Title	Understairs Cupboard - 020
Floor / Level	Ground Floor
Product Type	Floor Tile + Adhesive
Sample Reference	Previously Sampled
Item Description	Floor tiles & Adhesive: Floor Tile + Adhesive
Estimated Extent	4 m ²

Material Factor Rating	Result from Material Assessment (above)	3
Material Category	Potential for fibre release	Very Low

Manage - Condition and surface treatment are adequate for the material to be left in place. Asbestos warning stickers may be applied.

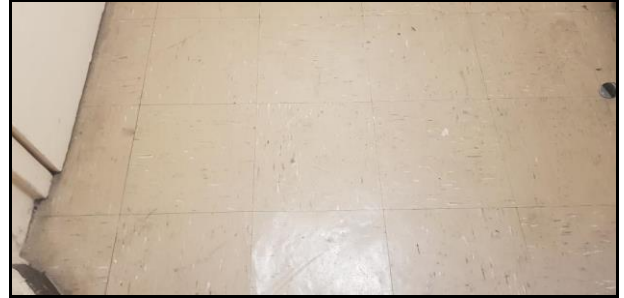
Area Title	Lobby - 023
Floor / Level	Ground Floor
Product Type	Floor Tile + Adhesive
Sample Reference	Previously Sampled
Item Description	Floor tiles & Adhesive: Floor Tile + Adhesive
Estimated Extent	3 m ²

Material Factor Rating	Result from Material Assessment (above)	3
Material Category	Potential for fibre release	Very Low

Manage - Condition and surface treatment are adequate for the material to be left in place. Asbestos warning stickers may be applied.

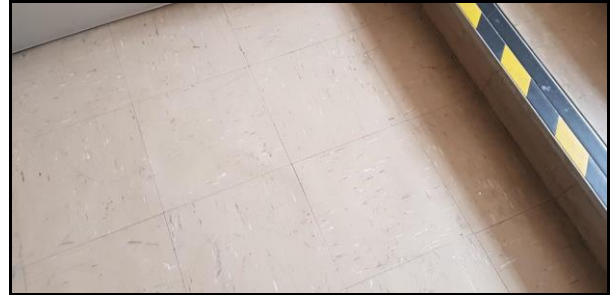
Area Title	Fire Escape - 024
Floor / Level	Ground Floor
Product Type	Floor Tile + Adhesive
Sample Reference	Previously Sampled
Item Description	Floor tiles & Adhesive: Floor Tile + Adhesive
Estimated Extent	3 m ²

Material Factor Rating	Result from Material Assessment (above)	3
Material Category	Potential for fibre release	Very Low

Manage - Condition and surface treatment are adequate for the material to be left in place. Asbestos warning stickers may be applied.

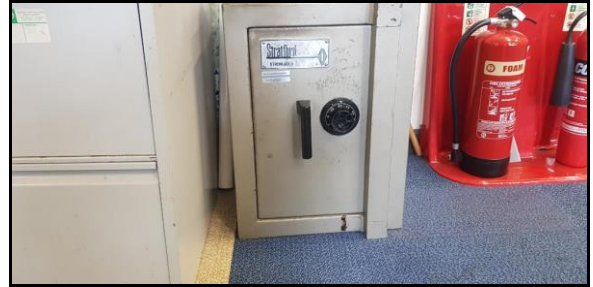
Area Title	Office - 105
Floor / Level	1st Floor
Product Type	Insulating Board
Sample Reference	Presumed
Item Description	Safe: Insulating Board
Estimated Extent	1 no

Material Factor Rating	Result from Material Assessment (above)	7
Material Category	Potential for fibre release	Medium

Manage - Condition and surface treatment are adequate for the material to be left in place. Asbestos warning stickers may be applied.

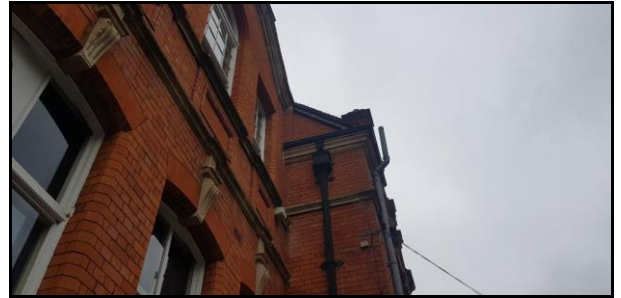
Area Title	External
Floor / Level	External
Product Type	Cement
Sample Reference	Previously Sampled
Item Description	Undercloak: Cement
Estimated Extent	6 lin m

Material Factor Rating	Result from Material Assessment (above)	4
Material Category	Potential for fibre release	Very Low

Manage - Condition and surface treatment are adequate for the material to be left in place. Asbestos warning stickers may be applied.

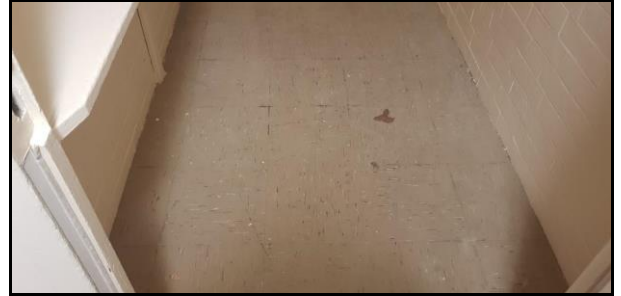
Area Title	Understairs Cupboard - 025
Floor / Level	Ground Floor
Product Type	Floor Tile + Adhesive
Sample Reference	Previously Sampled
Item Description	Floor tiles & Adhesive: Floor Tile + Adhesive
Estimated Extent	3 m ²

Material Factor Rating	Result from Material Assessment (above)	3
Material Category	Potential for fibre release	Very Low

Manage - Condition and surface treatment are adequate for the material to be left in place. Asbestos warning stickers may be applied.
