MANAGEMENT ASBESTOS SURVEY

16 LUNEDALE
PLATT BRIDGE
WIGAN
WN2 5NW

AUGUST 2013

Report prepared for:	Wigan & Leigh Housing Unity House Westwood Park Drive Wigan WN3 4HE
Report reference:	P-51332
Issue date:	August 2013
Survey completed by: Mr L. Gilligan Environmental Consultant	 
Approved by: Mr S. Joyce Assistant Asbestos Project Manager

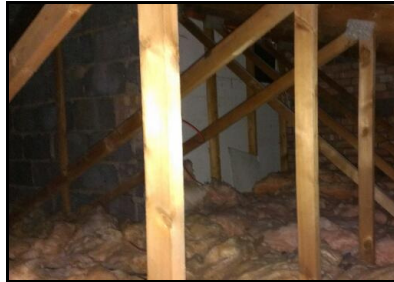
Location		8421435~16 Lunedale - Loft - Boarding

Item No:	1	Laboratory sample no:	P-51332 /	
Accessibility:		Highly inaccessible		
Installation:		Boarding (2)		
Approx extent (m² unless stated)		10		
Asbestos Type:		SP: Crocidolite (3)		
Condition:		Significant Damage (2)	Surface Treatment:	
Risk Assessment (H/M/L/VL)		Low (9)	Recommendation:	Presume ACM's are present until area has been surveyed

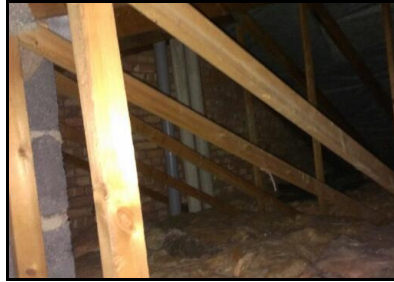
Location		8421435~16 Lunedale - Loft - Cement pipes

Item No:	2	Laboratory sample no:	P-51332 /	
Accessibility:		Highly inaccessible		
Installation:		Cement (1)		
Approx extent (m² unless stated)		10		
Asbestos Type:		SP: Crocidolite (3)		
Condition:		Low Damage (1)	Surface Treatment:	
Risk Assessment (H/M/L/VL)		Low (6)	Recommendation:	Presume ACM's are present until area has been surveyed

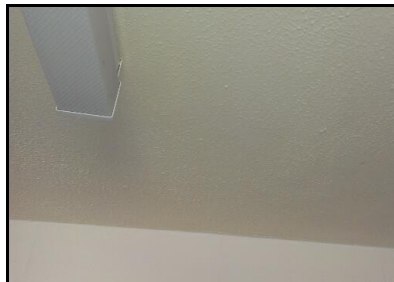
Location		8421435~16 Lunedale - Kitchen - Textured coating to ceiling

Item No:	3	Laboratory sample no:	P-51332 / 001	
Accessibility:		Normally accessible		
Installation:		Textured coating (1)		
Approx extent (m² unless stated)		5		
Asbestos Type:		Chrysotile(1)		
Condition:		Low Damage (1)	Surface Treatment:	
Risk Assessment (H/M/L/VL)		Very Low (4)	Recommendation:	Satisfactory condition, inspect periodically

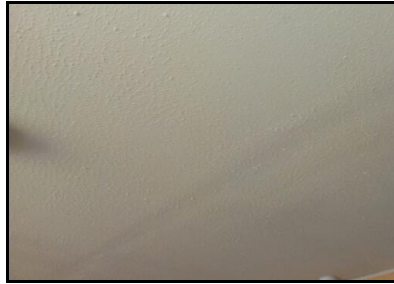
Location	8421435~16 Lunedale - Living room - Textured coating to ceiling

Item No: 4	Laboratory sample no:	SP-51332 / 001		
Accessibility:	Normally accessible			
Installation:	Textured coating (1)			
Approx extent (m² unless stated)	10			
Asbestos Type:	SP: Chrysotile(1)			
Condition:	Low Damage (1)	Surface Treatment:	Sealed (1)	
Risk Assessment (H/M/L/VL)	Very Low (4)	Recommendation:	Satisfactory condition, inspect periodically

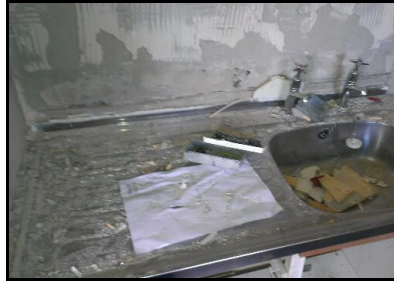
Location	8421435~16 Lunedale - Kitchen - Acoustic bitumen sink pad underneath sink

Item No: 5	Laboratory sample no:	P-51332 / 002		
Accessibility:	N/A			
Installation:	Sink pad(s)			
Approx extent (m² unless stated)	2 No			
Asbestos Type:	NAD			
Condition:	N/A	Surface Treatment:	N/A	
Risk Assessment (H/M/L/VL)	None	Recommendation:	None

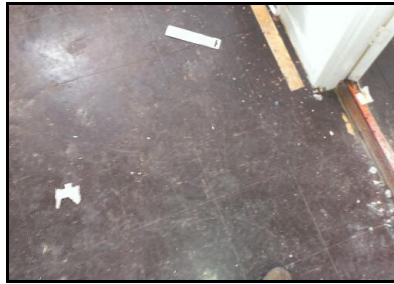
Location	8421435~16 Lunedale - Kitchen - Brown floor tiles with bitumen

Item No: 6	Laboratory sample no:	P-51332 / 003		
Accessibility:	Easily accessible			
Installation:	Floor tile(s) & bitumen (1)			
Approx extent (m² unless stated)	10			
Asbestos Type:	Chrysotile(1)			
Condition:	Low Damage (1)	Surface Treatment:	Composite (0)	
Risk Assessment (H/M/L/VL)	Very Low (3)	Recommendation:	Satisfactory condition, inspect periodically

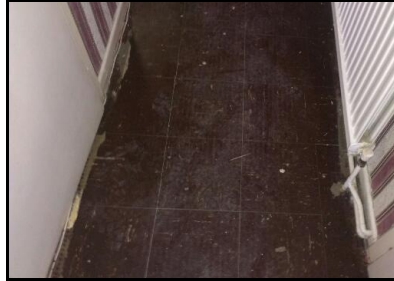
Location	8421435~16 Lunedale - Living room, hallway, hallway stores x 2 and bedroom - Brown floor tiles with bitumen

Item No:	7	Laboratory sample no:	SP-51332 / 003	
Accessibility:	Easily accessible			
Installation:	Floor tile(s) & bitumen (1)			
Approx extent (m² unless stated)	50			
Asbestos Type:	SP: Chrysotile(1)			
Condition:	Low Damage (1)	Surface Treatment:	Composite (0)	
Risk Assessment (H/M/L/VL)	Very Low (3)	Recommendation:	Satisfactory condition, inspect periodically

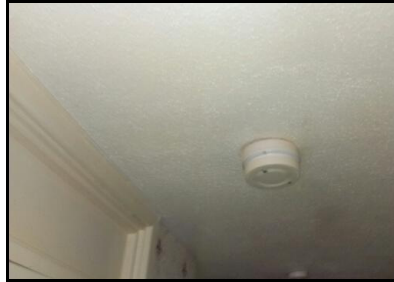
Location	8421435~16 Lunedale - Hallway - Textures coating to ceiling

Item No:	8	Laboratory sample no:	P-51332 / 004	
Accessibility:	N/A			
Installation:	Textured coating			
Approx extent (m² unless stated)	10			
Asbestos Type:	NAD			
Condition:	N/A	Surface Treatment:	N/A	
Risk Assessment (H/M/L/VL)	None	Recommendation:	None

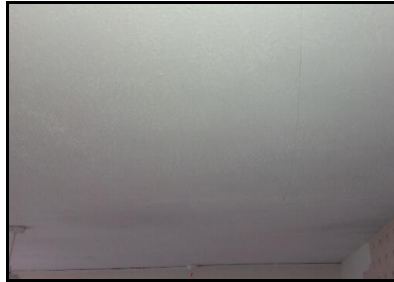
Location	8421435~16 Lunedale - Bathroom, hallway stores x 2 and bedroom - Textures coating to ceiling

Item No:	9	Laboratory sample no:	SP-51332 / 004	
Accessibility:	N/A			
Installation:	Textured coating			
Approx extent (m² unless stated)	25			
Asbestos Type:	SP: NAD			
Condition:	N/A	Surface Treatment:	N/A	
Risk Assessment (H/M/L/VL)	None	Recommendation:	None

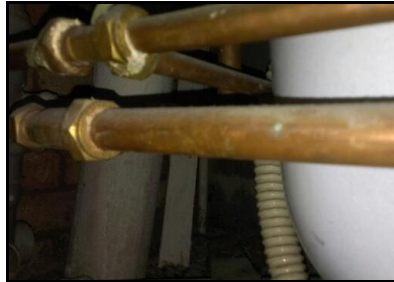
Location		8421435~16 Lunedale - Bathroom - Cement pipes behind bath within boxwork

Item No:	10	Laboratory sample no:	P-51332 / 005	
Accessibility:		Normally inaccessible.		
Installation:		Cement (1)		
Approx extent (m² unless stated)		8		
Asbestos Type:		Chrysotile(1)		
Condition:		Low Damage (1)	Surface Treatment: Sealed (1)	
Risk Assessment (H/M/L/VL)		Very Low (4)	Recommendation: Satisfactory condition, inspect periodically

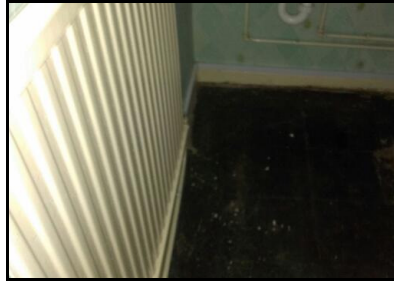
Location		8421435~16 Lunedale - Bathroom - Bitumen to floor

Item No:	11	Laboratory sample no:	P-51332 / 006	
Accessibility:		Easily accessible		
Installation:		Floor screed (1)		
Approx extent (m² unless stated)		5		
Asbestos Type:		Chrysotile(1)		
Condition:		Low Damage (1)	Surface Treatment: Composite (0)	
Risk Assessment (H/M/L/VL)		Very Low (3)	Recommendation: Satisfactory condition, inspect periodically
