## APPENDIX A - PHOTOGRAPHS

**COMMUNAL STAIRCASE** (Survey – 21/07/2017)

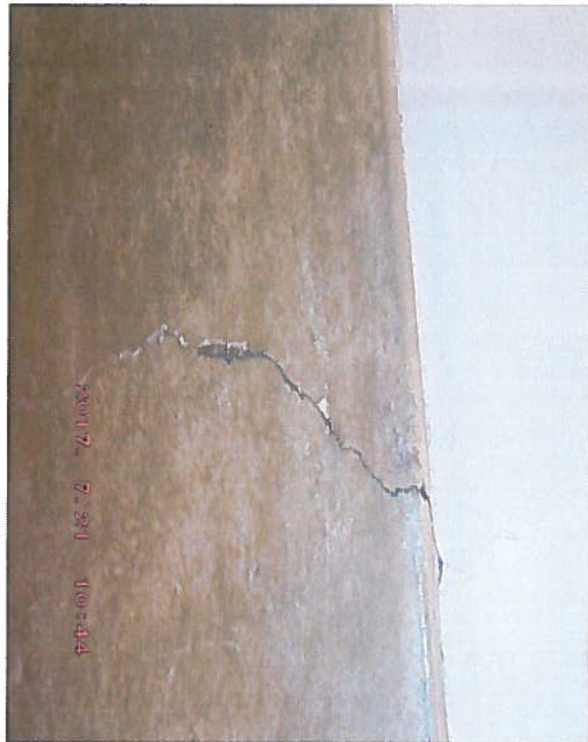
**Pic.1** Internal wall cracks

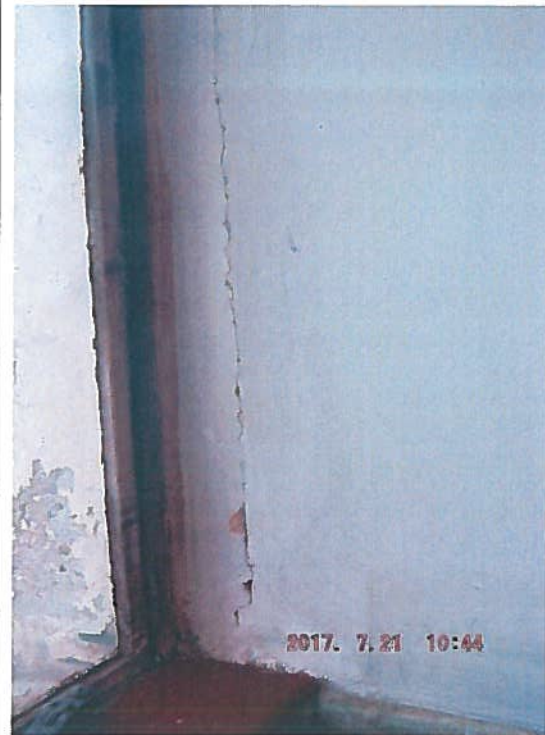
**Pic.2** Internal wall crack

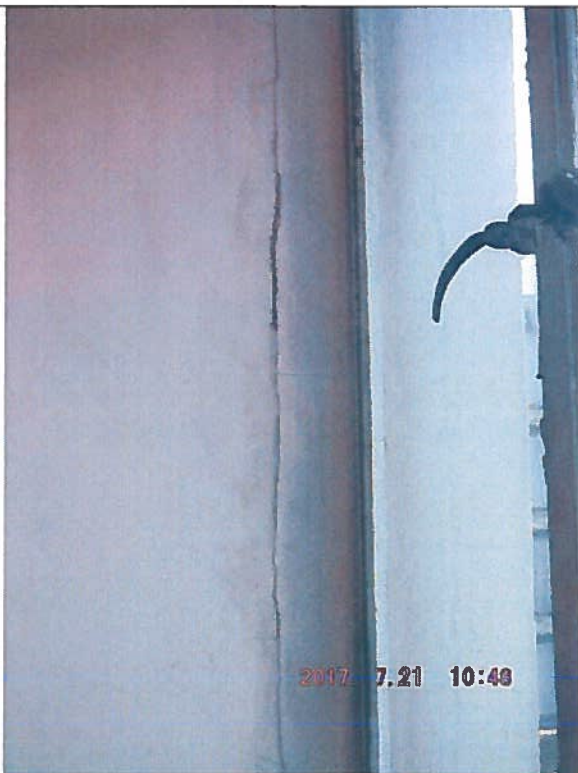
**Pic.3** Internal wall crack

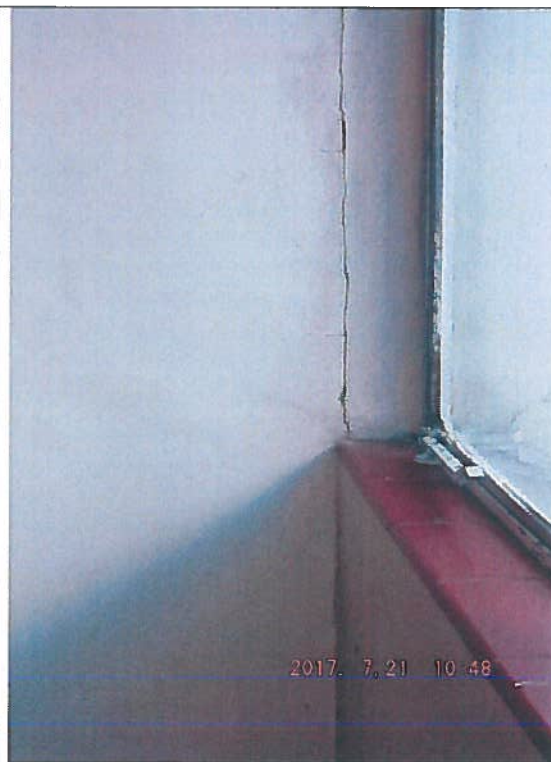
**Pic.4-** Internal wall crack

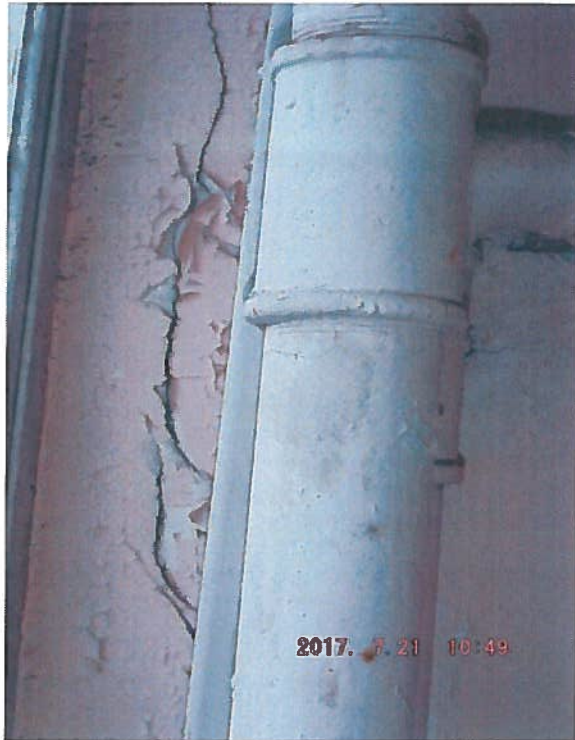
**Pic 5** – Internal wall crack

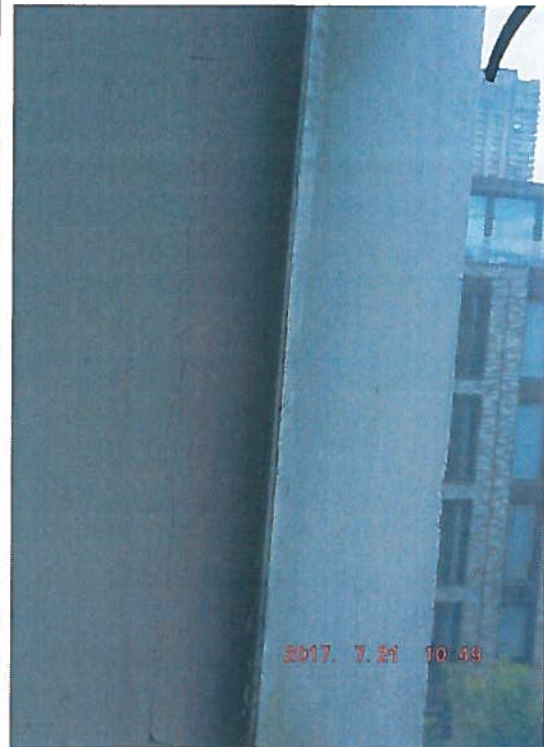
**Pic. 6** Hairline crack

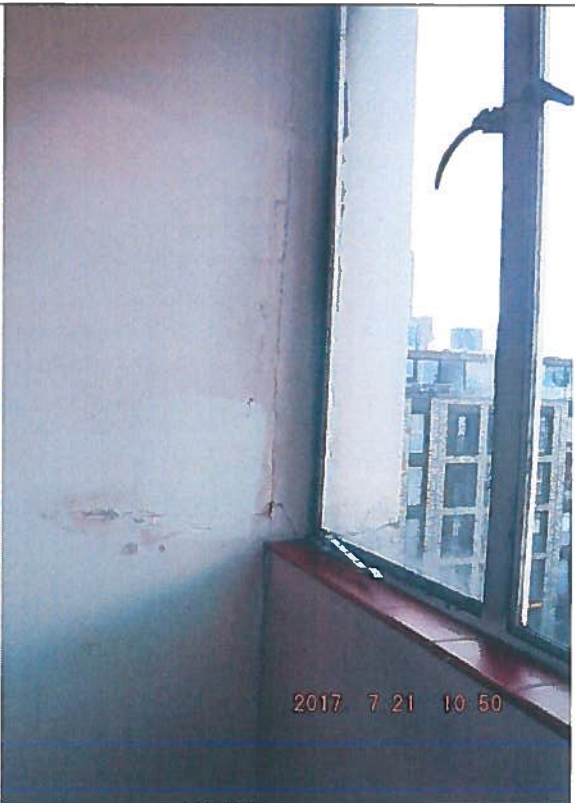
**Pic 7** Internal wall crack

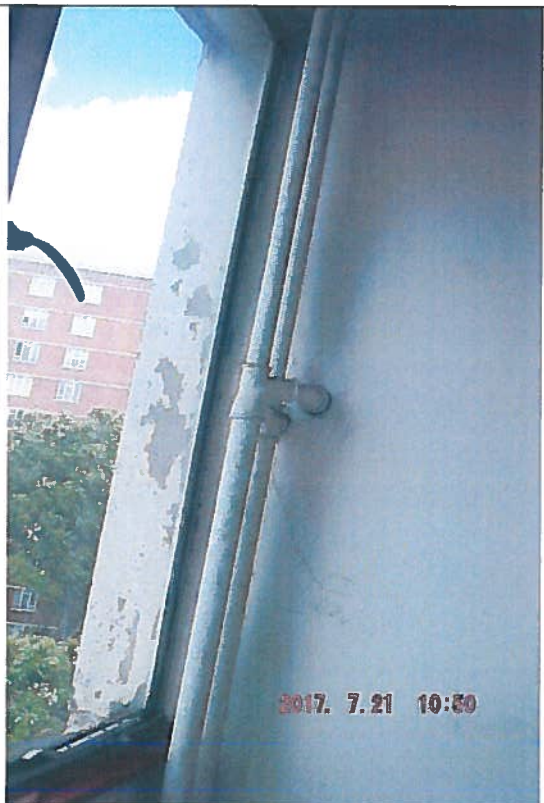
**Pic8** Internal wall crack

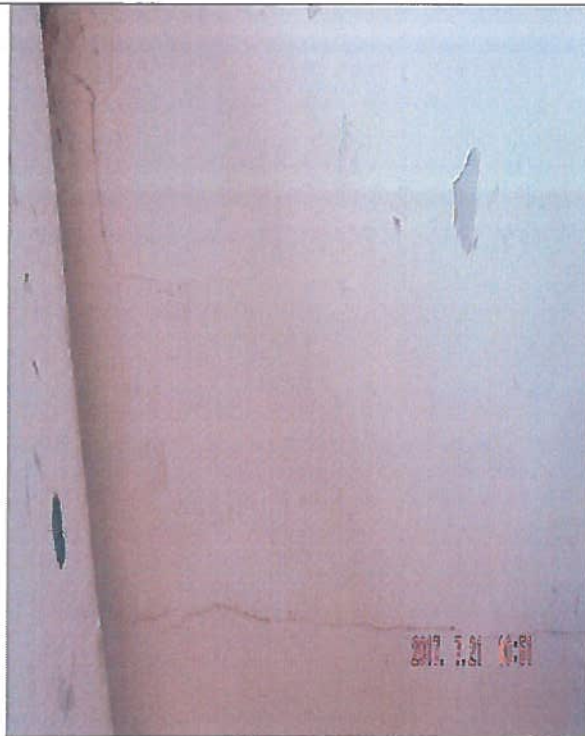
**Pic9** Internal wall crack

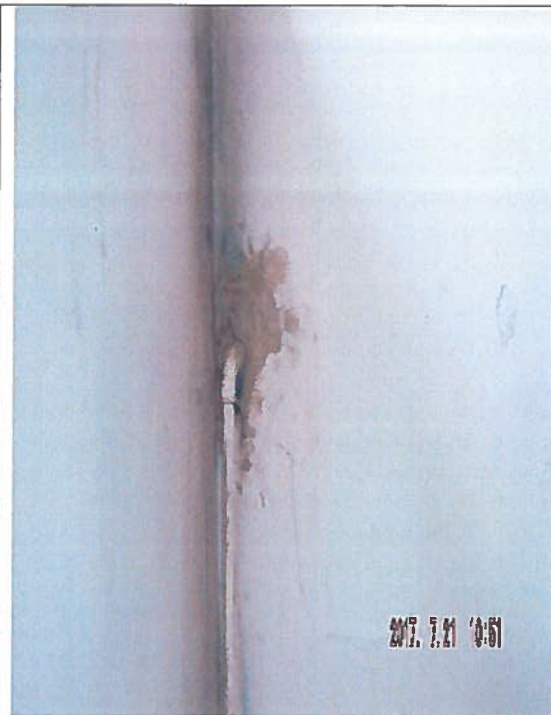
**Pic10** Internal wall crack

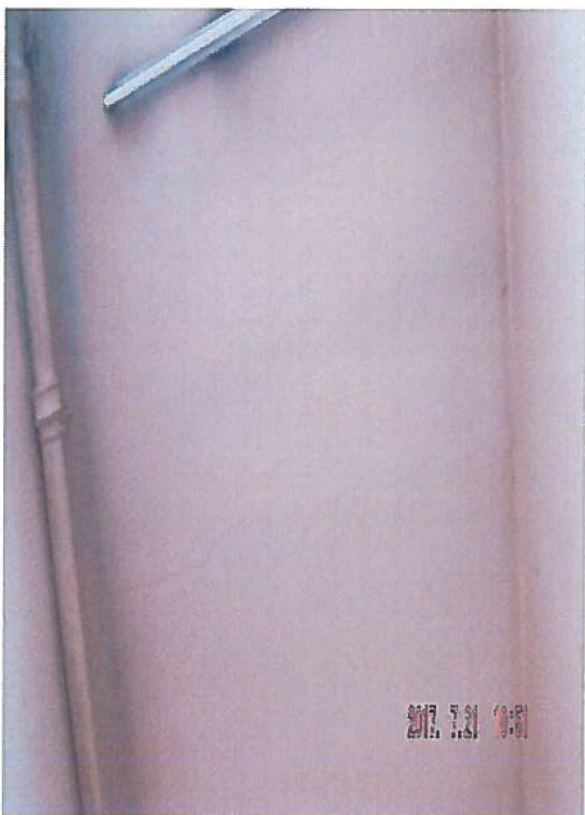
**Pic11** Internal wall crack

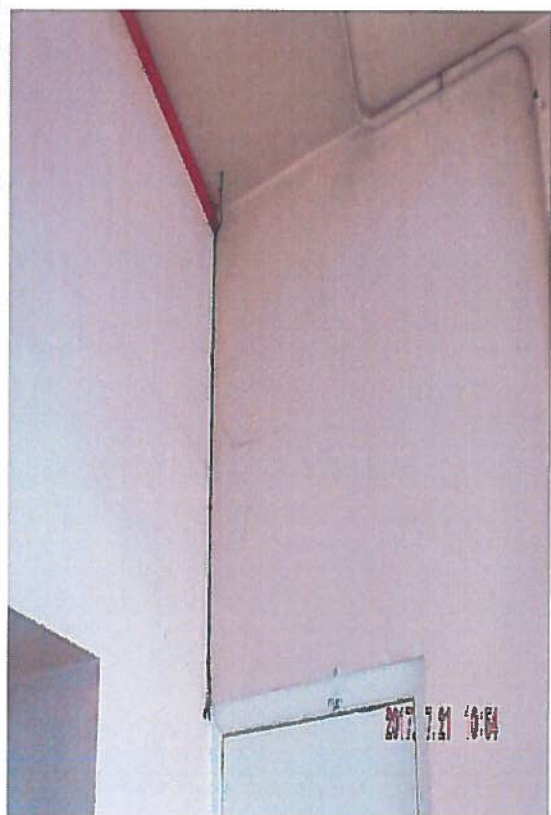
**Pic12** Internal wall crack

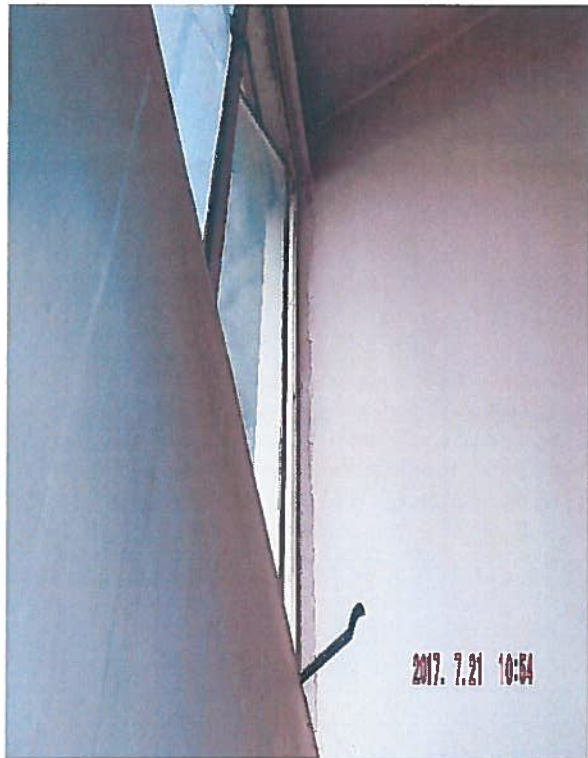
**Pic13** Internal wall crack

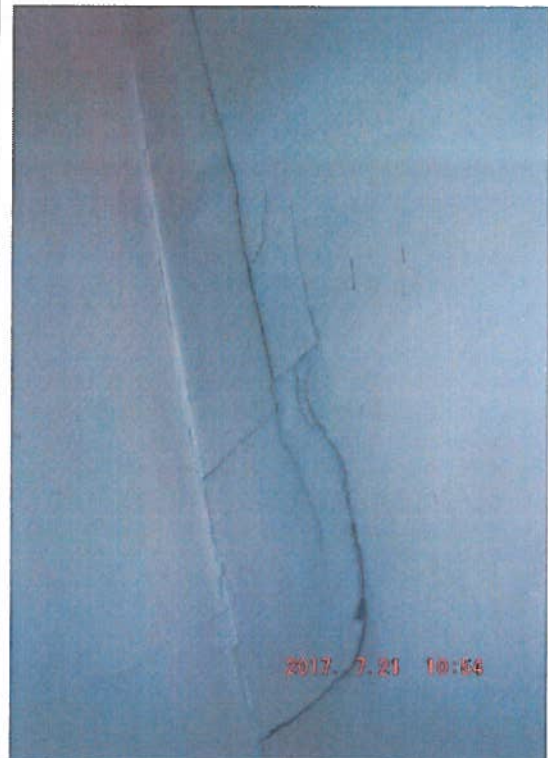
**Pic14** Internal wall crack

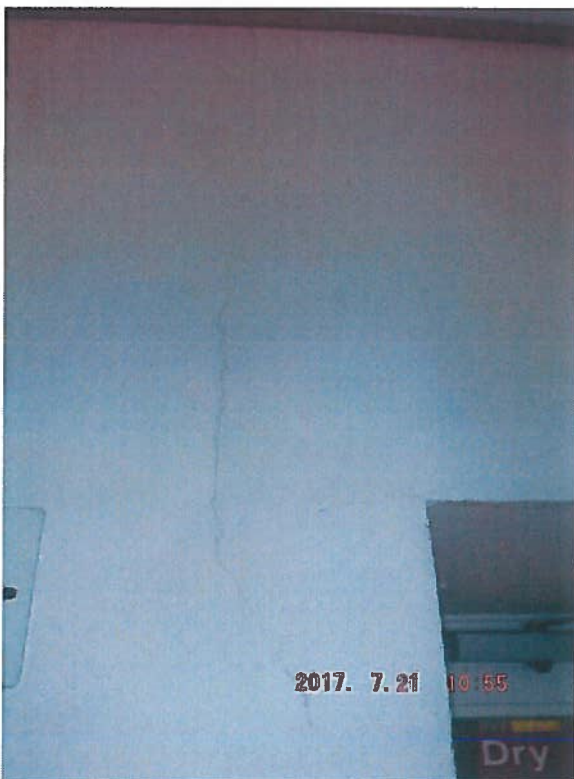
**Pic15** Internal wall crack

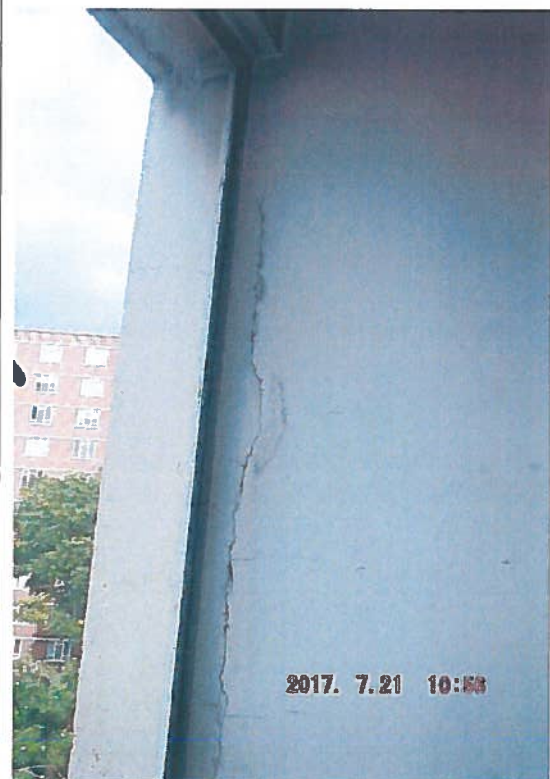
**Pic16** Internal wall crack

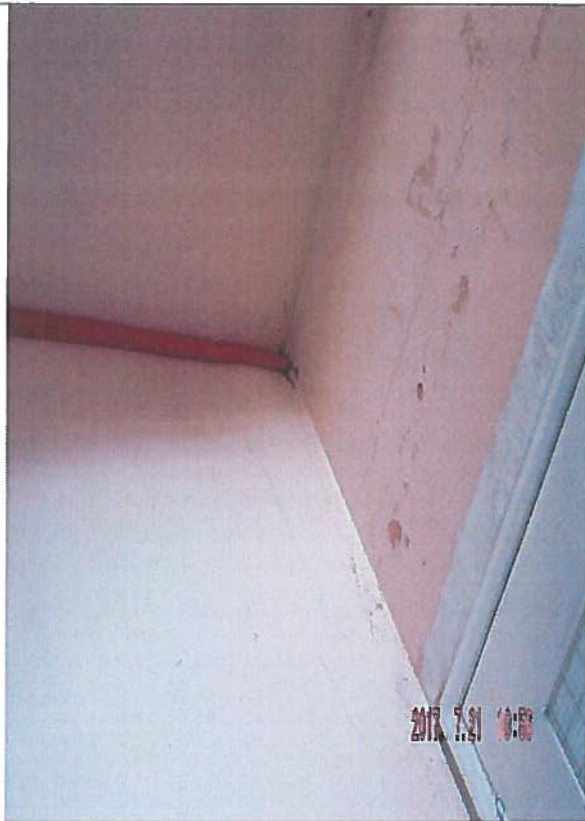
**Pic17** Internal wall crack

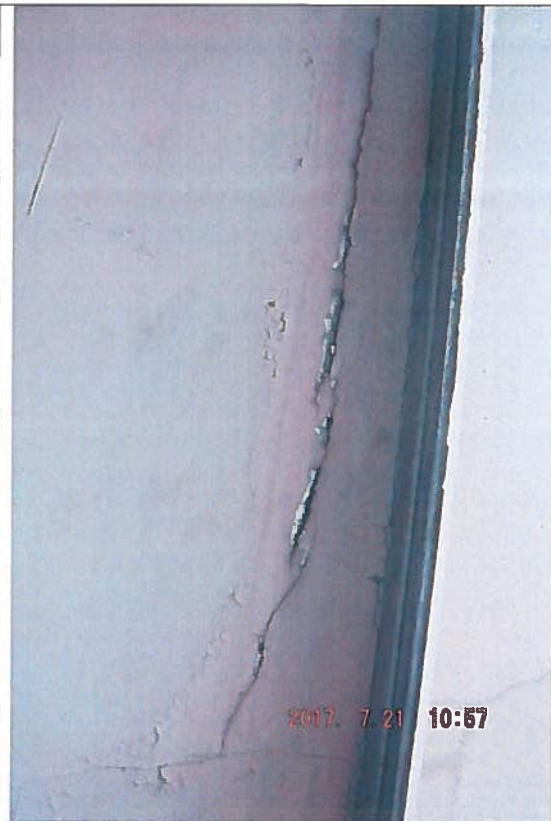
**Pic18** Internal wall crack

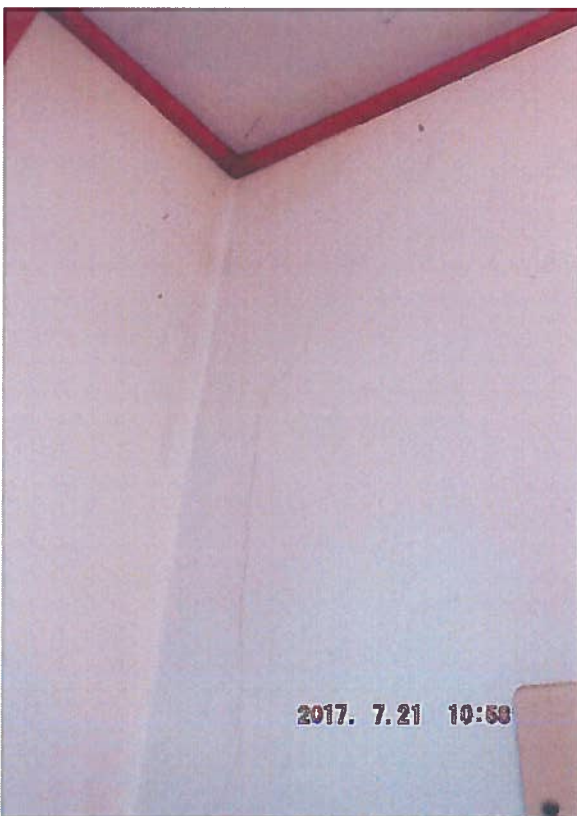
**Pic19** Internal wall crack

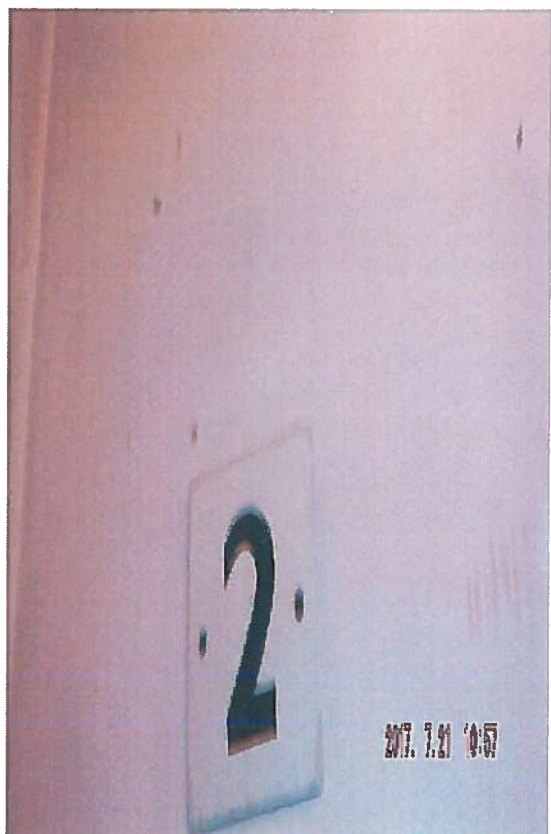
**Pic20** Internal wall crack

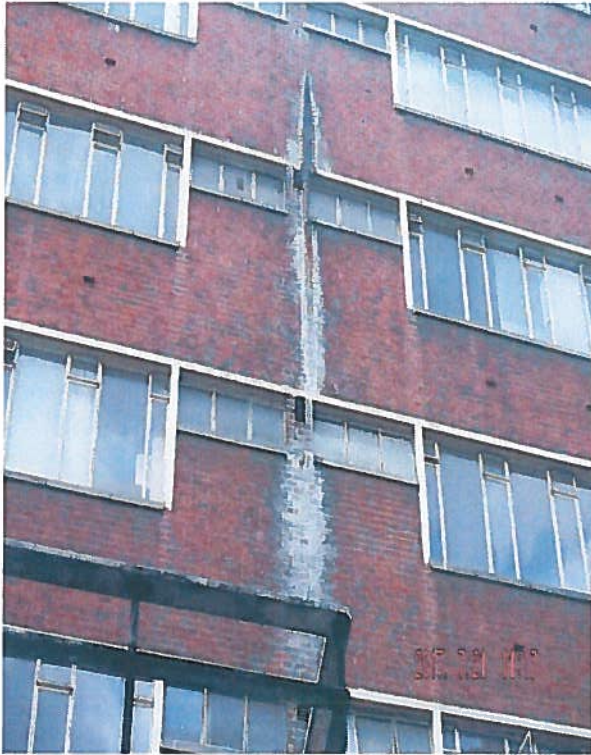
Pic.21 – Stained brickwork

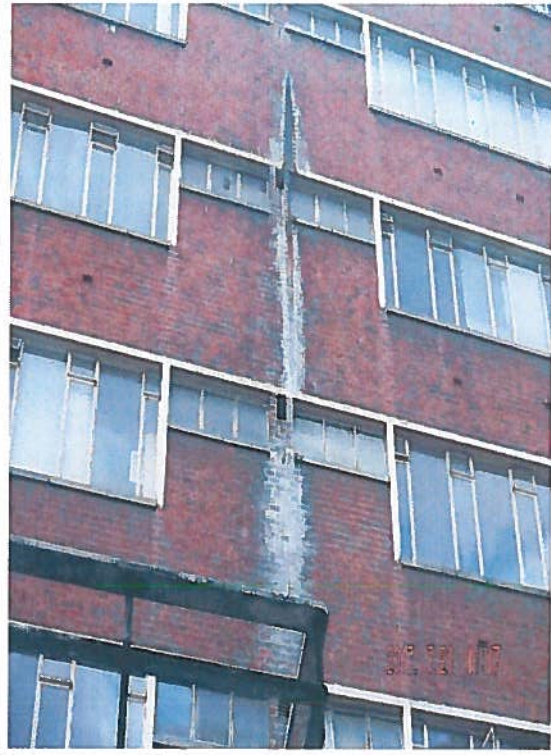
Pic.22 – Stained brickwork

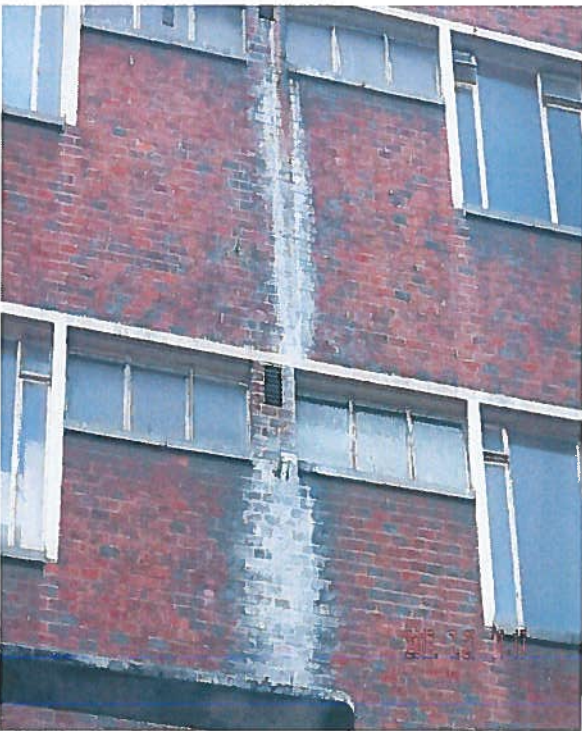
Pic.23 – Stained brickwork

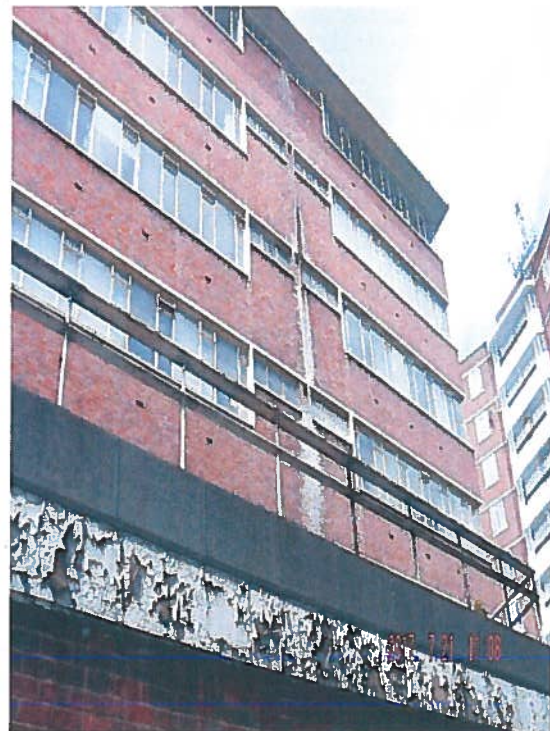
Pic.24 – Spalled concrete

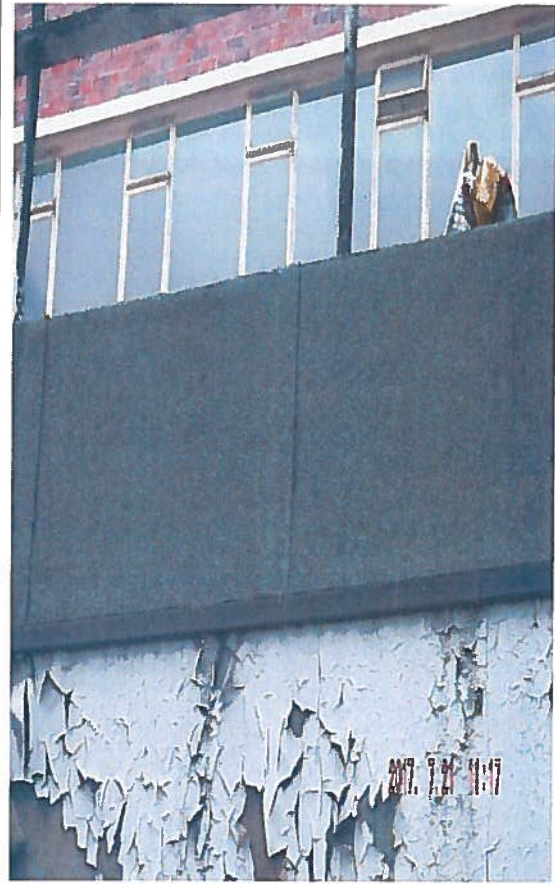
Pic. 26- spalled concrete/staining

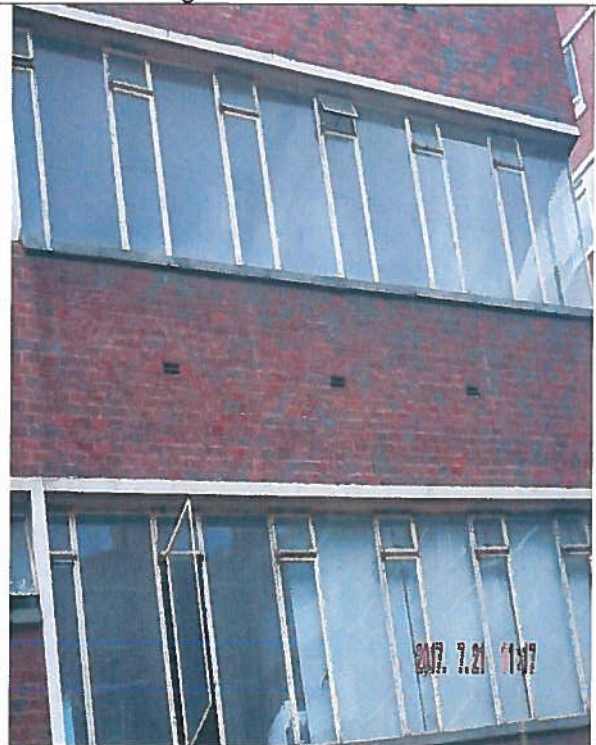
Pic 27-spalled concrete

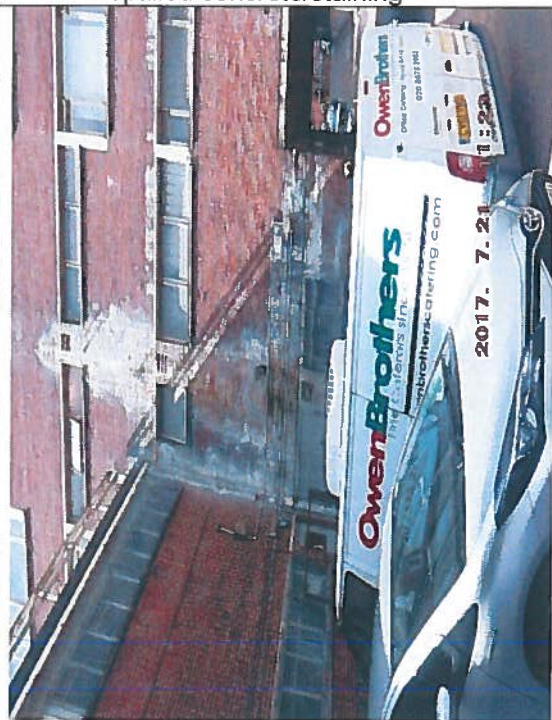
Pic 28- Stained brickwork

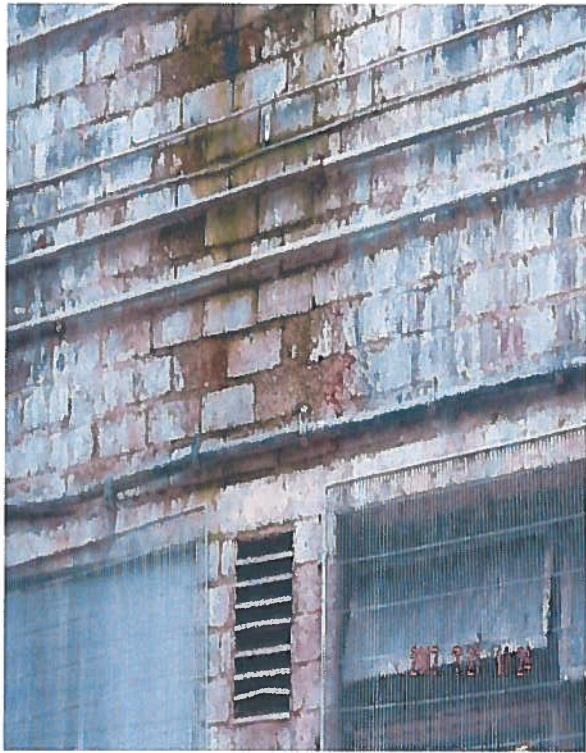
Pic 29 Stained brickwork

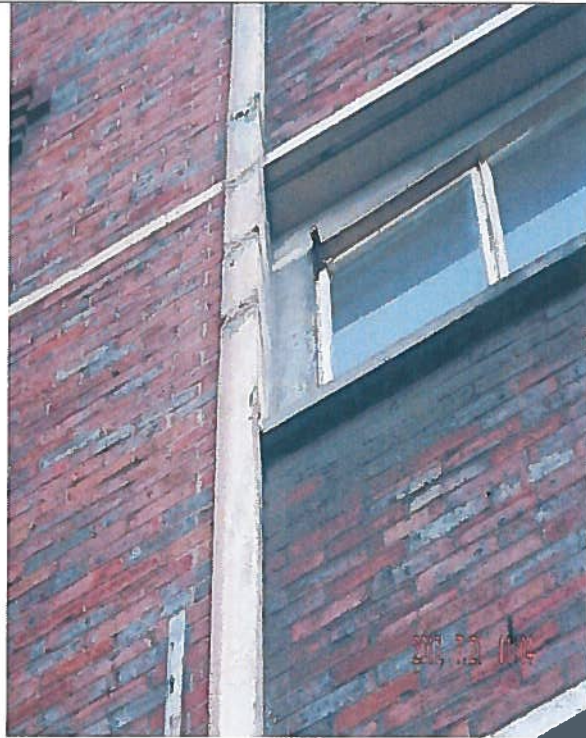
Pic.31 – Cracks in RC Column

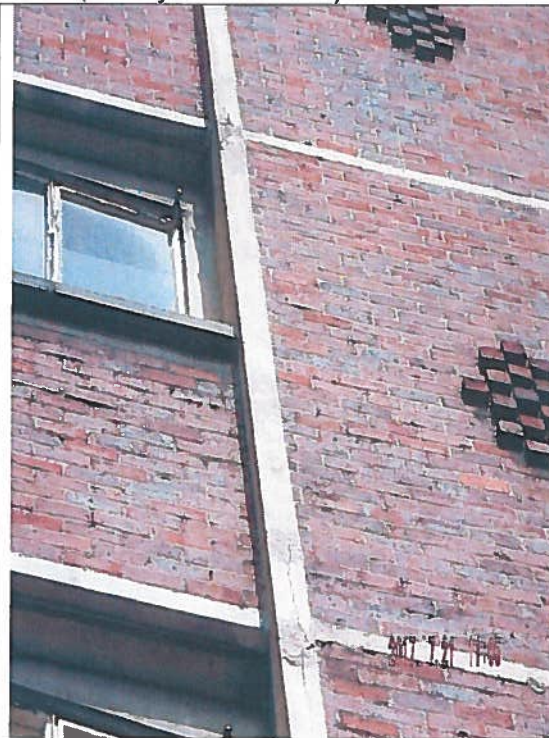
Pic.32 – Cracking in RC Column

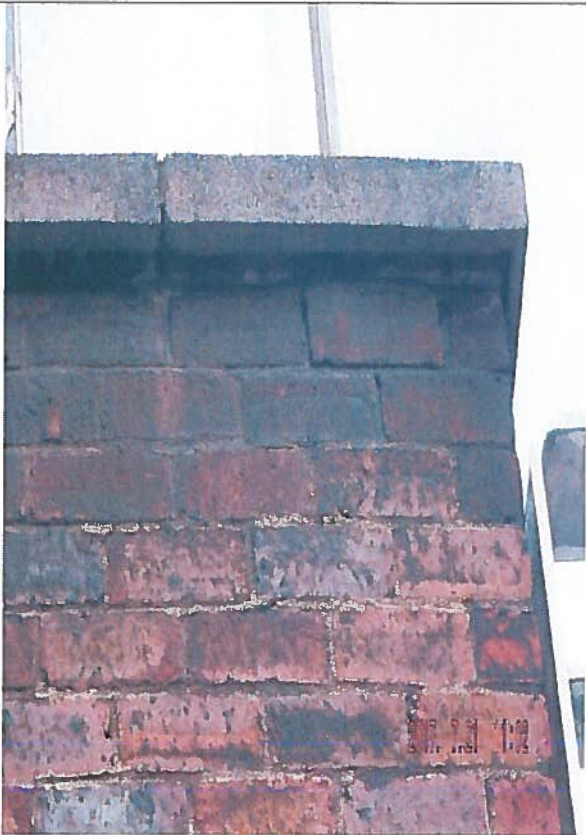
Pic.33 – Defective pointing in brickwork

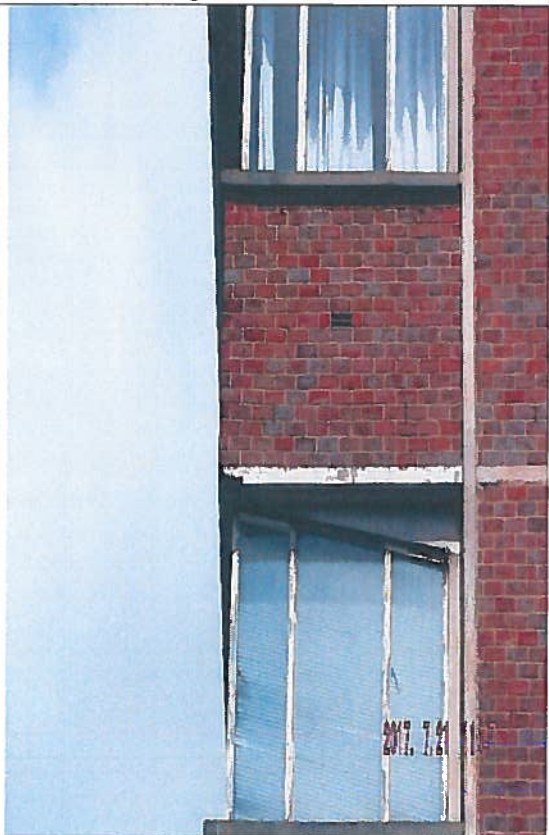
Pic.34 – Spalled concrete edge

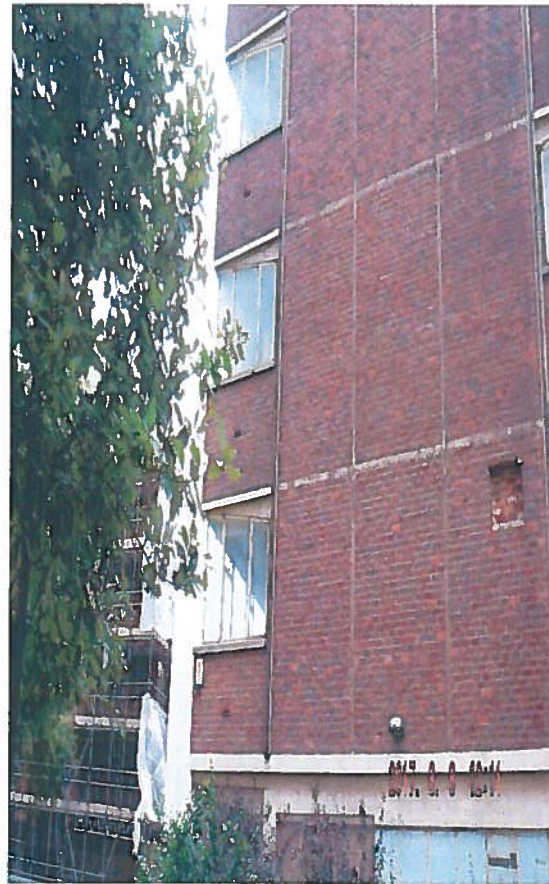
Pic. 36 Spalled slab edge concrete

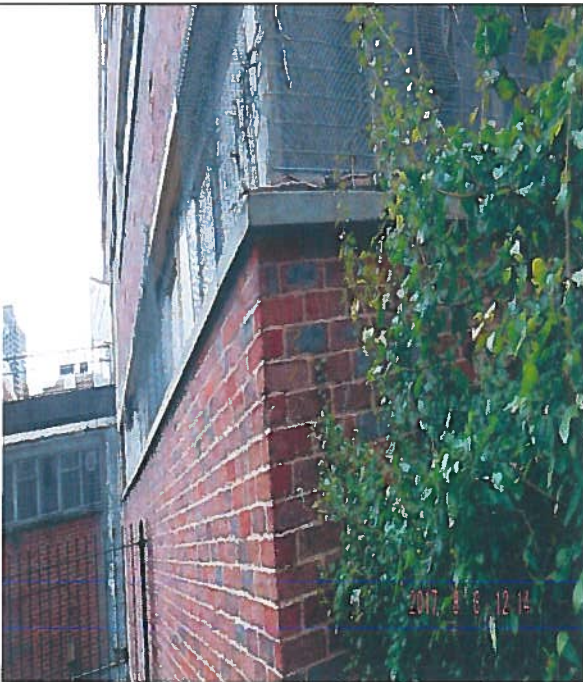
Pic. 37 – Spalled concrete

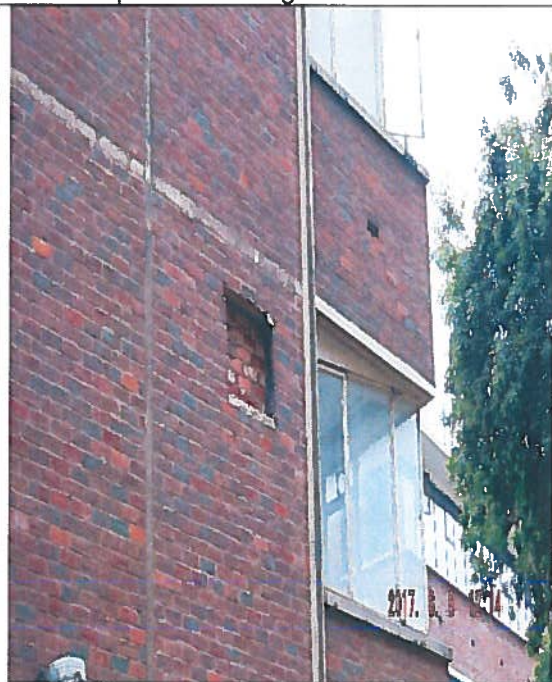
Pic. 38 – Opening in facing brick
