# Roof Survey Report

Warrington Museum  
Bold Street, WARRINGTON  
WA1 1DR, England

16th October 2019  
Project Reference: B194051/1

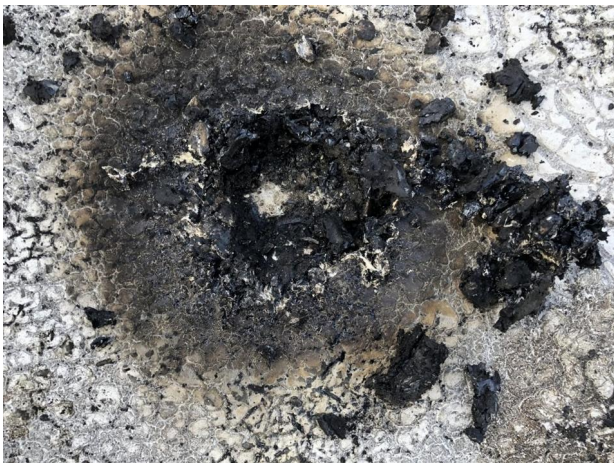
Overview of core sample

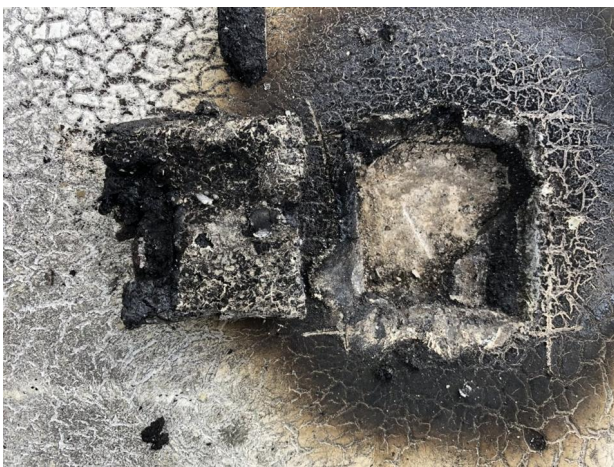
Overview of core sample.

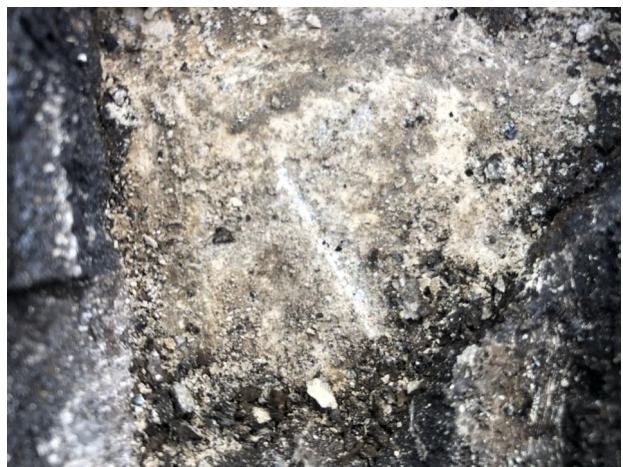
Confirmation of concrete deck.

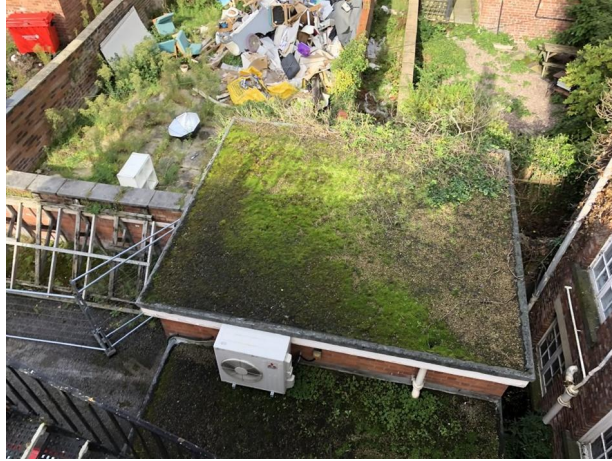
**Condition of core sample:** The deck is wet.

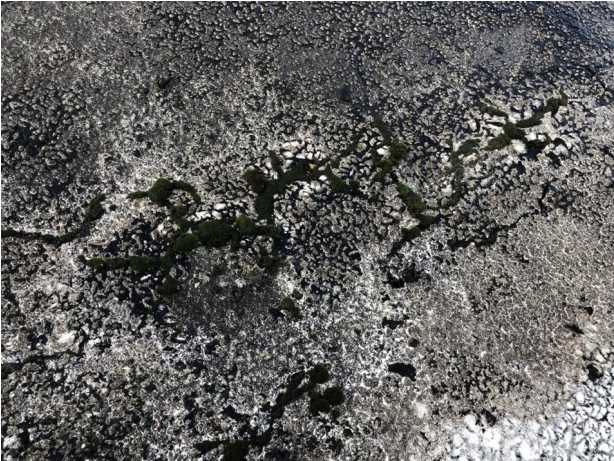
From our observations, the existing waterproofing has come to the end of its serviceable life. The system has suffered from leaks, with numerous defects.

This waterproofing system is showing all the typical defects consistent with a covering of this age including; surface oxidation, cracks, splits, blisters, rucks and signs of repair.

**Cracks have formed in the bitumen allowing moss to develop in the cracks.**

- The existing deck is to be re-used.
- **Roofs 1, 2, 3, 4, 7, 8 & gutter channels** - Due to its condition, the existing waterproofing system should be completely removed and replaced.

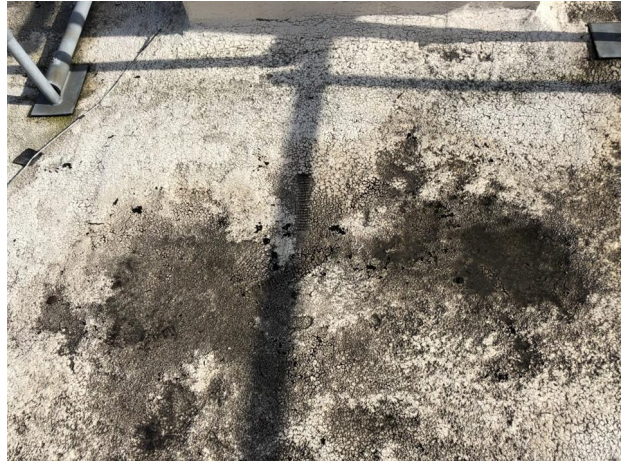
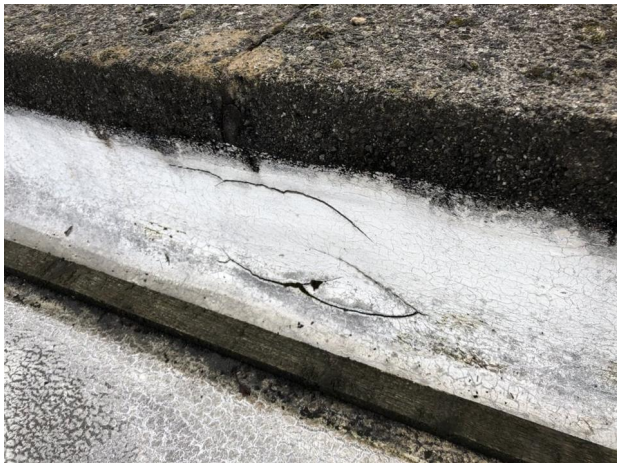
**Cracks have formed in the asphalt particularly at the waterproofing upstands.**

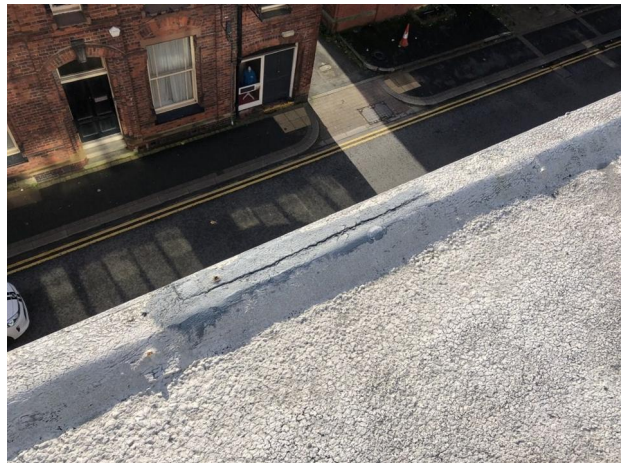
**Liquid repairs to perimeter kerb.**

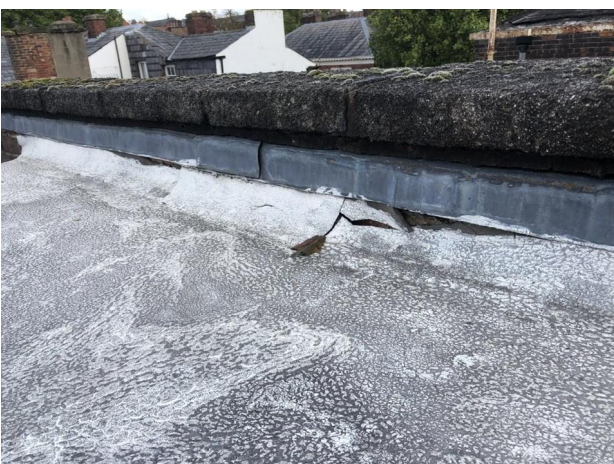
**Cracks in the upstand resulting in the waterproofing falling away.**

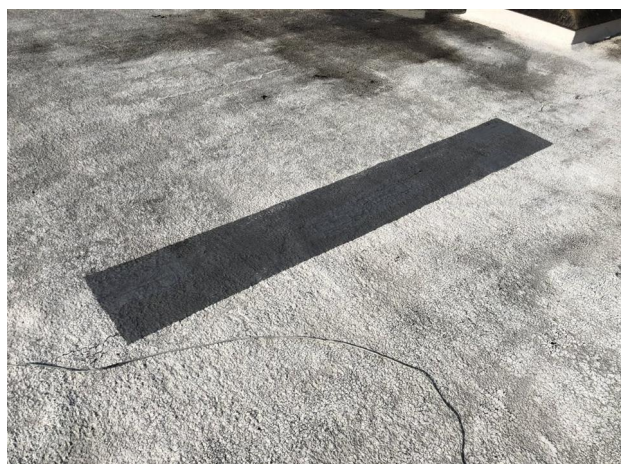
**Further liquid repair.**

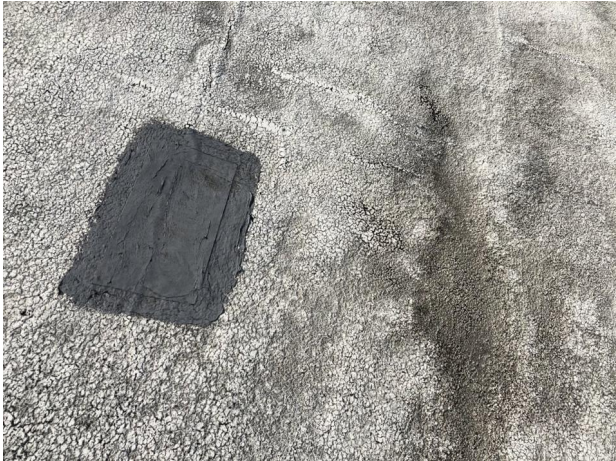
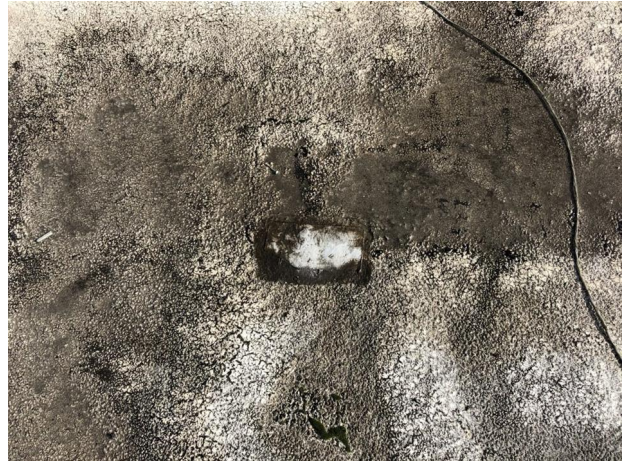
The asphalt is showing all the typical defects consistent with a covering of this age including; surface oxidation, cracks, splits, blows, slumping and signs of repair.

There is evidence of entrapped water between the layers. It firstly highlights that these layers have not been adequately bonded together, but also that water is able to enter and track through the system, either through a defect in the capping sheet lap joints, or via detailing at penetrations or abutment upstands.

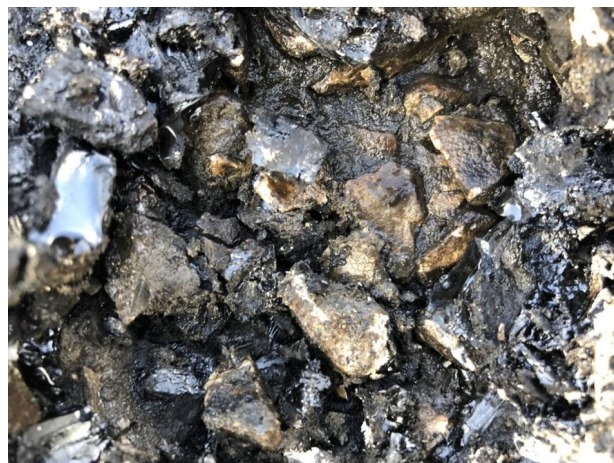
**Chippings were found to wet between the layers of bitumen.**

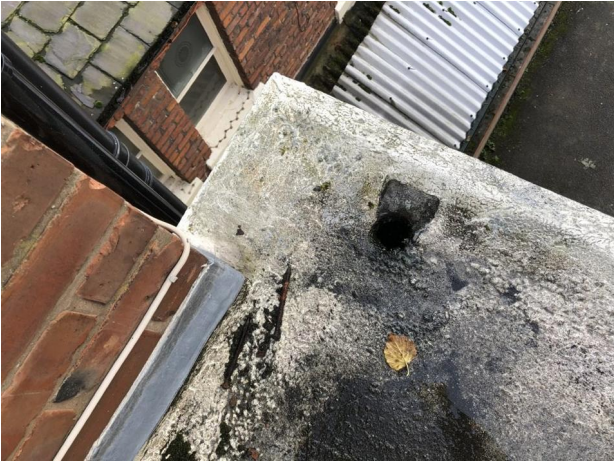
Following inspection, we have determined that the existing outlets are unsuitable for reuse with the new waterproofing system and therefore should be replaced.

**View of typical internal outlet.**

- New Bauder Refurbishment Outlets are to be installed that are compatible with the new waterproofing system and suitable for the connection to existing drainage pipework. As refurbishment outlets fit within existing outlets or pipe work, it is important that the flow rates of the new outlets are compared against the current outlets to ensure that drainage performance is not reduced or otherwise confirm if additional drainage provision may be required.

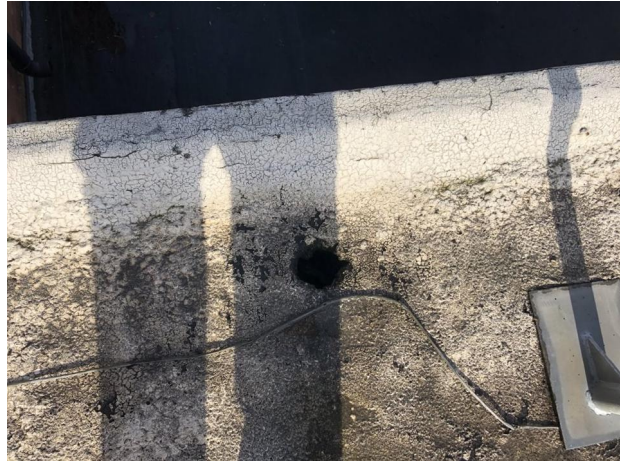
**These outlets are very narrow and have no debris guards.**

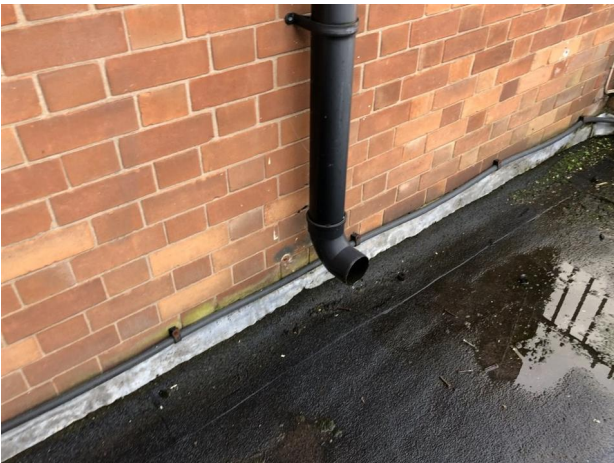
**Downpipes from high level roof areas will need to be modified to accommodate the increased level of insulation included within the proposed specification.**

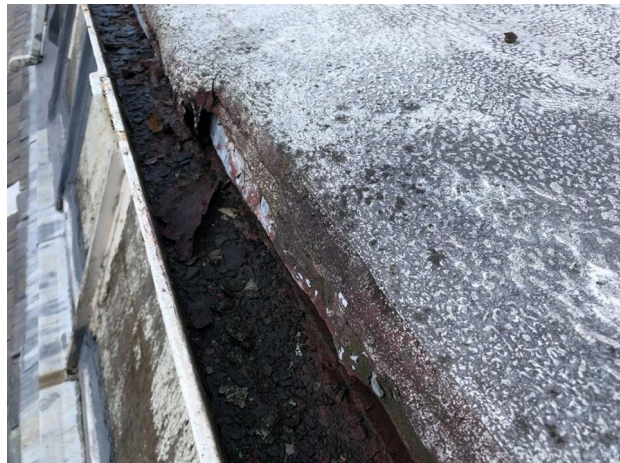
**External guttering is in poor condition and should also be replaced as part of the refurbishment.**

The existing external rainwater system is in very poor condition and should be replaced.

- The external rainwater system is in poor condition and should be completely replaced as part of the roof refurbishment works.
- The existing drainage chutes are to be removed and new site fabricated lead replacement items installed.

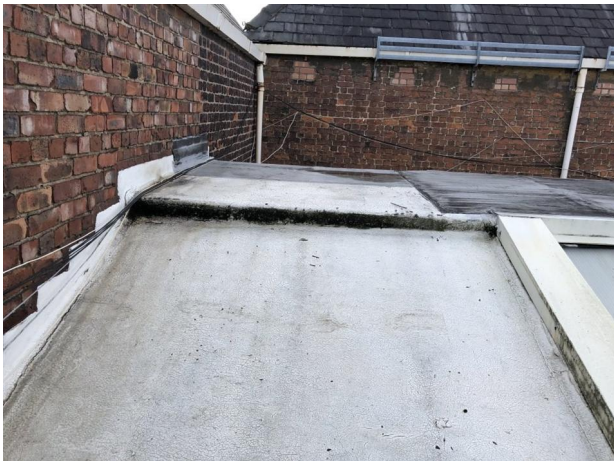
To comply with codes of practice the waterproofing should be dressed up the brickwork upstand to a minimum height of 150mm above the new finished roof level. This will impact on the position of any counter-flashings which also need to be raised accordingly.

**New details to brickwork are to be formed as part of the waterproofing. New secondary flashings are to be introduced.**

- The waterproofing upstand is to be raised to achieve the minimum required height of 150mm. Counter-flashings are to be positioned to suit.
- The existing door and frame are to be removed to allow access to raise the upstand kerb in preparation for re-waterproofing. The door and frame are to be either modified or replaced, these works need to be included within the main client specification/ schedule of works.

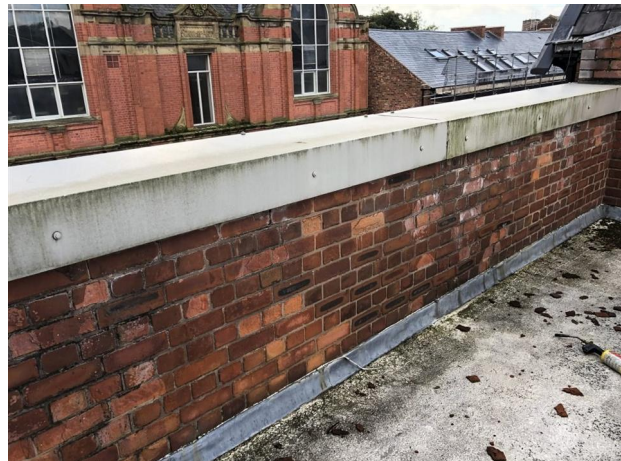
**Parapet walls are to be encapsulated in the proposed waterproofing system, subject to conservation approval.**

- The existing concrete coping to be left in situ and the upstand suitably prepared so that the new waterproofing system can encapsulate the upstand and top of the parapet wall, terminating with a GRP trim or welted drip detail.

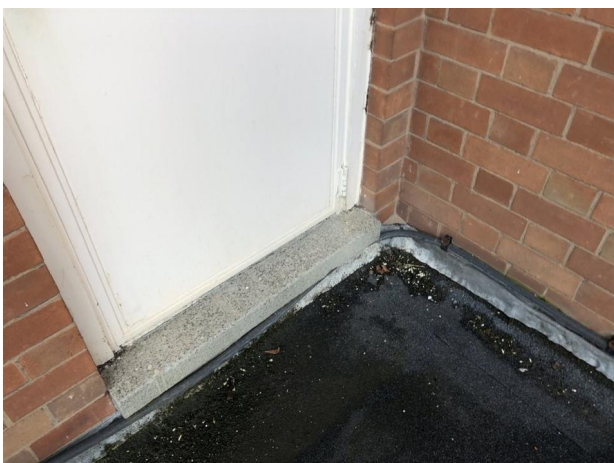
Once the roof has been refurbished there will not be sufficient height beneath the existing door threshold to form a sufficient waterproofing upstand. Due to new surface levels it will be necessary to either remove and replace or modify the door and frame.

**Doors with sills that finish close to the surface of the waterproofing will need to be modified to accommodate the increased insulation within the waterproofing system.**

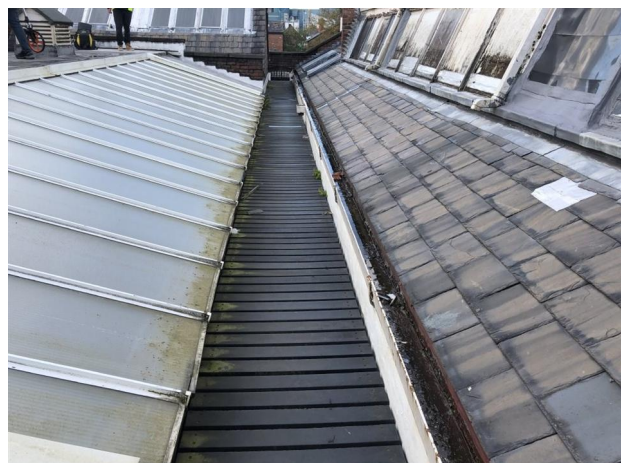
**In a number of locations the waterproofing abuts pitched tiled roof areas. Tiles will need to be removed to enable the waterproofing to be appropriately detailed.**

The lower courses of tiles/ slates from the adjacent abutment will need to be removed in order to allow access to re-waterproof the upstand behind and if necessary extend the supporting lay-board.

- The lower courses of tiles from the adjacent abutments will need to be removed to re-waterproof the upstand. This work should include provision for extending the lay-board to accommodate the change in surface level imposed by the new insulation in order to comply with the required minimum upstand height. As a consequence of these works, the lower course of tiles may need adjusting.

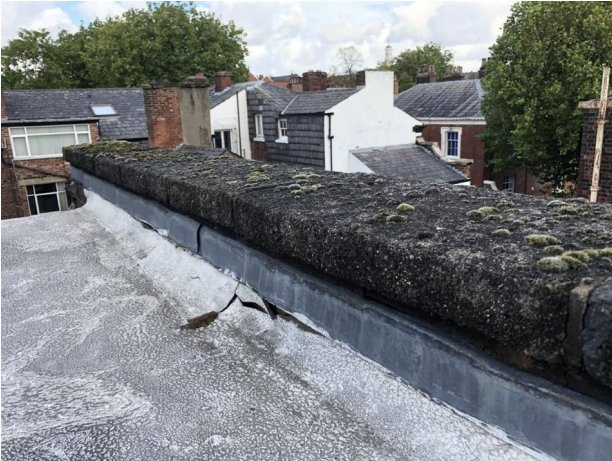
The joints in the existing coping on top of the parapet wall are defective. Water staining below the bed course is highlighting that any DPC that may be present is certainly no longer effective in preventing downward movement of water into the wall structure. Long term saturation will lead to gradual degradation of the structure and make the brickwork susceptible to frost damage.

**Coping stones are aged and covered in moss. These are to be encapsulated with the new waterproofing system as part of the proposed refurbishment.**

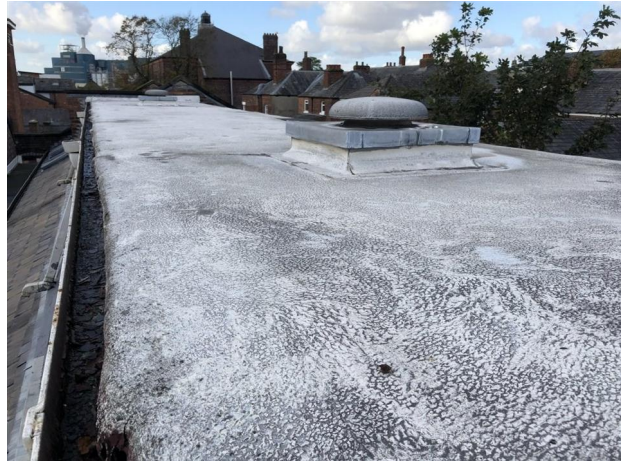
**External gutters will need to be replaced and raised as part of the refurbishment.**

The external gutter system will need to be re-positioned to suit the new surface level of the roof once the new waterproofing fascia board works are completed.

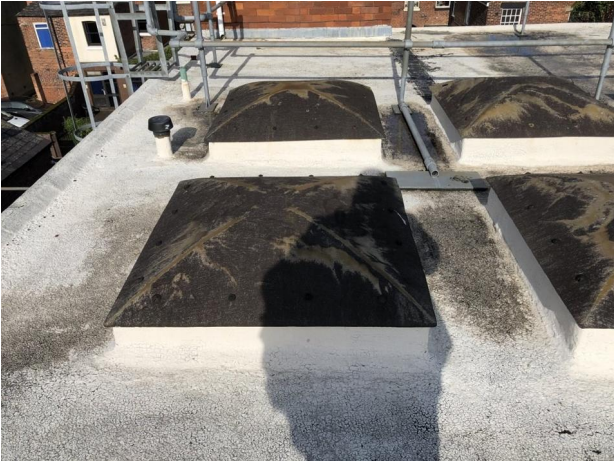
The existing rooflights mounted upon builders kerbs will need removing in order to allow the kerb height to be raised to the required minimum height and then re-waterproofed.

**Rooflight kerbs are to be modified and raised to accommodate the insulation levels included within the waterproofing system.**

- The existing rooflights must be removed to enable the upstand kerb to be raised to comply with the required minimum upstand height. Raising the kerbs will affect the internal linings and provision should be included for any consequential extension and re-decorating work to the linings.

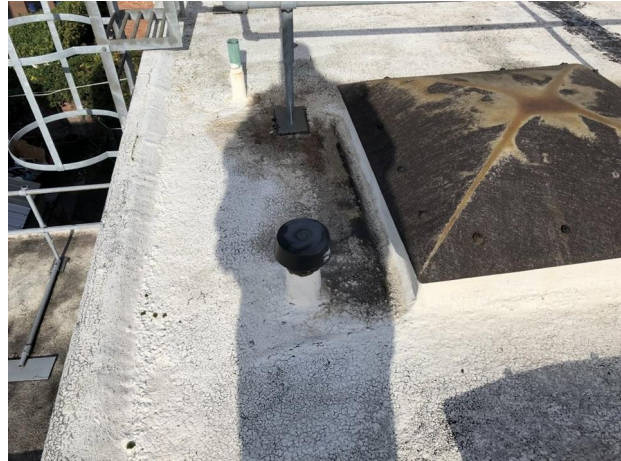
**Soil and vent pipes will also need to be modified and raised.**

The change in surface level, once the new waterproofing system is installed, will necessitate extending the existing soil vent pipes. This is to ensure there is sufficient provision for forming the waterproof upstand detailing to the pipes and fitting any secondary weathering collars.

- Provision should be made for extending the existing soil vent pipes in order to accommodate the increase in the finished surface level resulting from the thickness of the new waterproofing system.

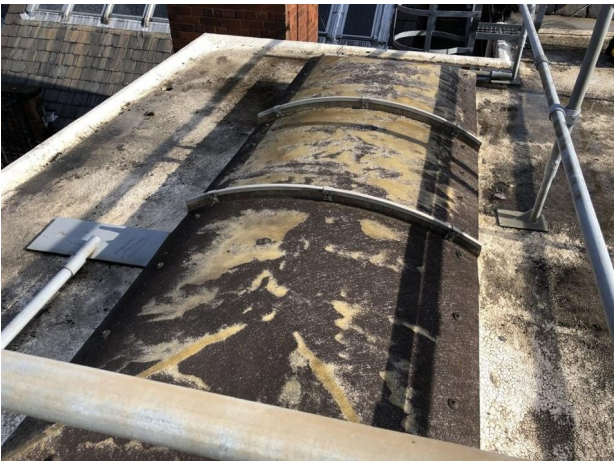
The current rooflights are proprietary plastic glazed units. These fall below current thermal and light transmittance standards and the performance will continue to decrease with age. The service life of these rooflights is not compatible with the service life of the new waterproofing system and for these reasons we propose that they are replaced. Please be aware that these units may contain asbestos in the internal linings.

**Rooflights are aged and are far below current regulations.**

- The existing rooflights should be replaced with new modular Bauder Rooflight units that offer improved thermal and light transmittance performance and are classified as being non-fragile. These will complement the performance of the replacement waterproofing system during its serviceable life. Please advise your requirements and we will include these within our separate schedule and specification for replacement Bauder Rooflights.

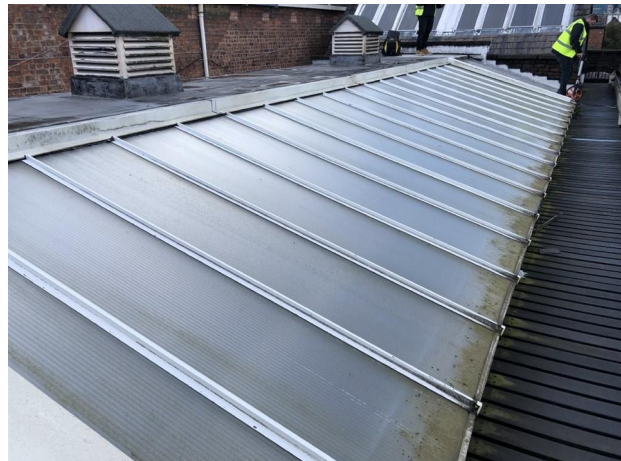
**Monitor glazing is also aged and glazed with georgian wired glazing which is below current standard and should be replaced as part of any refurbishment.**

Natural light is provided by roof mounted monitor lights. These feature a flat waterproofed roof with glazing within the sides of the structure. This glazing is thermally inefficient and should be replaced with modern glazing units to upgrade the thermal performance in line with thermal

- The windows to the sides of the existing monitor lights should be replaced with modern replacement glazing, so as to offer improved thermal performance and modern levels of light transmittance.

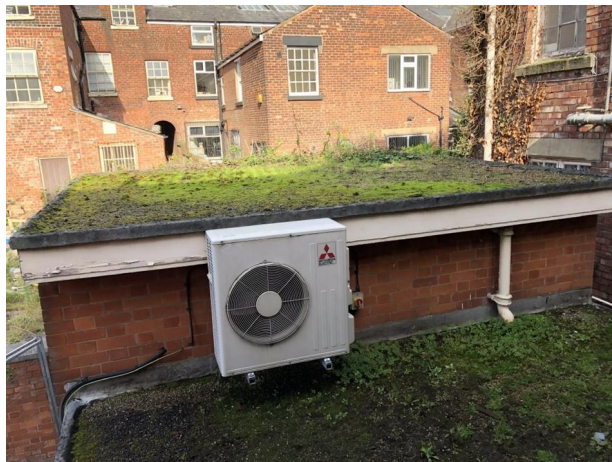
The roof mounted AC units appear to be functional, they are positioned on or very close to the roof. We assume they are to be retained on the roof following any refurbishment of the waterproofing. Unfortunately it will not be possible to refurbish the area of waterproofing beneath the AC units due to their proximity to the waterproofing membranes. They will require temporary disconnection and relocation while the roof is refurbished.

**A/C units will need to be temporarily disconnected and raised to accommodate the proposed insulation included within the refurbishment.**

- The roof mounted AC units are to be disconnected and temporarily relocated while the roof is re-waterproofed. The AC units are then to be repositioned on suitable surface protection and reconnected.

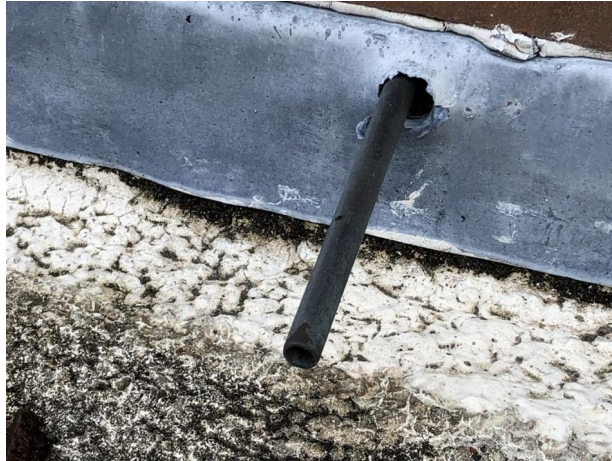
The tank house overflow pipe remains functional and must be retained. The overflow pipe should be re-positioned at a higher level to ensure it does not penetrate the new waterproof detailing following re-waterproofing.

**Further investigation is to be undertaken internally to identify the source of the overflow pipe. This overflow will need to be raised above the new waterproofing upstand.**

- The existing overflow pipes must be repositioned a minimum of 150mm above the new roof surface level, without impeding or penetrating the waterproof upstand detailing.

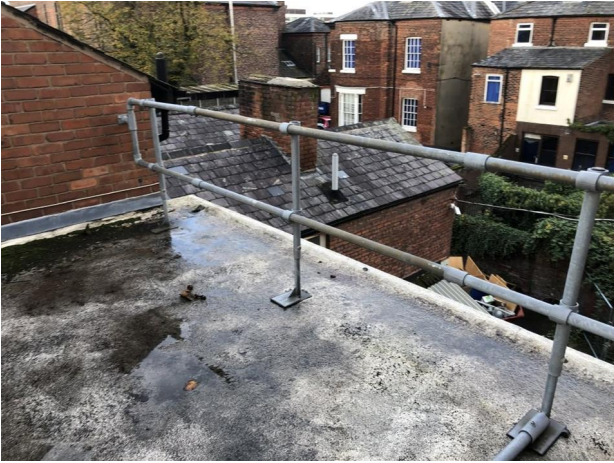
**Handrails are present across the roof areas, these are freestanding which have been fixed to the brickwork at either end.**

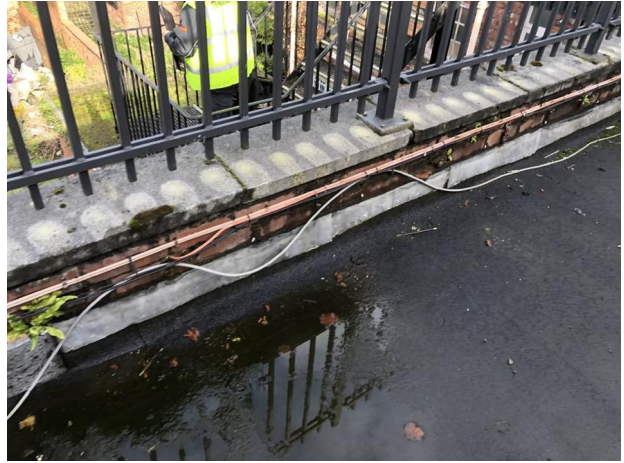
**Fixed handrails have also been fixed into the copings. These will need to be modified to ensure a robust detail is achieved as part of the refurbishment.**

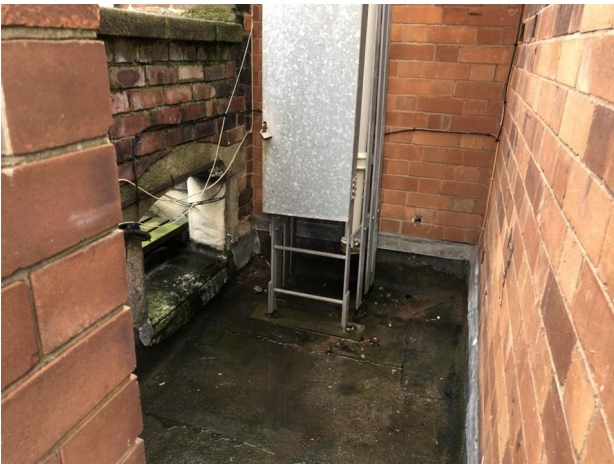
**Access ladders will need to be modified to accommodate the raised surface level of the proposed waterproofing.**

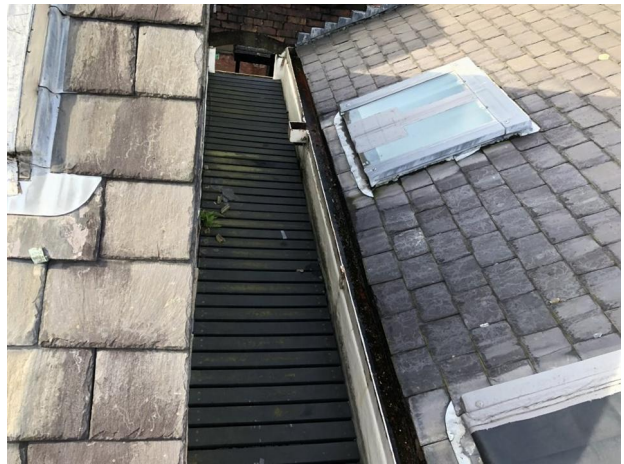
**Walkways will need to be recreated as part of the refurbishment.**
