Conservation
Anti-slavery Arch, Paganhill Stroud
for Stroud District Council

South east elevation Condition

295-SU02 RevA

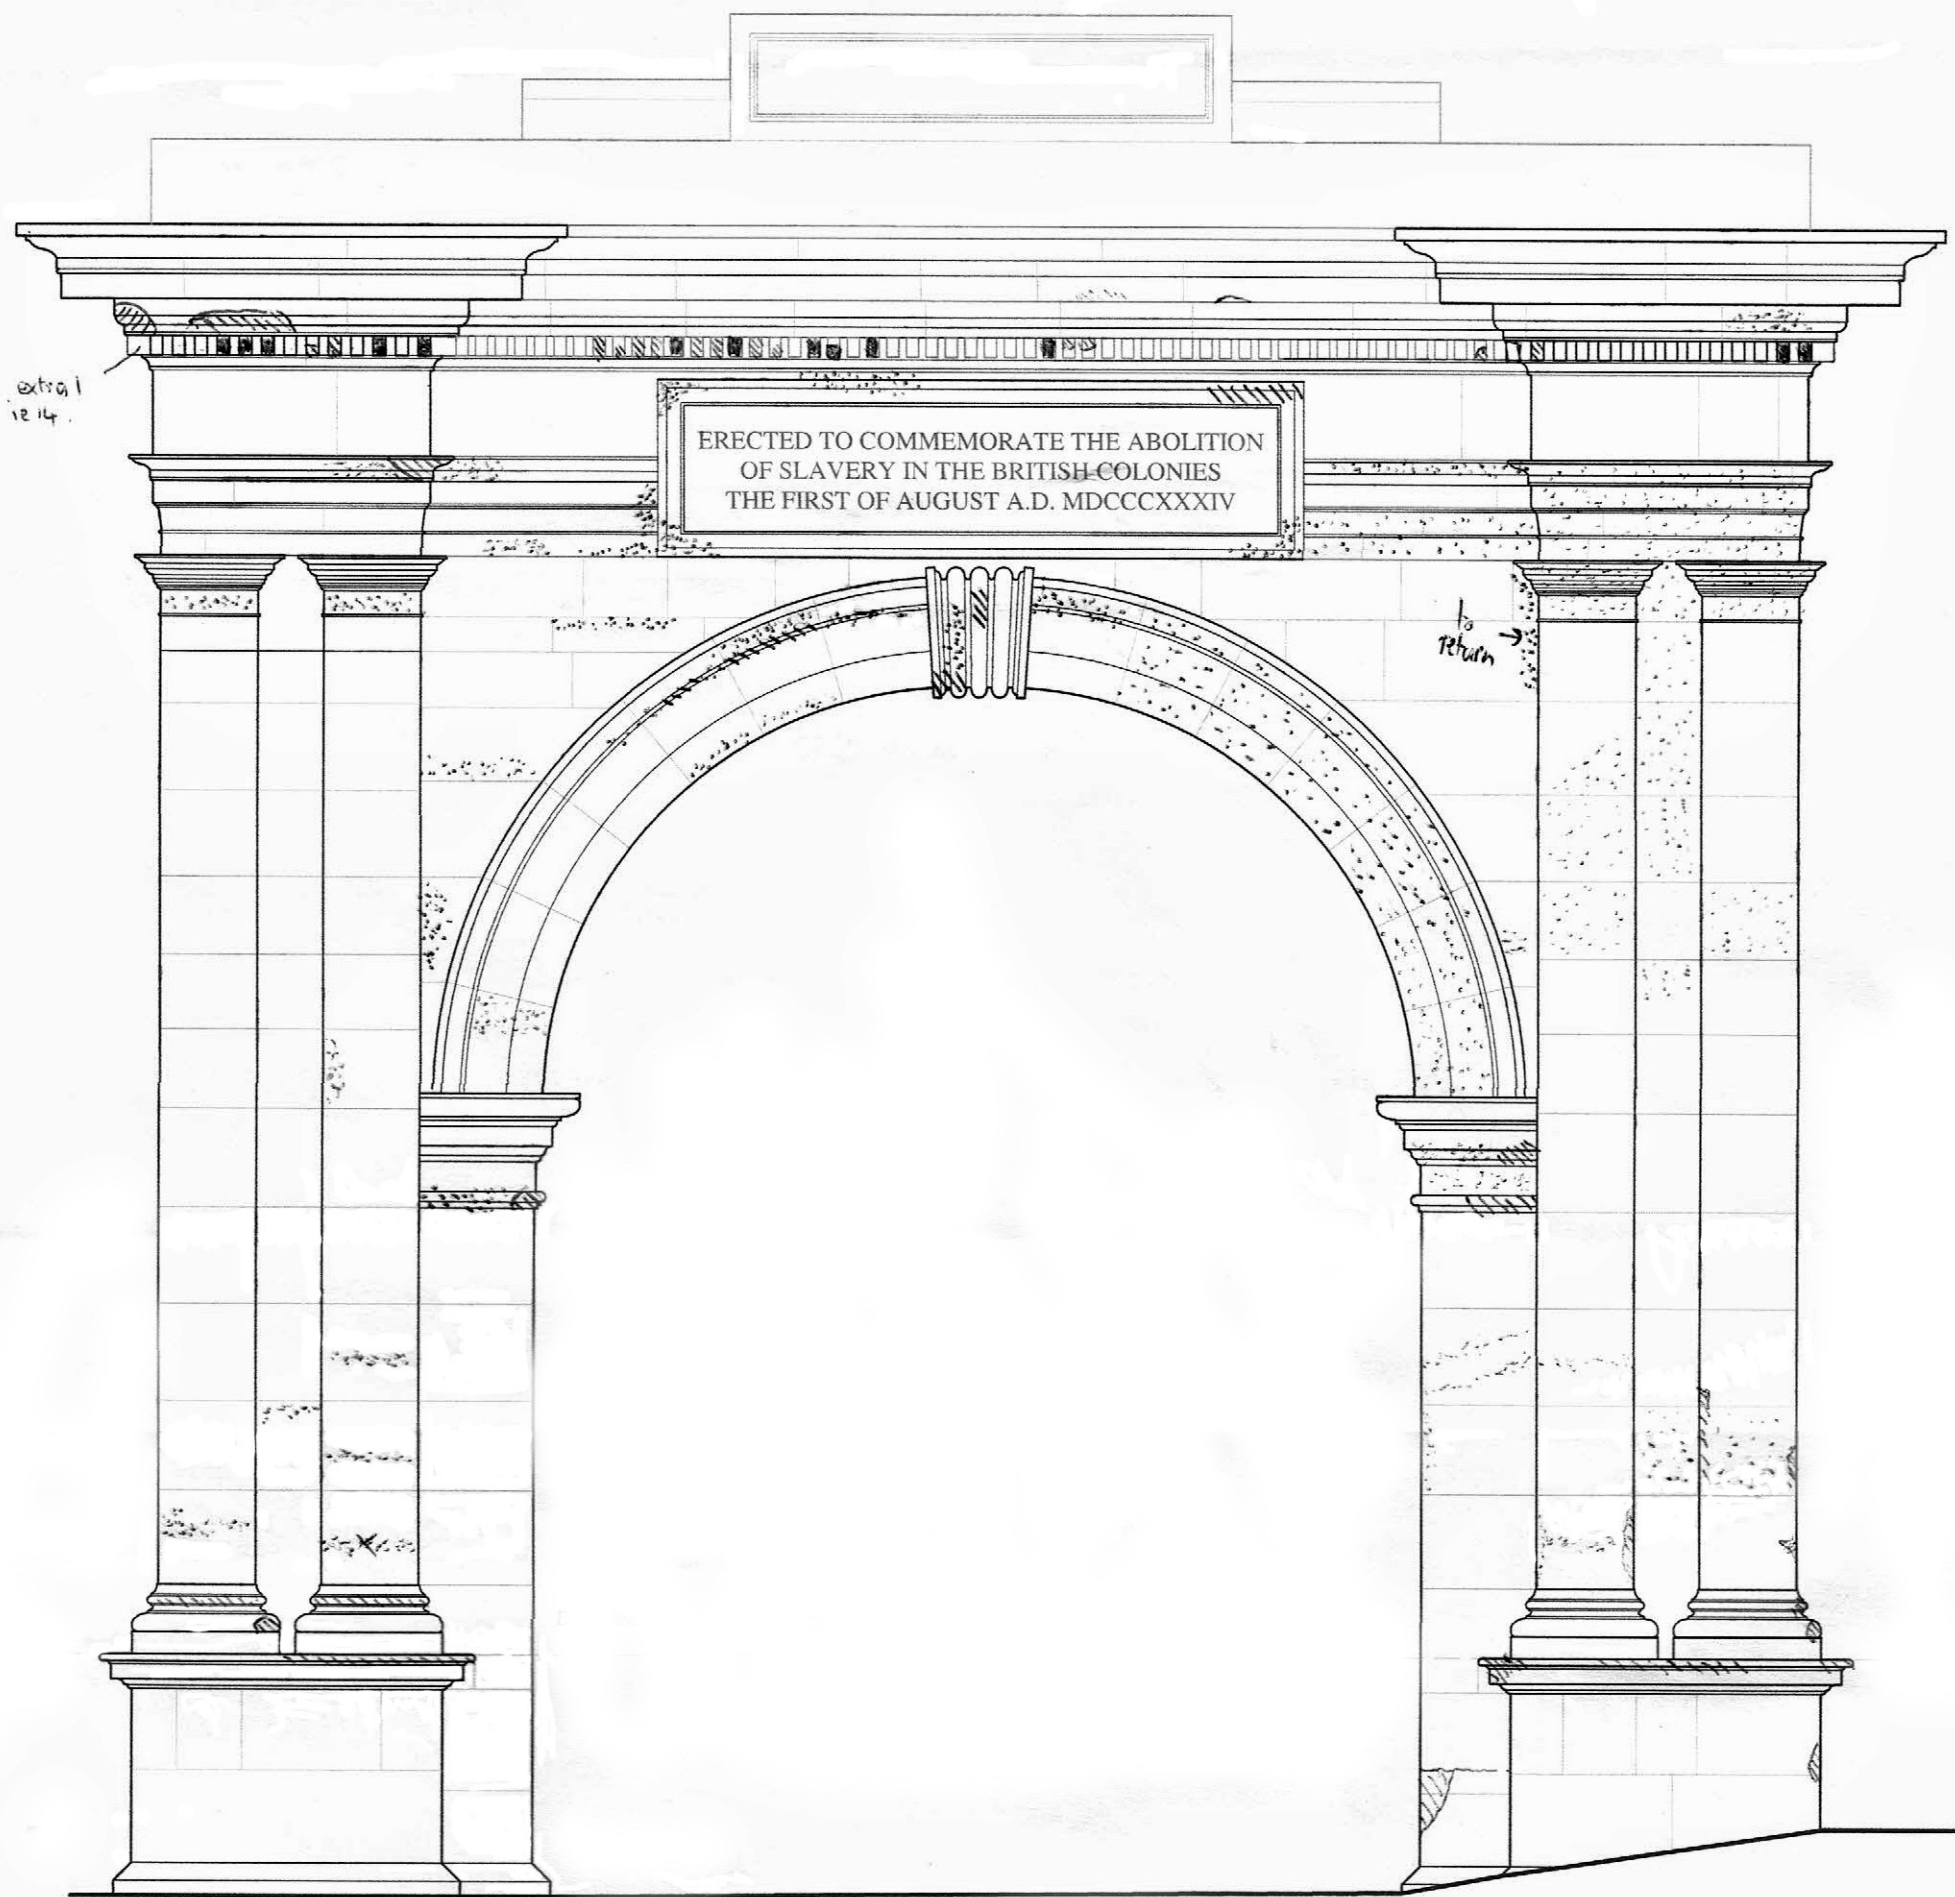
South east elevation (facing Farmhill Lane)

CONDITION	Friable/spalling surface	Friable/eroded surface with loss of section	Completed frost-damaged/lost section	F - Fracture	MR - Mortar repair	EB - Embedded iron
PROPOSED REMEDY	Consolidation with sheltercoat generally (whole block); mortar repair to remove water shedding	Mortar repair to non-weathering surfaces; stone indent to weathering surfaces	Stone indent or stone replacement	Pin/micro-pin	No work if sound Repeat if faulty	No work if stable Drill out and mortar repair if corroding
