# Bituminous Interim Inspection

<b>PROJECT NUMBER</b>	B193463/1	<b>AREA MANAGER</b>	Chris Rea
<b>PROJECT NAME</b>	Tony's Ballroom		
<b>PROJECT ADDRESS</b>	Town Hall Street, BLACKBURN Lancashire BB2 1AG		
<b>APPROVED CONTRACTOR</b>	Gables UK Ltd		
<b>TEL</b>	01772 455336		
<b>SITE CONTACT FOR ABOVE</b>	Lee Dodd (01772 455336)

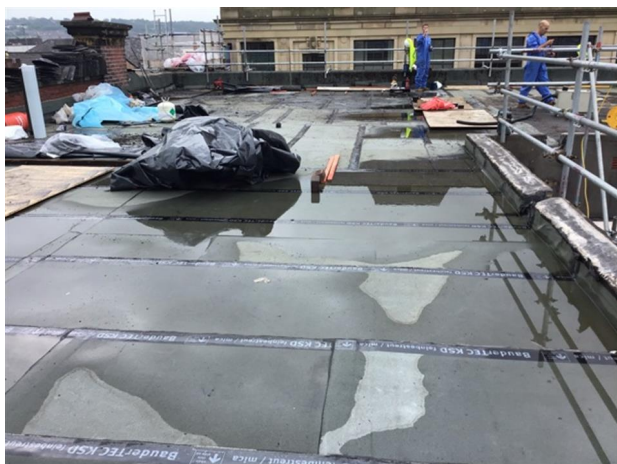
Progress to date as follows, roof 1 is being stripped of the existing waterproofing, approximately 50% has been re-decked and AVCL installed, remaining area is being re-joisted due to the condition of the existing timbers.

Photo 1 - View of progress to roof 1

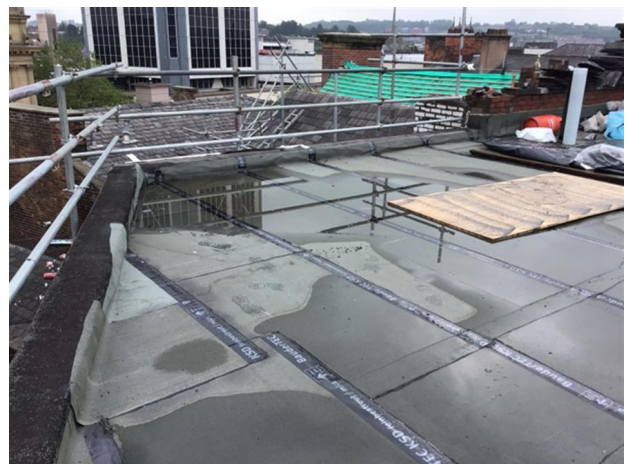
The area currently AVCL'd the falls look good with only a small amount of ponding in front of the chute, this could be minimised further if a tapered sump board was introduced and making sure that the lead chute doesn't have a back fall.

Photo 2 - View of AVCL to roof one and water in front of chute

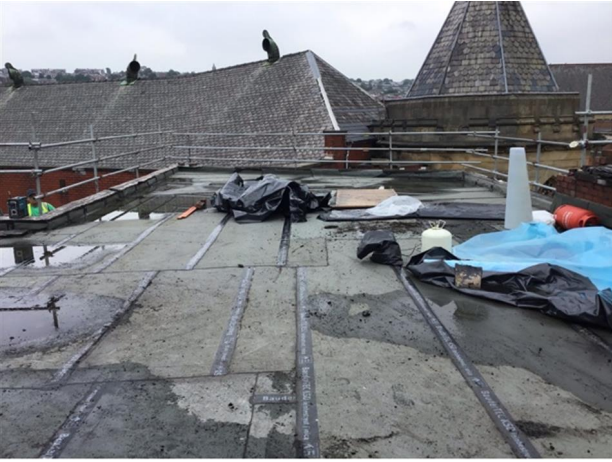
**Photo 3 - Overview of progress to roof 1 and falls**

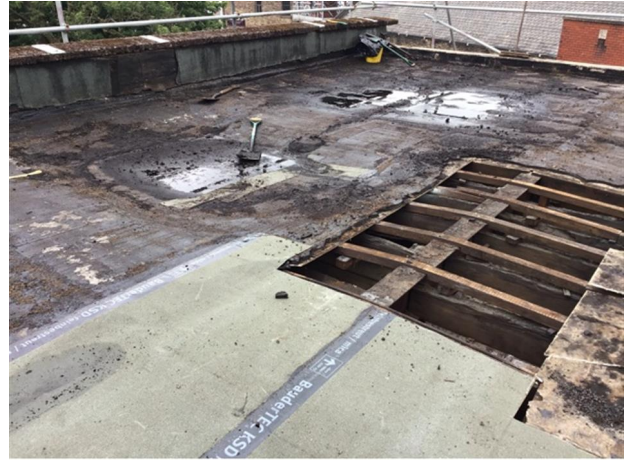
**Photo 4 - View of area to be re-joisted**

To the area to be re-joisted, as a suggestion furrings can be introduced to create the desired fall, either duo pitched or singular, single would allow the blocking off, of the awkward outlet detail in the far corner, this can be ran in to a gutter along the parapet with two chutes draining on to the lower pitched roof

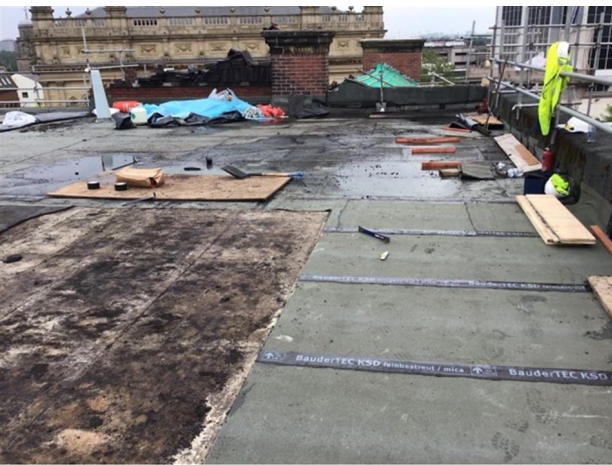
**Photo 5 - View of roof 1**

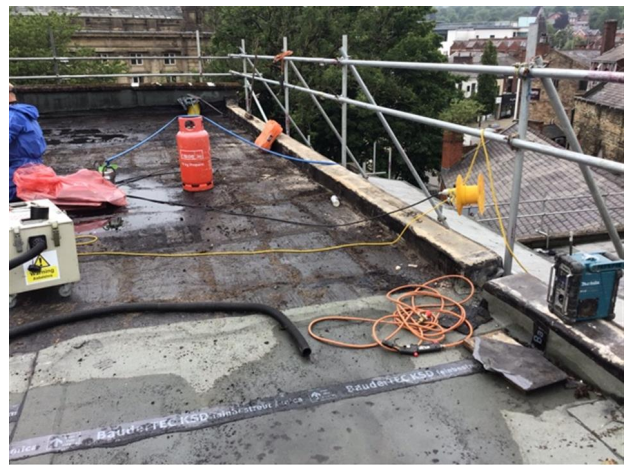
**Photo 6 - Suggestion of furrings to fall from left to right in to a gutter with two chutes draining on to lower pitch roof**
