Roof Survey Report

Whiterock Academy
Davies Avenue, PAIGNTON
TQ4 7AW, England

1 August 2022
Project Reference: B223924/1

PREPARED FOR:
Simon Wright
Torbay Development Agency

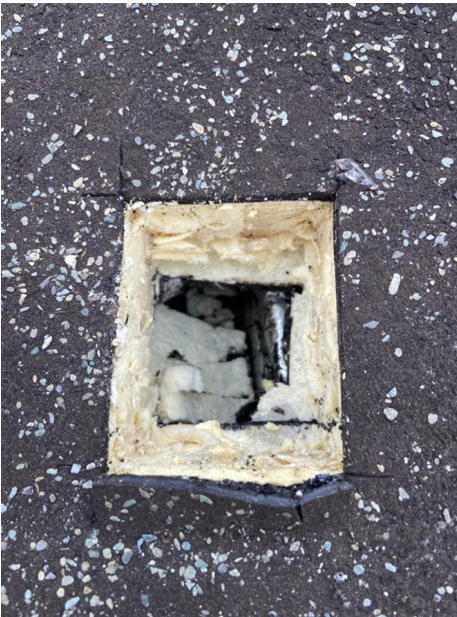
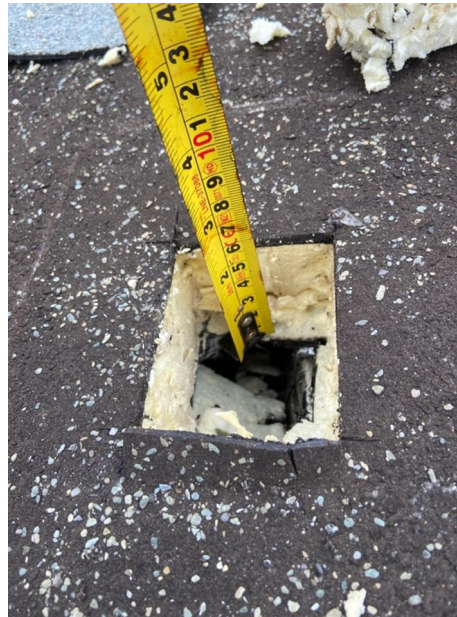
Core 1

Condition of core sample: The core showed that the existing build up was dry and would be suitable to overlay

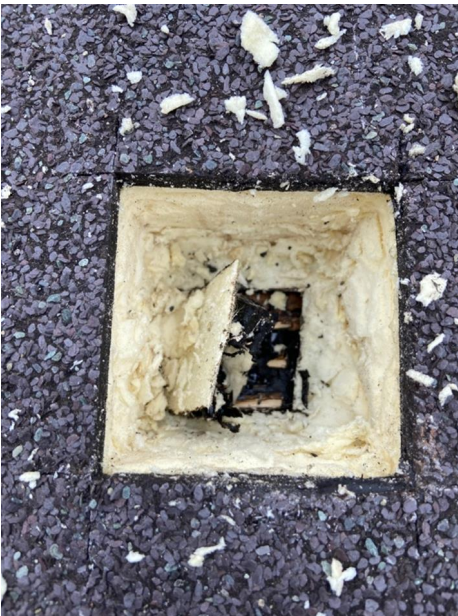
Core 2

No. of core samples taken:	1
Construction Type:	Warm Roof
Surfacing:	Slate mineral finish
Waterproofing:	SBS modified built-up bituminous membrane system
Insulation:	Rigid PUR/ PIR board 60mm thick
Vapour Control:	Bituminous membrane vapour control layer
Roof Deck:	Timber boarding
Condition of core sample:	The core showed that the roof was dry and would be suitable to overlay

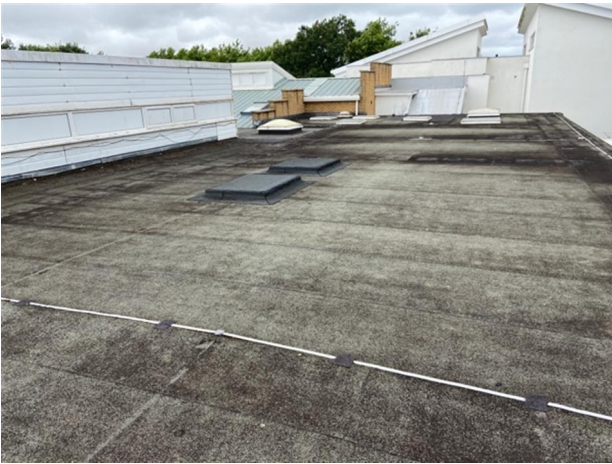
Overview of the roof area

The condition of the existing waterproofing is of concern. The material covering is coming to the end of its serviceable life and demonstrating signs of age, fatigue and fragility that could lead to serious failure.

This waterproofing system is showing all the typical defects consistent with a covering of this age including; surface oxidation, cracks, splits, blisters, rucks and signs of repair.

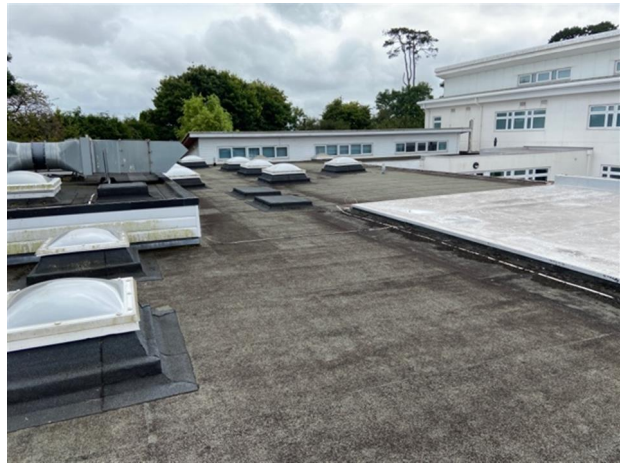
Overview of the roof area

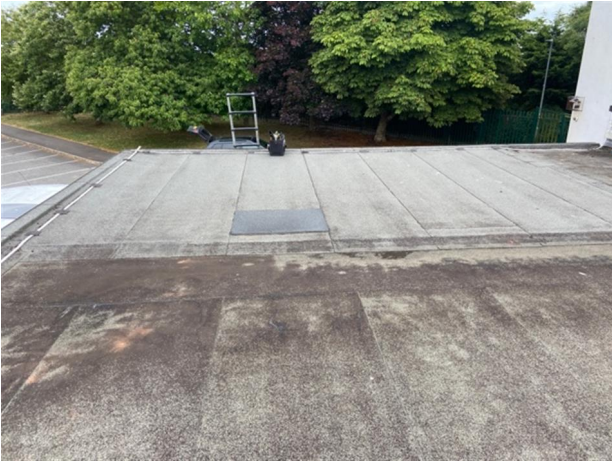
The existing felt is old and starting to loose its mineral cover

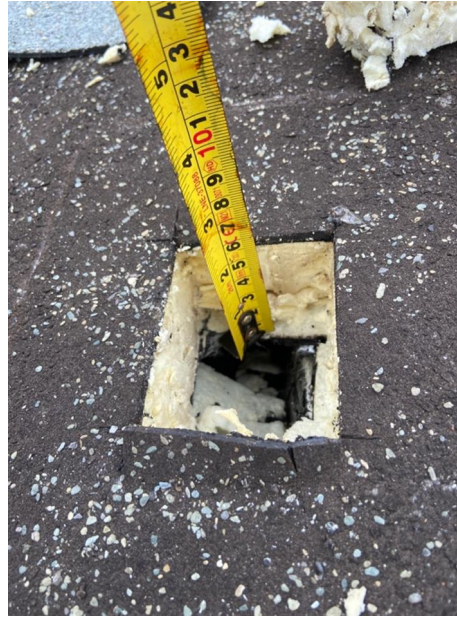
In accordance with BS6229:2018, Building regulations and Energy Conservation Standards for England and Wales roofs should be "designed and constructed so that thermal transmittance does not exceed 0.35W/m²K at any point." The thermal performance of the existing roof build-up is poor and falls below the above standards.

The current level of insulation falls below the 0.35 w/m2k required

- The existing deck is to be re-used.
- The condition of the existing waterproofing is considered suitable for receiving an overlay system.
- We propose that the insulation is upgraded to comply with current Energy Conservation Regulations, which will improve the thermal performance of this building and offers longer term payback in respect of reduced heating and/or cooling costs. In areas where a reduced thickness of insulation is required it will be in line with BS6229:2018 and Building regulations Approved Document C where the worst U-value allowed will be 0.35W/m²K equivalent to 60mm of Bauder PIR FA-TE flat board insulation.

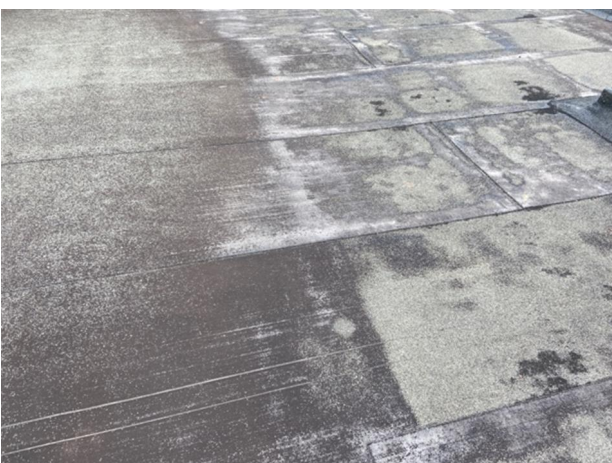
At the time of our survey the roof surface was dry. However, we noted visual evidence that some standing water does occur on the roof surface after rainfall. This indicates inadequate falls which can be viewed as undesirable, excessive standing water can impact the performance of the roof and/or supporting structure. Adequate falls should be provided as part of the roof refurbishment in accordance with BS6229:2018.

Tide marks are evident and would suggest that roof holds water

- Bauder Tapered Insulation will be incorporated into our specification, as provision for creating a minimum fall of 1:80 on all areas of the roof in accordance with BS6229:2018. Our standard design will direct water to drainage outlets, sumps and external gutters.

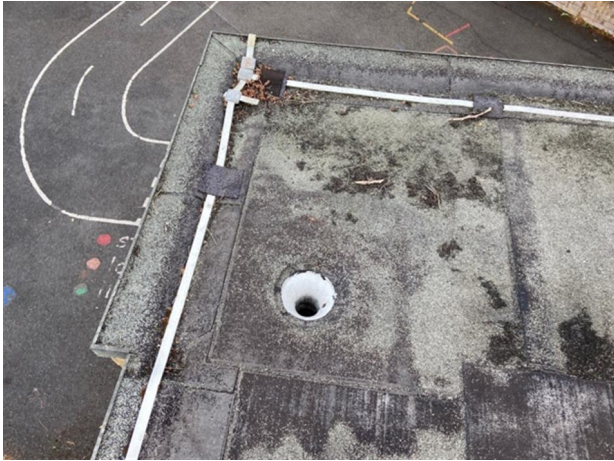
The current outlets are considered unsuitable for reuse. However, it will prove problematic to remove these without causing damage to the existing pipework or otherwise gain suitable access to re-connect any replacement units. Therefore, we propose leaving these in-situ and installing refurbishment outlets that can be fitted from above without causing internal disturbance. This is based upon the presumption that the internal pipework is currently in serviceable condition and secure and that the use of a refurbishment outlet does not significantly reduce flow rate performance. You may also wish to consider inspecting the existing pipework to confirm its condition and suitability, given the longevity of the new waterproofing system.

The existing outlets are old and missing leaf guards and appear to have slumped in areas

- New Bauder Refurbishment Outlets are to be installed that are compatible with the new waterproofing system and suitable for the connection to existing drainage pipework. As refurbishment outlets fit within existing outlets or pipe work, it is important that the flow rates of the new outlets are compared against the current outlets to ensure that drainage performance is not reduced or otherwise confirm if additional drainage provision may be required.

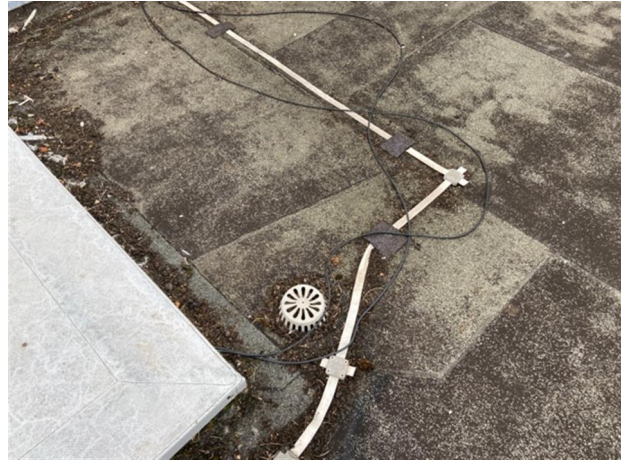
Outlet has slumped

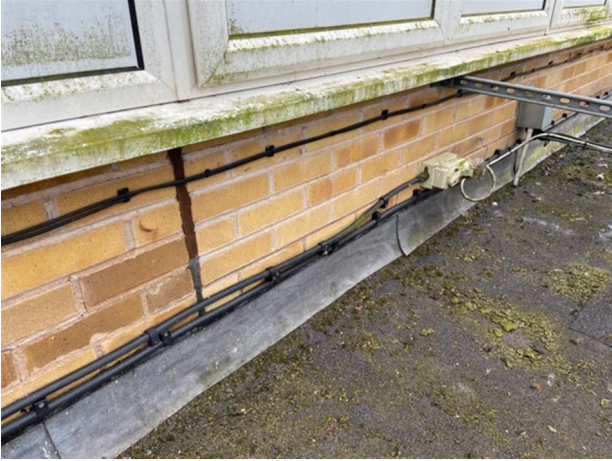
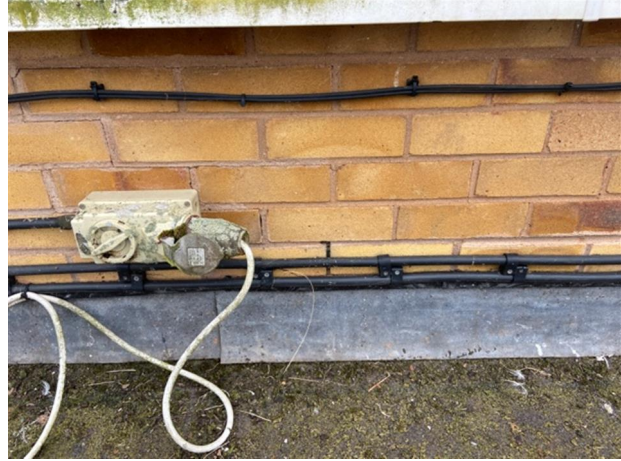
We noted that an existing cavity tray is present within the abutment wall. Should this roof be refurbished, this cavity tray will have to be raised as a consequence of the new waterproofing system.

The existing cavity trays will need to be raised with a new lead cover flashing

- The waterproofing upstand is to be raised to achieve the minimum required height of 150mm. Counter-flashings are to be positioned to suit.
- New cavity trays need to be installed, positioned at the required height above the bed joint where the upstand waterproof terminates. Work will need to be done sequentially i.e. opening the brickwork up in sections to install the new tray.

The installation of new cavity trays should be carried out prior to removing the existing waterproofing system. This will avoid the risk of damaging the new system and creating debris on the new finished surface. Provision must include for re-positioning and installing the new lead counter-flashings.

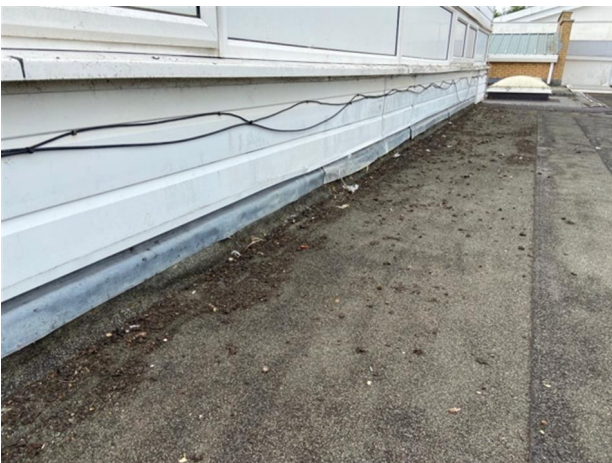
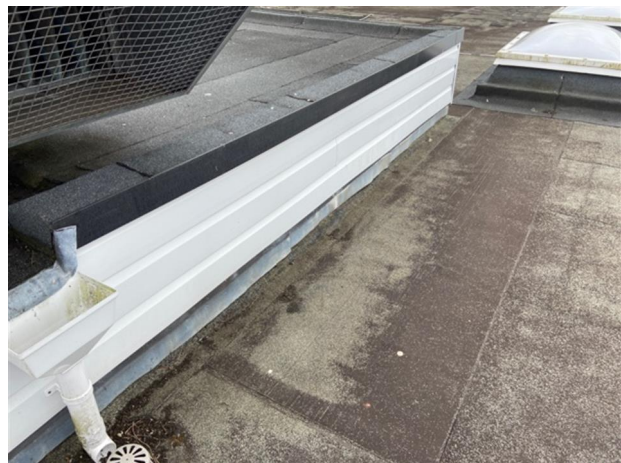
The existing cladding obstructs access to re-waterproof the upstand. It will therefore be necessary to remove the cladding to enable the roofing works to be undertaken. Upon completion the cladding can be reinstated allowing for any modification that maybe required.

Cladding will need to be removed to allow the new system to be taken vertically

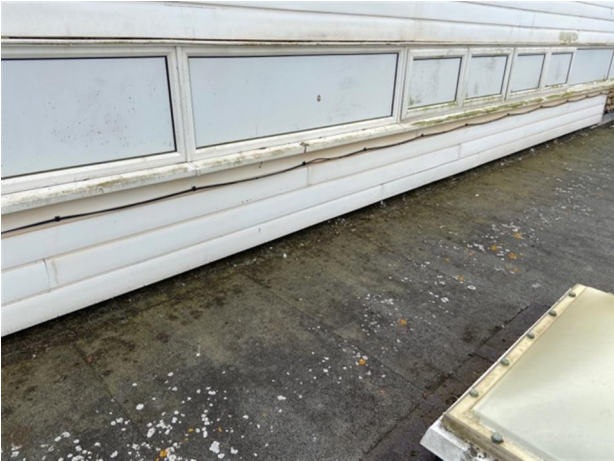
Once the roof has been refurbished there will not be sufficient height beneath the existing clerestory windows to form a sufficient waterproofing upstand. Due to new surface levels it will be necessary to remove and replace the clerestory windows with smaller units to fit a reduced opening.

The existing windows may need to be raised depending on the new roof height

- The existing clerestory windows are to be removed to allow access to raise the upstand kerb in preparation for re-waterproofing. New counter flashings must be installed prior to the new resized window units being fitted. Work should include making good and redecoration.
- Provision should be made for temporarily removing the cladding to allow working access to raise and waterproof the abutment upstands. Allowance is to be made for trimming the cladding and modifying the position of the lower fixing rails and/or metal drip flashing where required.
- The height of existing perimeter check kerbs must be increased to provide a minimum 50mm upstand above the finished roof level. The perimeter is to be raised to one consistent level around the full roof area.

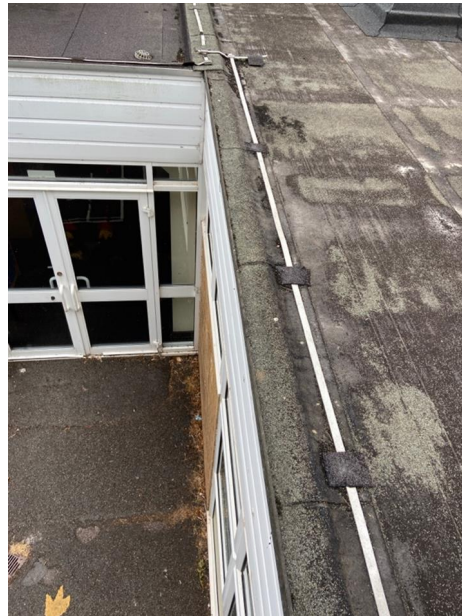
When the waterproofing is refurbished the perimeter check kerbs will not provide a 50mm upstand above the finished roof level. As a consequence the perimeter kerb will require raising.

The existing kerbs will need to be raised as part of the works

- An additional depth of fascia board is to be installed to cover the new perimeter kerb. Alternatively the existing perimeter fascia boards could be renewed in their entirety. Any new fascia system to be installed to cover the perimeter kerb should be manufactured from a maintenance free material to offer a life expectancy that is at least comparable to the guarantee of the new waterproofing system. This avoids the risk of disturbing the waterproofing system or affecting the roof guarantee, should the existing fascia require replacing whilst the roof remains in-situ. Full details of the system and scope of works to the fascia boards is to be included within the main client specification/ schedule of works.

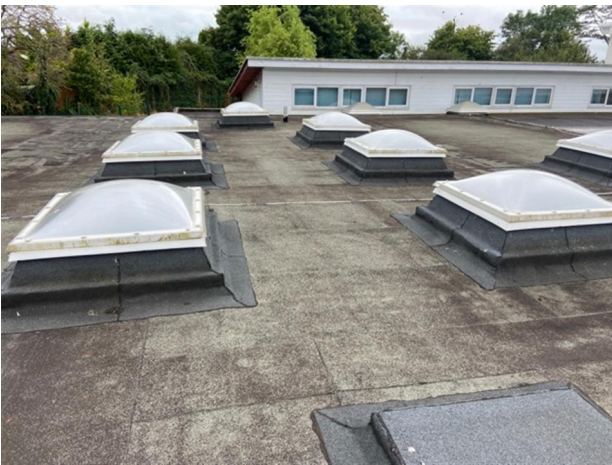
The current polycarbonate rooflights remain functional, are in good condition and considered suitable for re-use.

The existing polycarbonate rooflights can remain

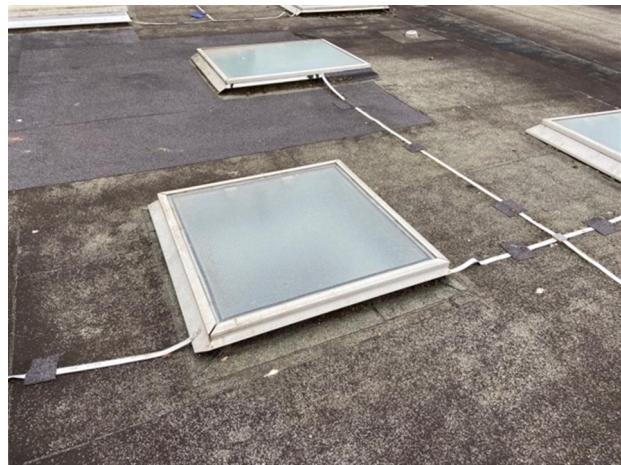
The rooflights are Georgian wired glazing within metal frames mounted upon a builders kerb. These rooflights are single glazed, thermally inefficient and prone to condensation. These should be considered unsuitable for re-use and replaced.

The existing wired glass rooflights will need to be changed for new fall safe units

- The existing rooflights should be replaced with new modular Bauder Rooflight units that offer improved thermal and light transmittance performance and are classified as being non-fragile. These will complement the performance of the replacement waterproofing system during its serviceable life. Please advise your requirements and we will include these within our separate schedule and specification for replacement Bauder Rooflights.

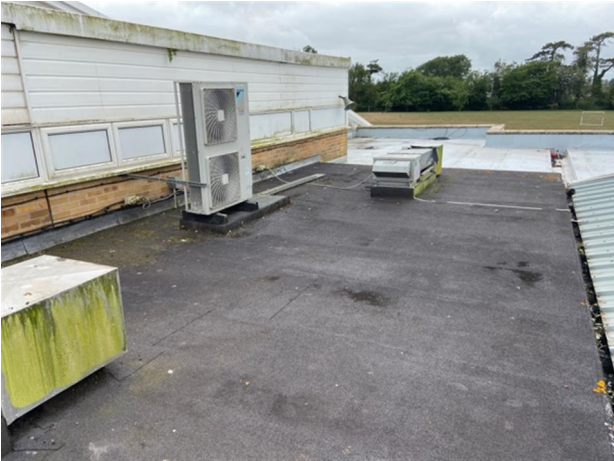
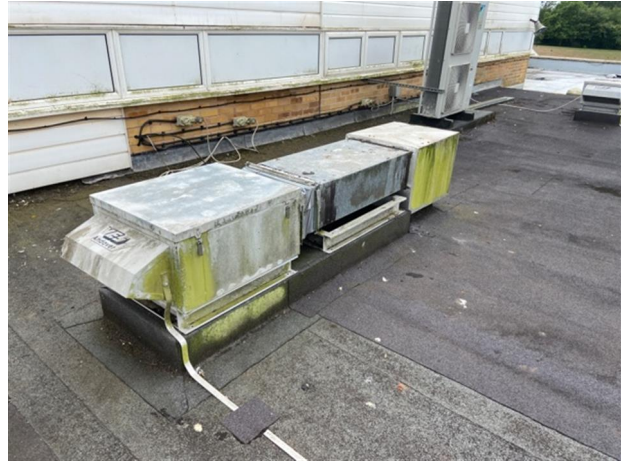
The roof mounted AC units appear to be functional, they are positioned on or very close to the roof. We assume they are to be retained on the roof following any refurbishment of the waterproofing. Unfortunately it will not be possible to refurbish the area of waterproofing beneath the AC units due to their proximity to the waterproofing membranes. They will require temporary disconnection and relocation while the roof is refurbished.

The existing items of M&E equipment are located on or very close to the surface of the waterproofing. The proximity of the equipment to the waterproofing will prevent access to re-waterproof. To allow the refurbishment to take place the equipment will require temporary disconnection and be set aside for later reinstatement.

The existing AC and plant will need to be removed to allow the works to be installed

- The roof mounted AC units are to be disconnected and temporarily relocated while the roof is re-waterproofed. The AC units are then to be repositioned on suitable surface protection and reconnected.

- To enable access for the re-waterproofing works, all roof mounted plant will require temporary disconnection and be set aside for later reinstatement.

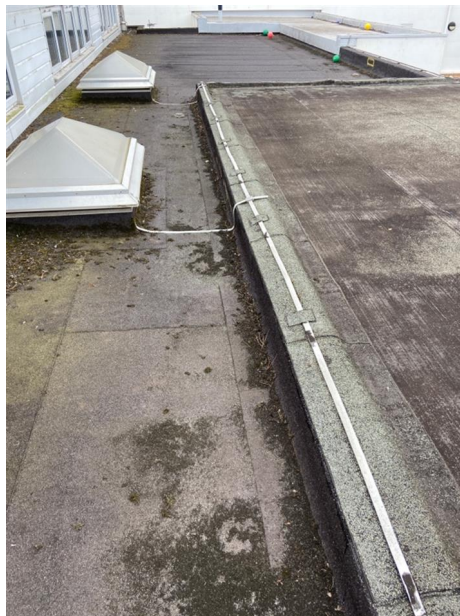
Roof overview

The condition of the existing waterproofing is of concern. The material covering is coming to the end of its serviceable life and demonstrating signs of age, fatigue and fragility that could lead to serious failure.

This waterproofing system is showing all the typical defects consistent with a covering of this age including; surface oxidisation, cracks, splits, blisters, rucks and signs of repair.

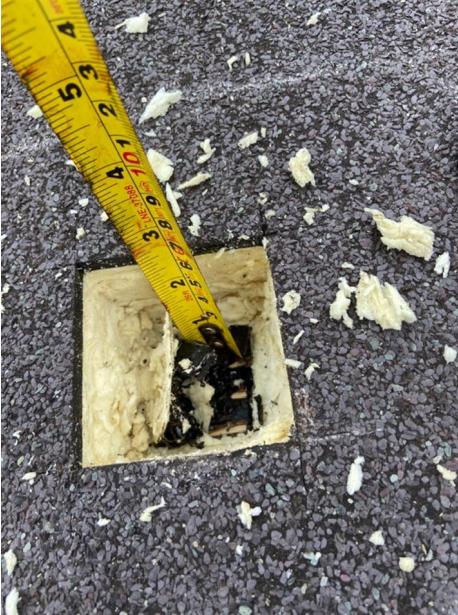
The existing system just provides the minimum 0.35 w/m²k u value

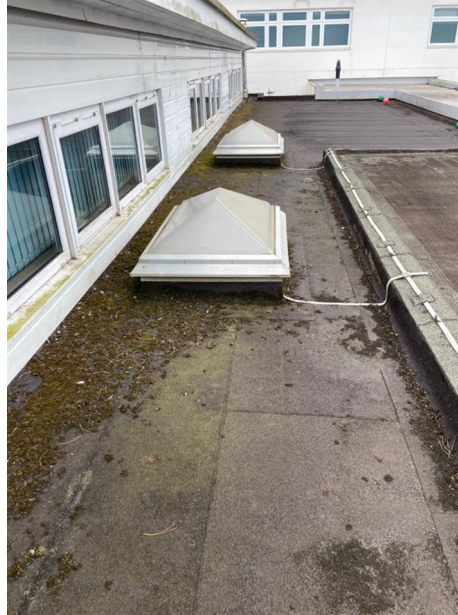
The existing felt system is starting to loose its mineral cover

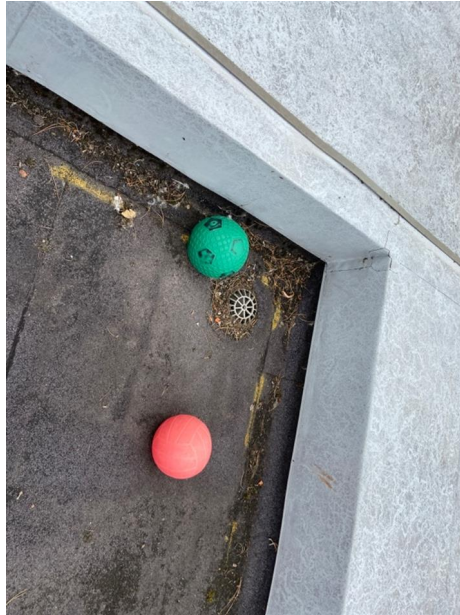
The current outlets are considered unsuitable for reuse. However, it will prove problematic to remove these without causing damage to the existing pipework or otherwise gain suitable access to re-connect any replacement units. Therefore, we propose leaving these in-situ and installing refurbishment outlets that can be fitted from above without causing internal disturbance. This is based upon the presumption that the internal pipework is currently in serviceable condition and secure and that the use of a refurbishment outlet does not significantly reduce flow rate performance. You may also wish to consider inspecting the existing pipework to confirm its condition and suitability, given the longevity of the new waterproofing system.

The existing outlets should be renewed with refurb outlets

- The existing deck is to be re-used.
- The condition of the existing waterproofing is considered suitable for receiving an overlay system.
- New Bauder Refurbishment Outlets are to be installed that are compatible with the new waterproofing system and suitable for the connection to existing drainage pipework. As refurbishment outlets fit within existing outlets or pipe work, it is important that the flow rates of the new outlets are compared against the current outlets to ensure that drainage performance is not reduced or otherwise confirm if additional drainage provision may be required.

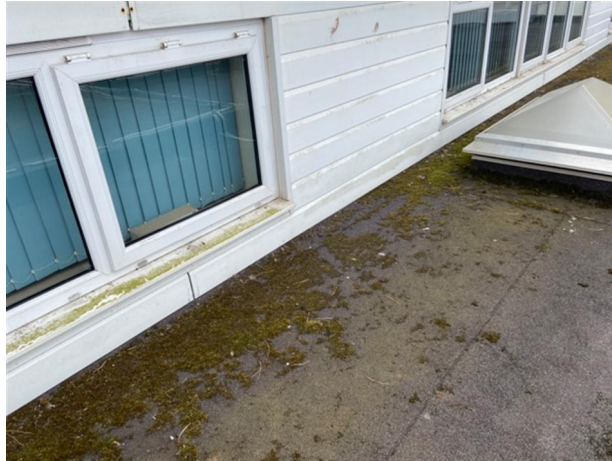
The existing cladding obstructs access to re-waterproof the upstand. It will therefore be necessary to remove the cladding to enable the roofing works to be undertaken. Upon completion the cladding can be reinstated allowing for any modification that maybe required.

The existing cladding should be removed to allow the waterproofing to be installed

- Provision should be made for temporarily removing the cladding to allow working access to raise and waterproof the abutment upstands. Allowance is to be made for trimming the cladding and modifying the position of the lower fixing rails and/or metal drip flashing where required.

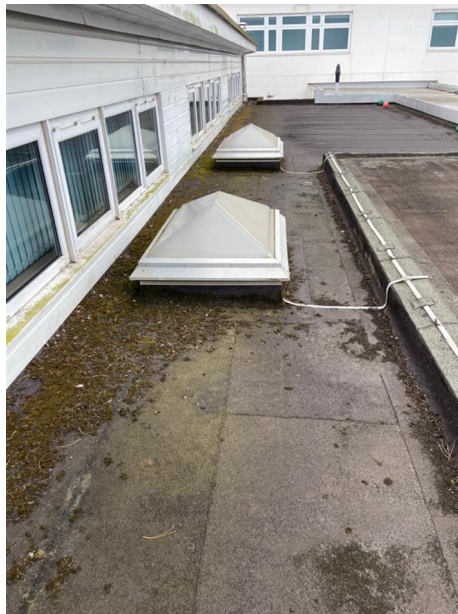
The current rooflights are proprietary plastic glazed units. These fall below current thermal and light transmittance standards and the performance will continue to decrease with age. The service life of these rooflights is not compatible with the service life of the new waterproofing system and for these reasons we propose that they are replaced. Please be aware that these units may contain asbestos in the internal linings.

The existing rooflights should be replaced with new fall safe units

- The existing rooflights should be replaced with new modular Bauder Rooflight units that offer improved thermal and light transmittance performance and are classified as being

non-fragile These will complement the performance of the replacement waterproofing system during its serviceable life. Please advise your requirements and we will include these within our separate schedule and specification for replacement Bauder Rooflights.
