Site Details	Torquay Central Library Torquay	Asset Ref: T0470AF
Survey Type	Type 2 Survey/Management Asbestos Survey	
Client Details	Torbay Development Agency	
Survey Date	25.08.05 Re-inspected 09.04.08 Re-inspected 16.02.11 Re-inspected 12.04.12 Re-inspected 15.04.13	
Report Date	24/04/2013	Issue No. Five
Surveyor	Peter Whetman Re-inspected by Daniel Jenkins Re-inspection by Charlotte Parry Re-inspection by Tom Palmer Re-inspection by Tom Palmer	
Job No.	J17597

Site Address: Torquay Central Library, Asset No. TO470AF.

Re-inspection date: 15/04/2013 by Tom Palmer

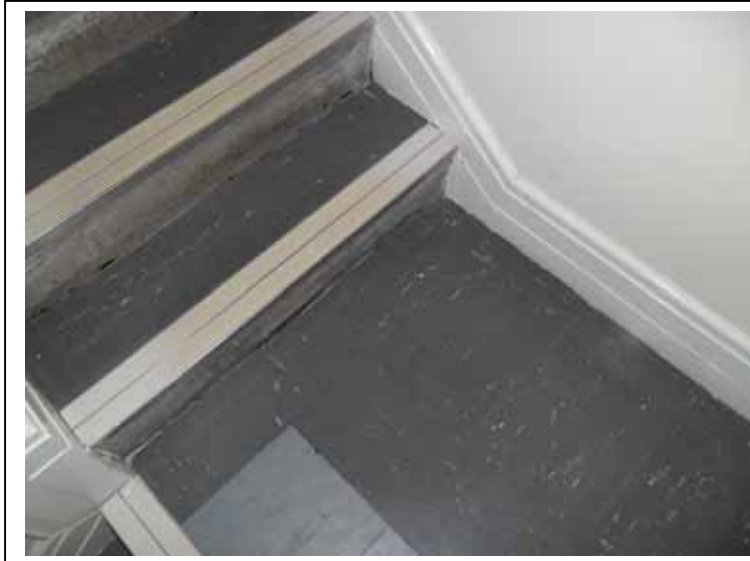
Photograph No.
824

Description
**LGF 01SA - Grey vinyl
floor tiles and adhesive**

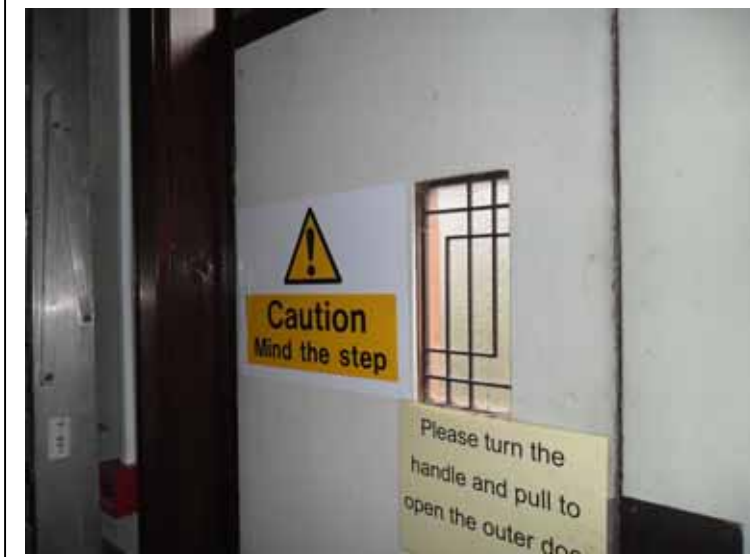
Photograph No.
825

Description
**GF 20LO - Fire Escape
Doors**

The fire doors are "suspected" to have asbestos containing materials within.

These fire doors were not opened up at the time of the survey due to damaging the integrity of the door or the decoration around them. If works are required, a competent person should first examine the door for the presence of any Asbestos Containing Materials. The results of the inspection should be recorded on the database.

If replacement of the door is required then it should be removed whole, double bagged in 1000 gauge polythene, labelled appropriately and disposed of as special waste, to a suitably licensed waste facility or an approved landfill site by a registered waste carrier.

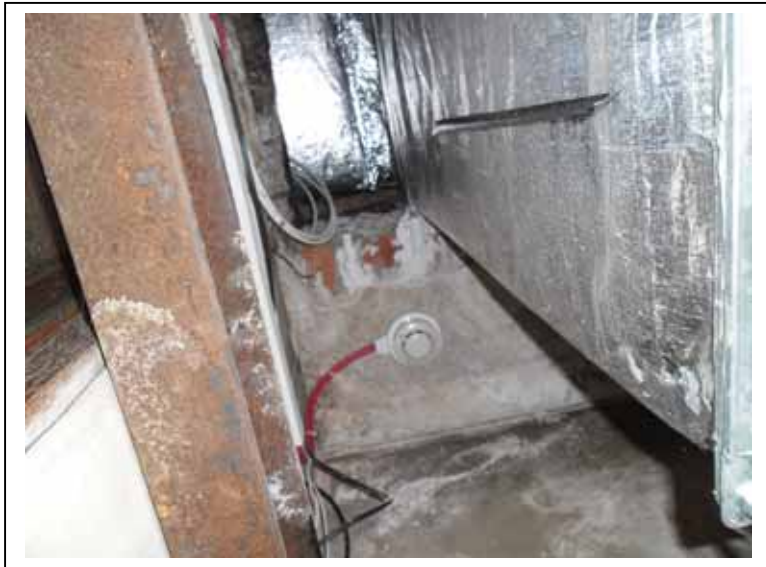
Photograph No.
828

Description
**UGF 02OF - Ceiling
Slab in 'Dumb Waiter' -
Pipe Sheath**

The Asbestos Cement (AC) pipe sheathing protruding from the broken out ceiling slab (accessed via the redundant 'dumb waiter' shaft in the corner of room UGF 02OF) was sampled and identified by analysis as containing Chrysotile (White) asbestos. The pipe sheathing has also been observed within the wall cavity of the same room and has had to be presumed to be the same material as sampling access was not possible through the grille. Similar grilles can be observed at various locations throughout the building, the most apparent being in the public library areas.

The damaged face of the AC pipe sheathing on the dumb waiter ceiling has been sealed since the previous inspection.

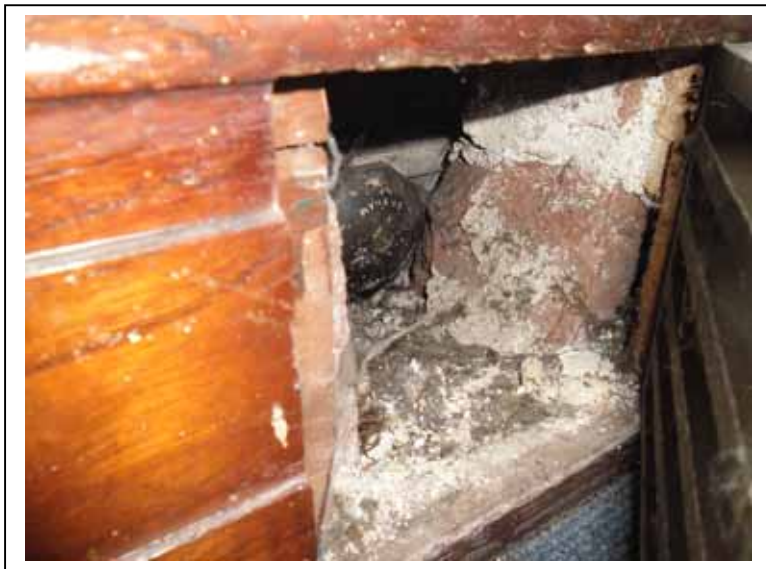
Photograph No.
829

Description
**UGF 02OF - Wall Cavity
- Pipe Sheath**

Further evidence from archive photographs of the building construction shows the library can be suspected to contain a redundant under-floor heating system. This would appear to have been fed by pipes in the wall cavities. Therefore the survey presumes all floor/ceiling slabs and wall cavities to contain the AC pipe sheathing.

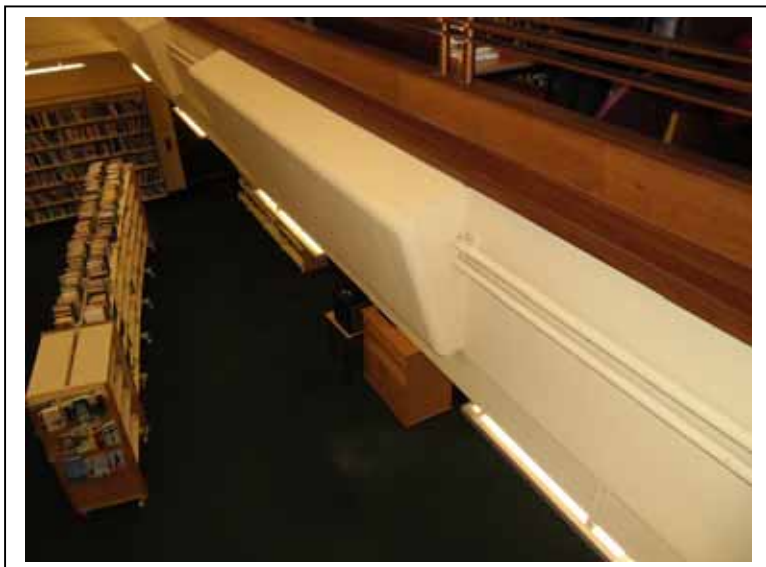
Photograph No.
830

Description
**UGF 01VE - Surround
To Pipes/Heaters**

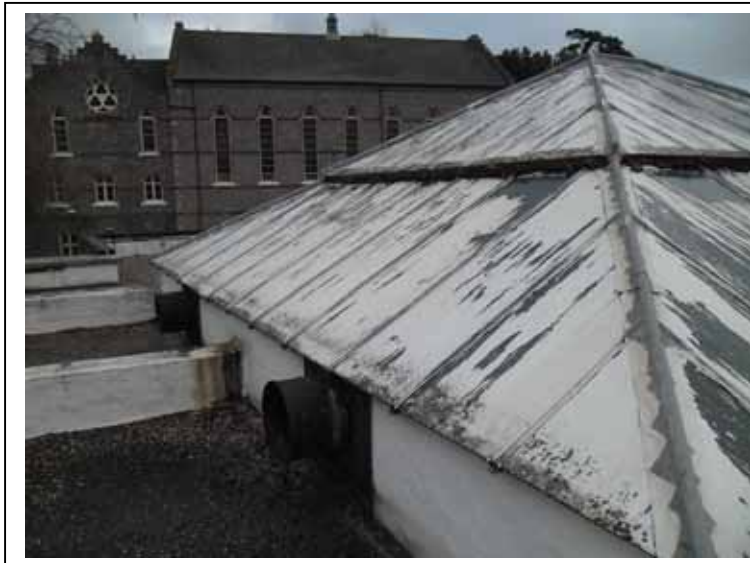
Photograph No.
832

Description
**External - Lantern Roof
Light - Packing to Steel
Clamps**

Asbestos textiles are normally made of 100% Chrysotile (white) asbestos. The packers, when securely clamped on the roof, represent a low hazard. However if worked on, this

material has the capacity to release asbestos fibres. Therefore, although not a licensed product, we would suggest any works be carried out by a licensed contractor. This work under the new Control of Asbestos 2012 Regulations will almost certainly be considered to be notifiable non- licensed work.

Any work undertaken should be done so using a safe system of work. A safe system of work can be found on the HSE website at <http://www.hse.gov.uk/asbestos/essentials/index.htm>. Waste should be double bagged in '1000 gauge' polythene, labelled appropriately and disposed of as hazardous waste, to a suitably licensed waste facility or an approved landfill site by a registered waste carrier.

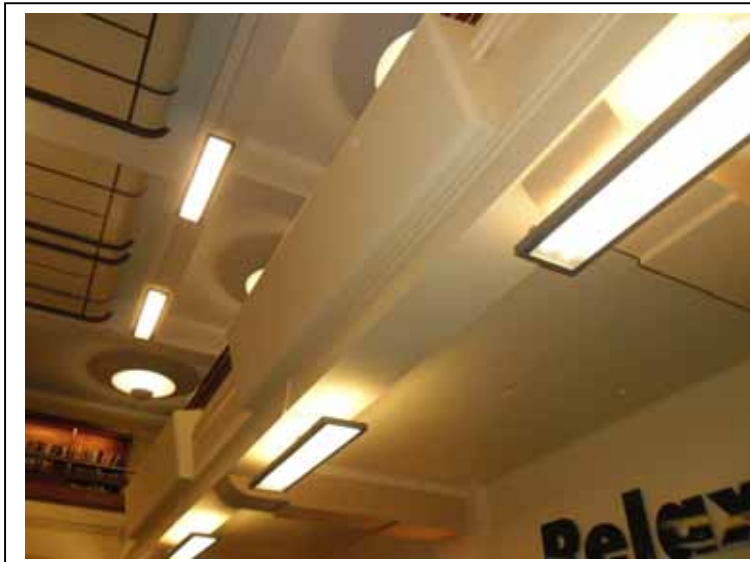
Photograph No.
833

Description
**UGF 01VE - Panel To
Balcony Bulkhead**

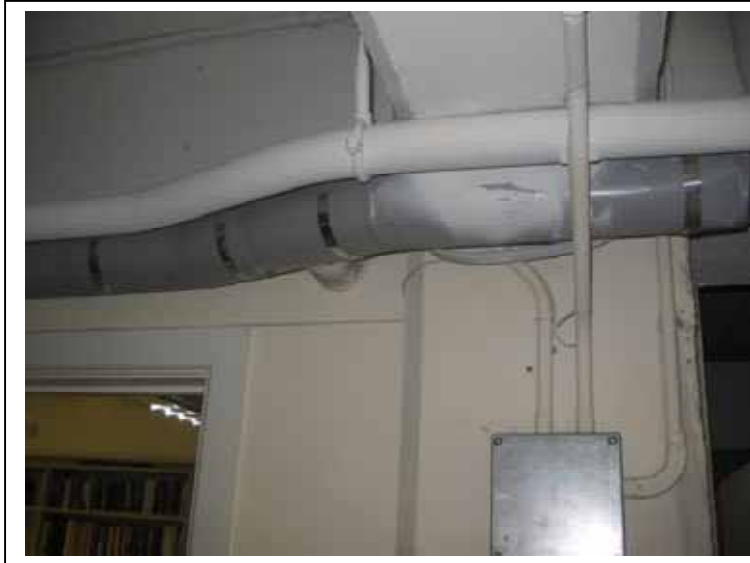
Photograph No.
7095

Description
**Base 06LS - Pipe above
door to 08OF**

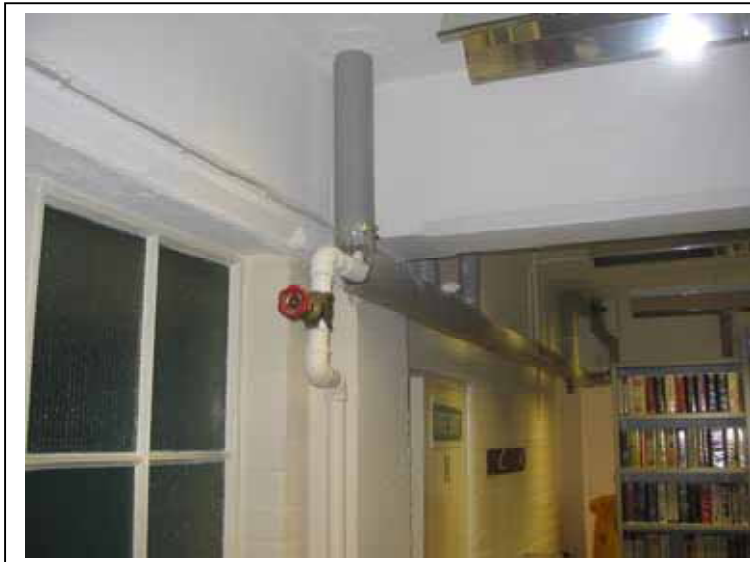
Photograph No.
7096

Description
**Base 08OF - Pipe
beside & above door to
09ST**

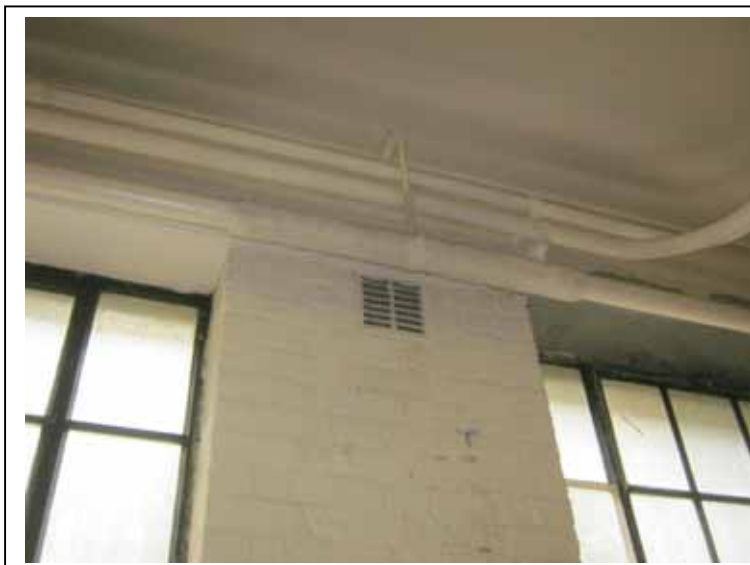
Photograph No.
7097

Description
**Base B50 (Town Hall
Basement) - Pipe above
window to moat**

The one meter length section of asbestos thermal insulation located in the town hall basement (B50) is at high level on a pipe and was sampled and identified as containing Amosite (Brown) asbestos. The insulation is painted, in good condition and is unlikely to be disturbed.

The insulation can remain in situ but should be managed i.e. regular inspections should be carried out and a management plan put in place. Any significant work involving the pipe insulation would require the services of a licensed asbestos contractor.

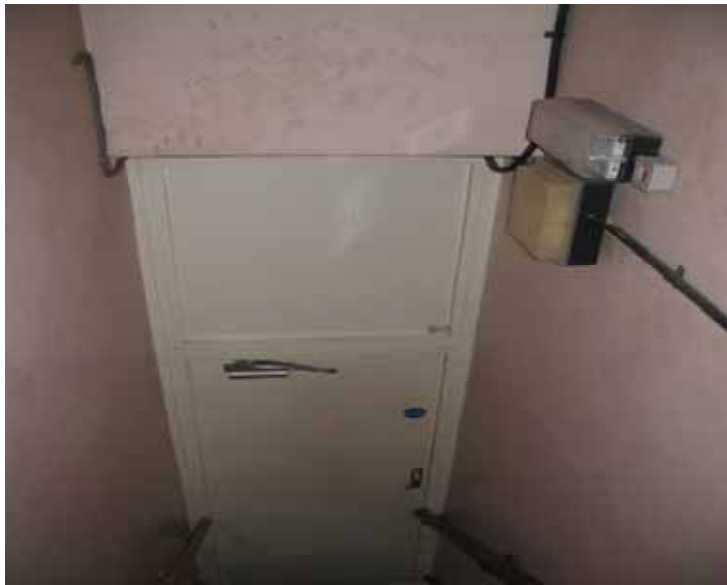
Photograph No.
7099

Description
**LGF 18SA - Panel
Above Door**

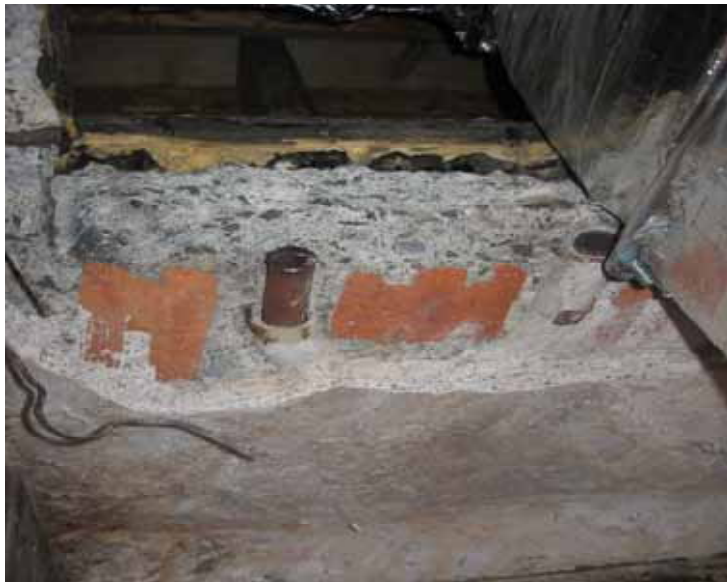
Photograph No.
7507

Description
**UGF 02OF - Ceiling in
"Dumb Waiter"**

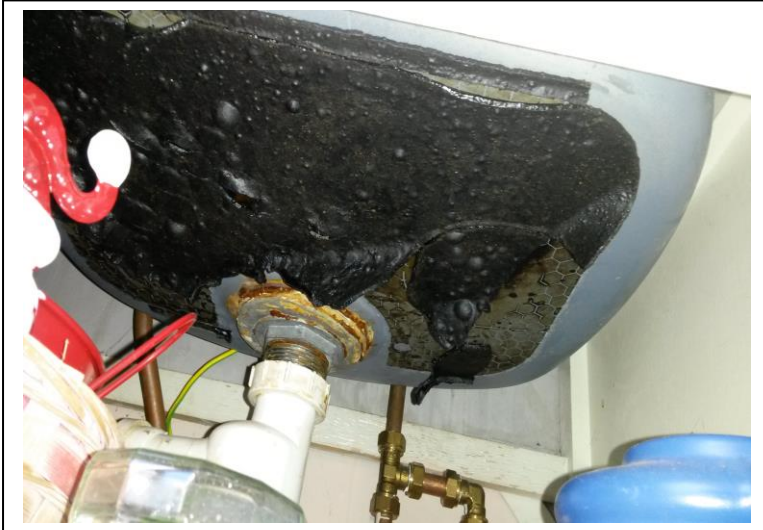
Photograph No.
1

Description
**GF01/ Staff room –
Bitumen pads below
Sink and Drainer**

Sink pads have been found through laboratory analysis to contain Chrysotile (White) asbestos.

Sink pads found to contain asbestos through laboratory analysis may remain in situ as the asbestos fibres are well bonded in the Bitumastic material. If replacement of the sink is required then the sink and pad should be removed whole, double bagged in 1000 gauge polythene, labelled appropriately and disposed of as hazardous waste, to a suitably licensed waste facility or an approved landfill site by a registered waste carrier. An unlicensed contractor may conduct this work.

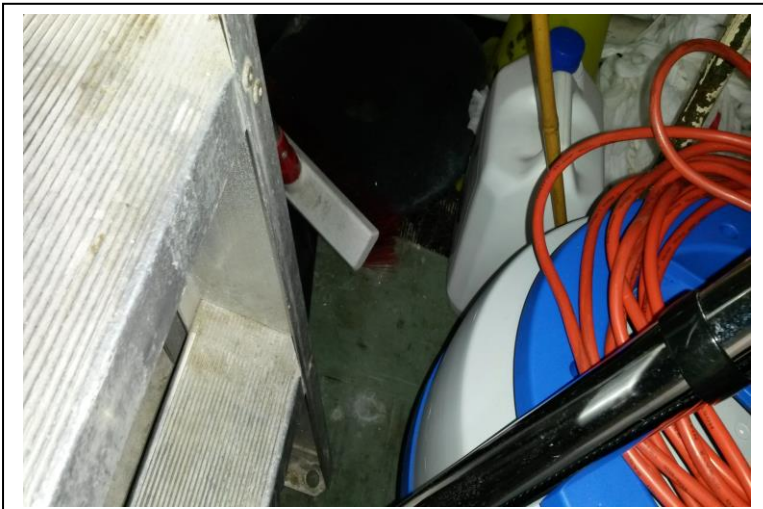
Photograph No.
2

Description
**GF05/ Cleaners
cupboard –
Green vinyl floor tiles**

The adhesive has been found through laboratory analysis to contain Chrysotile (White) asbestos.

If works are required with these materials an unlicensed contractor in accordance with a safe system of work may conduct it. A suggested safe system can be found on the HSE website at <http://www.hse.gov.uk/asbestos/essentials/index.htm>.

The adhesive fixing the tile contains Chrysotile asbestos fibres. Removal is next to impossible, and may cause far more risk than simply leaving in place and managing

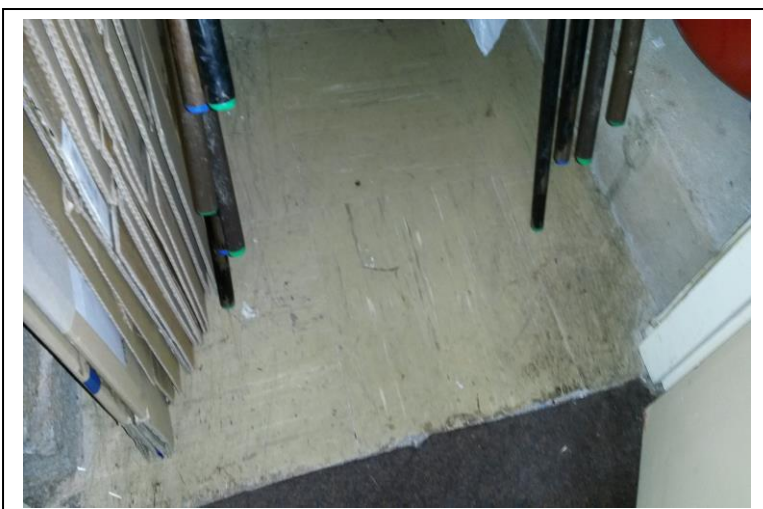
Photograph No.
3

Description
**GF07/ Cupboard –
Yellow vinyl floor tiles**
