Riverside House
Bedford Road
Northampton
NN1 5NX

Lift Condition Report

Prepared for: R J Lift Services Ltd

Prepared by: Karl Grey
Date: 12 May 2020
Project No: ALC350

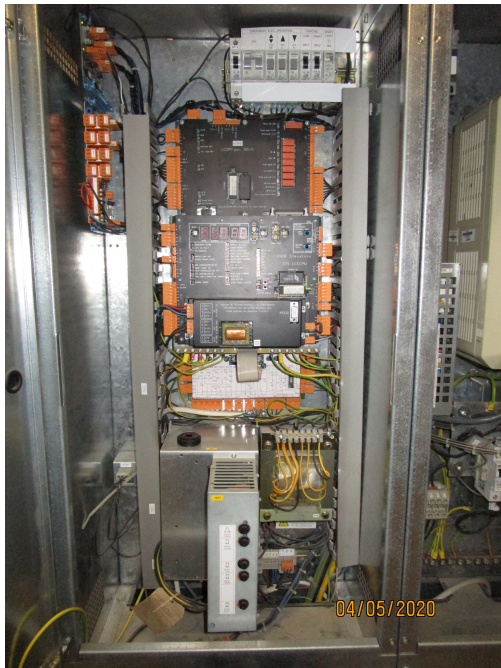
Photo 1

The equipment in the motor room consists of the new Kone controller, in which are housed the Kone 375 LCE microprocessor, variable speed variable voltage (3VF) drive, relays and contactors for the lifts. The equipment is worn with the microprocessor now an old design.

Typical Lift Controller and microprocessor.

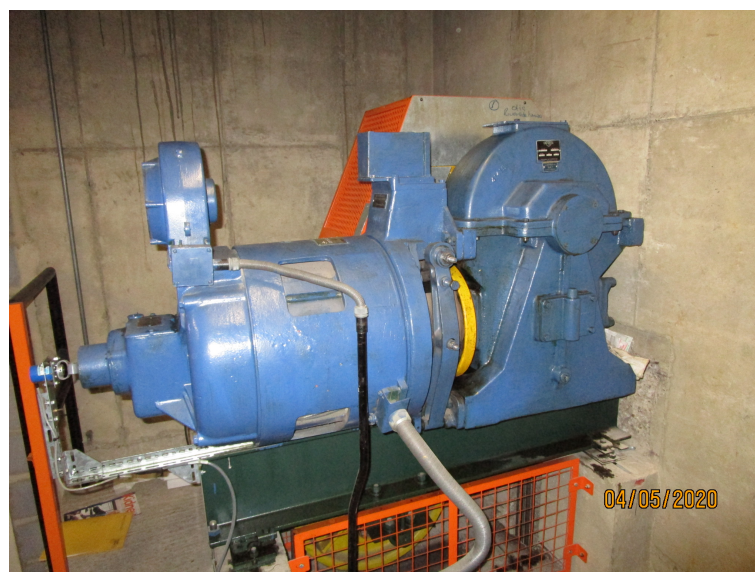
Photo 2

The hoist units are original and consist of a reduction gearbox with a separate flange mounted AC motor and brake assembly. The units are worn, with leaks evident in a number of places, but in a reasonable condition.

Typical Hoist unit.

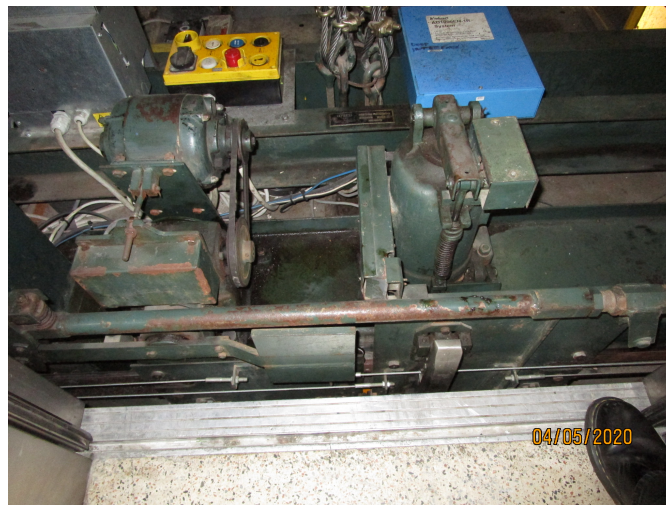
The door operation on the lifts is reasonable considering there is considerable wear on the component parts of the operator, which are 46 years old, the operation is not smooth and positive in the operation. The landing door equipment also has worn component parts with adjustment required on several landing and car doors.

Photo 3
Typical Door operator.

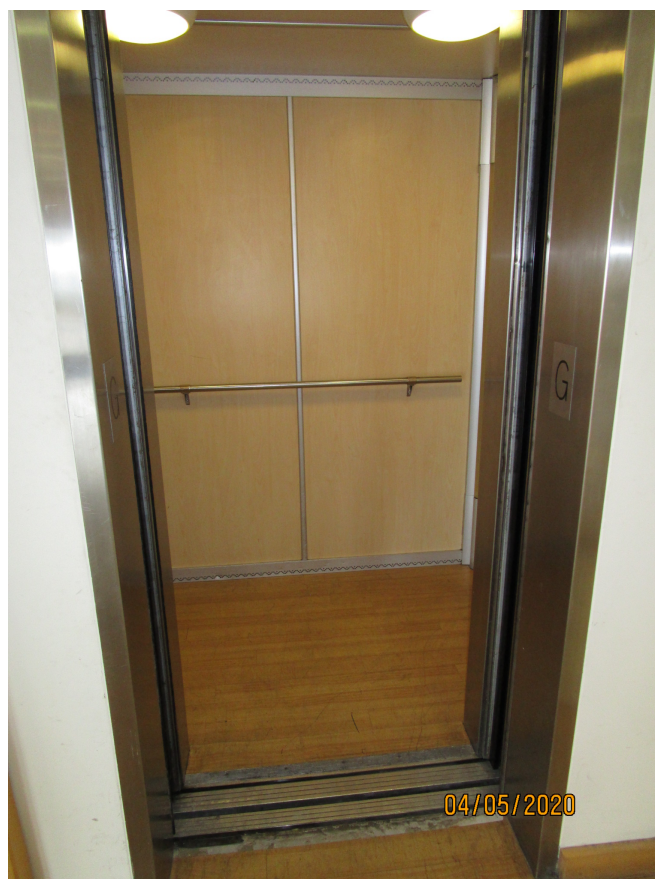
The car interiors are in very work condition, being original from circa 1974. The right hand lift No2 has a large hole from impact damage on the right hand side front wall , which has been taped up. There is extensive wear and light cover parts missing from the interior.

Wear on the panels and scratches from goods transportation are evident. Several car door panels have wear scratches and grooves on the doors.

Photo 4
Typical Lift car interior.

The lifts do not comply with current British Lift standards from a technical and safety aspect regarding the control of uncontrolled upward movement to prevent uncontrolled upward movement of the lift car in the event of failure of the hoist unit, the gearboxes are leaking and the car interiors need to be completely removed and replaced with a contemporary interior design.

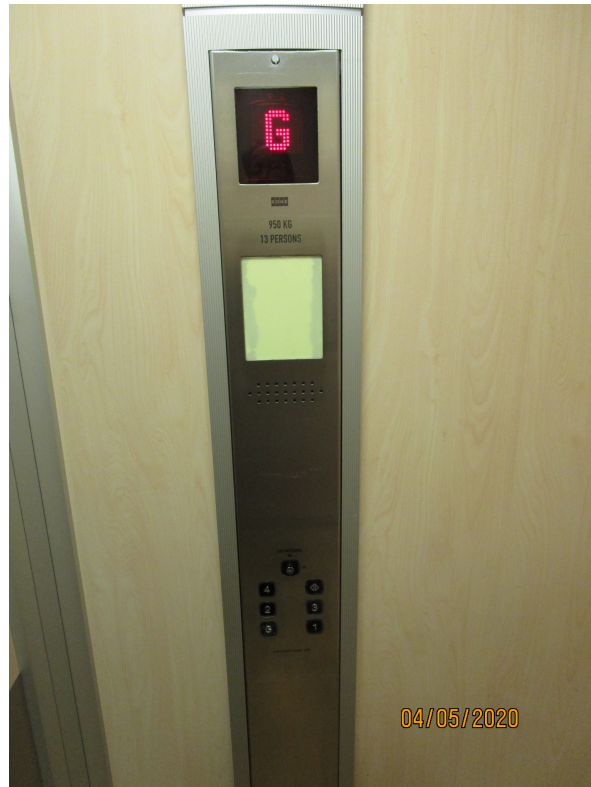
The call accepted pushes in the lift car, are worn with wear on the pressels. The position indicator is working and the light level is sufficient.

Photo 5
Typical Car operating panel.

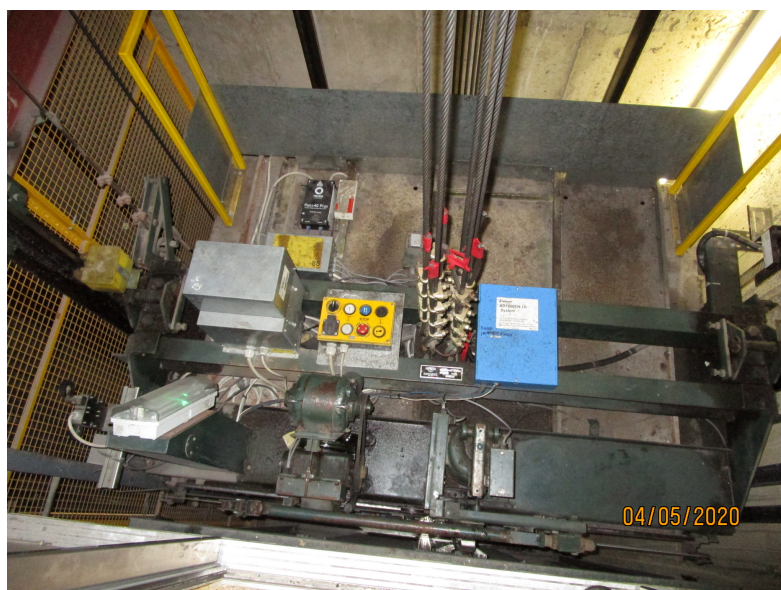
The shaft equipment appears to be in reasonable but worn condition, but is showing signs of wear due to the age of the equipment.

Photo 6
Typical Lift car top.

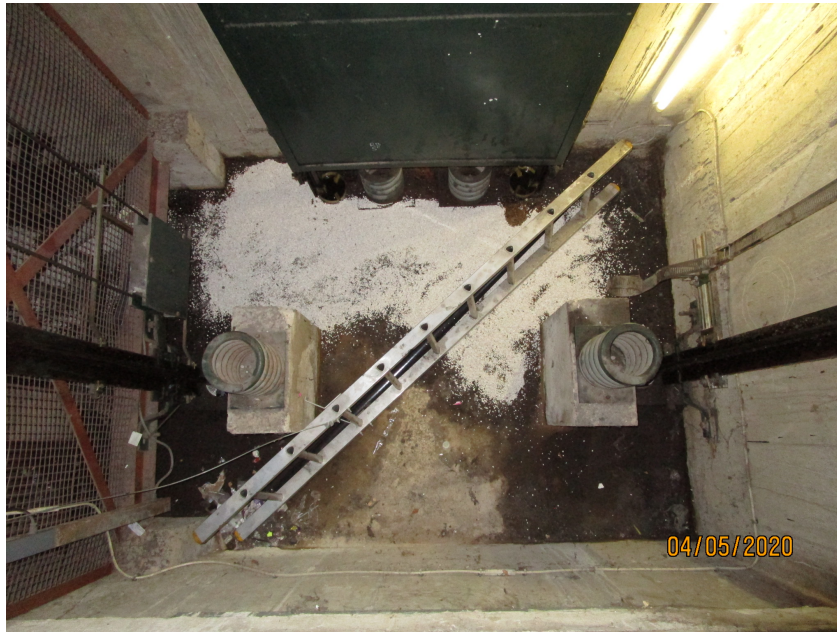
The pit area requires cleaning and again the equipment is in a reasonable condition but worn.

Photo 7
Typical Lift pit.
