<b>Group Name:</b>	Pendle Borough Council
<b>Subsidiary Name:</b>	Fleet Street Depot
<b>Site Address:</b>	Fleet Street Nelson
<b>Occupancy:</b>	Depot and garage
<b>Conferred with:</b>	Andrew Bean, Technical Officer Ryan Chappell, Liberata David Walker, Environmental Services Manager
<b>Prepared By:</b>	Maureen Macmillan, Senior Consultant
<b>Consultant's Contact Details:</b>	Commercial Risk Solutions Aon Global Risk Consulting – Risk Control & Engineering  <b>Mobile: 07703 410817</b> <b>E-mail: <a href="mailto:Maureen.macmillan@aon.co.uk">Maureen.macmillan@aon.co.uk</a></b>
<b>Date of Visit:</b>	14 <sup>th</sup> November 2019
<b>Document Ref:</b>	Pendle BC - MD Report - Fleet Street Depot Nov 2019.docx
<b>Document History Rev No:</b>	0

## 1. Executive Summary

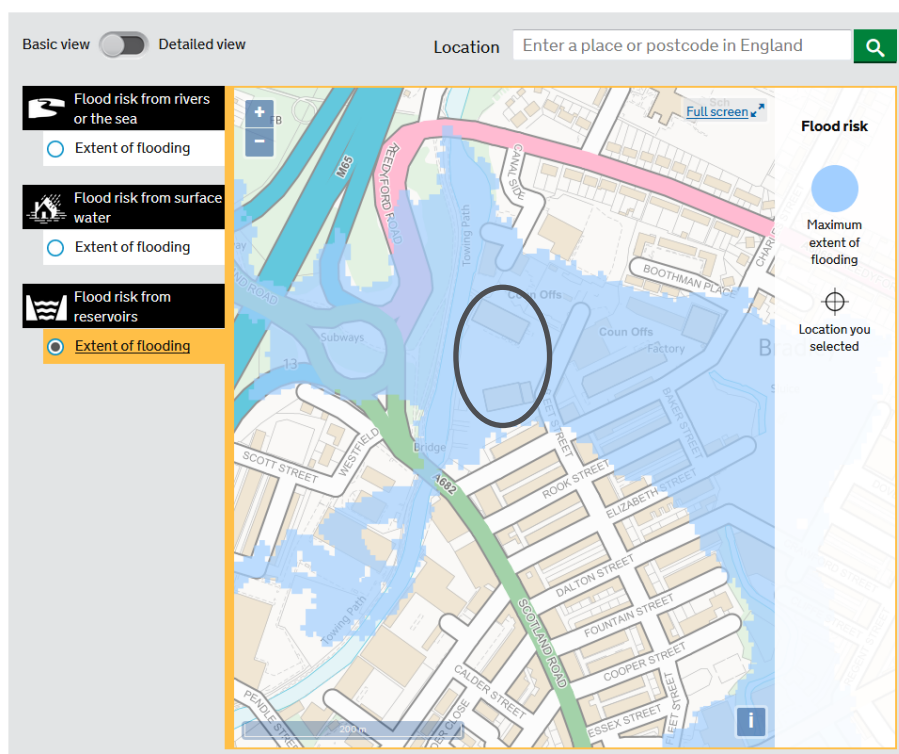
#### Risk of flooding from reservoirs

The whole site is at risk of flooding from a reservoir.

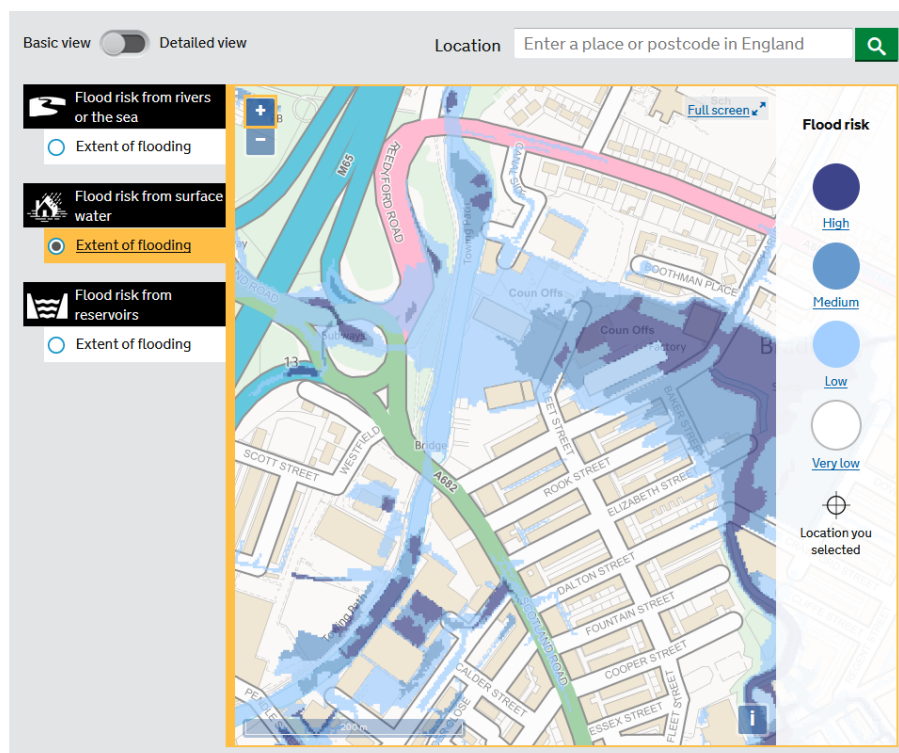
## Risk of flooding from surface water

The main building could be affected by flooding.

**Low risk** means that each year this area has a chance of flooding of between 0.1% and 1%. Flooding from surface water is difficult to predict as rainfall location and volume are difficult to forecast. In addition, local features can greatly affect the chance and severity of flooding.

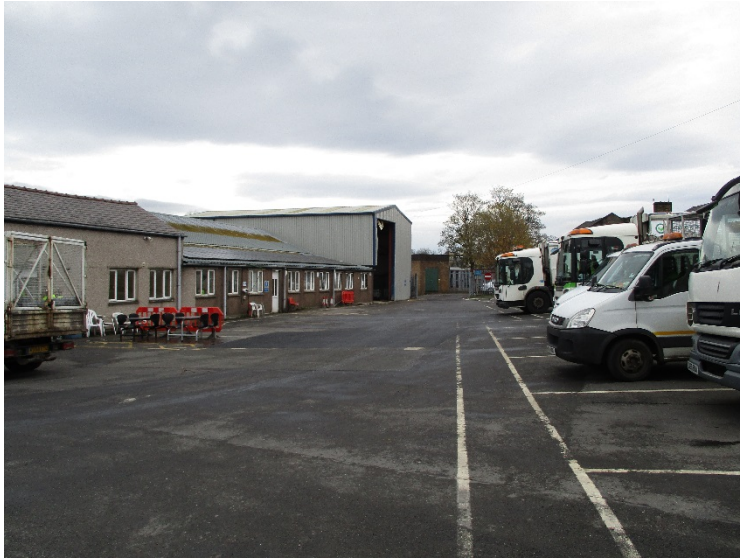
The site comprises of two separate building ranges (main building range and Parks building range). The two building ranges are detached by over 30m however vehicles are parked overnight between the buildings reducing any separation distance.

**Parks building range with vehicles parked between it and the main building**
