Conservation
Anti-slavery Arch, Paganhill Stroud
for Stroud District Council

Arch inner surfaces Condition

295-SU05 RevA

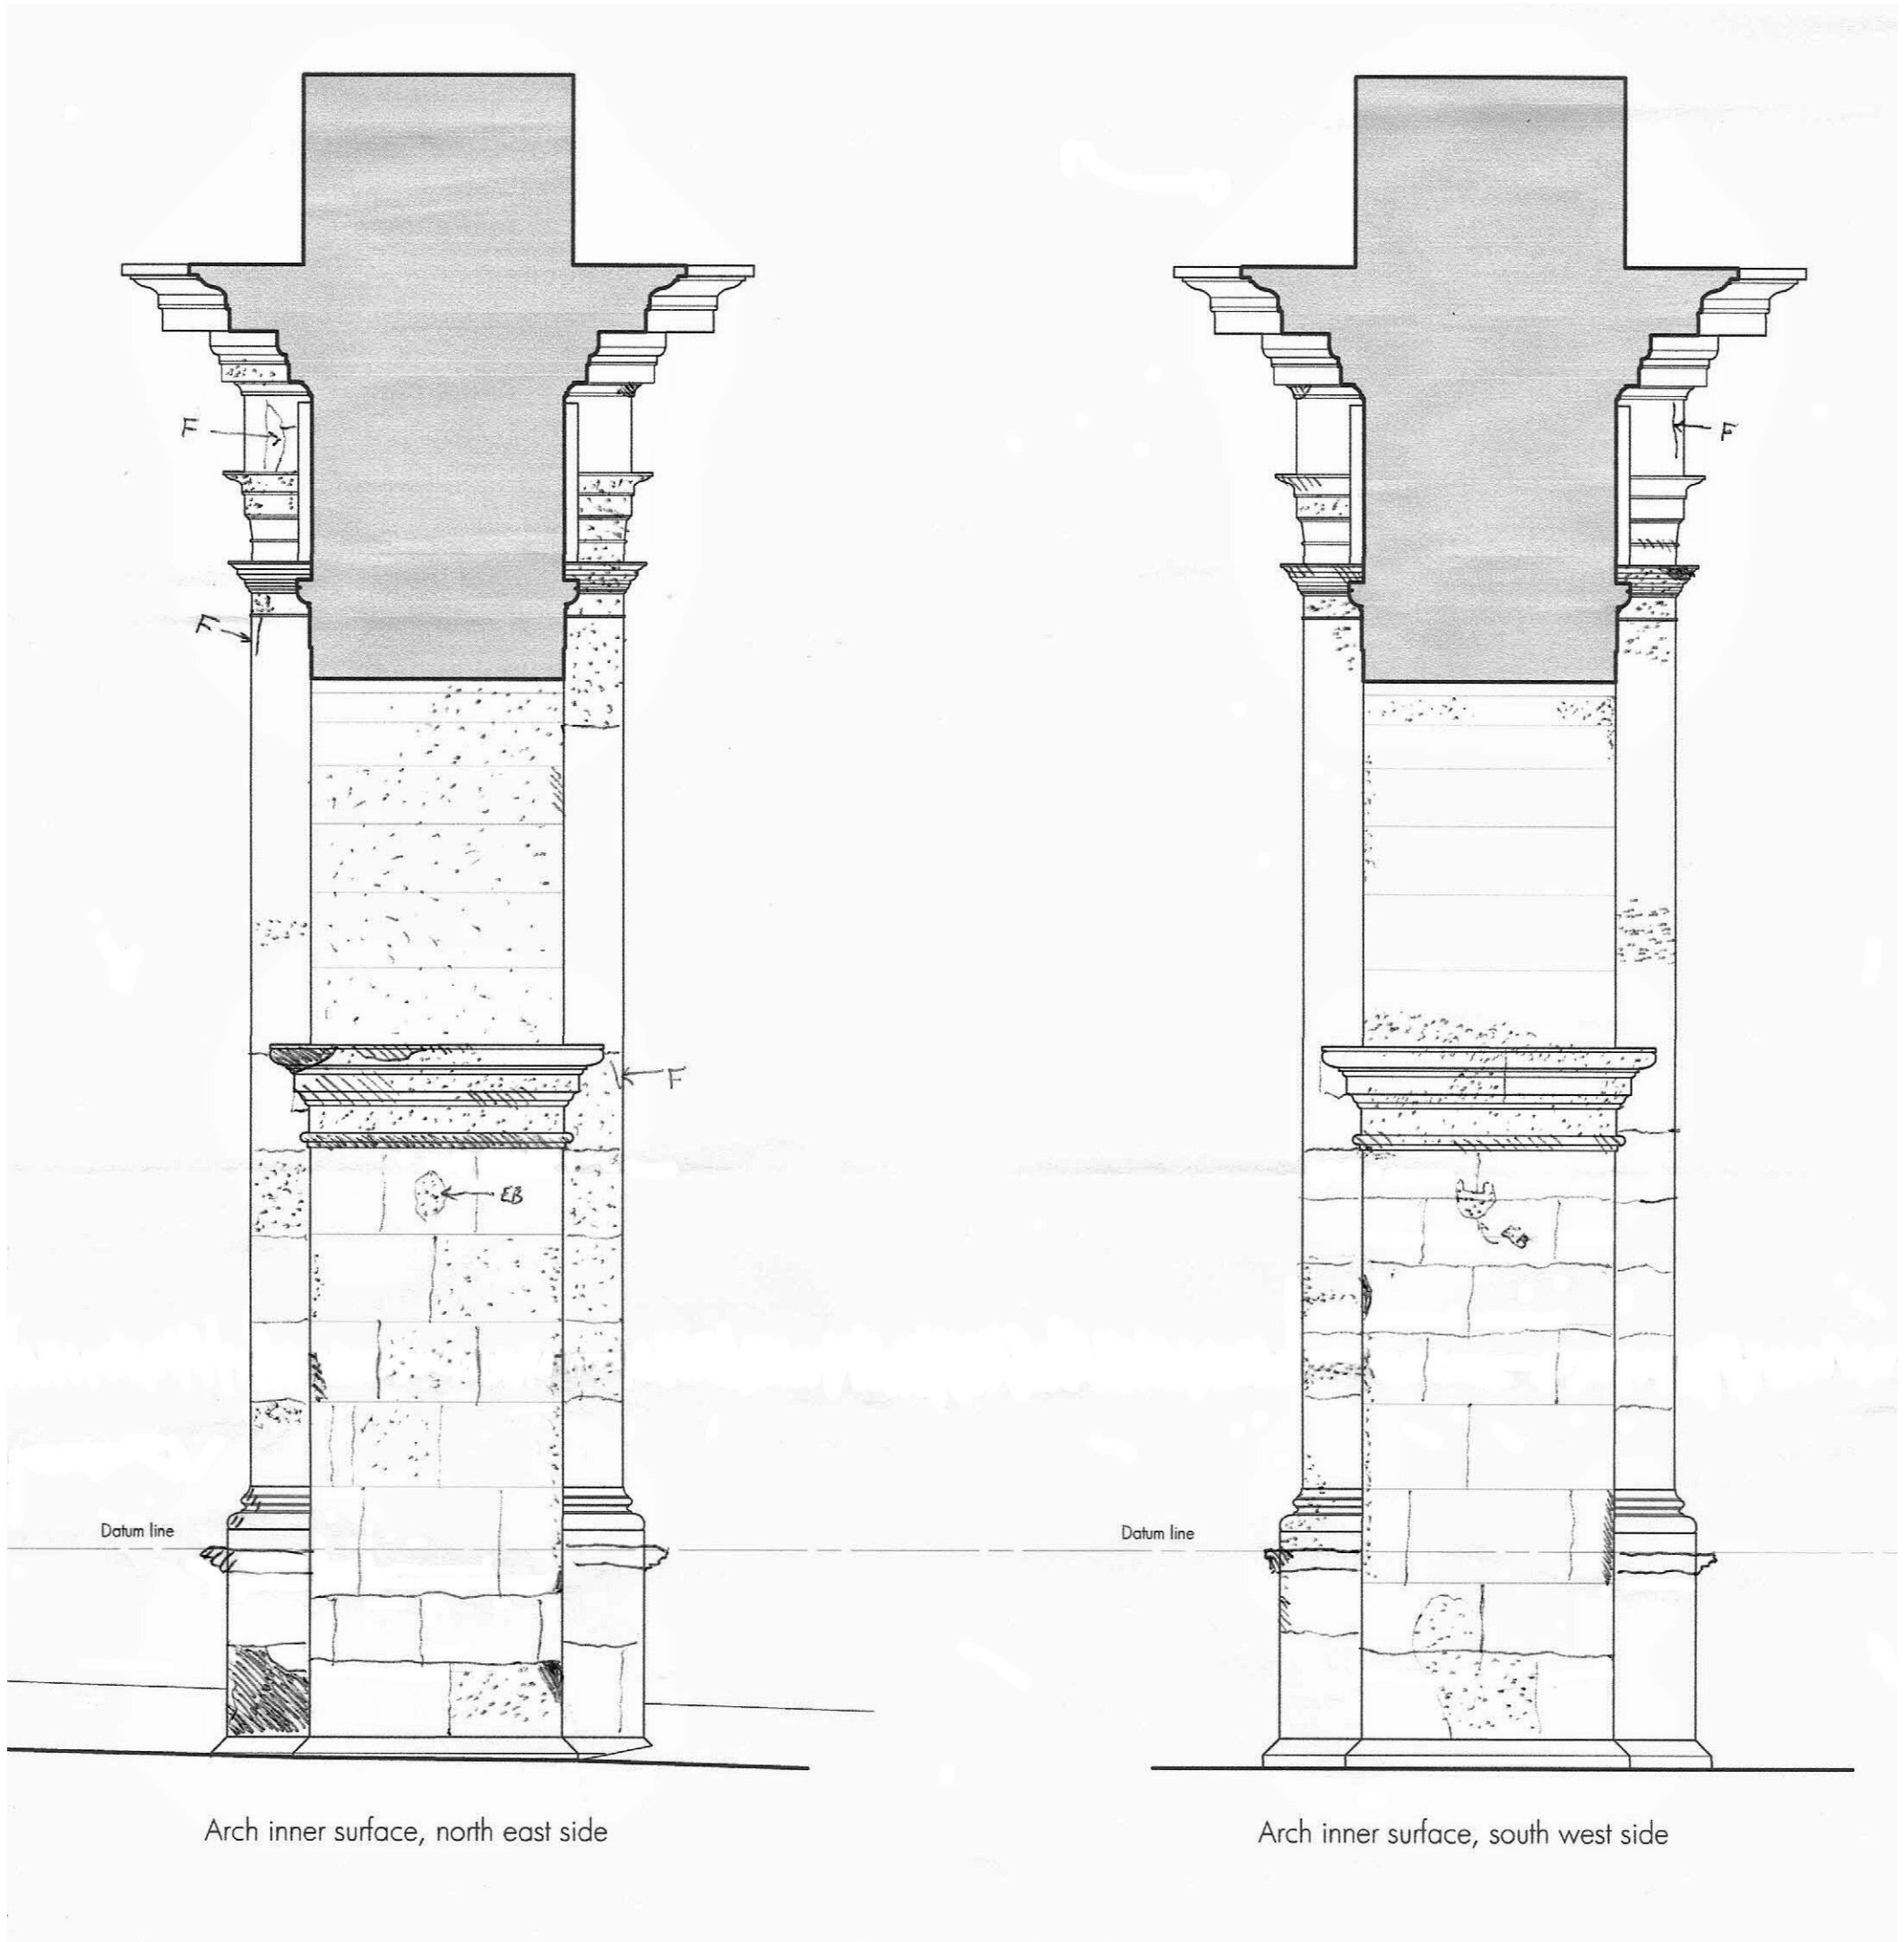
Arch inner surface, north east side

Arch inner surface, south west side

Friable/spalling surface

Friable/eroded surface with loss of section

Completed frost-damaged/lost section	F - Fracture	MR - Mortar repair	EB - Embedded iron
PROPOSED REMEDY	Consolidation with sheltercoat generally (whole block); mortar repair to remove water shedding	Mortar repair to non-weathering surfaces; stone indent to weathering surfaces	Stone indent or stone replacement	Pin/micro-pin	No work if sound Repeat if faulty	No work if stable Drill out and mortar repair if corroding
