Asbestos Survey Report

**19 Lunedale UPRN 8421438
Woodcock Drive
Platt Bridge
Wigan
WN2 5NW**

Type of survey – Management Survey

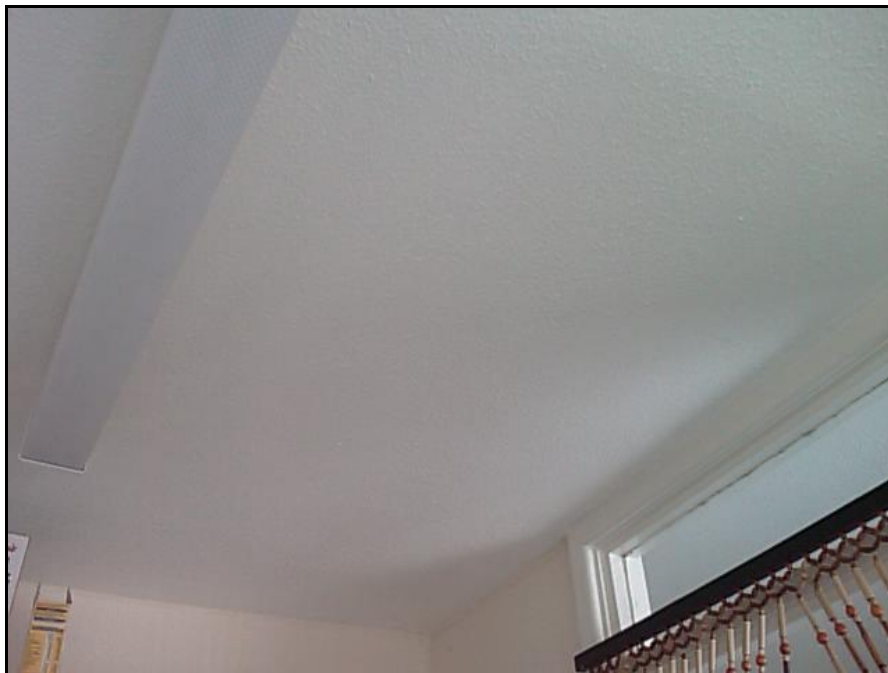
Building	8421438
Floor	First Floor
Room/Area	001 - Rooms throughout property
Sample No	1

Description Item: Ceilings throughout property.

Score
Product Type	Textured coating	1
Extent of Damage	Low Damage	1
Surface Treatment	Composite materials containing asbestos, plastics, resins etc.	0
Asbestos Type	Chrysotile (white)	1
Amount	50m ²	
Accessibility	Occasional Disturbance	
Algorithm Score		3

RECOMMENDATION	Manage and re-inspect
-----------------------	-----------------------

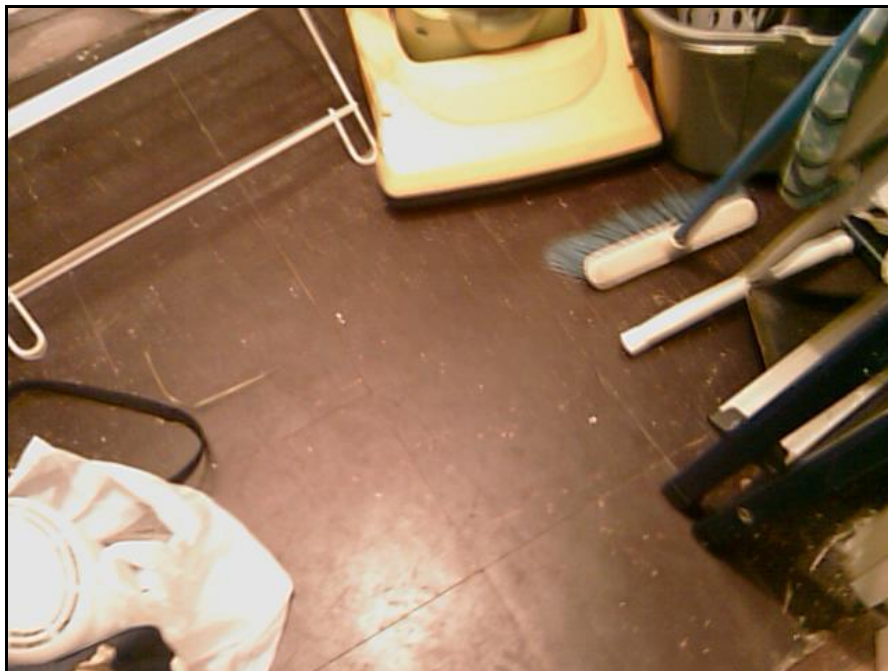
Building	8421438
Floor	First Floor
Room/Area	001 - Rooms throughout property
Sample No	2

Description Item: Floor tiles throughout property.
Present below fixed flooring throughout

Score
Product Type	Floor tiles	1
Extent of Damage	Low Damage	1
Surface Treatment	Composite materials containing asbestos, plastics, resins etc.	0
Asbestos Type	Chrysotile (white)	1
Amount	50m ²	
Accessibility	Occasional Disturbance	
Algorithm Score		3

RECOMMENDATION	Manage and re-inspect
-----------------------	-----------------------
