**ASBESTOS REINSPECTION SURVEY
OF
HARBOUR MULTI-STOREY CAR PARK (FORMERLY TERRACE), MUSEUM ROAD,
TORQUAY, TQ1 1DL**

**CLIENT: TORBAY COUNCIL
3RD FLOOR, TOR HILL HOUSE, UNION STREET, TORQUAY, TQ2 5QW**

**UPRN NO: T0076AA
PROJECT NO: J583513
DATE: December 2019**

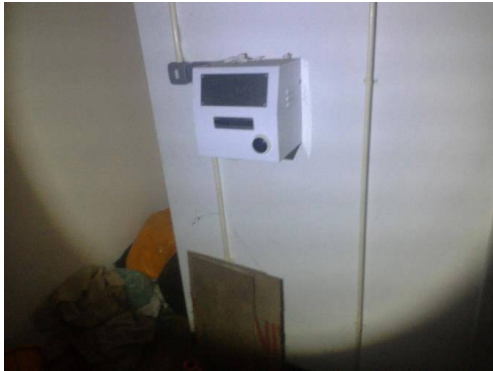
FLOOR/LOCATION:	1st Floor FF03 (FF03)	
DESCRIPTION:	Presumed asbestos containing material within heating element holders on hand dryer.	
RECOMMENDATIONS:	Conduct further investigation prior to relevant maintenance / refurbishment works	
EXTENT:	<10m² or <10m pipe run	
SAMPLE REF:	Presumed	
RESULT:	Presumed Crocidolite (or unknown)

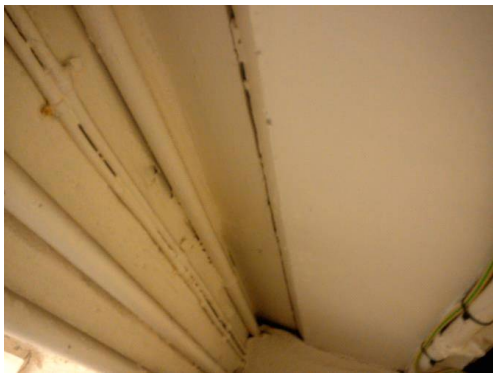
FLOOR/LOCATION:	1st Floor FF04 (FF04)	
DESCRIPTION:	Ceiling Panels	
RECOMMENDATIONS:	Encapsulate	
EXTENT:	<10m² or <10m pipe run	
SAMPLE REF:	TS170908/01 {CW011210} **	
RESULT:	Amosite

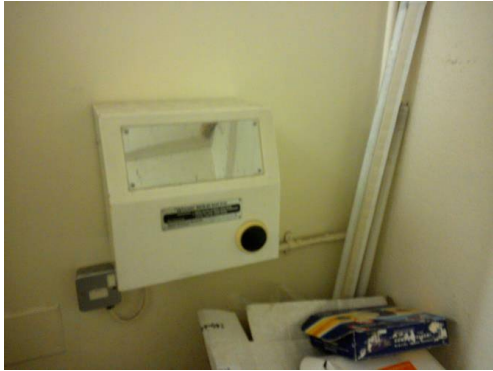
Man	1st Floor / FF04 / FF04 (1)	4 - 10 (2)	Presumed asbestos containing material within Heating Element holders on Hand Dryer (2)	1no. (1)	Sealed (1)	Good Condition (0)	Rare (0)	Crocidolite (or unknown) (3)	6 + 4 = 10	Low	Conduct further investigation prior to relevant maintenance / refurbishment works
Man	1st Floor / FF04 / FF04										
Man	1st Floor / FF05 / FF05 (1)	4 - 10 (2)	Discarded toilet cistern on floor (1)	1no. (1)	Composite Material (0)	Good Condition (0)	High (3)	Previously Identified 1 Identified {CW011211}** / Chrysotile (1)	2 + 7 = 9	Very Low	Remove under controlled conditions
Man	1st Floor / FF05 / FF05 (1)	4 - 10 (2)	Discarded cistern lid in sink (1)	1no. (1)	Composite Material (0)	Good Condition (0)	High (3)	Previously Identified Strongly presumed similar to 1 Identified {CW011211}** / Chrysotile (1)	2 + 7 = 9	Very Low	Remove under controlled conditions
Indicates parameter for Material Assessment algorithm(MA)				Product type *C Surface Treatment *E Extent of damage *F Asbestos Type *H				Priority Rating: Very low <9 Low 10-12 Medium 13-15 High ≥16

FLOOR/LOCATION:	1st Floor FF04 (FF04)	
DESCRIPTION:	Presumed asbestos containing material within Heating Element holders on Hand Dryer	
RECOMMENDATIONS:	Conduct further investigation prior to relevant maintenance / refurbishment works	
EXTENT:	<10m² or <10m pipe run	
SAMPLE REF:	Presumed	
RESULT:	Presumed Crocidolite (or unknown)

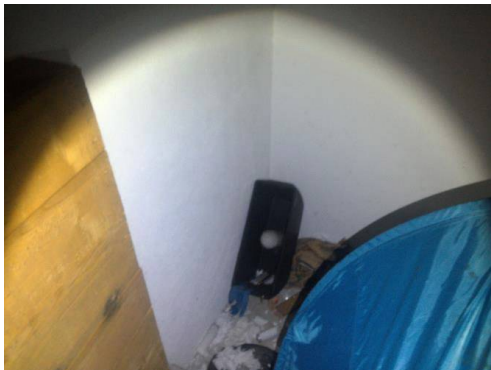
FLOOR/LOCATION:	1st Floor FF05 (FF05)	
DESCRIPTION:	Discarded toilet cistern on floor	
RECOMMENDATIONS:	Remove under controlled conditions	
EXTENT:	<10m ² or <10m pipe run	
SAMPLE REF:	1 Identified {CW011211}**	
RESULT:	Chrysotile

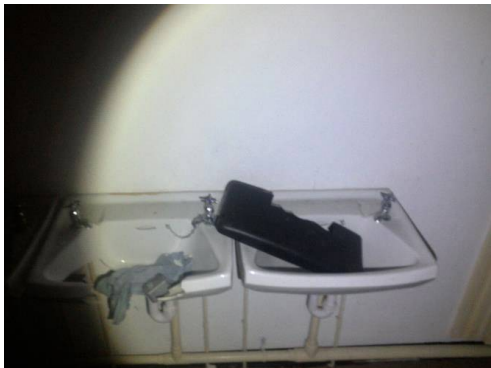
FLOOR/LOCATION:	1st Floor FF05 (FF05)	
DESCRIPTION:	Discarded cistern lid in sink	
RECOMMENDATIONS:	Remove under controlled conditions	
EXTENT:	<10m ² or <10m pipe run	
SAMPLE REF:	SPST 1 Identified {CW011211}**	
RESULT:	Chrysotile

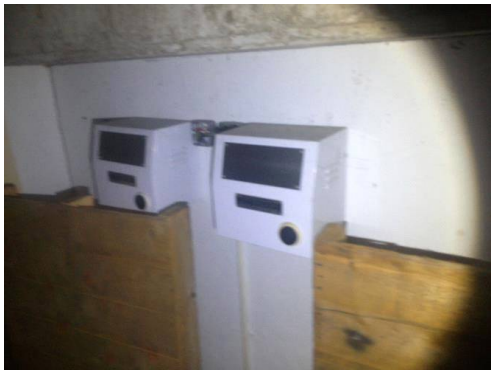
FLOOR/LOCATION:	1st Floor FF05 (FF05)	
DESCRIPTION:	Presumed asbestos containing material within heating element holders on hand dryer	
RECOMMENDATIONS:	Conduct further investigation prior to relevant maintenance / refurbishment works	
EXTENT:	<10m ² or <10m pipe run	
SAMPLE REF:	Presumed	
RESULT:	Presumed Crocidolite (or unknown)

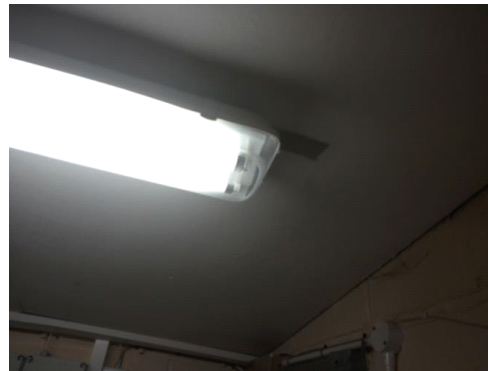
Man	1st Floor / FF08 / FF08 (1)	4 - 10 (2)	Ceiling Panels (2)	12m² (2)	Sealed (1)	Good Condition (0)	Low (1)	Previously Identified Strongly presumed similar to TS170908/01 {CW011210}** / Amosite (2)	5 + 6 = 11	Low	Manage, monitor and inform maintenance personnel prior to relevant works		
Man	1st Floor / FF08 / FF08												
Indicates parameter for Material Assessment algorithm(MA)				Product type *C Surface Treatment *E Extent of damage *F Asbestos Type *H								Priority Rating: Very low <9 Low 10-12 Medium 13-15 High ≥16	
Indicates parameter for Priority Assessment algorithm(PA)				Location a A No.of Occupants a B Vulnerability to damage a G Extent of materials a D									
All the following areas have been checked:				A: Roof/external eaves and soffits B: Boilers/vessels pipes C: Ceilings D: Ducts E: Flooring F: Air handling systems G: Industrial appliances H: Heating system I: Interior walls panels

BUILDING NAME:	Main building
FLOOR/LOCATION:	1st Floor FF08 (FF08)
DESCRIPTION:	Ceiling Panels
RECOMMENDATIONS:	Manage, monitor and inform maintenance personnel prior to relevant works
EXTENT:	10 - 50 m ² or 10 - 50m pipe run
SAMPLE REF:	SPST TS170908/01 {CW011210}**
RESULT:	Amosite
