CCTV SURVEY

Foul & **Surface Water** Drainage

St Stephens Hall, St Stephen's Way, Bournemouth, BH2 6JZ

Tuesday 22nd February 2022

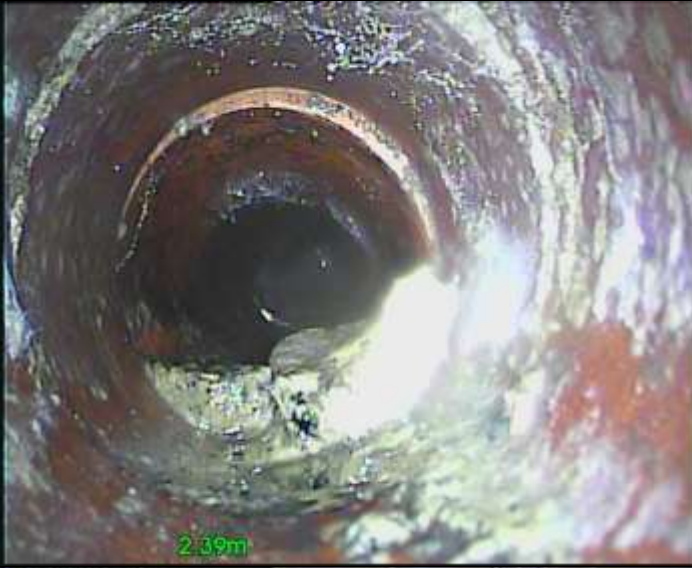
<p>2.39m</p>	<p>3. At: 2.39m Scale 5%</p>

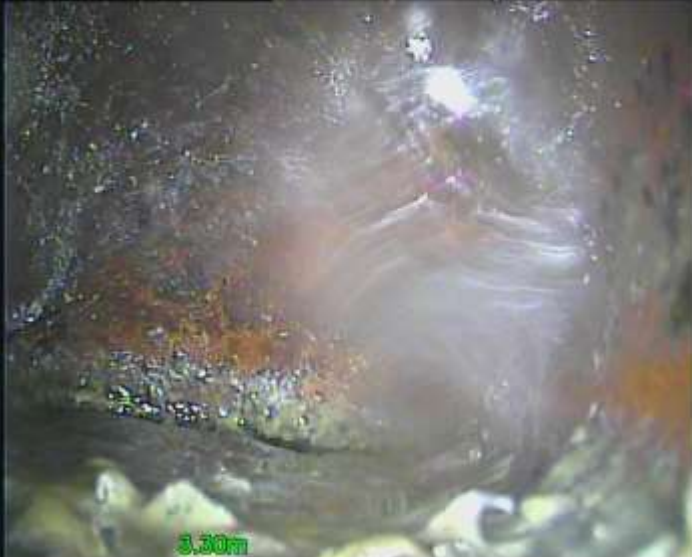
<p>3.30m</p>	<p>4. At: 3.30m Gully</p>

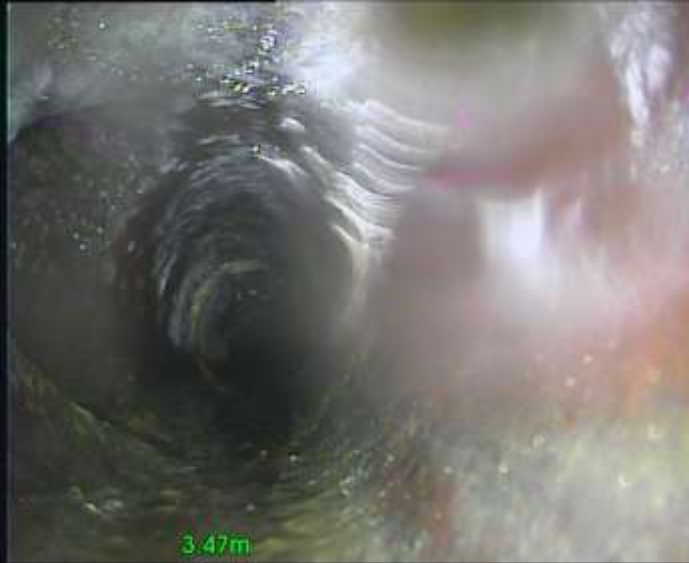
<p>3.47m</p>	<p>1. At: 3.47m Junction @ 9 O'clock (100mm)</p>

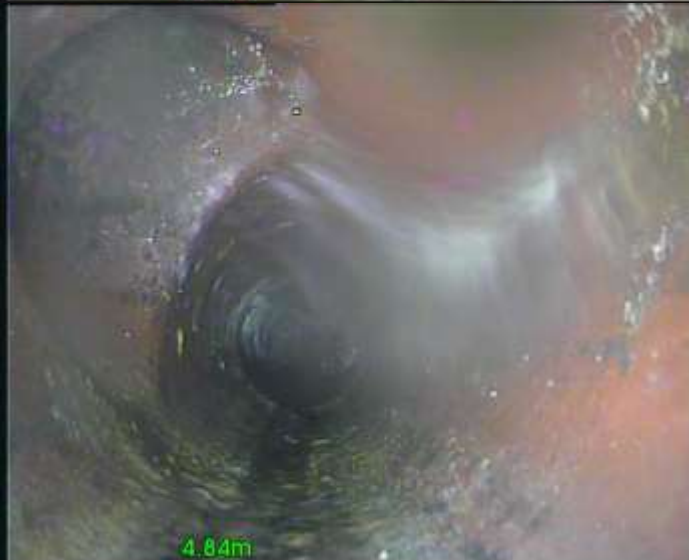
<p>4.84m</p>	<p>2. At: 4.84m Junction @ 9 O'clock (100mm)</p>

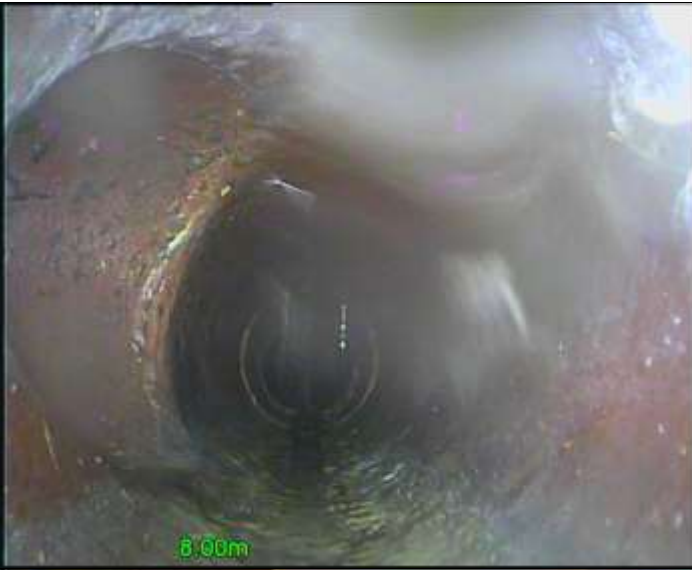
<p>3. At: 8.00m Junction @ 9 O'clock (100mm)</p>

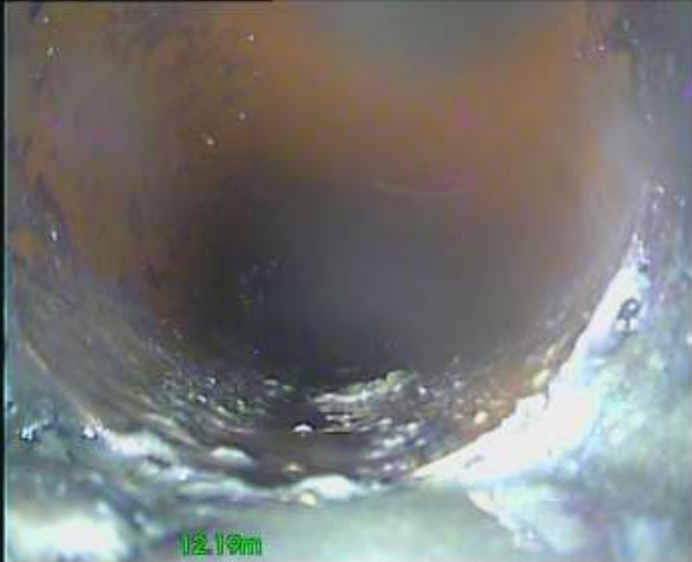
<p>4. At: 12.19m Material Change (MC) CLAY TO PLASTIC</p>

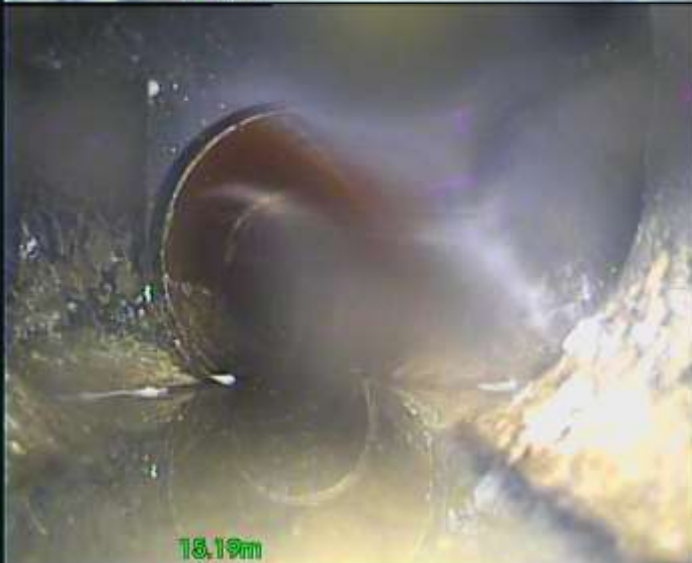
<p>5. At: 15.19m MH2</p>

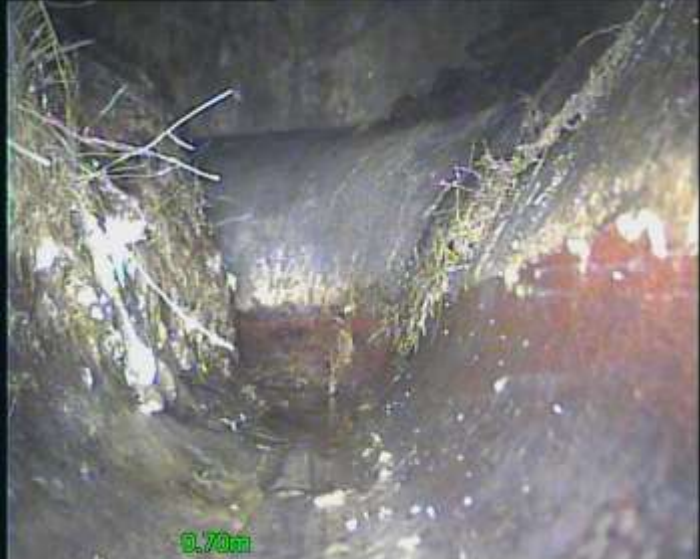
<p>1. At: 0.70m MH3 (Buried & Roots in Chamber)</p>
--	---

Track / trace required to accurately locate before raising to ground level. This chamber, and possibly the downstream pipework, has root ingress and possible silt build up so will require extensive jetting, resurveying and probable lining works.

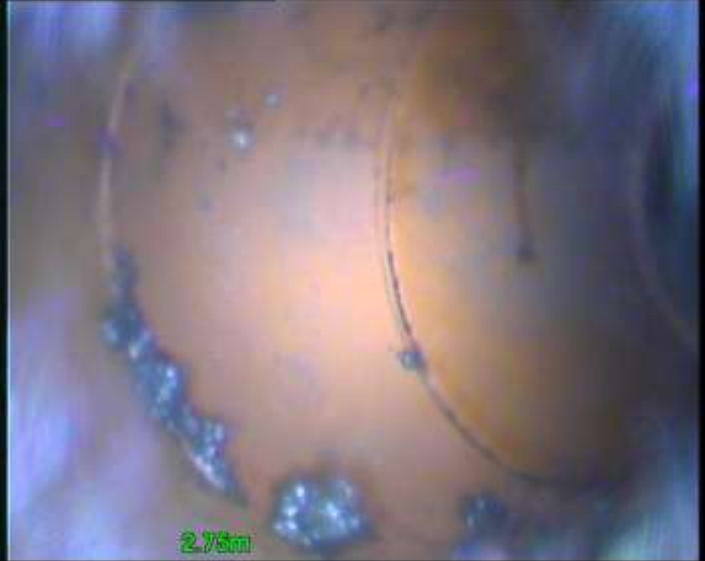
<p>1. At: 2.73m Line Deviates Right (LDR)</p>

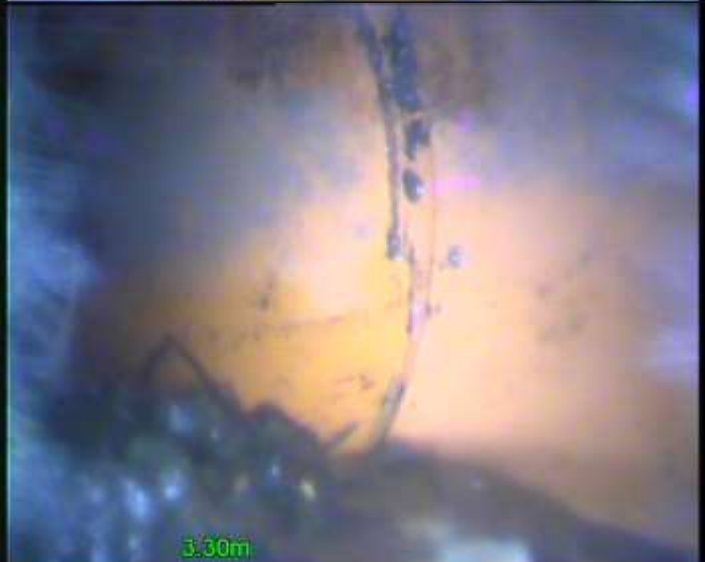
<p>2. At: 3.30m Line Deviates Left (LDL)</p>

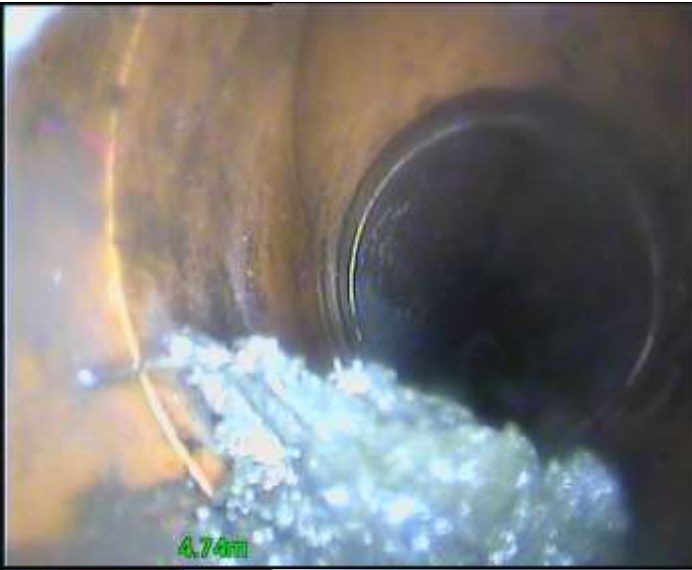
<p>4.74m</p>	<p>3. At: 4.74m Junction @ 12 O'clock (100mm)</p>

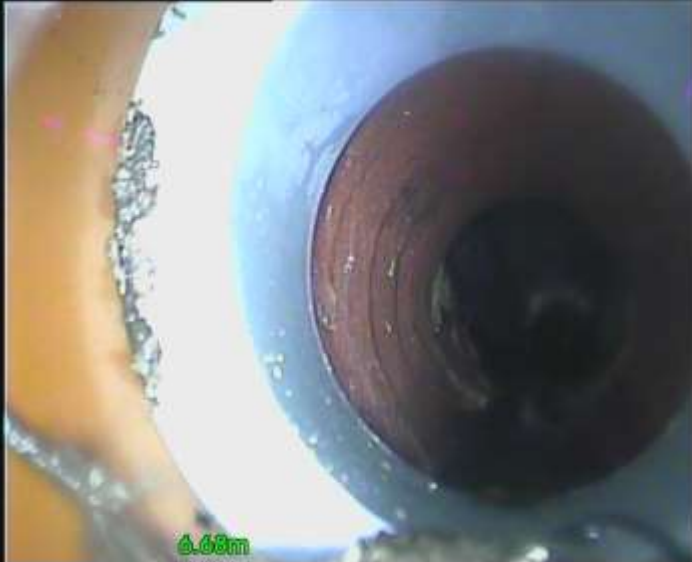
<p>6.68m</p>	<p>4. At: 6.68m Material Change (MC) PLASTIC TO CLAY</p>
  <p>7.12m</p>	<p>5. At: 7.12m MH5</p>

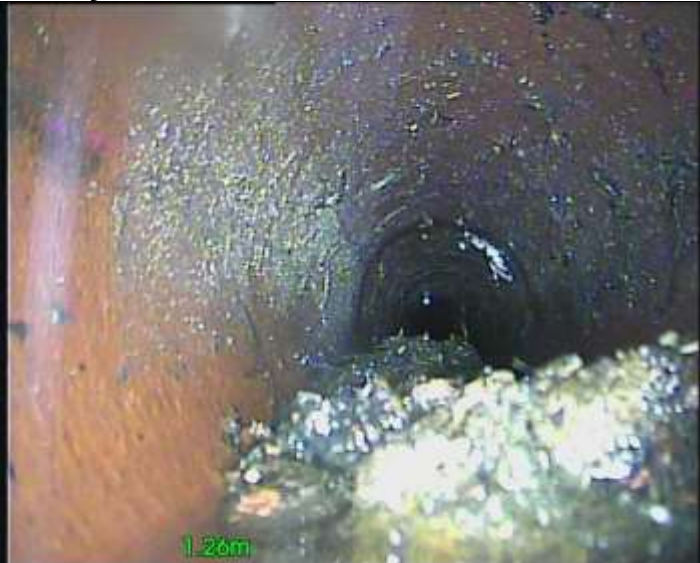
<p>1. At: 1.26m Silt 25%</p>

Requires high pressure jetting to clean and remove silt then installation of a 100mm structural patch liner at approx. 9 meters.

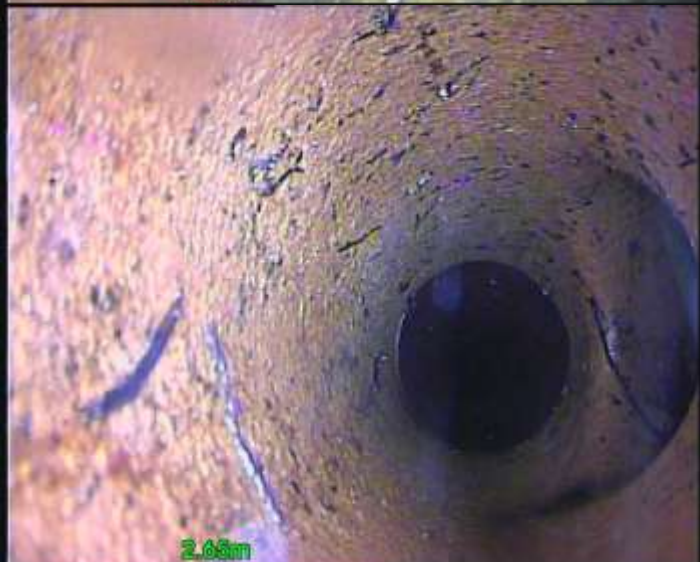
<p>2. At: 2.65m Junction @ 3 O'clock (100mm)</p>

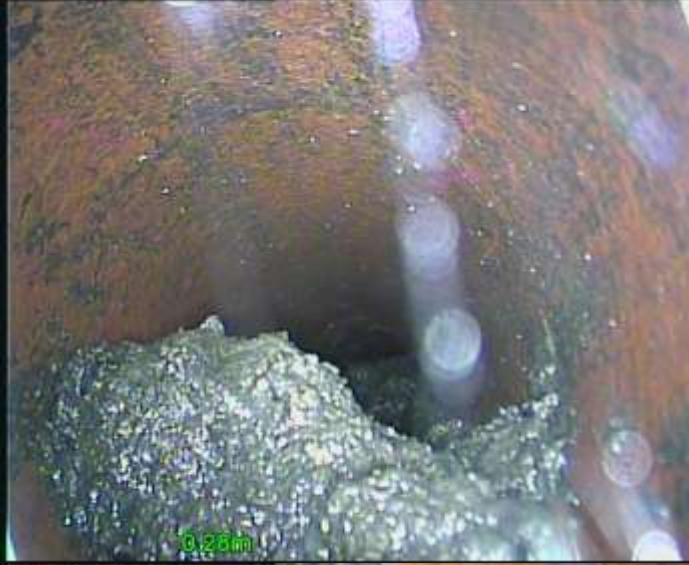
<p>1. At: 0.28m Silt 40%</p>

Requires high pressure jetting to remove silt build up

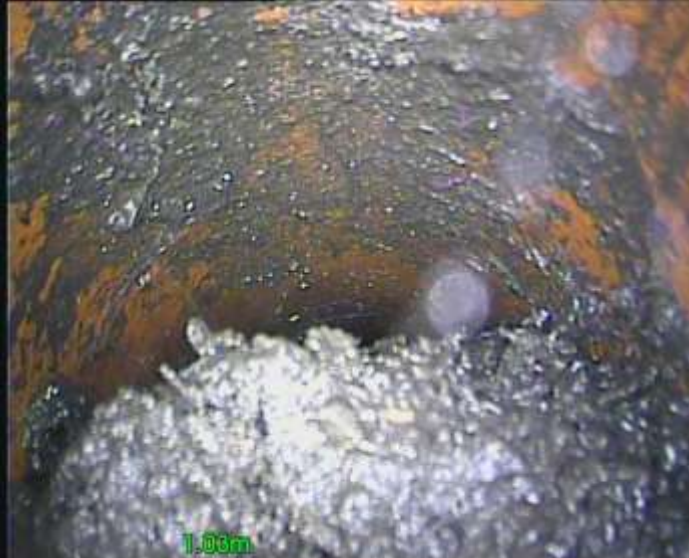
<p>2. At: 1.03m Silt 80% (Unable to Pass)</p>

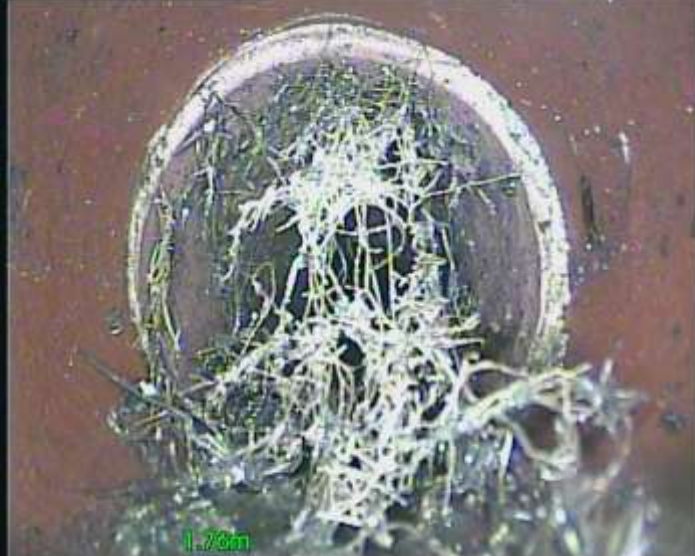
<p>3. At: 1.76m Roots</p>

Requires extensive high pressure jetting to clear roots and silt build up before resurveying, 8x 100mm structural patch liners can then be installed to seal cracks and root damaged areas already noted, we can then quote for any further repairs needed on this section.

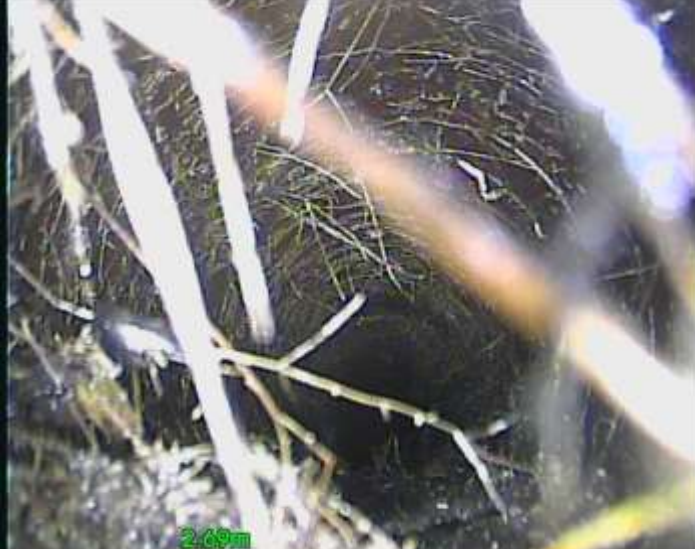
<p>4. At: 2.69m Roots</p>

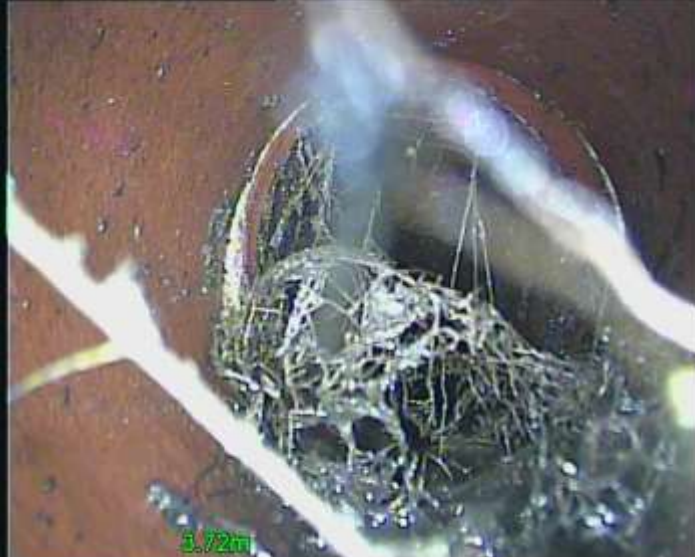
<p>5. At: 3.70m Roots</p>

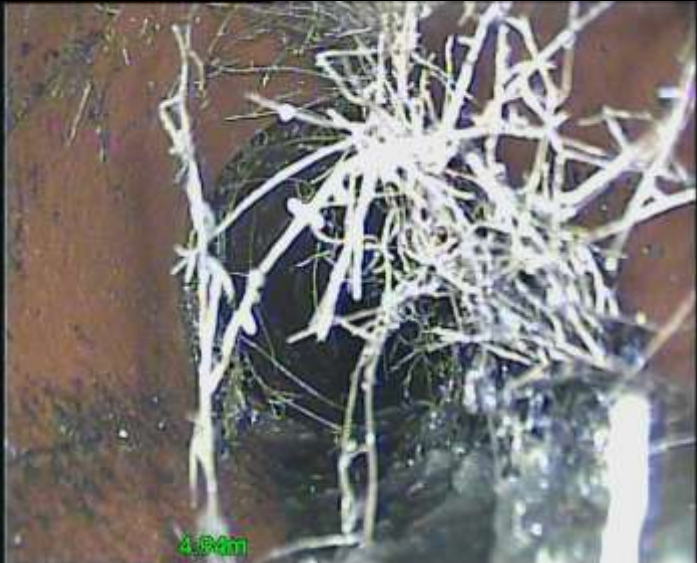
<p>6. At: 4.94m Roots</p>

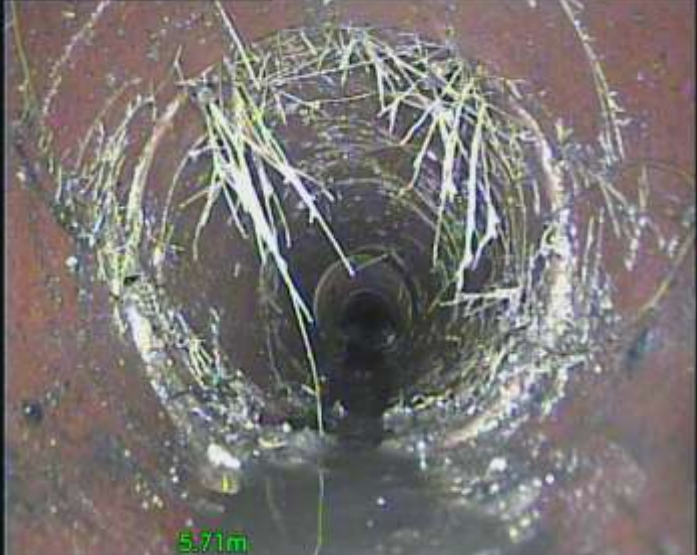
<p>7. At: 5.71m Roots</p>
 	<p>8. At: 7.15m Silt 20%</p>

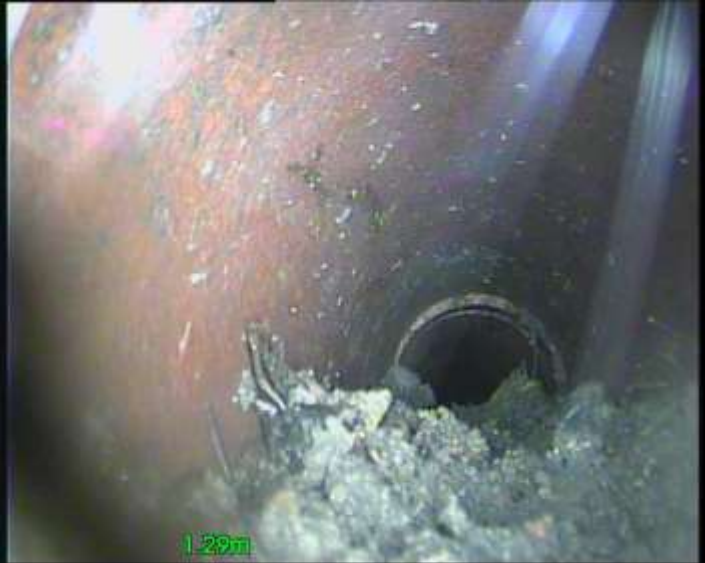
<p>1. At: 1.29m Silt 10%</p>

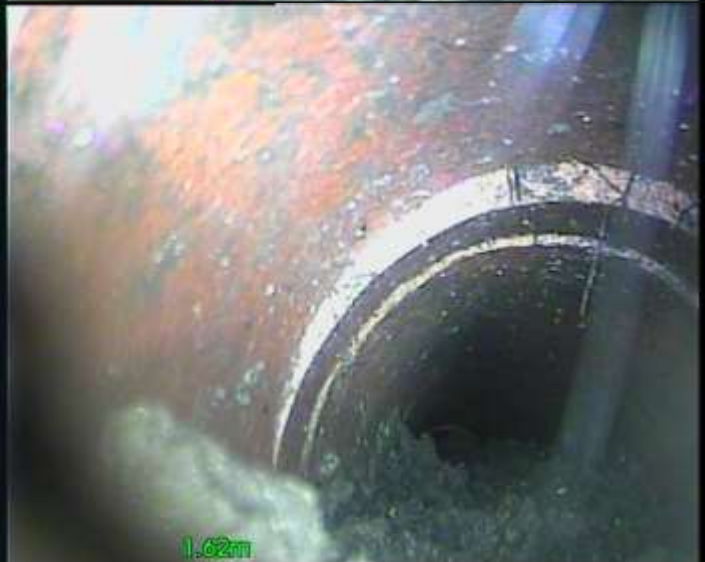
<p>2. At: 1.62m Silt 40%</p>

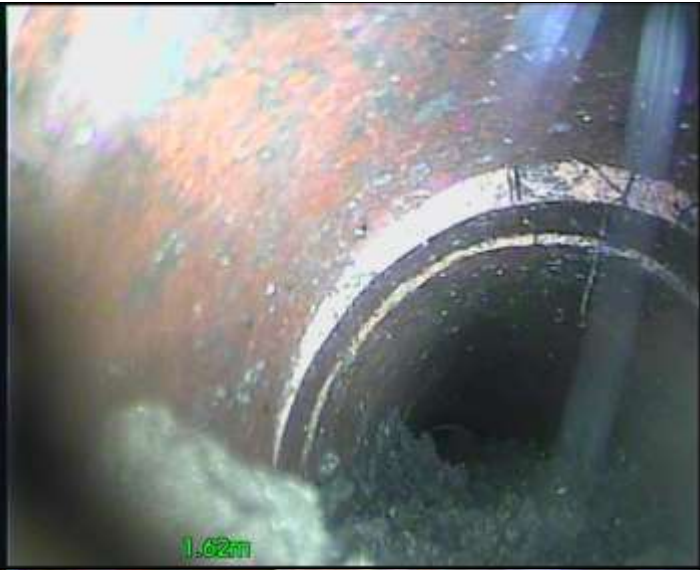
<p>3. At: 1.62m Circumferential Fracture (FC) 12 O'clock to 12 O'clock</p>

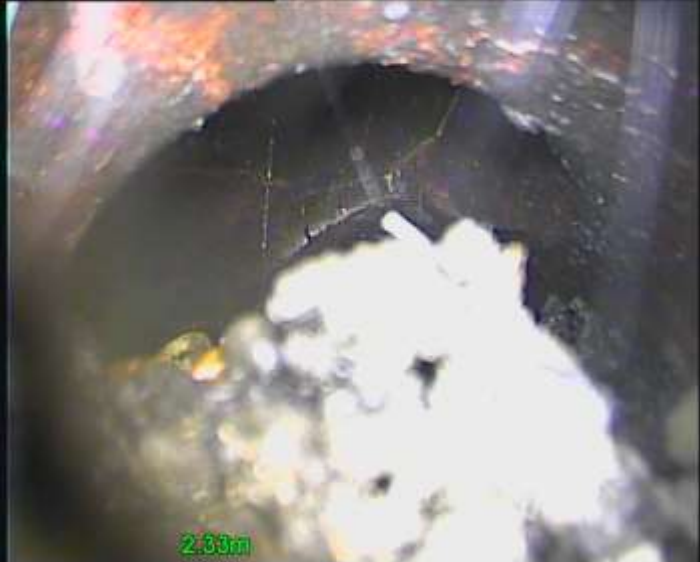
<p>4. At: 2.33m Junction @ 10 O'clock (100mm)</p>

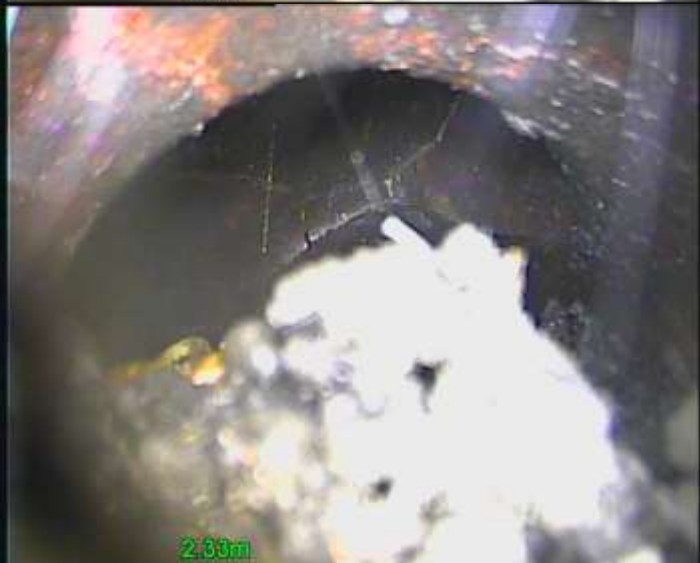
<p>5. At: 2.33m Silt 80% (Unable to Pass)</p>

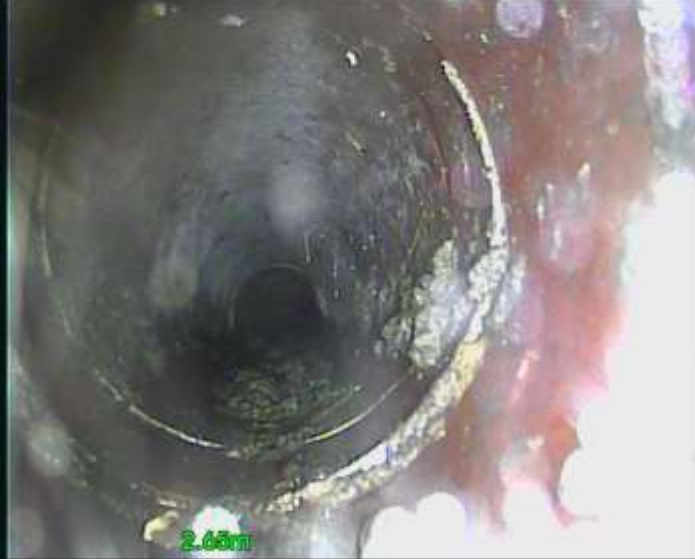
<p>1. At: 2.65m Circumferential Crack (CC) 12 O'clock to 12 O'clock</p>

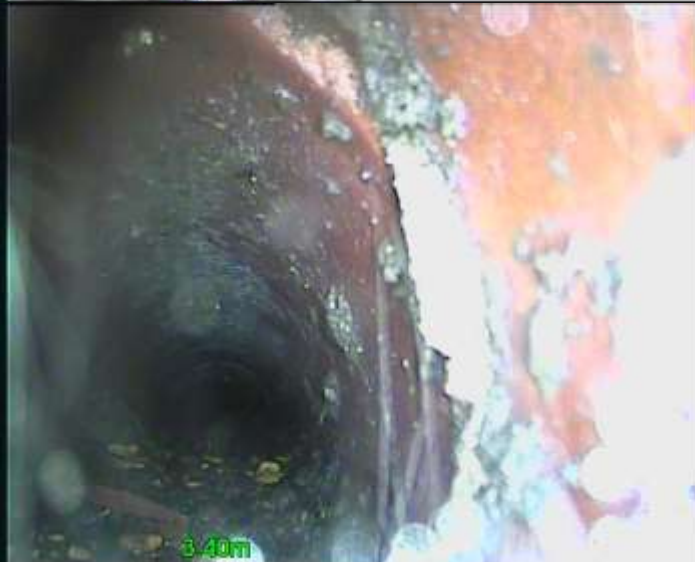
<p>2. At: 3.40m Silt 20%</p>

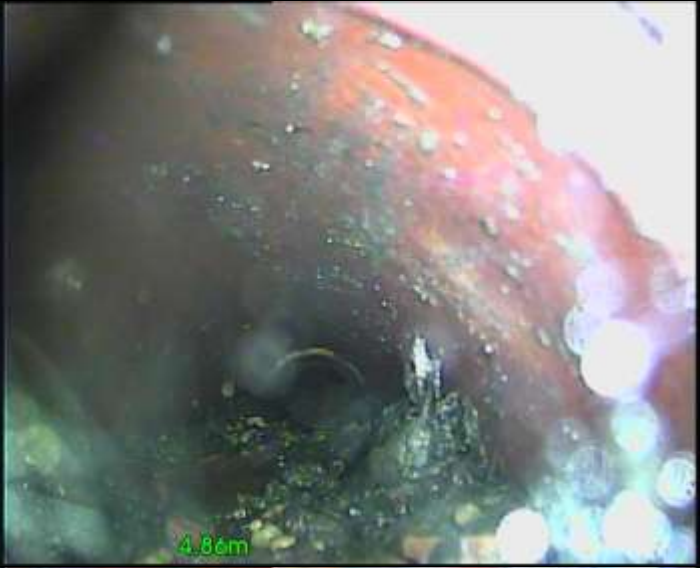
<p>3. At: 4.86m Silt 40%</p>

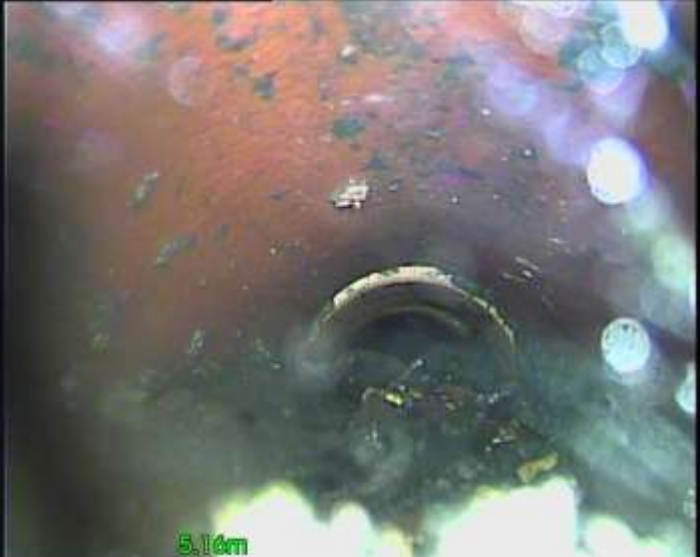
<p>4. At: 5.14m Silt 80% (Unable to Pass)</p>

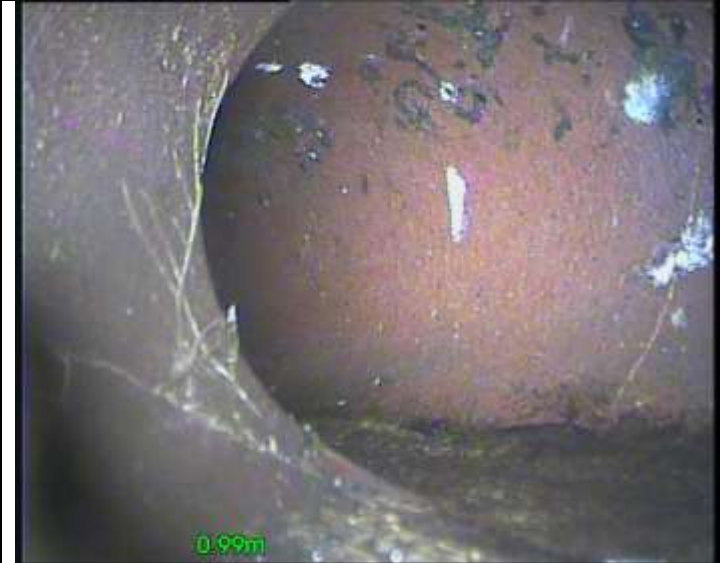
<p>1. At: 0.99m Enter Main Run @ 'Y' Junction</p>

This main run requires dye testing from the internal WCs to check if still in use. We would require access to the hall to enable us to carry out these dye tests.

If this run is found to be redundant then MH7 can be done away with and the gully re-routed into MH8. The reasoning behind this is that channel and 'Y' junction within this chamber are broken and leaking.

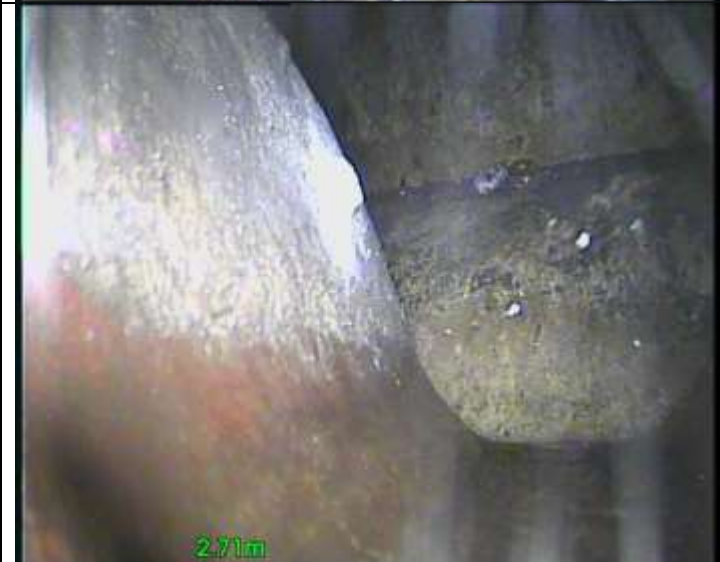
<p>2. At: 2.71m Buried Manhole</p>

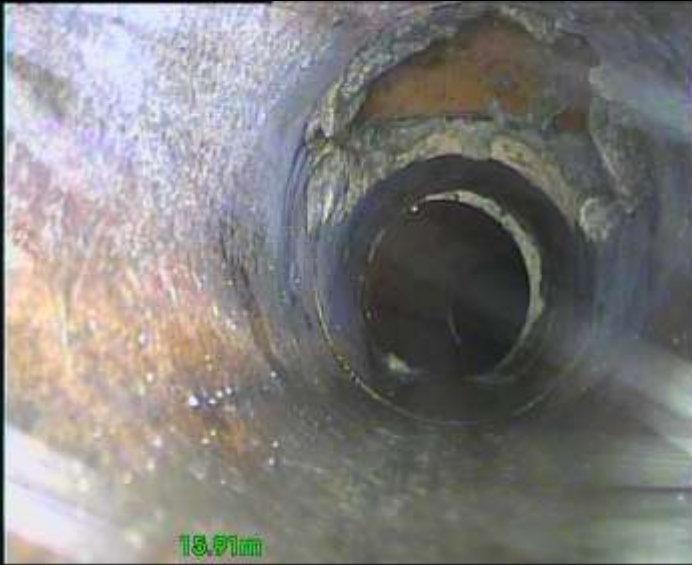
<p>3. At: 15.91m Connection @ 12 O'clock</p>

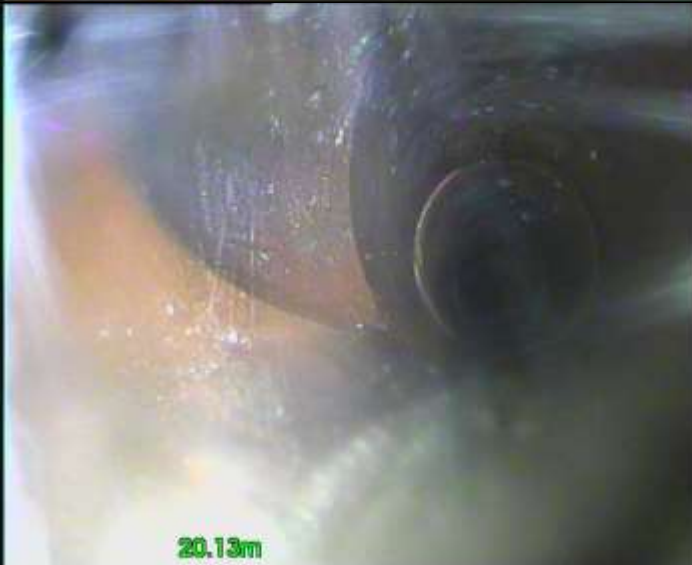
<p>4. At: 20.11m Junction @ 9 O'clock (100mm)</p>

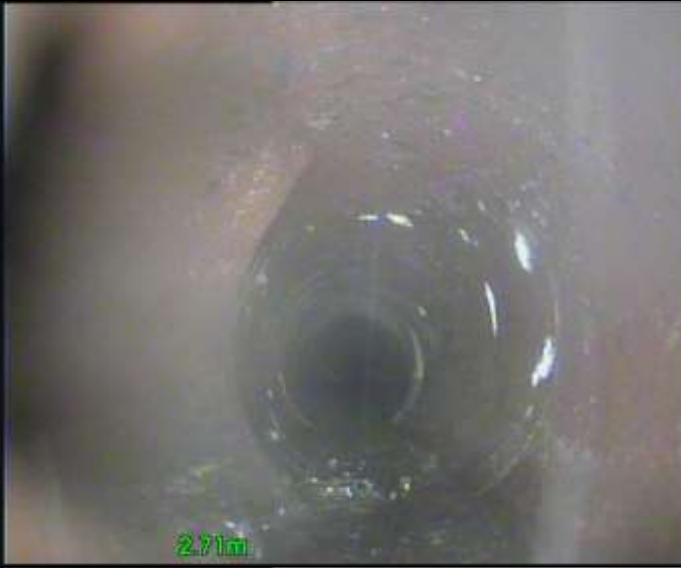
<p>2. At: 2.71m Junction @ 9 O'clock (100mm)</p>

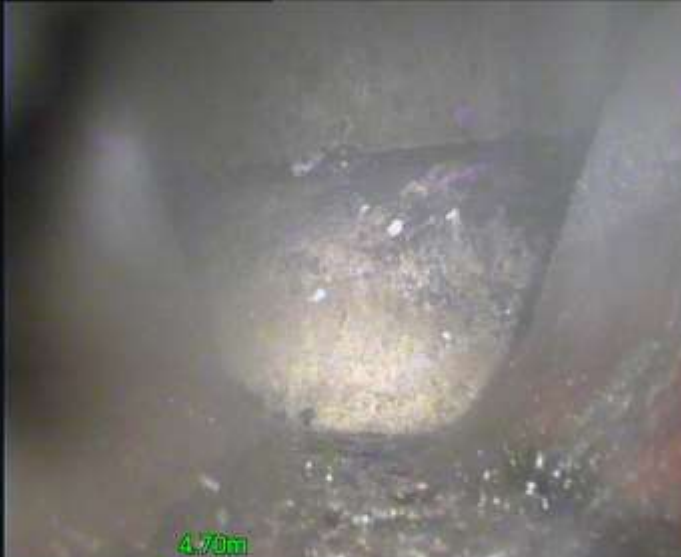
<p>3. At: 4.70m MH8 (Buried)</p>

Track / trace accurate location of MH8 then expose and raise. Survey all pipework serving this chamber to check for any further faults.
