# **Cooper & Withycombe**

**Rushmoor Borough Council  
Farnborough Community Centre  
Ellis Hall  
Meudon Avenue  
Farnborough  
GU14 7LE**

## **Structural Survey and Assessment Report**

**March 2020**

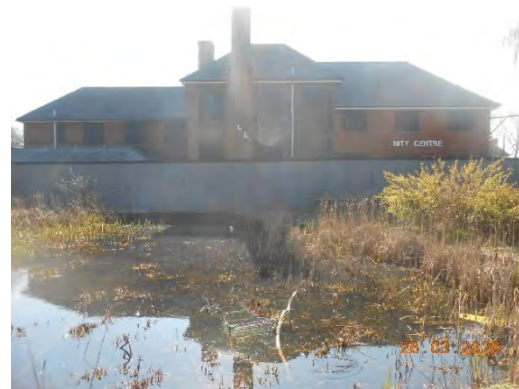
P 2

North elevation - external

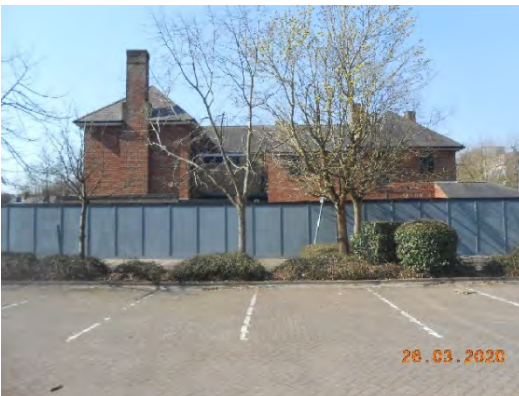
P 3

Rear elevation (east) external

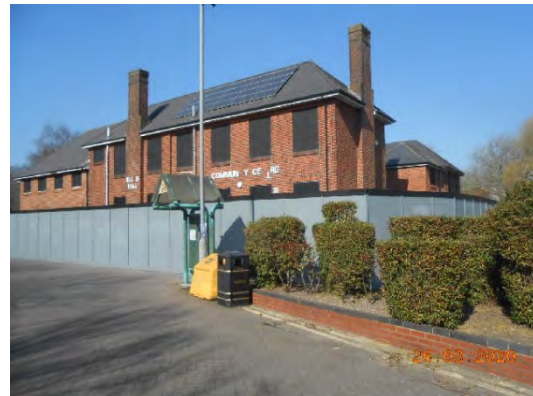
P 4

South elevation - external

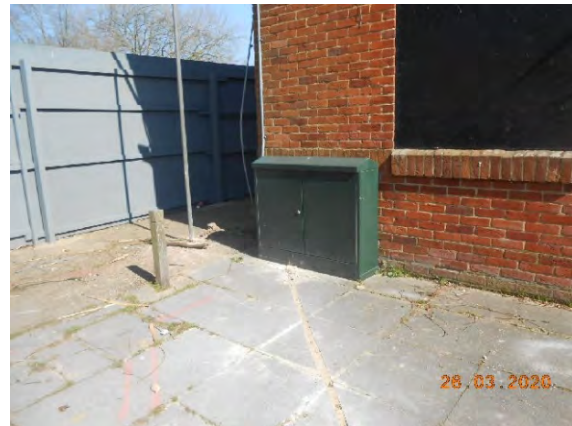
P 8

**Front elevation – service box – north-west corner**

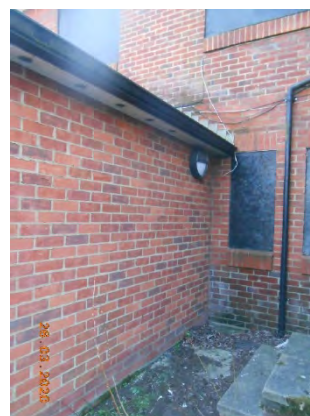
P 12

**North elevation – junction to core**

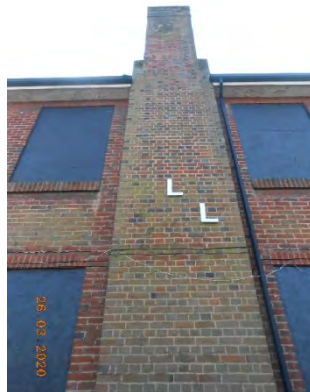
P 15

**North elevation - chimney**

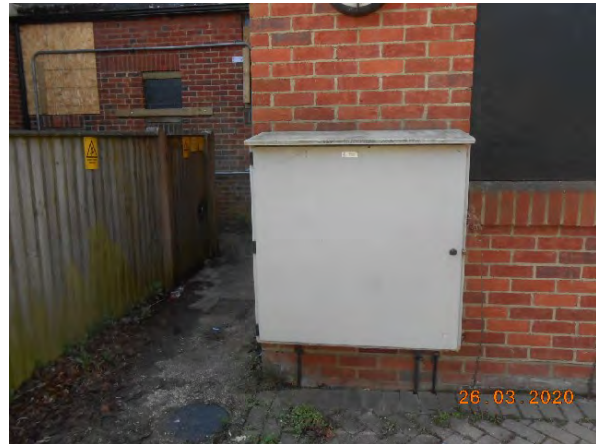
P 20

**Rear elevation (east) service box**

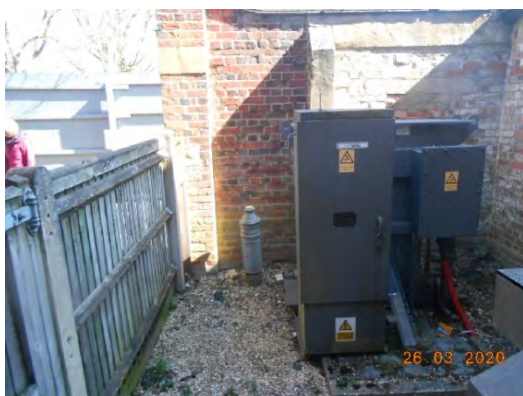
P 23

**Rear elevation – substation enclosure**

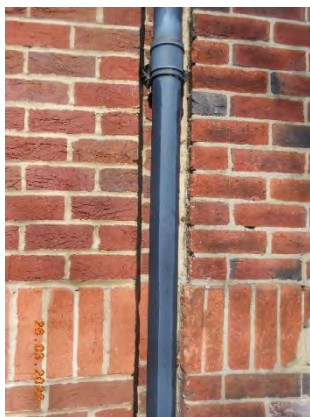
P 29

**Junction between front elevation and original**

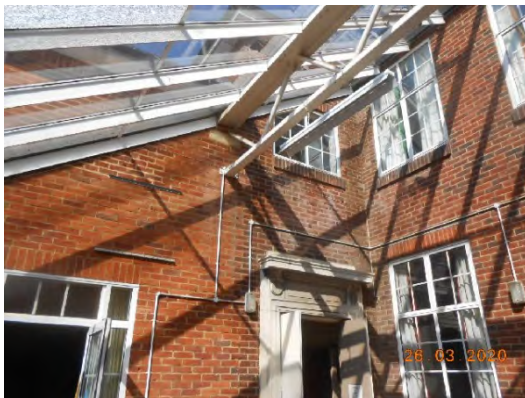
P 33

- Originally an open yard area to the front of the original building.
- This has now been enclosed as a glazed atrium with a lean-to roof supported on a central steel girder truss spanning between the front wing walls.
- It has glazed mullions supporting the glazing which is supported on the front face of the main building and eaves gutter on the west side. This eaves gutter appears to be supported on four circular hollow steel columns set independently from the front infill building. This implies it was a later construction and loading on the front wall was avoided.

**G5 truss to glazed roof**

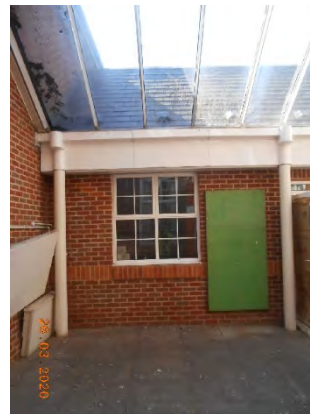
P 34

**G5 support to glazing at front**

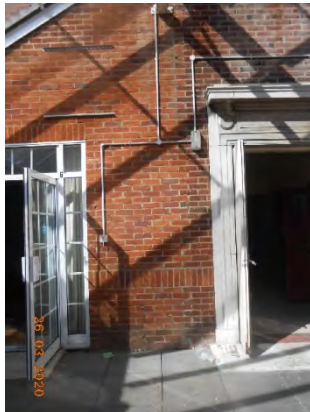
P 37

**Junction between original (G2) and  
extension (G1)**

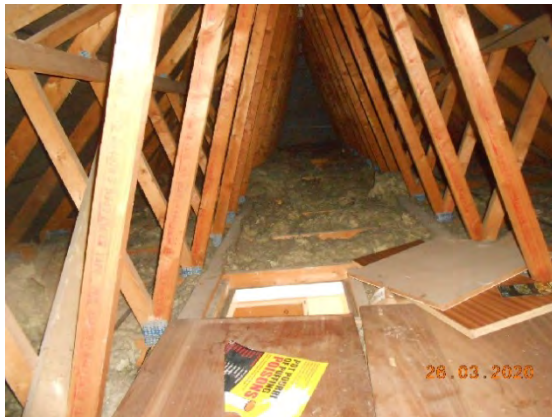
P 39

- The walls are masonry.
- Off of G4 there is a further office with a solid carpet floor with an access hatch into the roof space over.
- The roof over the infill area is of proprietary gangnail trussed rafters.

**Roof over G4**

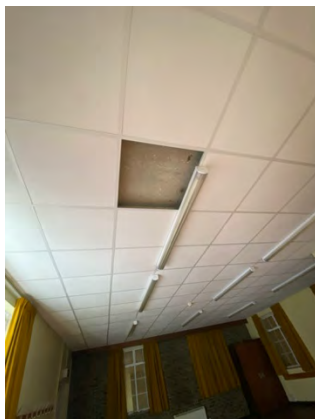
P 41

- Brick facing to the west wall.
- Laying tile ceiling.
- Parquet flooring on bitumen d.p.m on solid floor.
- Parquet flooring raised in two areas across the floor.
- Partition in right-hand corner.
- Where a lay in ceiling tile has been omitted the concrete soffit to the slab over can be seen. This is cast in in-situ slab.

**Room G1 Concrete Ceiling**

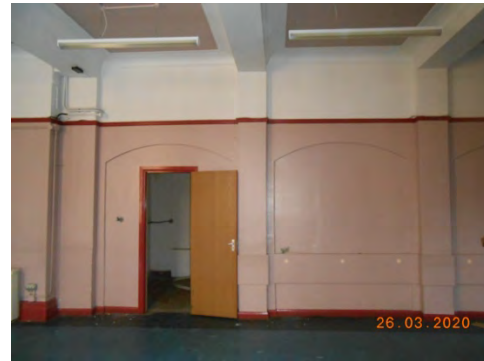
P 44

**G6 East Wall - Arches**

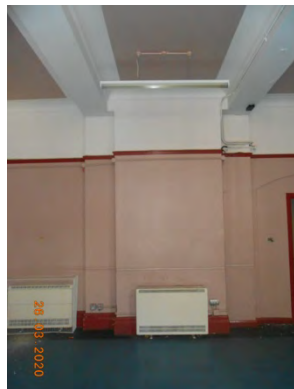
P 45

**G6 Downstand Beams**

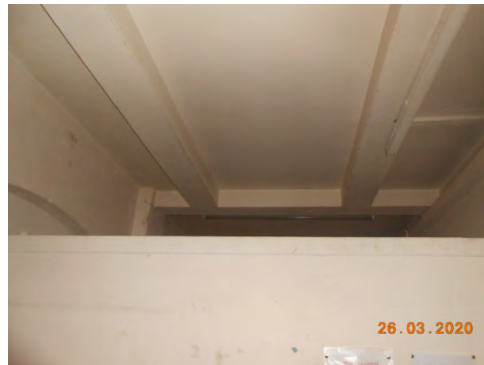
P 46

- This is an ancillary room located off the main hall.
- There are beams over this area and a central partition wall, which does not continue to full height, in timber frame construction. This has clearly been modified.

**G7 Trimming Beams to Flat Roof Over**

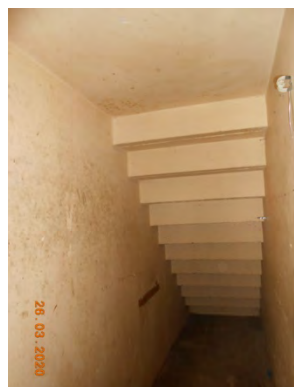
P 47

**G9 Underside of Stairs**

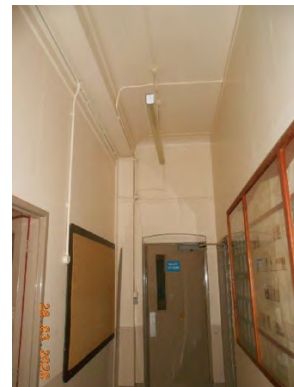
P 48

- Link corridor behind the hall.
- This is separated from the hall by a timber stud partition which extends up to the underside of a downstand beam which spans between columns at each end. It is assumed that at some stage this was part of the main hall.
- In the middle of the corridor there is a further downstand beam spanning from the cross beam to the south flank wall. This extends over the adjacent rooms G17 and G18.

**G16 Corridor – Framing to end of Hall**

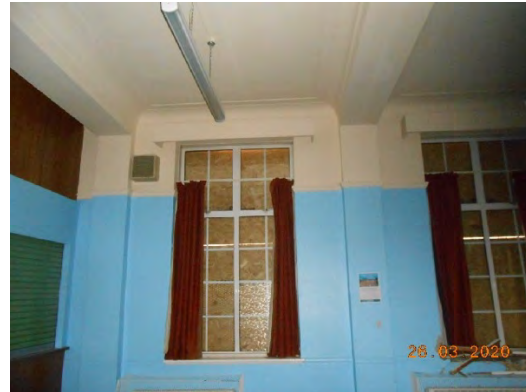
P 50

**G20 External wall – Downstand Beam**

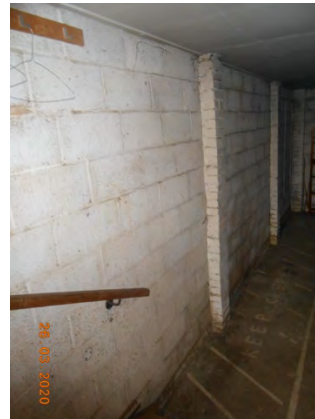
P 56

F13 Infill Single Storey Store

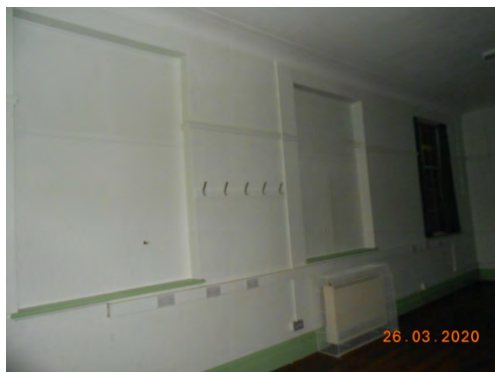
P60

F16 External Wall
