Asbestos Refurbishment/Demolition Survey for Bournemouth Christchurch & Poole Council

St Stephens Hall
St Stephens Road
Bournemouth
Dorset
BH2 6JZ

Project Number: AS9066

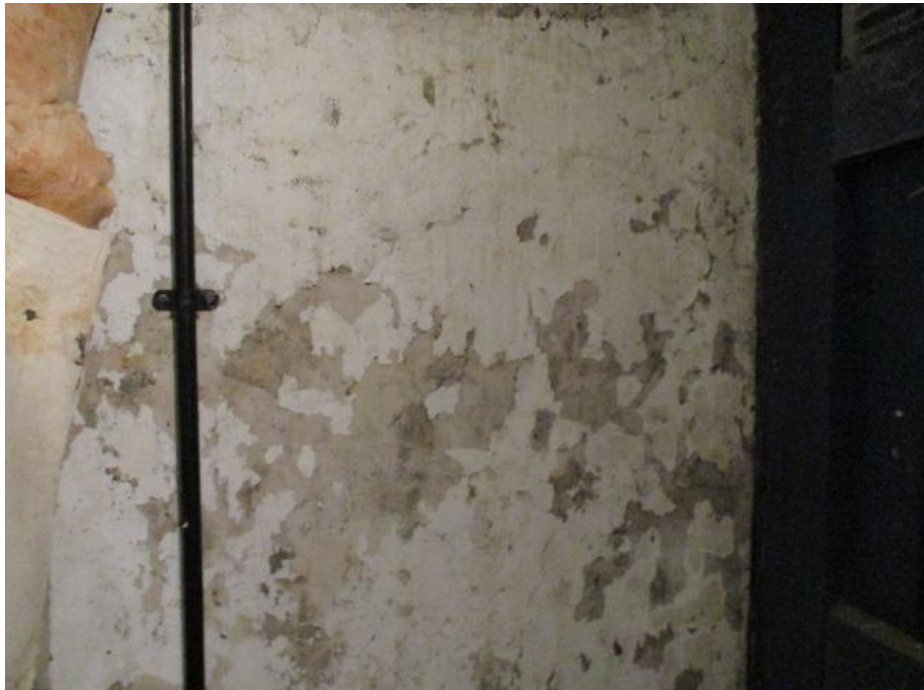
Location ID:	60735	Survey Type:	RDS
Location Ref:	Sample 1	Product Type:	NADIS
Product:	Pipe insulation	Damage:	NADIS
Area:	01	Treatment:	NADIS
Floor:	Ground floor	Asbestos Type:	NADIS
Room:	Boiler room	Identification:	Identified
Surveyor Name:	Andrew Mayes	Quantity:	Throughout Area
Drawing Ref:	01		
Asbestos ?	No		
Date:	01 March 2022		
Next Inspection:	Not Applicable

Pipe insulation residue to walls

No Action Required

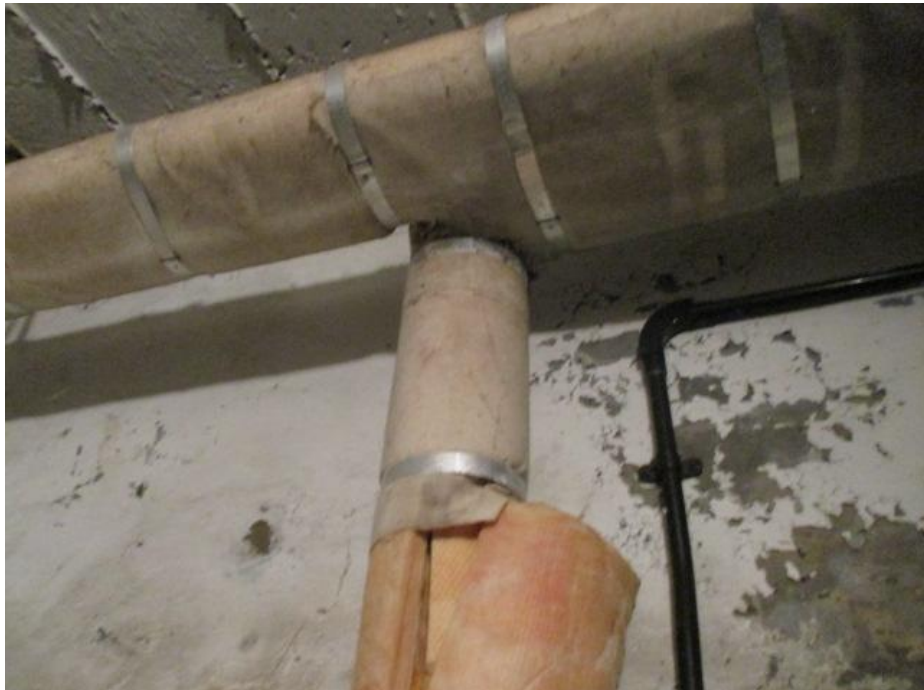
Location ID:	60738	Survey Type:	RDS
Location Ref:	Visual ID	Product Type:	NADIS
Product:	Non Asbestos Materials	Damage:	NADIS
Area:	01	Treatment:	NADIS
Floor:	Ground floor	Asbestos Type:	NADIS
Room:	Boiler room	Identification:	Identified
Surveyor Name:	Andrew Mayes	Quantity:	
Drawing Ref:	01		
Asbestos ?	No		
Date:	01 March 2022		
Next Inspection:	Not Applicable

MMM/Polystyrene insulation to newer pipework

No Action Required

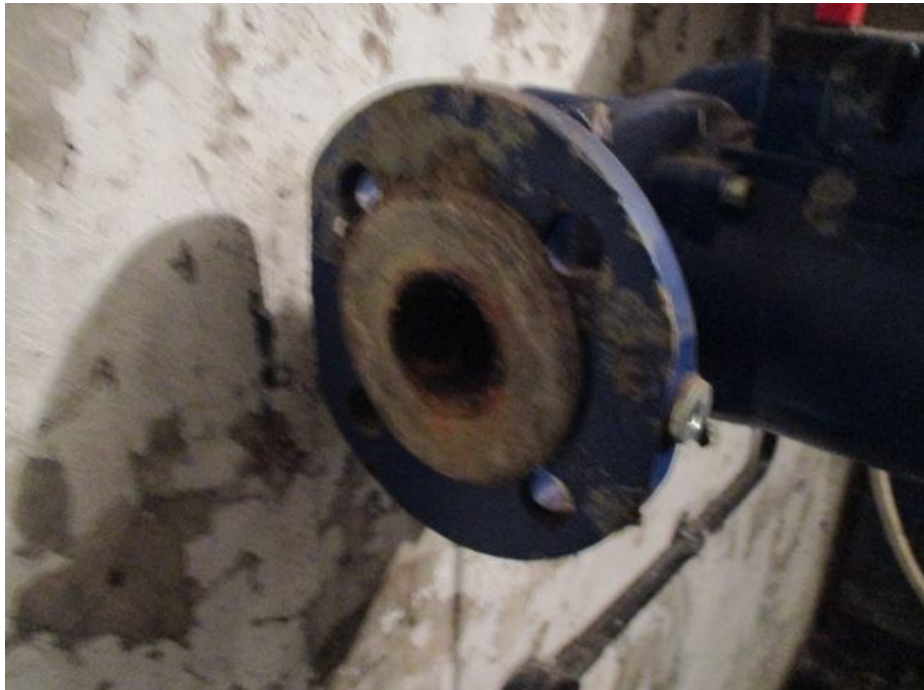
Location ID:	60740	Survey Type:	RDS
Location Ref:	Sample 2	Product Type:	NADIS
Product:	Flange Gaskets	Damage:	NADIS
Area:	01	Treatment:	NADIS
Floor:	Ground floor	Asbestos Type:	NADIS
Room:	Boiler room	Identification:	Identified
Surveyor Name:	Andrew Mayes	Quantity:	1 item
Drawing Ref:	01		
Asbestos ?	No		
Date:	01 March 2022		
Next Inspection:	Not Applicable

Flange gasket

No Action Required

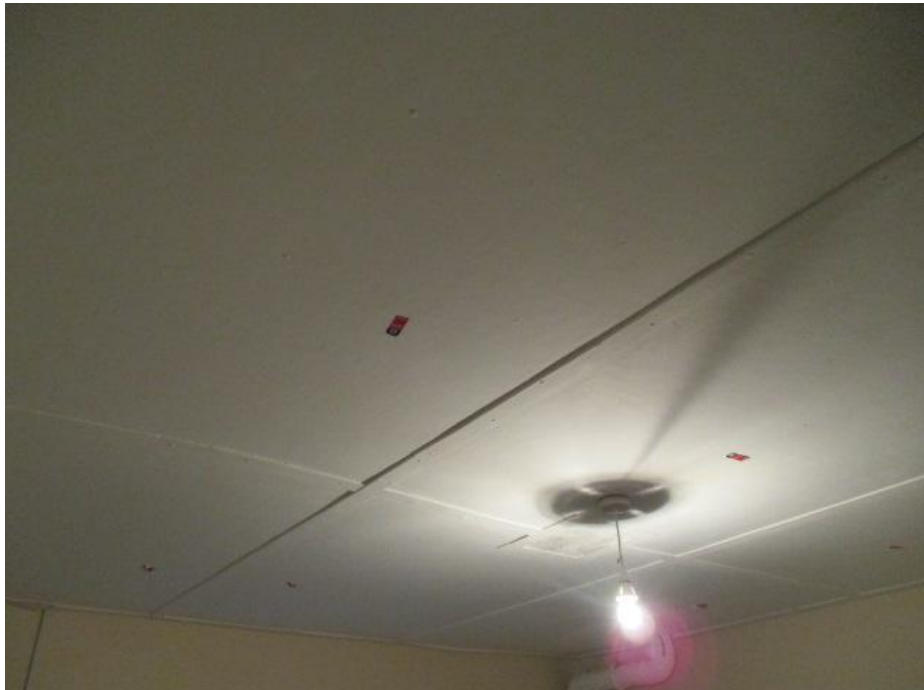
Location ID:	60742	Survey Type:	RDS
Location Ref:	Sample 3	Product Type:	Asbestos cement
Product:	Cement board	Damage:	Good condition
Area:	02	Treatment:	Cement Sheet
Floor:	First floor	Asbestos Type:	Chrysotile
Room:	Projector room	Identification:	Identified
Surveyor Name:	Andrew Mayes	Quantity:	18m ²
Drawing Ref:	02		
Asbestos ?	Yes		
Date:	01 March 2022		
Next Inspection:	28 February 2023

Asbestos cement sheeting to ceiling

Remove As Per CAR 2012 In Compliance With HSE

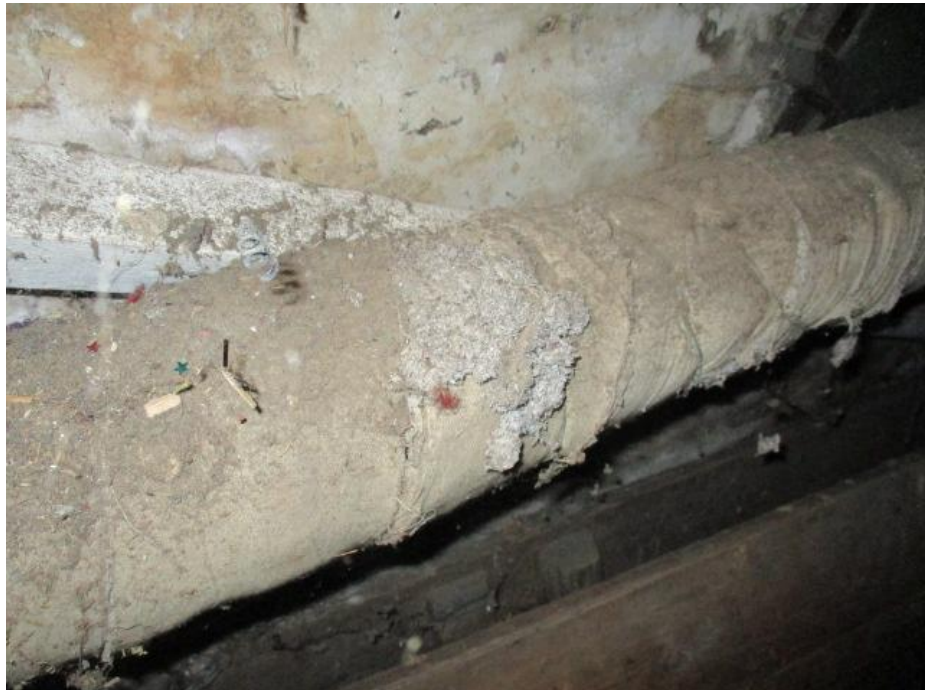
Location ID:	60744	Survey Type:	RDS
Location Ref:	Sample 4	Product Type:	Pipe and boiler lagging
Product:	Pipe insulation	Damage:	High damage
Area:	03	Treatment:	Unsealed laggings and sprays
Floor:	Ground floor	Asbestos Type:	Chrysotile
Room:	Stage area	Identification:	Identified
Surveyor Name:	Andrew Mayes	Quantity:	10 Linear Metres
Drawing Ref:	03		
Asbestos ?	Yes		
Date:	01 March 2022		
Next Inspection:	28 February 2023

Pipe insulation to pipework within void below stage

Remove by a Licensed Asbestos Removal Contractor

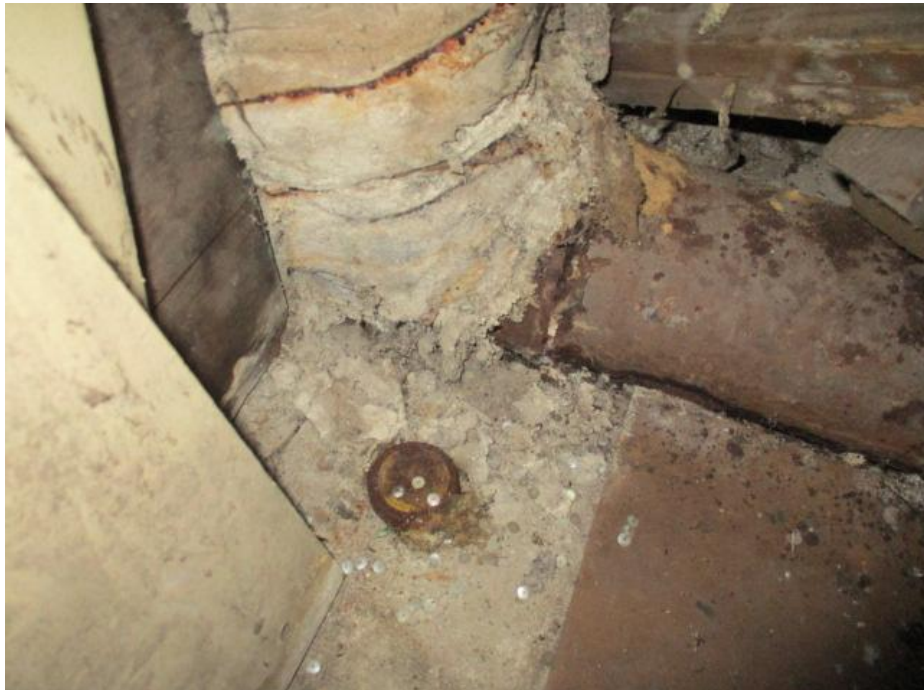
Location ID:	60745	Survey Type:	RDS
Location Ref:	Visual ID To Sample 4	Product Type:	Pipe and boiler lagging
Product:	Debris	Damage:	High damage
Area:	03	Treatment:	Debris
Floor:	Ground floor	Asbestos Type:	Chrysotile
Room:	Stage area	Identification:	Strongly Presumed as previous sample
Surveyor Name:	Andrew Mayes	Quantity:	Throughout Area
Drawing Ref:	03		
Asbestos ?	Yes		
Date:	01 March 2022		
Next Inspection:	28 February 2023

Debris in stage void from worn pipe insulation

Remove by a Licensed Asbestos Removal Contractor

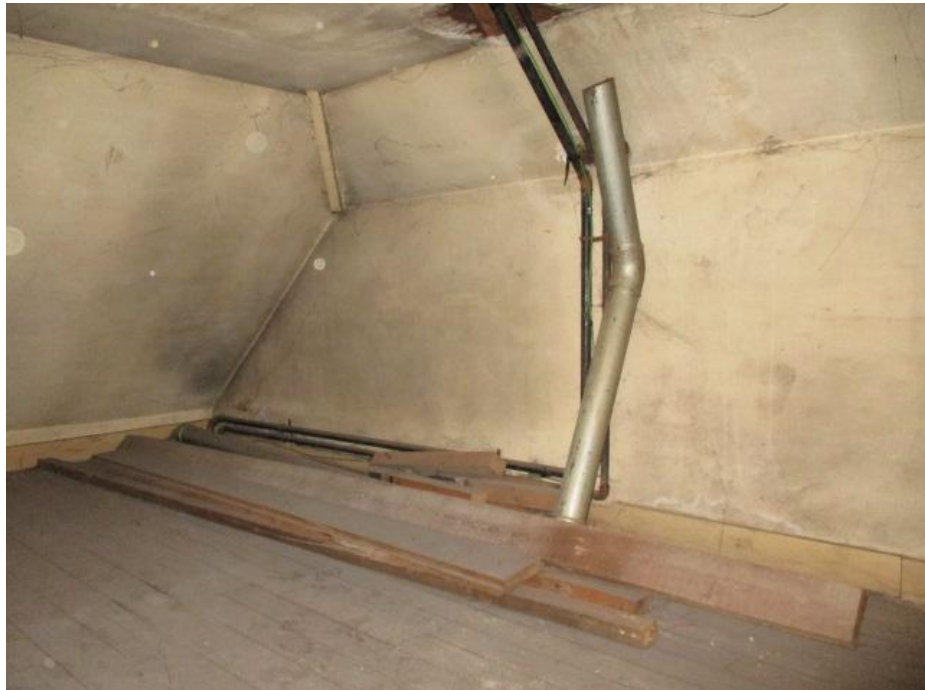
Location ID:	60746	Survey Type:	RDS
Location Ref:	Visual ID	Product Type:	NADIS
Product:	No Asbestos Found	Damage:	NADIS
Area:	03	Treatment:	NADIS
Floor:	Ground floor	Asbestos Type:	NADIS
Room:	Stage area	Identification:	Identified
Surveyor Name:	Andrew Mayes	Quantity:	
Drawing Ref:	03		
Asbestos ?	No		
Date:	01 March 2022		
Next Inspection:	Not Applicable

Loft void to the rear of the stage accessed

No Action Required

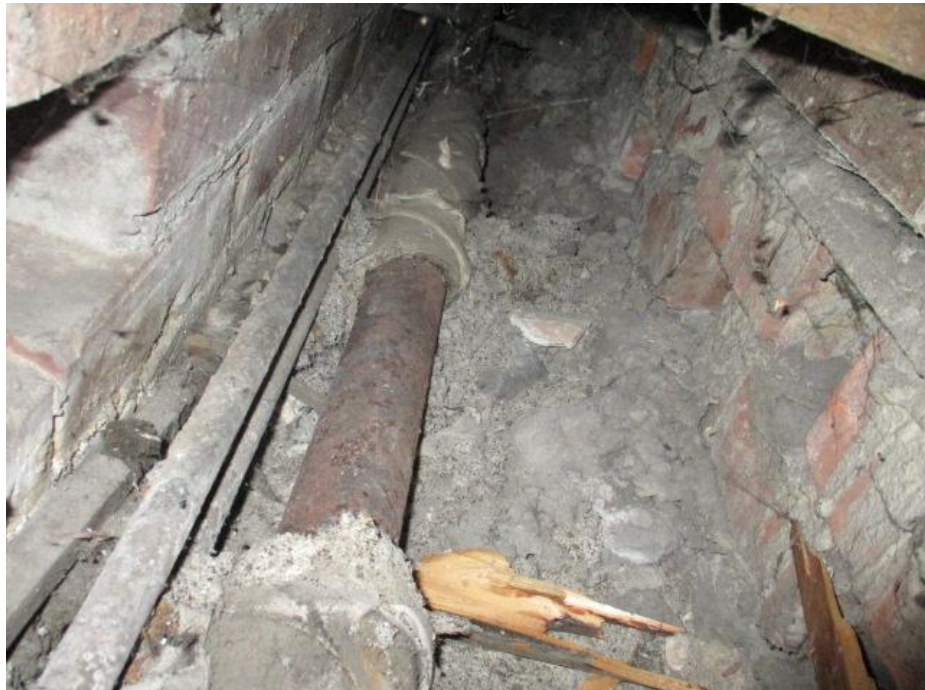
Location ID:	60748	Survey Type:	RDS
Location Ref:	Sample 5	Product Type:	Pipe and boiler lagging
Product:	Pipe insulation	Damage:	High damage
Area:	04	Treatment:	Unsealed laggings and sprays
Floor:	Ground floor	Asbestos Type:	Chrysotile
Room:	Store Room (1)	Identification:	Identified
Surveyor Name:	Andrew Mayes	Quantity:	12 Linear Metres
Drawing Ref:	04		
Asbestos ?	Yes		
Date:	01 March 2022		
Next Inspection:	28 February 2023

Limited access due to damage limitations, pipe insulation to pipework within floor void presumed throughout

Remove by a Licensed Asbestos Removal Contractor

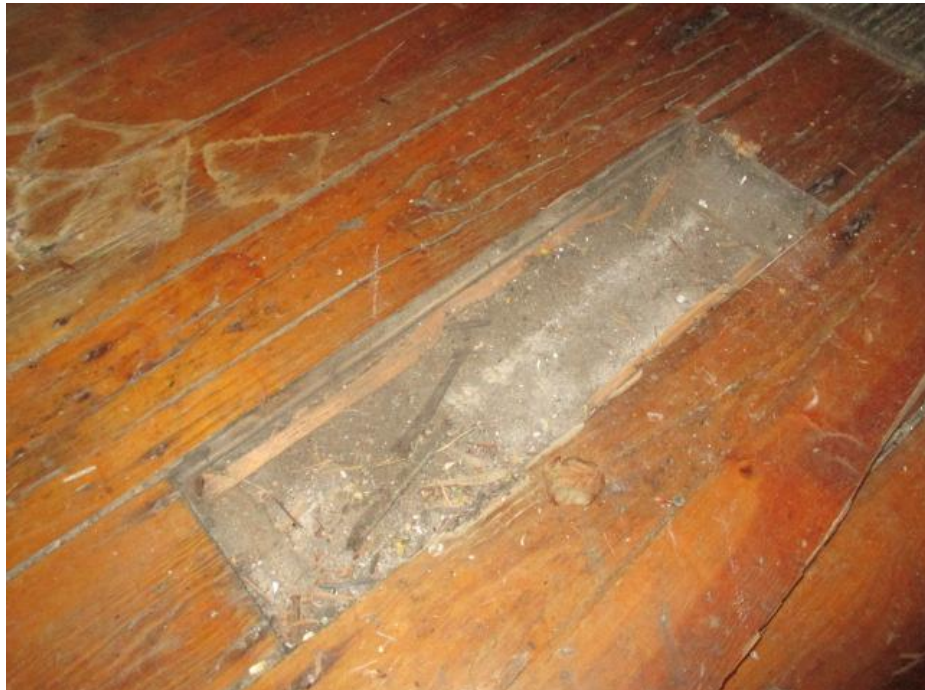
Location ID:	60749	Survey Type:	RDS
Location Ref:	Visual ID	Product Type:	NADIS
Product:	Limited Access	Damage:	NADIS
Area:	05	Treatment:	NADIS
Floor:	Ground floor	Asbestos Type:	NADIS
Room:	Store Room (2)	Identification:	Identified
Surveyor Name:	Andrew Mayes	Quantity:	
Drawing Ref:	05		
Asbestos ?	No		
Date:	01 March 2022		
Next Inspection:	Not Applicable

Limited access due to damage limitations, wooden floor boards over solid concrete floor

Proceed With Caution

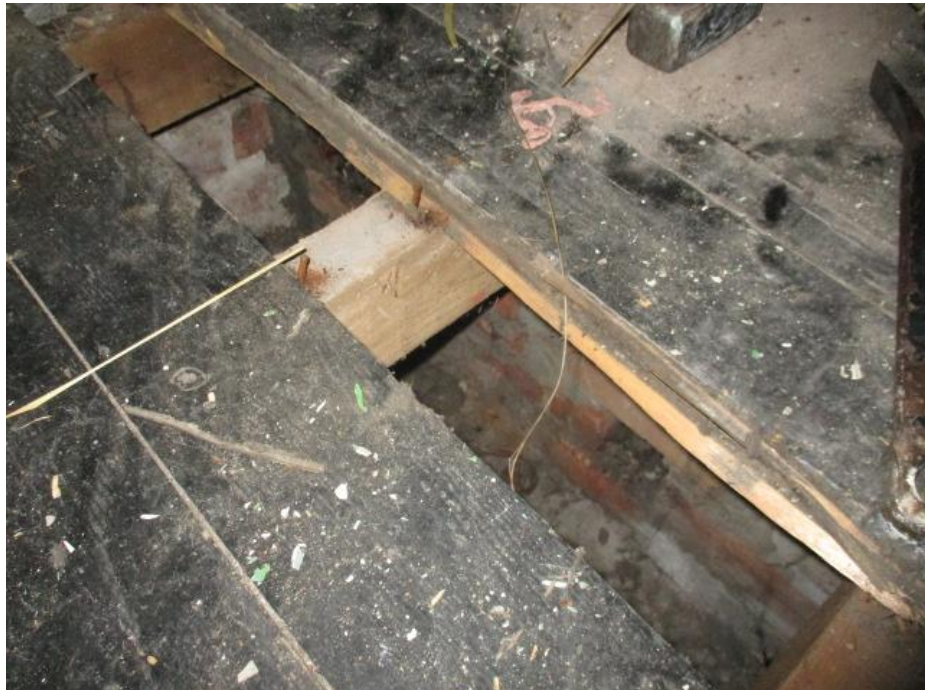
Location ID:	60751	Survey Type:	RDS
Location Ref:	Visual ID	Product Type:	NADIS
Product:	No Asbestos Found	Damage:	NADIS
Area:	05	Treatment:	NADIS
Floor:	Ground floor	Asbestos Type:	NADIS
Room:	Store Room (2)	Identification:	Identified
Surveyor Name:	Andrew Mayes	Quantity:	
Drawing Ref:	05		
Asbestos ?	No		
Date:	01 March 2022		
Next Inspection:	Not Applicable

Limited access to small floor void no ACM's present where inspected

Proceed With Caution

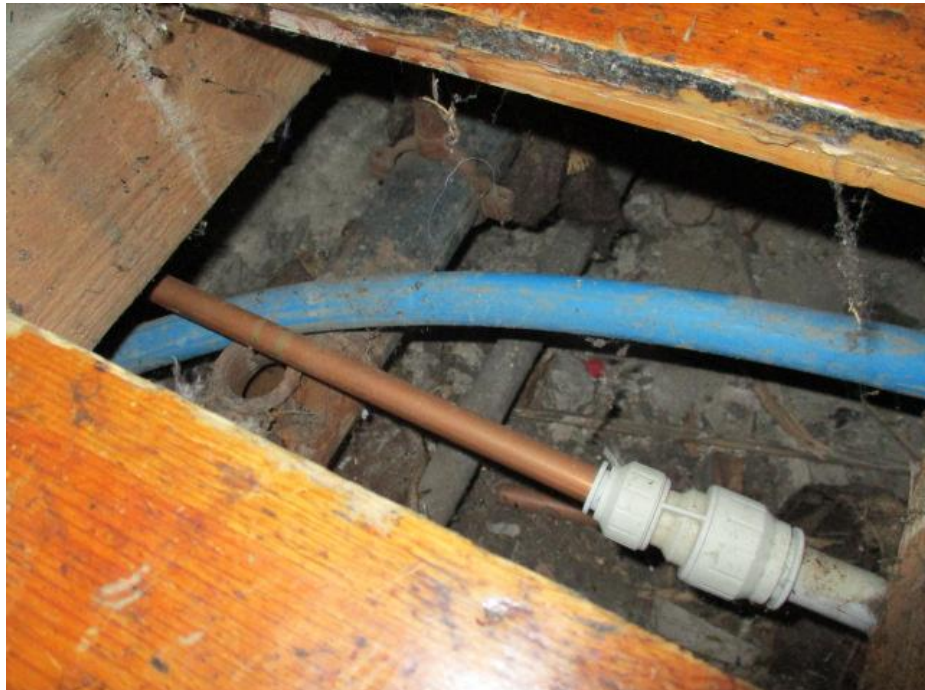
Location ID:	60752	Survey Type:	RDS
Location Ref:	Visual ID	Product Type:	NADIS
Product:	Limited Access	Damage:	NADIS
Area:	06	Treatment:	NADIS
Floor:	Ground floor	Asbestos Type:	NADIS
Room:	Ellen Berry Room	Identification:	Identified
Surveyor Name:	Andrew Mayes	Quantity:	
Drawing Ref:	06		
Asbestos ?	No		
Date:	01 March 2022		
Next Inspection:	Not Applicable

Limited access to floor void as room still in frequent use, no ACM's present where inspected

Proceed With Caution

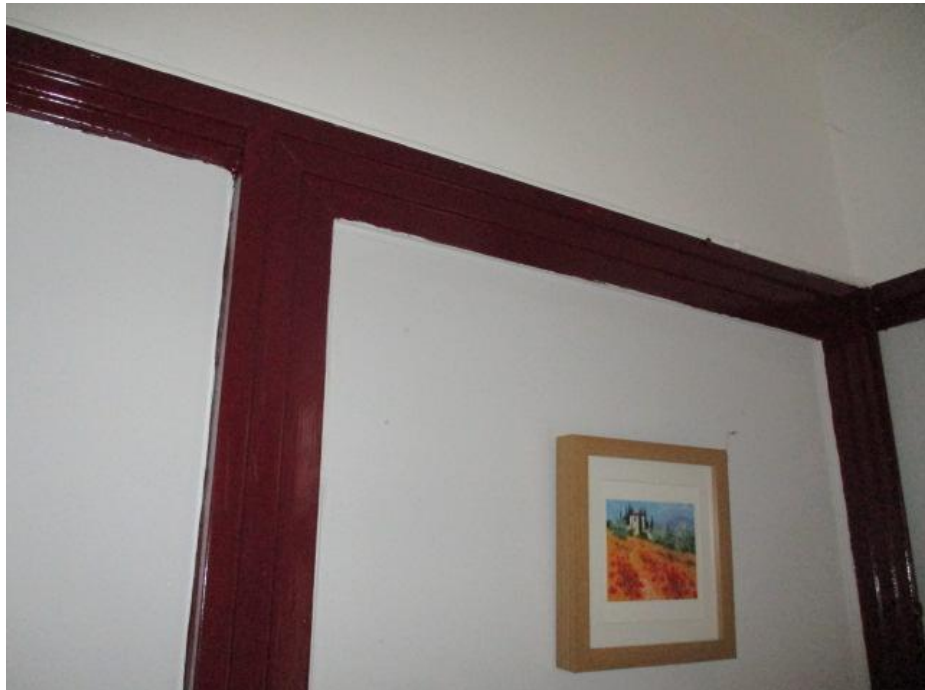
Location ID:	60756	Survey Type:	RDS
Location Ref:	Visual ID	Product Type:	NADIS
Product:	No Asbestos Found	Damage:	NADIS
Area:	06	Treatment:	NADIS
Floor:	Ground floor	Asbestos Type:	NADIS
Room:	Ellen Berry Room	Identification:	Identified
Surveyor Name:	Andrew Mayes	Quantity:	
Drawing Ref:	06		
Asbestos ?	No		
Date:	01 March 2022		
Next Inspection:	Not Applicable

Wooden panel covering an old door way to the rear right handside of the room

No Action Required

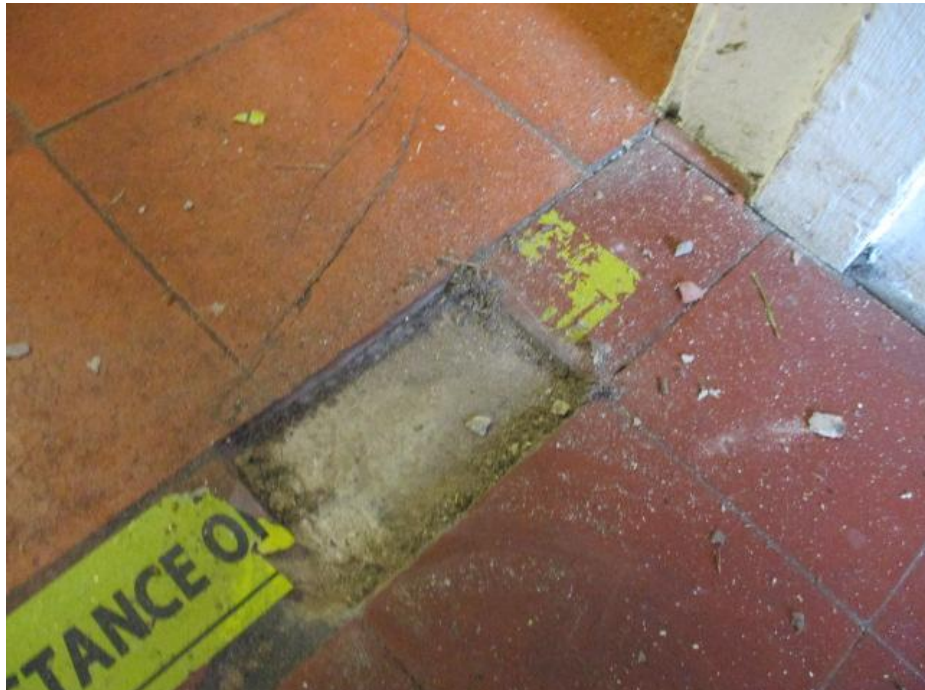
Location ID:	60759	Survey Type:	RDS
Location Ref:	Visual ID	Product Type:	NADIS
Product:	No Asbestos Found	Damage:	NADIS
Area:	07	Treatment:	NADIS
Floor:	Ground floor	Asbestos Type:	NADIS
Room:	Kitchen	Identification:	Identified
Surveyor Name:	Andrew Mayes	Quantity:	
Drawing Ref:	07		
Asbestos ?	No		
Date:	01 March 2022		
Next Inspection:	Not Applicable

Floor tiles to concrete floor limited access due to damage limitations, no ACM's present where inspected

Proceed With Caution

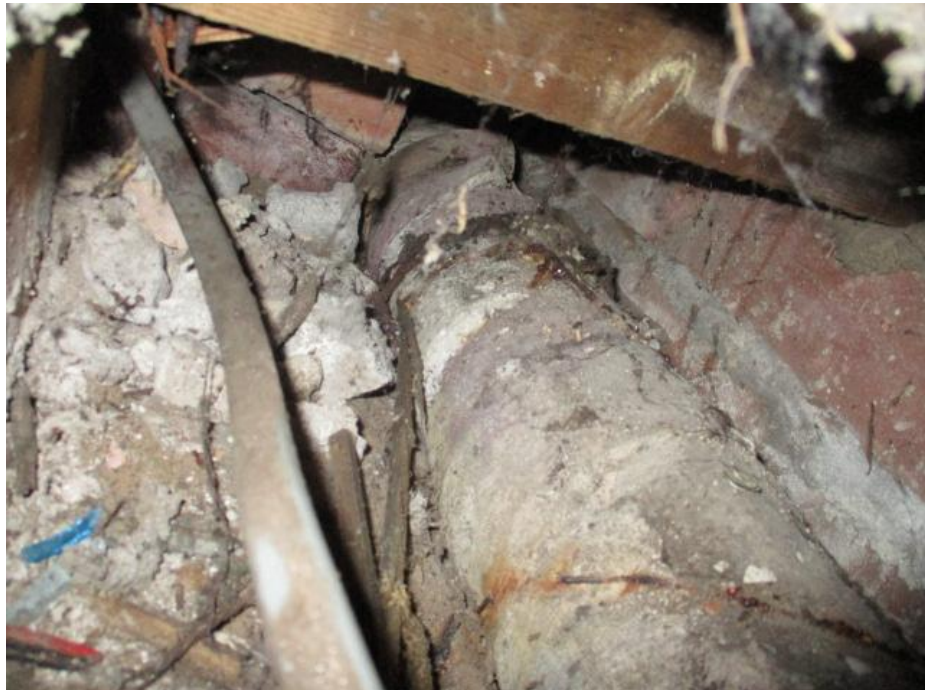
Location ID:	60761	Survey Type:	RDS
Location Ref:	Sample 7	Product Type:	Pipe and boiler lagging
Product:	Pipe insulation	Damage:	High damage
Area:	08	Treatment:	Unsealed laggings and sprays
Floor:	Ground floor	Asbestos Type:	Chrysotile
Room:	Main Hall	Identification:	Identified
Surveyor Name:	Andrew Mayes	Quantity:	44 Linear Metres
Drawing Ref:	08		
Asbestos ?	Yes		
Date:	01 March 2022		
Next Inspection:	28 February 2023

Floor void accessed pipe insulation present running around the perimeter of the main hall

Remove by a Licensed Asbestos Removal Contractor

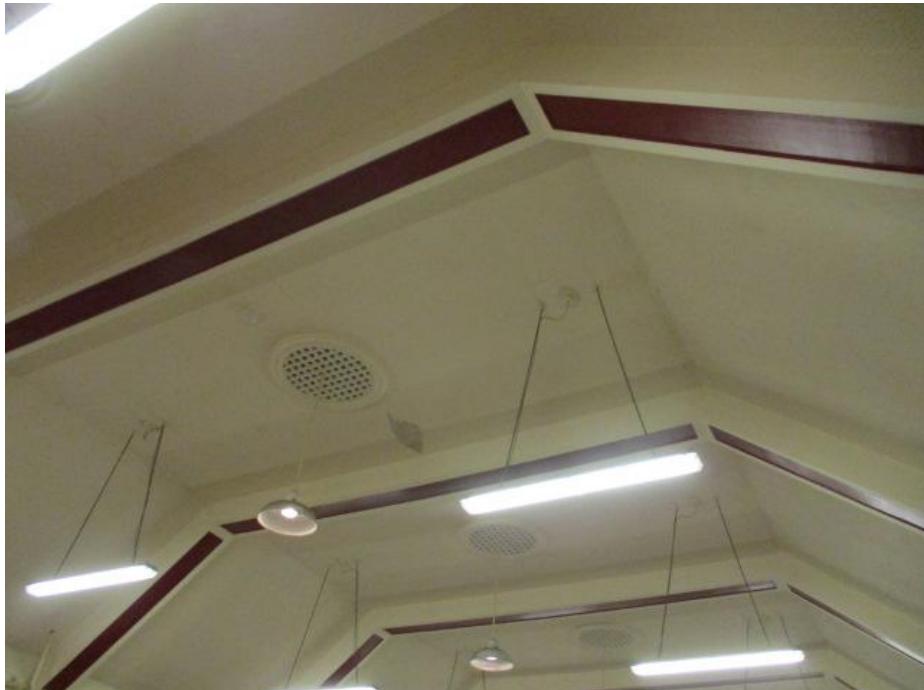
Location ID:	60763	Survey Type:	RDS
Location Ref:	Visual ID	Product Type:	NADIS
Product:	No Access	Damage:	NADIS
Area:	08	Treatment:	NADIS
Floor:	Ground floor	Asbestos Type:	NADIS
Room:	Main Hall	Identification:	Identified
Surveyor Name:	Andrew Mayes	Quantity:	
Drawing Ref:	08		
Asbestos ?	No		
Date:	01 March 2022		
Next Inspection:	Not Applicable

No access to high level ceiling

Proceed With Caution

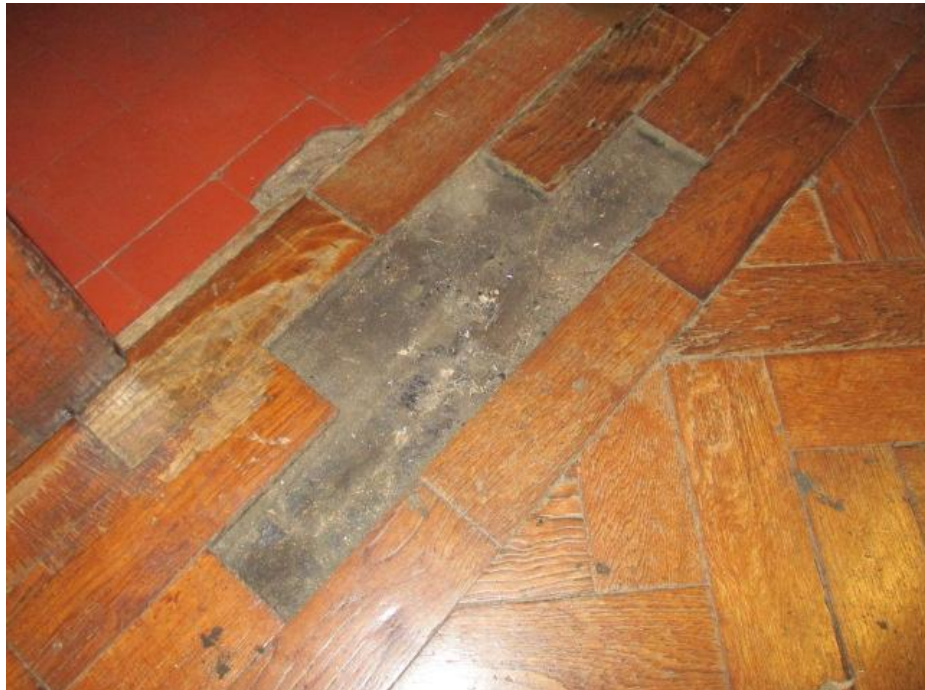
Location ID:	60765	Survey Type:	RDS
Location Ref:	Sample 8	Product Type:	NADIS
Product:	Bitumen Adhesive	Damage:	NADIS
Area:	08	Treatment:	NADIS
Floor:	Ground floor	Asbestos Type:	NADIS
Room:	Main Hall	Identification:	Identified
Surveyor Name:	Andrew Mayes	Quantity:	170m ²
Drawing Ref:	08		
Asbestos ?	No		
Date:	01 March 2022		
Next Inspection:	Not Applicable

Bitumen adhesive to underside of parquet flooring

No Action Required

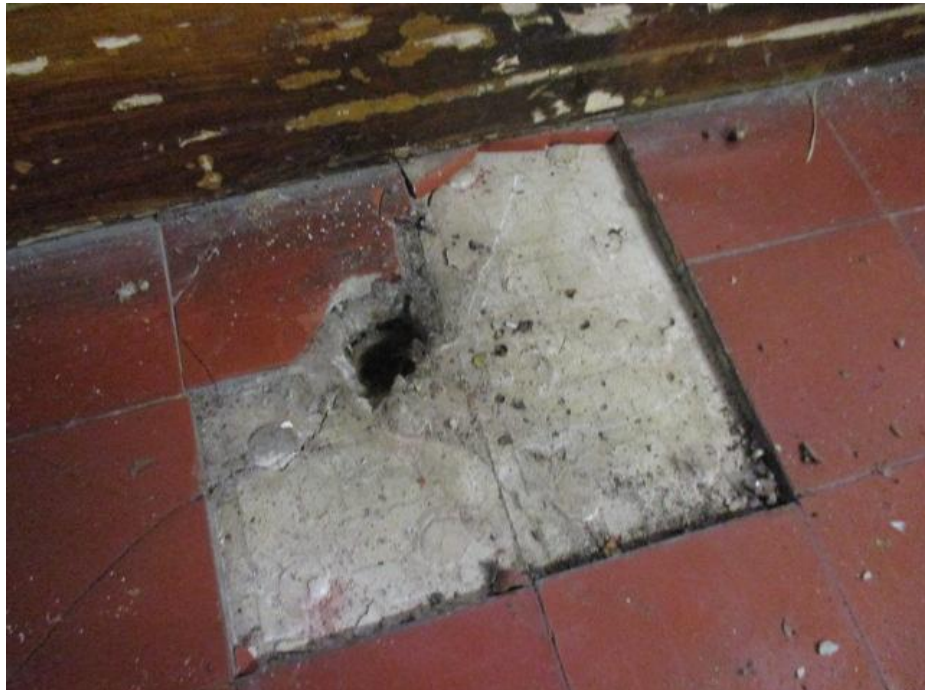
Location ID:	60766	Survey Type:	RDS
Location Ref:	Visual ID	Product Type:	NADIS
Product:	No Access	Damage:	NADIS
Area:	09	Treatment:	NADIS
Floor:	Ground floor	Asbestos Type:	NADIS
Room:	Lobby	Identification:	Identified
Surveyor Name:	Andrew Mayes	Quantity:	
Drawing Ref:	09		
Asbestos ?	No		
Date:	01 March 2022		
Next Inspection:	Not Applicable

No access below floor level

Proceed With Caution

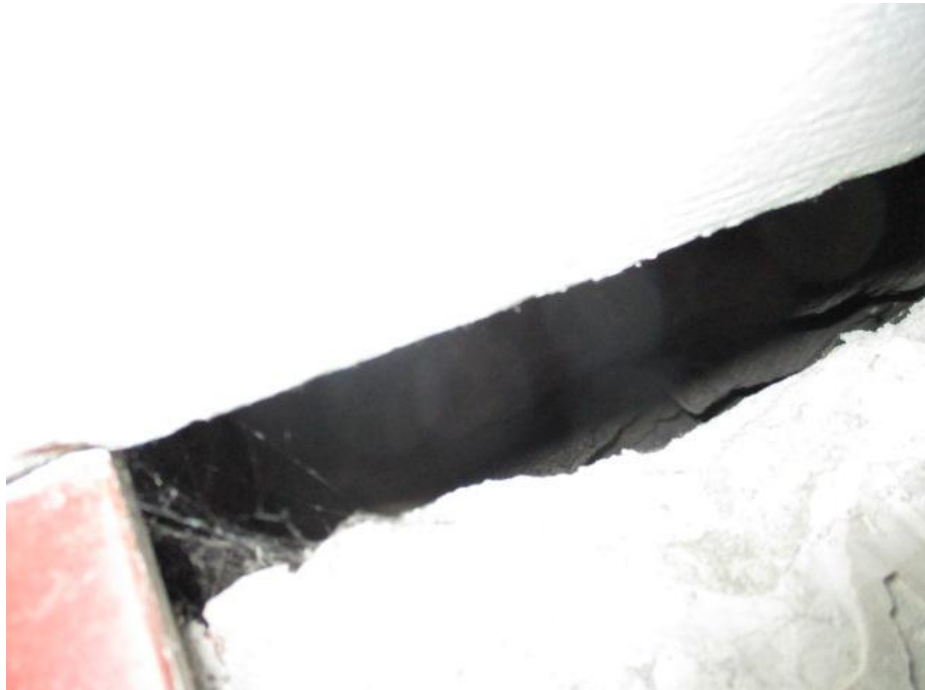
Location ID:	60768	Survey Type:	RDS
Location Ref:	Visual ID	Product Type:	NADIS
Product:	Limited Access	Damage:	NADIS
Area:	12	Treatment:	NADIS
Floor:	Ground floor	Asbestos Type:	NADIS
Room:	Ladies toilet	Identification:	Identified
Surveyor Name:	Andrew Mayes	Quantity:	
Drawing Ref:	12		
Asbestos ?	No		
Date:	01 March 2022		
Next Inspection:	Not Applicable

Limited access to window surrounds due to damage limitations, no ACM's present where inspected

Proceed With Caution

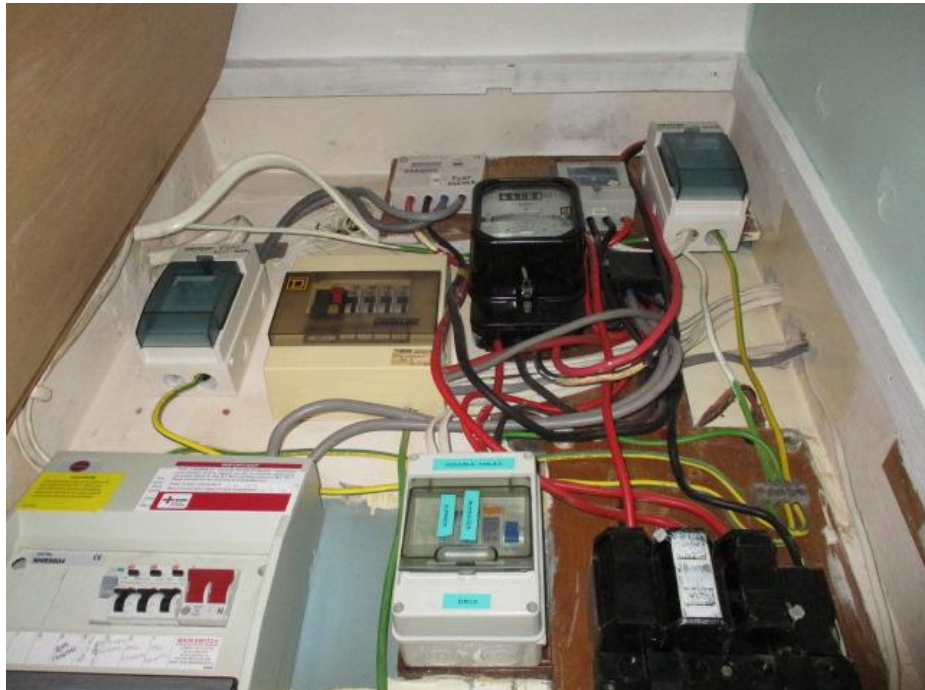
Location ID:	60770	Survey Type:	RDS
Location Ref:	Visual ID	Product Type:	Ropes and woven textiles
Product:	Flash guards	Damage:	Not Applicable
Area:	12	Treatment:	Sealed Ropes/Woven Textiles
Floor:	Ground floor	Asbestos Type:	Chrysotile
Room:	Ladies toilet	Identification:	Presumed
Surveyor Name:	Andrew Mayes	Quantity:	Small
Drawing Ref:	12		
Asbestos ?	Yes		
Date:	01 March 2022		
Next Inspection:	28 February 2023

No access gained within electrical boxing due to live status. Presumed asbestos containing flash guards/rope lining within

Remove As Per CAR 2012 In Compliance With HSE

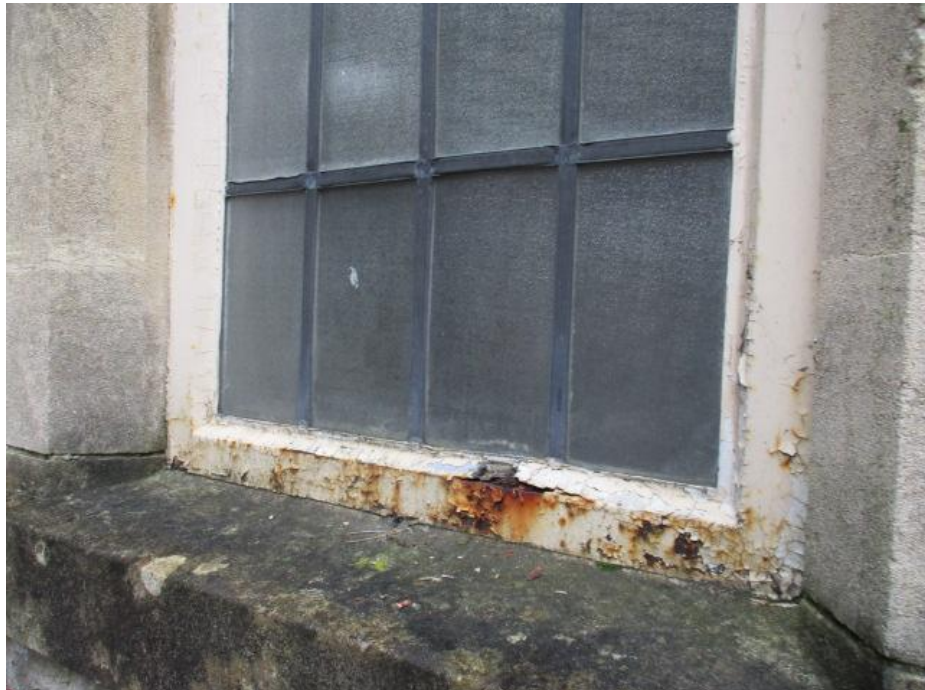
Location ID:	60772	Survey Type:	RDS
Location Ref:	Sample 9	Product Type:	NADIS
Product:	Mastic	Damage:	NADIS
Area:	13	Treatment:	NADIS
Floor:	External	Asbestos Type:	NADIS
Room:	Exterior Of Building	Identification:	Identified
Surveyor Name:	Andrew Mayes	Quantity:	Throughout Site
Drawing Ref:	13		
Asbestos ?	No		
Date:	01 March 2022		
Next Inspection:	Not Applicable

Window mastic to windows throughout exterior of building

No Action Required

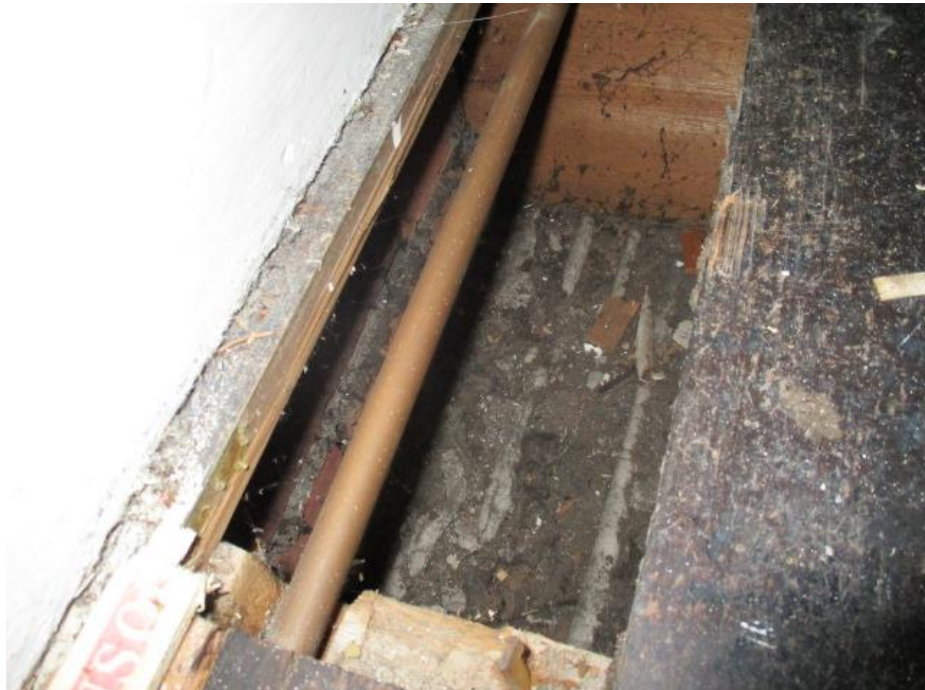
Location ID:	60774	Survey Type:	RDS
Location Ref:	Visual ID	Product Type:	NADIS
Product:	Limited Access	Damage:	NADIS
Area:	14	Treatment:	NADIS
Floor:	First floor	Asbestos Type:	NADIS
Room:	Dining Area	Identification:	Identified
Surveyor Name:	Andrew Mayes	Quantity:	
Drawing Ref:	14		
Asbestos ?	No		
Date:	01 March 2022		
Next Inspection:	Not Applicable

Limited access to floor void within flat dining room, no ACM's present where inspected

Proceed With Caution

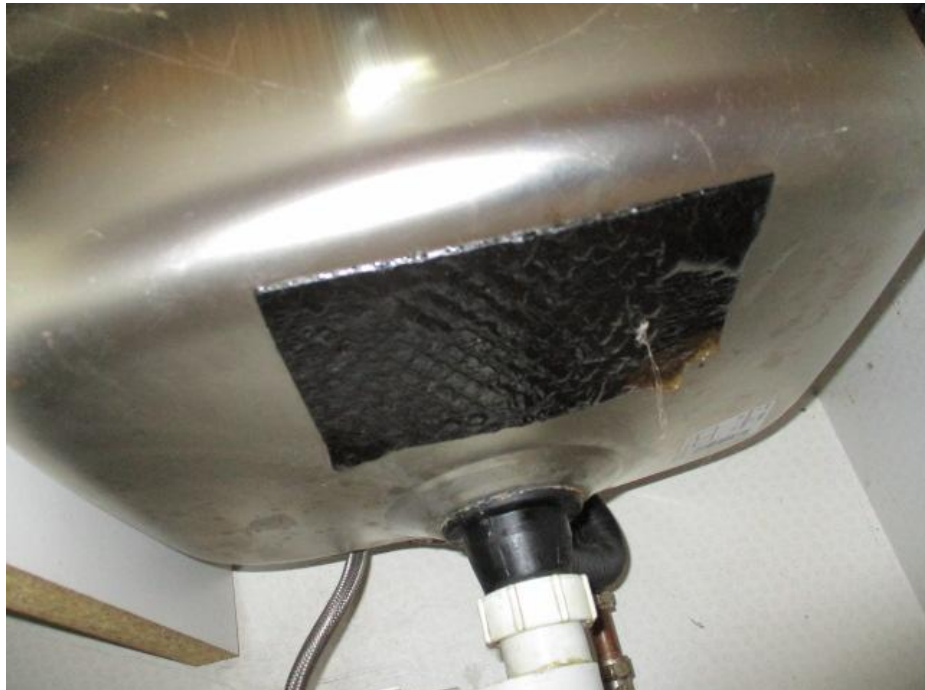
Location ID:	60775	Survey Type:	RDS
Location Ref:	Sample 6	Product Type:	NADIS
Product:	Sink & Drainer Pads	Damage:	NADIS
Area:	15	Treatment:	NADIS
Floor:	First floor	Asbestos Type:	NADIS
Room:	Flat Kitchen	Identification:	Identified
Surveyor Name:	Andrew Mayes	Quantity:	Small
Drawing Ref:	15		
Asbestos ?	No		
Date:	01 March 2022		
Next Inspection:	Not Applicable

Sink pad to the underside of sink unit

No Action Required

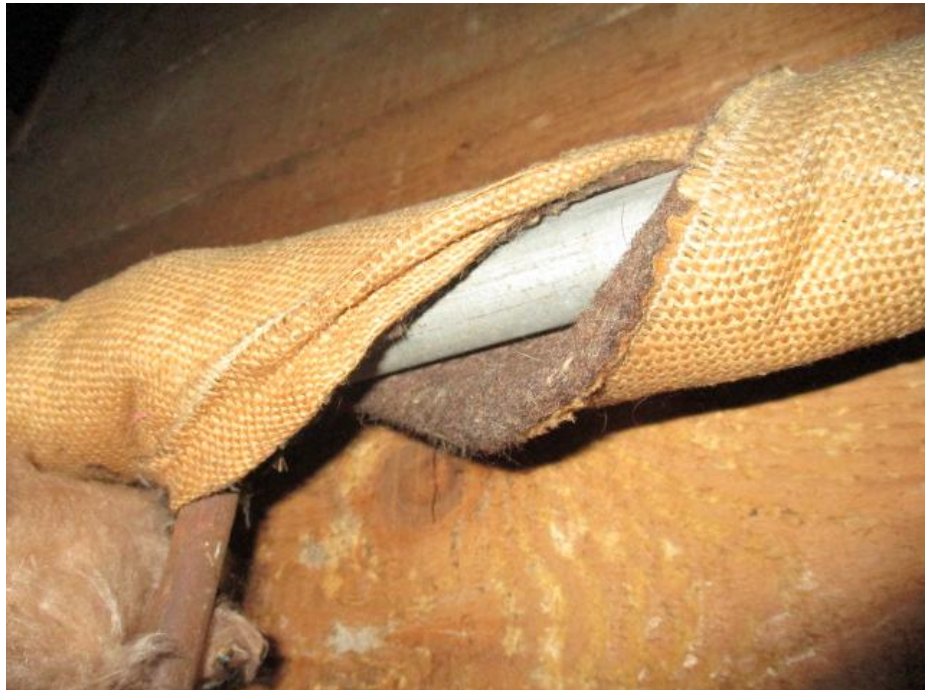
Location ID:	60776	Survey Type:	RDS
Location Ref:	Visual ID	Product Type:	NADIS
Product:	Non Asbestos Materials	Damage:	NADIS
Area:	16	Treatment:	NADIS
Floor:	First floor	Asbestos Type:	NADIS
Room:	Flat Loft Void	Identification:	Identified
Surveyor Name:	Andrew Mayes	Quantity:	
Drawing Ref:	16		
Asbestos ?	No		
Date:	01 March 2022		
Next Inspection:	Not Applicable

Non asbestos pipe lagging

Proceed With Caution

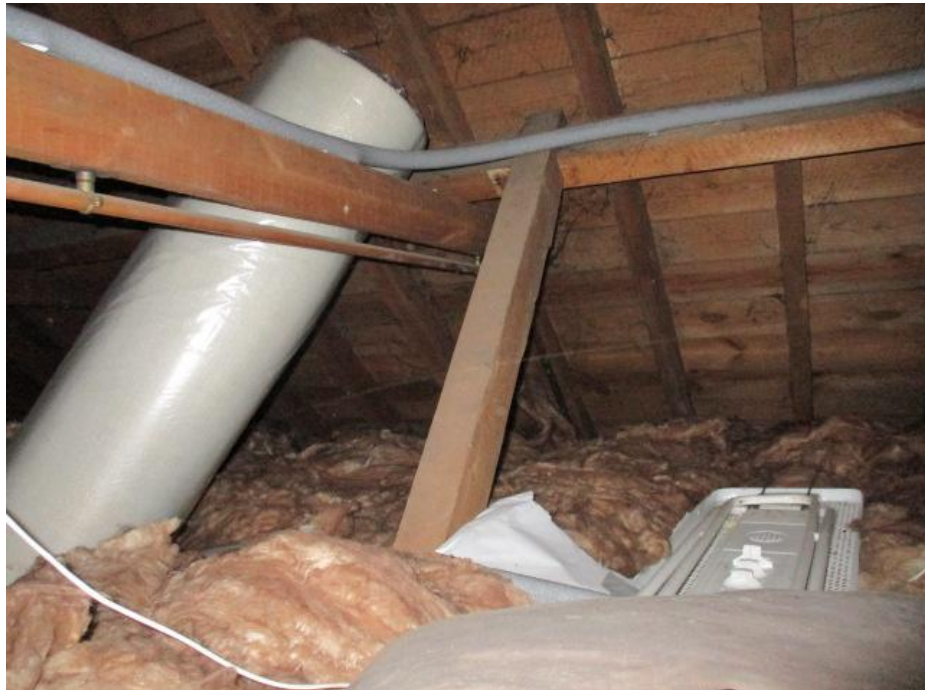
Location ID:	60777	Survey Type:	RDS
Location Ref:	Visual ID	Product Type:	NADIS
Product:	Limited Access	Damage:	NADIS
Area:	16	Treatment:	NADIS
Floor:	First floor	Asbestos Type:	NADIS
Room:	Flat Loft Void	Identification:	Identified
Surveyor Name:	Andrew Mayes	Quantity:	
Drawing Ref:	16		
Asbestos ?	No		
Date:	01 March 2022		
Next Inspection:	Not Applicable

Limited access gained within loft space due to lack of crawl/walk boards & amount of MMMF insulation present. No sign of ACM's in areas inspected

Proceed With Caution
