Asbestos Survey Report

20 Lunedale UPRN 8421439
Woodcock Drive
Platt Bridge
Wigan
WN2 5NW

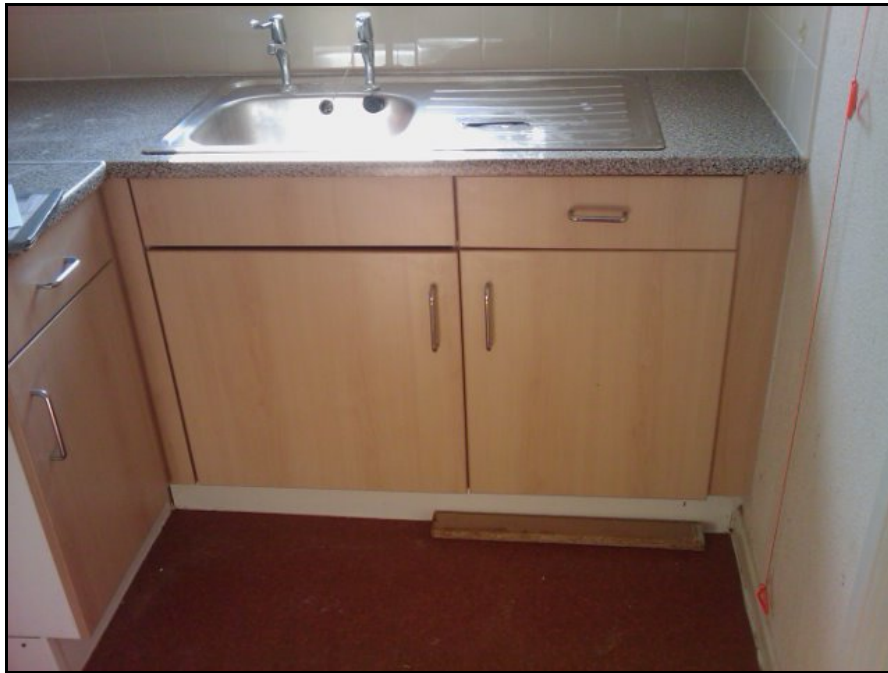
Building	8421439
Floor	First Floor
Room/Area	002 - Kitchen
Sample No	1

Description Item: Sink Pad.

Score
Product Type	Bitumen products	1
Extent of Damage	Low Damage	1
Surface Treatment	Composite materials containing asbestos, plastics, resins etc.	0
Asbestos Type	Chrysotile (white)	1
Amount	x1	
Accessibility	Occasional Disturbance	
Algorithm Score		3

RECOMMENDATION	Manage & Re-inspect
-----------------------	---------------------

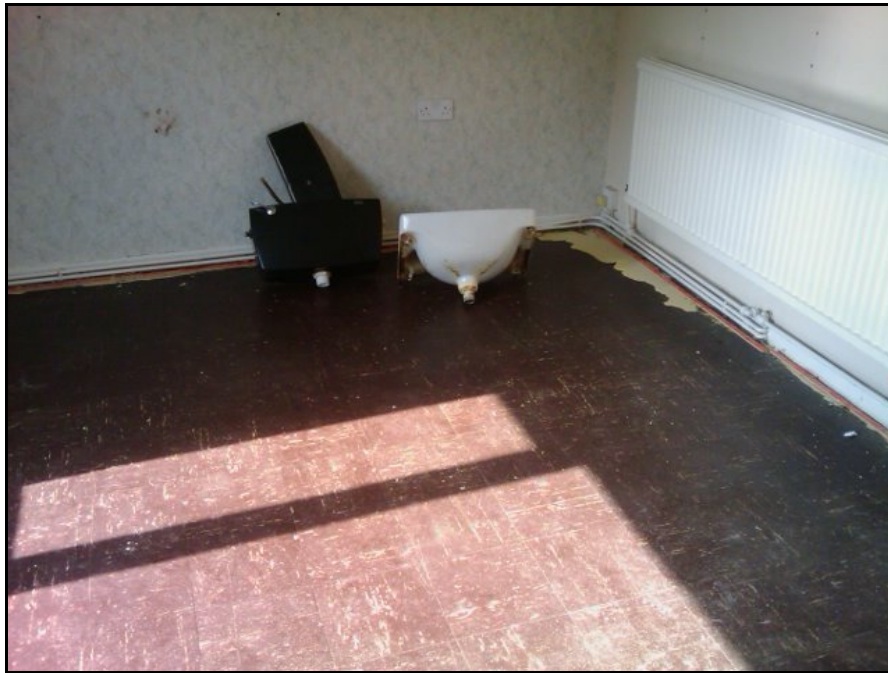
Building	8421439
Floor	First Floor
Room/Area	003 - Through Out
Sample No	2

Description Item: Floor.

Score
Product Type	Floor tiles	1
Extent of Damage	Low Damage	1
Surface Treatment	Composite materials containing asbestos, plastics, resins etc.	0
Asbestos Type	Chrysotile (white)	1
Amount	60m ²	
Accessibility	Occasional Disturbance	
Algorithm Score		3

RECOMMENDATION	Manage & Re-inspect
-----------------------	---------------------

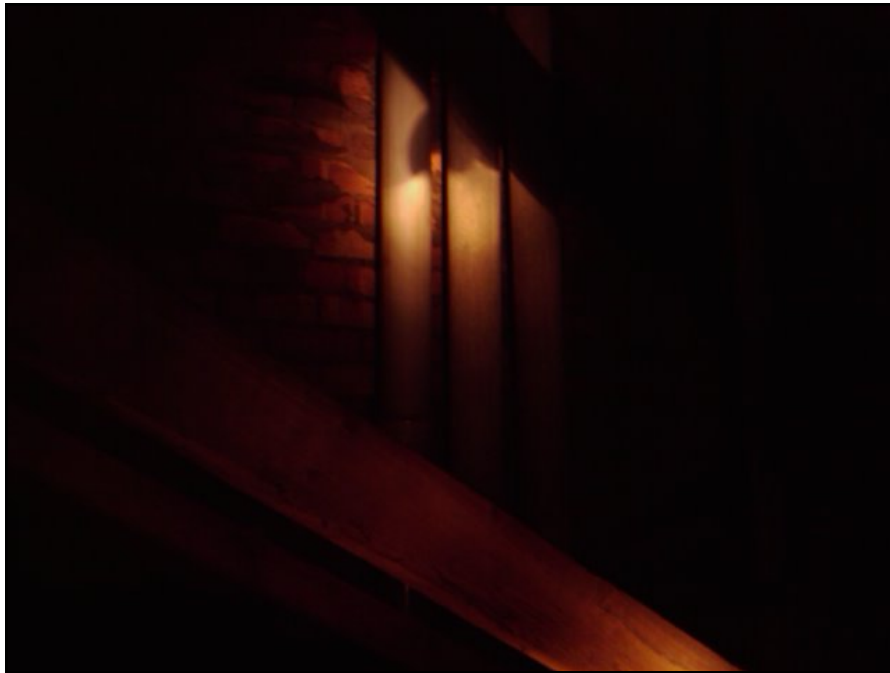
Building	8421439
Floor	First Floor
Room/Area	005 - Loft Void
Sample No

Description Item: Flue.
No access without crawl boards.

Score
Product Type	Asbestos cement	1
Extent of Damage	Low Damage	1
Surface Treatment	Cement products Sealed AIB, spray, textile etc.	1
Asbestos Type		3
Amount	1.5lm	
Accessibility	Usually inaccessible	
Algorithm Score		6

RECOMMENDATION	Encapsulate, Manage & Re-inspect
-----------------------	----------------------------------

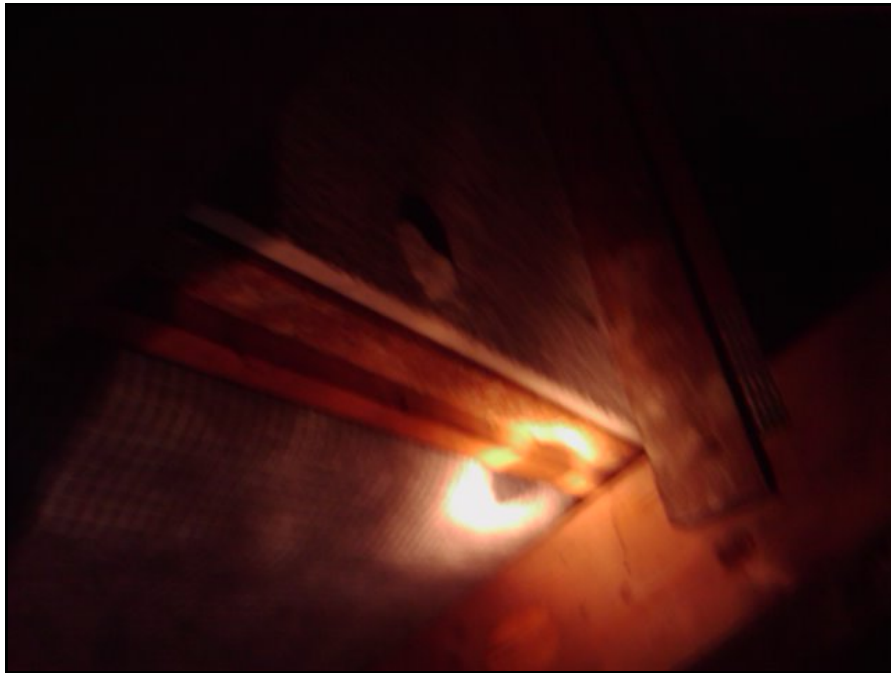
Building	8421439
Floor	First Floor
Room/Area	005 - Loft Void
Sample No	4

Description Item: Beam Cladding.

Score
Product Type	Asbestos insulating board	2
Extent of Damage	Medium Damage	2
Surface Treatment	Unsealed AIB, encapsulated spray, textiles, & T.I.	2
Asbestos Type	Amosite (brown) Chrysotile (white)	2
Amount	15mL	
Accessibility	Usually inaccessible	
Algorithm Score		8

RECOMMENDATION	Encapsulate, Manage & Re-inspect
-----------------------	----------------------------------

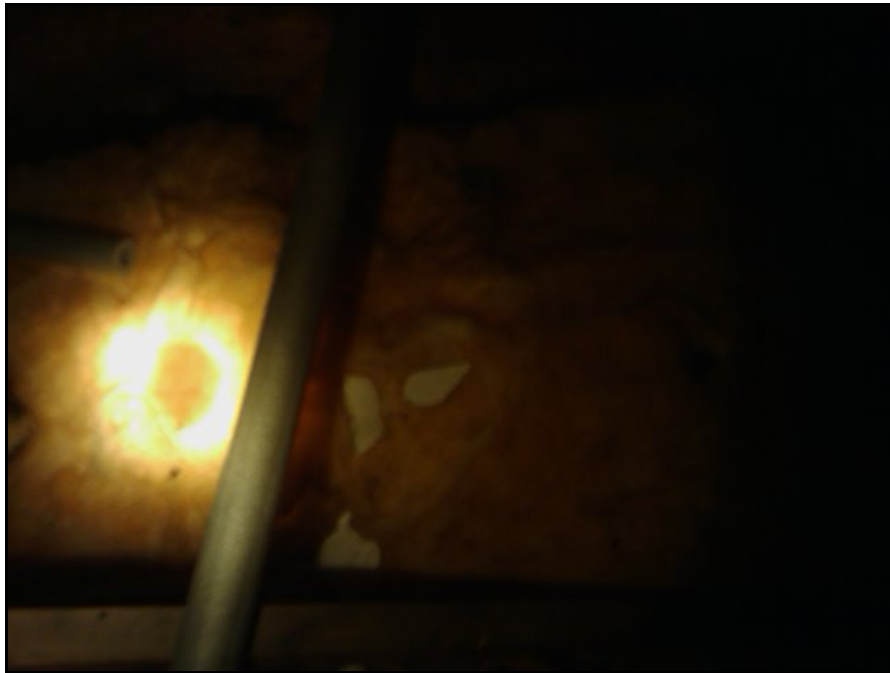
Building	8421439
Floor	First Floor
Room/Area	005 - Loft Void
Sample No	5

Description Item: Debris.

Score
Product Type	Asbestos insulating board	2
Extent of Damage	High Damage	3
Surface Treatment	Unsealed AIB, encapsulated spray, textiles, & T.I.	2
Asbestos Type	Amosite (brown) Chrysotile (white)	2
Amount	NQ	
Accessibility	Usually inaccessible	
Algorithm Score		9

8421439	1	005 Loft Void	5	Asbestos insulating board	Amosite (brown) Chrysotile (white)	NQ	9	+	0	+	2	+	0	+	1	12	Remove by Licensed Contractor	20 September 2011

RECOMMENDATION	Remove by Licensed Contractor
-----------------------	-------------------------------
