Asbestos Report

Cambridgeshire County Council

Crowtree Farm

Farcet Fen Peterborough
Cambs
PE7 3DL

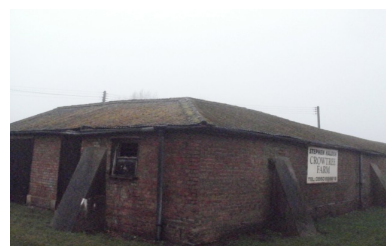
ASB04016

Description Roof - Barn 1 - Roof sheets (Material:Cement) Loc: 340B1

Risk Assessment	Very Low	5	
------------------------	----------	---	--

Material Assessment	Very Low	4	
----------------------------	----------	---	--

Product Type	Extent of Damage	Surface Treatment	Asbestos Type
1	1	1	1

Actions - Work Description	Complete	Priority
Establish monitoring regime (inspection and reassurance)		D - 2-5 years

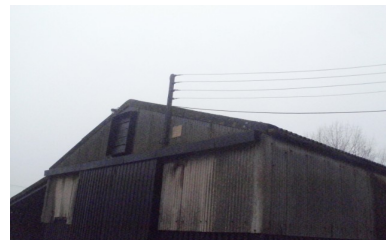
ASB04025

Description Wall and roof - Barn 2 - Wall and roof sheets (Material:Cement) Loc: 340B2

Risk Assessment	Very Low	5	
------------------------	----------	---	--

Material Assessment	Very Low	4	
----------------------------	----------	---	--

Product Type	Extent of Damage	Surface Treatment	Asbestos Type
1	1	1	1

Actions - Work Description	Complete	Priority
Establish monitoring regime (inspection and reassurance)		D - 2-5 years

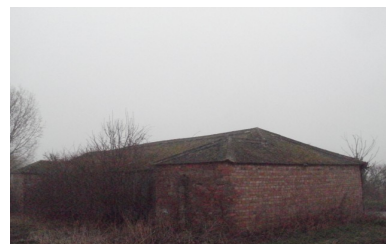
ASB04026 340/S1/03 Known ACM Survey Type: MAN

Building 340B3 - Barn 3
Area
Survey Date 08/03/2013
Survey Programme Management Asbestos Survey
Surveyor Ensaf Consultants Ltd - Dan Webster
Element Roofs - Structure
Description Roof - Barn 3 - Roof sheets (Material:Cement) Loc: 340B3

Risk Assessment	Very Low	5	
------------------------	----------	---	--

Material Assessment	Very Low	4	
----------------------------	----------	---	--

Product Type	Extent of Damage	Surface Treatment	Asbestos Type
1	1	1	1

Actions - Work Description	Complete	Priority
Establish monitoring regime (inspection and reassurance)		D - 2-5 years

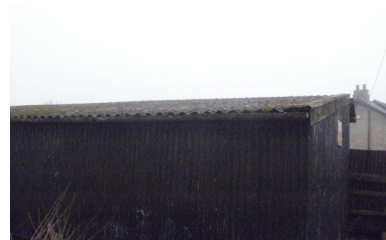
ASB04028 340/S1/05 Known ACM Survey Type: MAN

Building 340B5 - Barn 5
Area
Survey Date 08/03/2013
Survey Programme Management Asbestos Survey
Surveyor Ensaf Consultants Ltd - Dan Webster
Element Roofs - Structure
Description Roof - Barn 5 - Roof sheets (Material:Cement) Loc: 340B5

Risk Assessment	Very Low	5	
------------------------	----------	---	--

Material Assessment	Very Low	4	
----------------------------	----------	---	--

Product Type	Extent of Damage	Surface Treatment	Asbestos Type
1	1	1	1

Actions - Work Description	Complete	Priority
Establish monitoring regime (inspection and reassurance)		D - 2-5 years

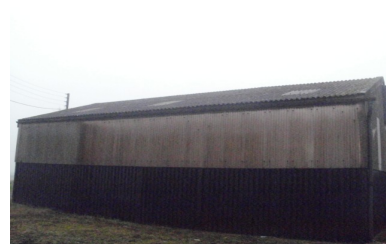
ASB04029 **340/S1/06** **Known ACM** **Survey Type: MAN**

Building 340B6 - Barn 6
Area
Survey Date 08/03/2013
Survey Programme Management Asbestos Survey
Surveyor Ensaf Consultants Ltd - Dan Webster
Element Walls (General) - Walls (General)
Description Wall and roof - Barn 6 - Wall and roof sheets
 (Material:Cement) Loc: 340B6

Risk Assessment

Material Assessment Very Low 4

Product Type	Extent of Damage	Surface Treatment	Asbestos Type
1	1	1	1

Actions - Work Description	Complete	Priority
Establish monitoring regime (inspection and reassurance)		D - 2-5 years

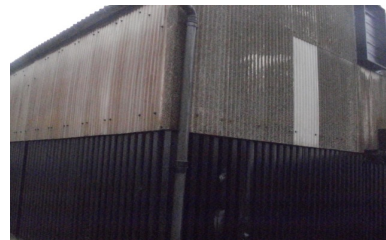
ASB04030 **340/S1/07** **Known ACM** **Survey Type: MAN**

Building 340B7 - Barn 7
Area
Survey Date 08/03/2013
Survey Programme Management Asbestos Survey
Surveyor Ensaf Consultants Ltd - Dan Webster
Element Walls (General) - Walls (General)
Description Wall and roof - Barn 7 - Wall and roof sheets
 (Material:Cement) Loc: 340B7

Risk Assessment

Material Assessment Very Low 4

Product Type	Extent of Damage	Surface Treatment	Asbestos Type
1	1	1	1

Actions - Work Description	Complete	Priority
Establish monitoring regime (inspection and reassurance)		D - 2-5 years

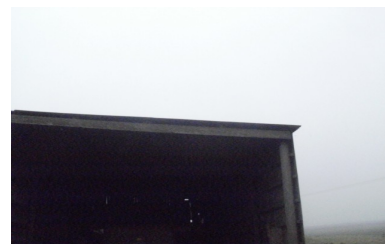
ASB04032

Building Area 340B8 - Barn 8
Survey Date 08/03/2013
Survey Programme Management Asbestos Survey
Surveyor Ensaf Consultants Ltd - Dan Webster
Element Walls (General) - Walls (General)
Description Wall and roof - Barn 8 - Wall and roof sheets
 (Material:Cement) Loc: 340B8

Risk Assessment

Material Assessment

Product Type	Extent of Damage	Surface Treatment	Asbestos Type
1	1	1	3

Actions - Work Description	Complete	Priority
Establish monitoring regime (inspection and reassurance)		D - 2-5 years
