MANAGEMENT ASBESTOS SURVEY

22 LUNEDALE
WOODCOCK DRIVE
PLATT BRIDGE
WIGAN
WN2 5NW

JANUARY 2013

Report prepared for:	Wigan & Leigh Housing Unity House Westwood Park Drive Wigan WN3 4HE
Report reference:	P-41775
Issue date:	January 2013
Survey completed by: Mr D. Gilbert Environmental Consultant	 
Approved by: Mr J. Schultz-Lloyd BSc (Hons) Environmental Consultant

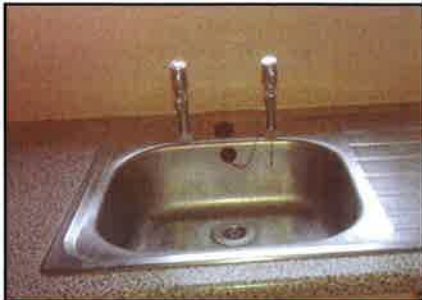
Location		8421441~22 Lunedale - Kitchen - Bitumen pad to sink unit

Item No:	1	Laboratory sample no:	P-41775 / 001	
Accessibility:		N/A		
Installation:		Sink pad(s)		
Approx extent (m² unless stated)		1 No		
Asbestos Type:		NAD		
Condition:		N/A	Surface Treatment: N/A	
Risk Assessment (H/M/L/VL)		None	Recommendation: None

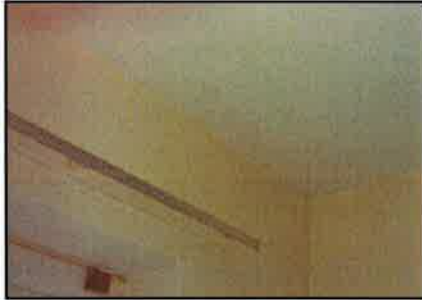
Location		8421441~22 Lunedale - Kitchen - Textured coating to ceiling

Item No:	2	Laboratory sample no:	P-41775 / 002	
Accessibility:		Normally accessible		
Installation:		Textured coating (1)		
Approx extent (m² unless stated)		2		
Asbestos Type:		Chrysotile(1)		
Condition:		Low Damage (1)	Surface Treatment: Sealed (1)	
Risk Assessment (H/M/L/VL)		Very Low (4)	Recommendation: Remove if affected by refurbishment works, inspect periodically otherwise

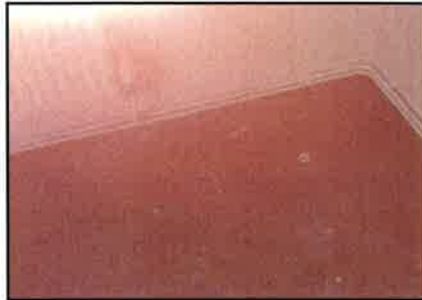
Location		8421441~22 Lunedale - Lounge - Brown vinyl floor tiles & bitumen

Item No:	3	Laboratory sample no:	P-41775 / 003	
Accessibility:		Normally accessible		
Installation:		Floor tile(s) & bitumen (1)		
Approx extent (m² unless stated)		16		
Asbestos Type:		Chrysotile(1)		
Condition:		Low Damage (1)	Surface Treatment: Composite (0)	
Risk Assessment (H/M/L/VL)		Very Low (3)	Recommendation: Remove if affected by refurbishment works. Manage in-situ otherwise.

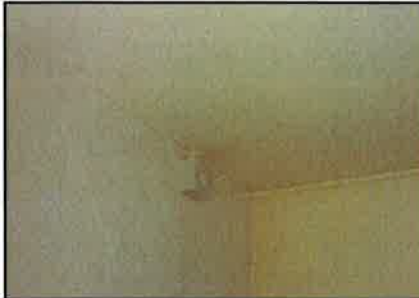
Location		8421441~22 Lunedale - Lounge - Textured coating ceiling

Item No:	4	Laboratory sample no:	P-41775 / 004	
Accessibility:		Normally accessible		
Installation:		Textured coating (1)		
Approx extent (m² unless stated)		16		
Asbestos Type:		Chrysotile(1)		
Condition:		Low Damage (1)	Surface Treatment: Sealed (1)	
Risk Assessment (H/M/L/VL)		Very Low (4)	Recommendation: Remove if affected by refurbishment works. Manage in-situ otherwise.

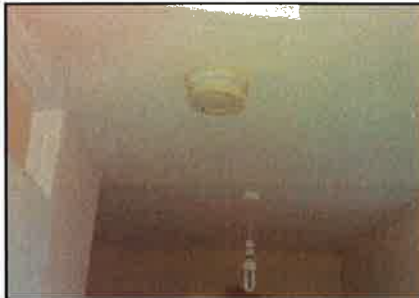
Location		8421441~22 Lunedale - Hallway - Textured coating to ceiling

Item No:	5	Laboratory sample no:	SP-41775 / 004	
Accessibility:		Normally accessible		
Installation:		Textured coating (1)		
Approx extent (m² unless stated)		4		
Asbestos Type:		SP: Chrysotile(1)		
Condition:		Low Damage (1)	Surface Treatment: Sealed (1)	
Risk Assessment (H/M/L/VL)		Very Low (4)	Recommendation: Remove if affected by refurbishment works. Manage in-situ otherwise.

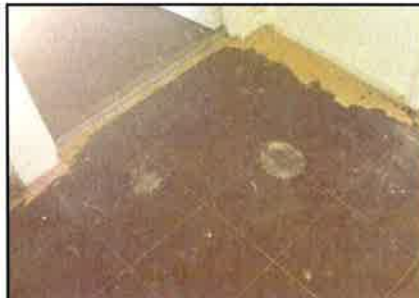
Location		8421441~22 Lunedale - Hallway - Brown vinyl floor tiles & bitumen

Item No:	6	Laboratory sample no:	SP-41775 / 003	
Accessibility:		Easily accessible		
Installation:		Floor tile(s) & bitumen (1)		
Approx extent (m² unless stated)		4		
Asbestos Type:		SP: Chrysotile(1)		
Condition:		Low Damage (1)	Surface Treatment: Composite (0)	
Risk Assessment (H/M/L/VL)		Very Low (3)	Recommendation: Remove if affected by refurbishment works. Manage in-situ otherwise.

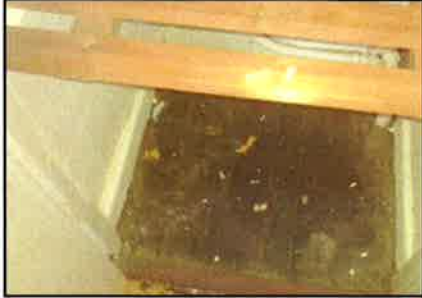
Location		8421441~22 Lunedale - Airing cupboard - Brown vinyl floor tiles

Item No:	7	Laboratory sample no:	P-41775 / 005	
Accessibility:		Easily accessible		
Installation:		Floor tile(s) (1)		
Approx extent (m² unless stated)		1		
Asbestos Type:		Chrysotile(1)		
Condition:		Low Damage (1)	Surface Treatment: Composite (0)	
Risk Assessment (H/M/L/VL)		Very Low (3)	Recommendation: Remove if affected by refurbishment works. Manage in-situ otherwise.

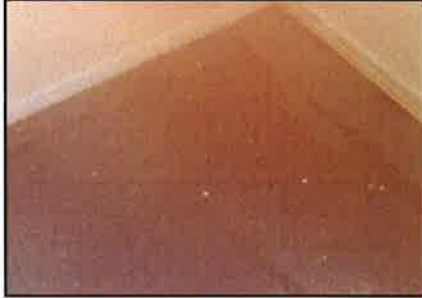
Location		8421441~22 Lunedale - Bedroom - Brown vinyl floor tiles

Item No:	8	Laboratory sample no:	SP-41775 / 005	
Accessibility:		Easily accessible		
Installation:		Floor tile(s) (1)		
Approx extent (m² unless stated)		9		
Asbestos Type:		SP: Chrysotile(1)		
Condition:		Low Damage (1)	Surface Treatment: Composite (0)	
Risk Assessment (H/M/L/VL)		Very Low (3)	Recommendation: Remove if affected by refurbishment works. Manage in-situ otherwise.

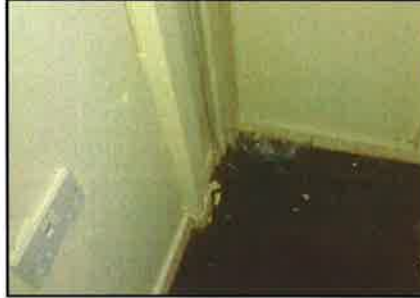
Location		8421441~22 Lunedale - Tank cupboard - Brown vinyl floor tiles

Item No:	11	Laboratory sample no:	SP-41775 / 005	
Accessibility:		Easily accessible		
Installation:		Floor tile(s) (1)		
Approx extent (m² unless stated)		2		
Asbestos Type:		SP: Chrysotile(1)		
Condition:		Low Damage (1)	Surface Treatment: Composite (0)	
Risk Assessment (H/M/L/VL)		Very Low (3)	Recommendation: Remove if affected by refurbishment works. Manage in-situ otherwise.

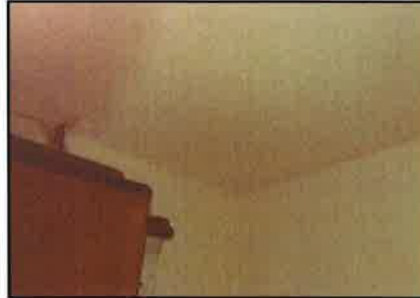
Location		8421441~22 Lunedale - Tank cupboard - Textured coating to ceiling

Item No:	12	Laboratory sample no:	SP-41775 / 006	
Accessibility:		Normally accessible		
Installation:		Textured coating (1)		
Approx extent (m² unless stated)		2		
Asbestos Type:		SP: Chrysotile(1)		
Condition:		Low Damage (1)	Surface Treatment: Sealed (1)	
Risk Assessment (H/M/L/VL)		Very Low (4)	Recommendation: Remove if affected by refurbishment works. Manage in-situ otherwise.

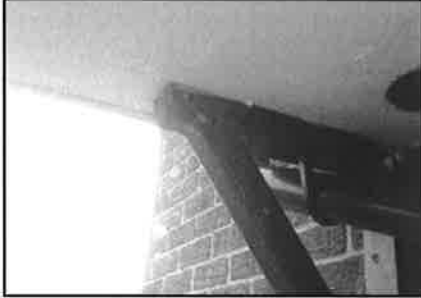
Location		8421441~22 Lunedale - External - Soffit board adjacent to flat 22

Item No:	13	Laboratory sample no:		
Accessibility:		Normally inaccessible		
Installation:		Boarding (2)		
Approx extent (m² unless stated)		5m-lin		
Asbestos Type:		P: Grunerite & Chrysotile (2)		
Condition:		Low Damage (1)	Surface Treatment: Sealed (1)	
Risk Assessment (H/M/L/VL)		Low (6)	Recommendation: Presume asbestos is present until surveyed or re-inspected
