HC1245 Sluice Gate Report

Poole Park

Date: 11 May 2018

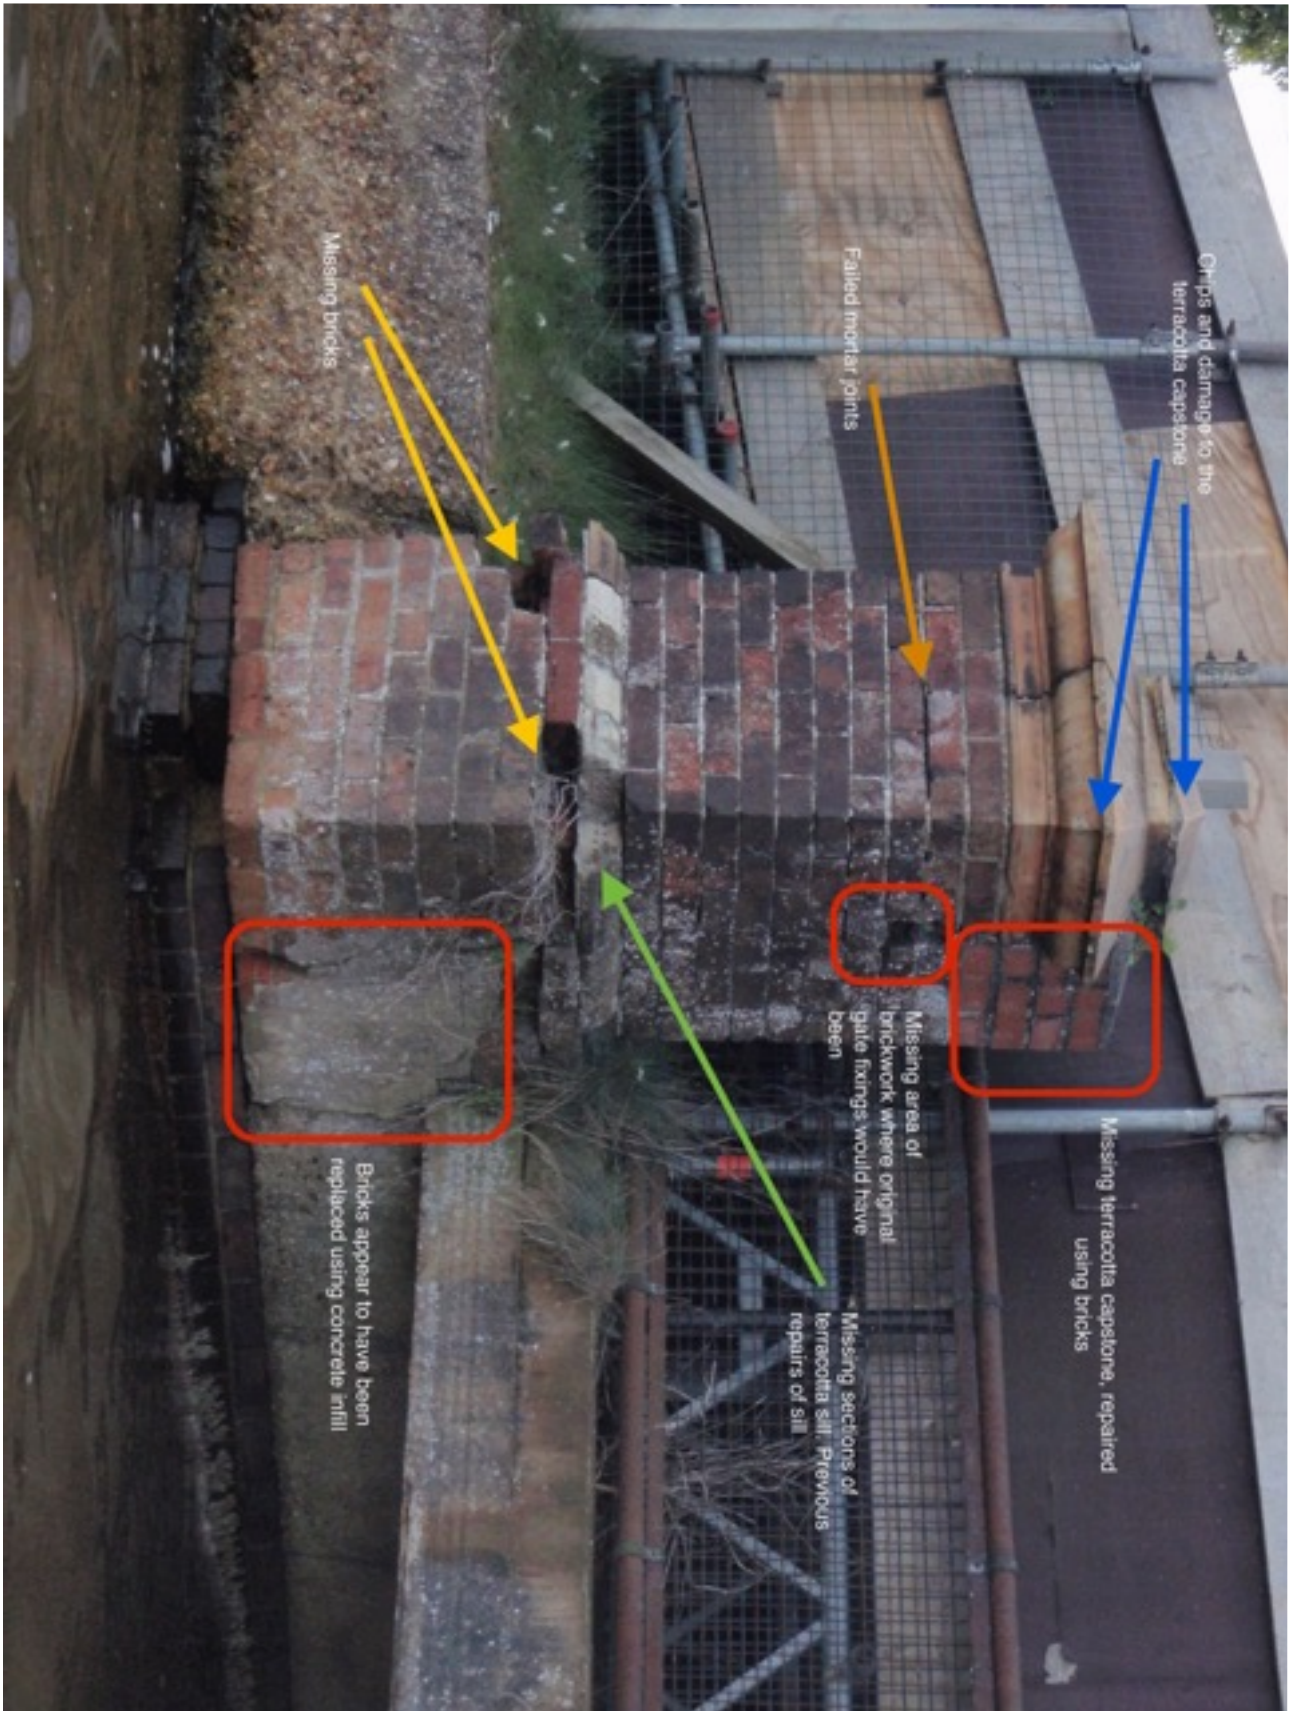
Image 1 - Eastern Pier

Organic growth and weather has impacted on the mortar resulting in large areas of loss to joints, there are also a number of cracks and missing bricks. The steel/iron I beam running into the bases of the piers, these beams have been cut back flush with piers and are now heavily corroded and likely to be putting pressure onto the internal brickwork. They are likely to be part of the original sluice gate mechanism.

The terracotta caps have numerous chips and marks from impact and/or frost. There are also areas of old repairs which show poor brick replacement/repair and mortar repairs applied over the brickwork.

It has been confirmed to us that the brickwork of the brick channel below the water level is in a relatively good condition however the piers show signs of extensive structural degradation due to mortar loss and there seems to be on both piers a fracture between the base of the plinth and the main base sections of the brick channel making them likely to be unstable.

Both the Eastern and the Western piers require repairs to the terracotta capstone, these should be carried out using the approved Lime mortar and a terracotta compound mix that is to be manually applied using hand tools to build up the missing sections/detail to match the original. Any cracks will be consolidated and filled using specified mortar and will be finished to match the original area.

Removal of any defective or damaged bricks, capstones or sill sections, will be carried out by hand, removing the mortar manually using specialist hand tools. Labelling, separating and deconstructing sections of the pier will allow the damaged sections to be removed and the new stone to be installed in place using the approved lime mortar. The piers should be braced and supported as required during this process.
