Asbestos Management Survey Report

Clarence House, Civic Campus, Euclid Street, Swindon, SN1 2SG

Executive Summary

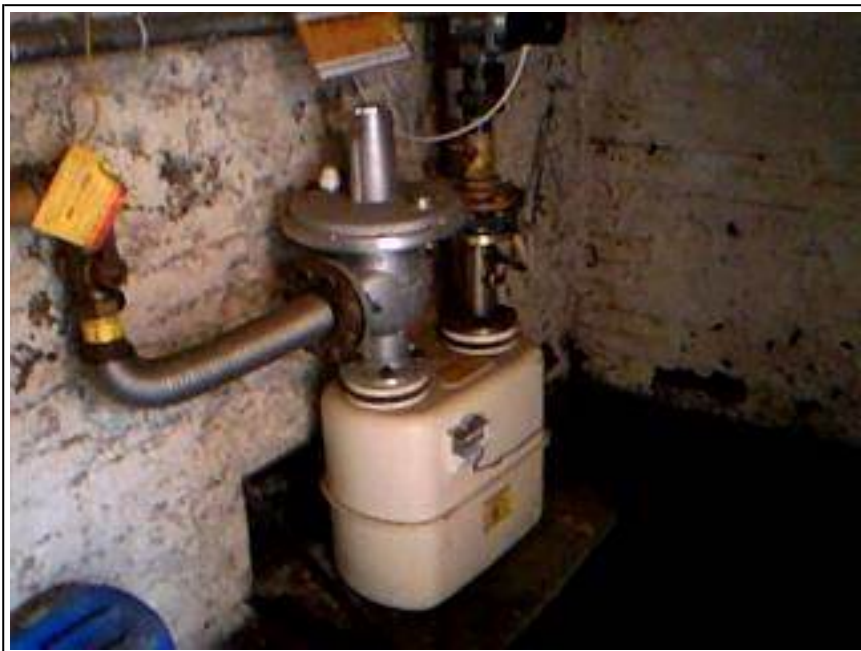
Sample Ref	FI	Location	Description	Qty	Analysis Result	Total M.A.S	Licensed Material Y/N
AD006137	Z-Sub Level 1	Gas Meter Room. B01	Gas meter - Gaskets - Textiles/Paper	<1m ²	NADIS		N

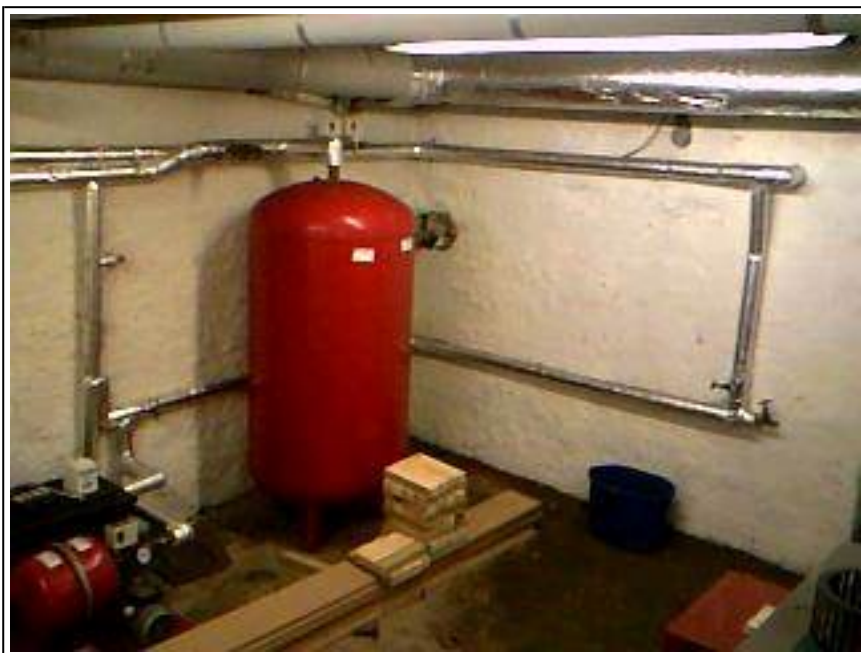
Sample Ref	FI	Location	Description	Qty	Analysis Result	Total M.A.S	Licensed Material Y/N
AD006139	Z-Sub Level 1	Boiler Room. B02	Walls - Insulation residue - Insulation	30m ²	NADIS		N

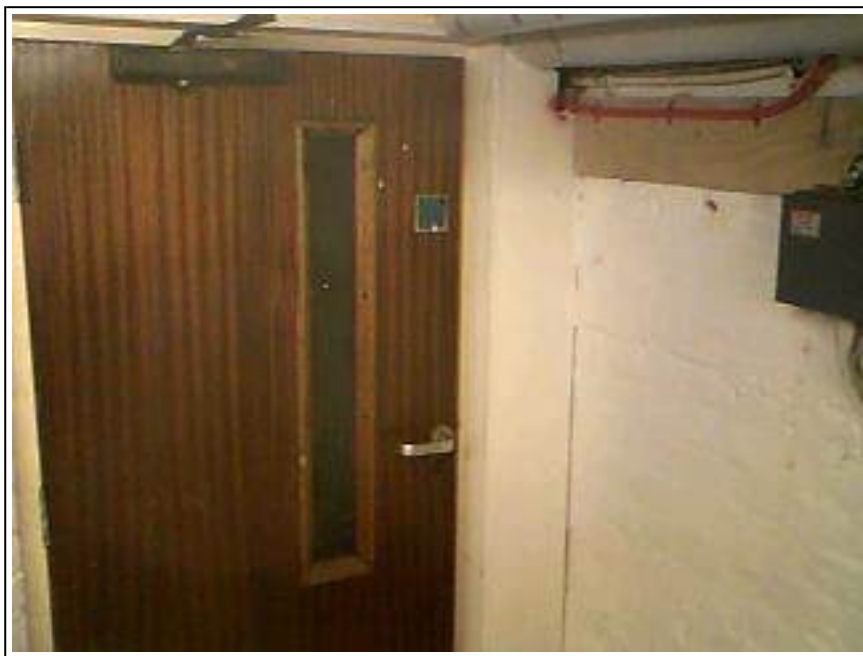
Sample Ref	FI	Location	Description	Qty	Analysis Result	Total M.A.S	Licensed Material Y/N
AD006140	Z-Sub Level 1	Boiler Room. B02	Surrounding door - Insulation board boxing - Insulating Board	3lm	NADIS		N

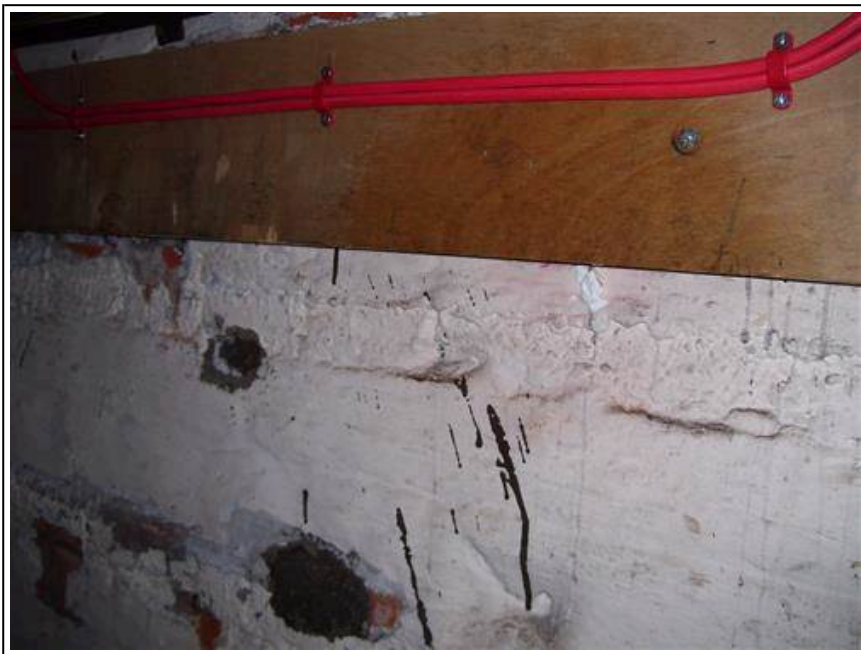
Sample Ref	FI	Location	Description	Qty	Analysis Result	Total M.A.S	Licensed Material Y/N
AD006141	Z-Sub Level 1	Store. B03	Walls - Insulation residue - Asbestos Insulation/Coating	<1m ²	Amosite	7	Y

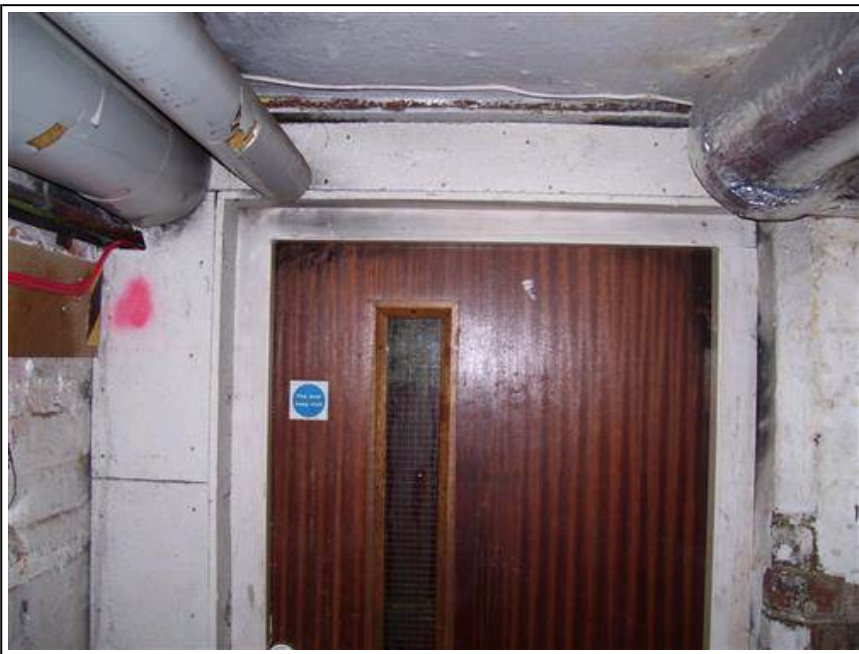
Sample Ref	FI	Location	Description	Qty	Analysis Result	Total M.A.S	Licensed Material Y/N
REFER (AD006140)	Z-Sub Level 1	Store. B03	Surrounding door - Insulation board boxing - Insulating Board	3lm	NADIS		N

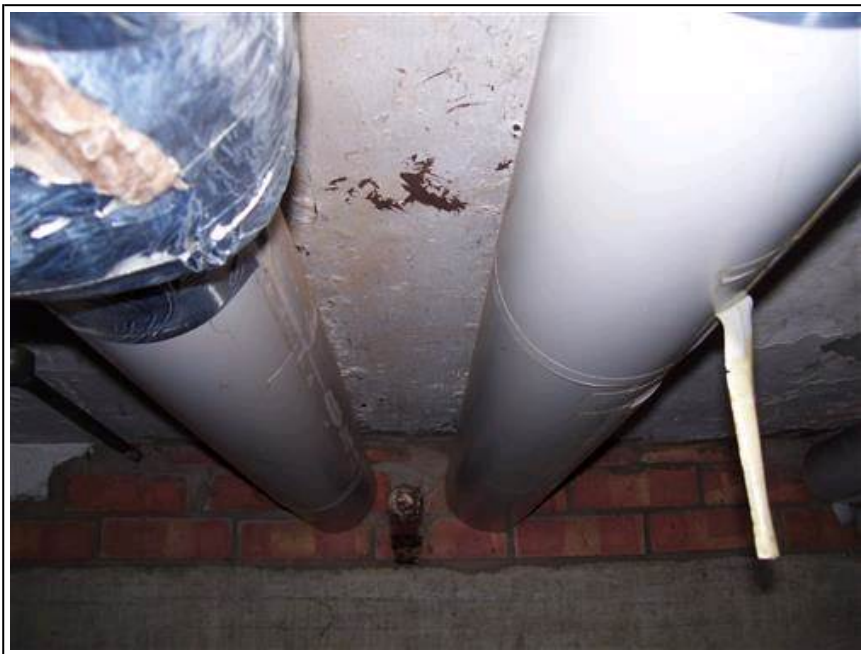
Sample Ref	FI	Location	Description	Qty	Analysis Result	Total M.A.S	Licensed Material Y/N
AD006143	Z-Sub Level 1	Store. B03	Pipework (below fibreglass insulation) - Insulation residue - Asbestos Insulation/Coating	<1m ²	Amosite	7	Y

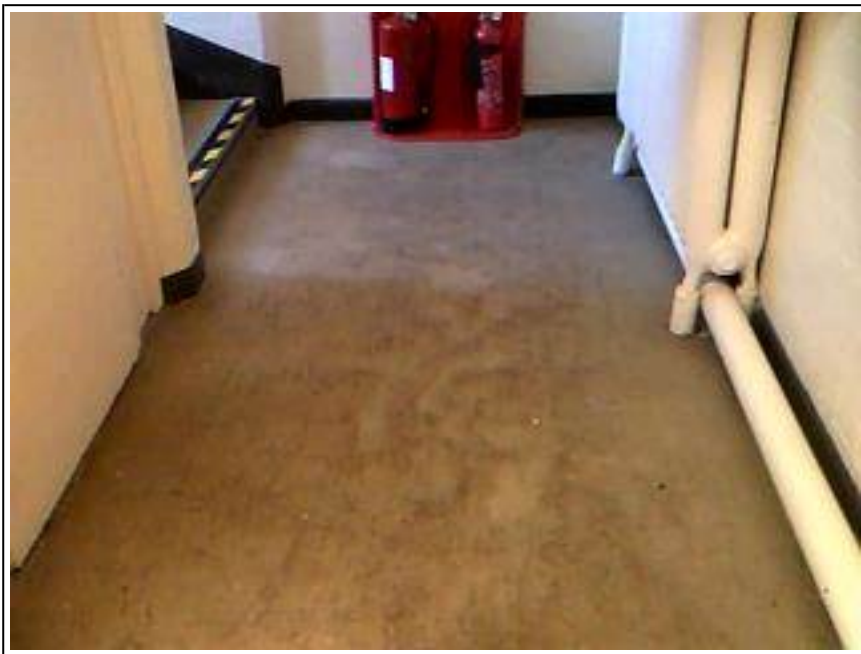
Sample Ref	FI	Location	Description	Qty	Analysis Result	Total M.A.S	Licensed Material Y/N
AD006131	Ground Floor	Lobby. 003	Floor - Vinyl floor tiles and bitumen adhesive - Well Bound Material	8m ²	Chrysotile	2	N

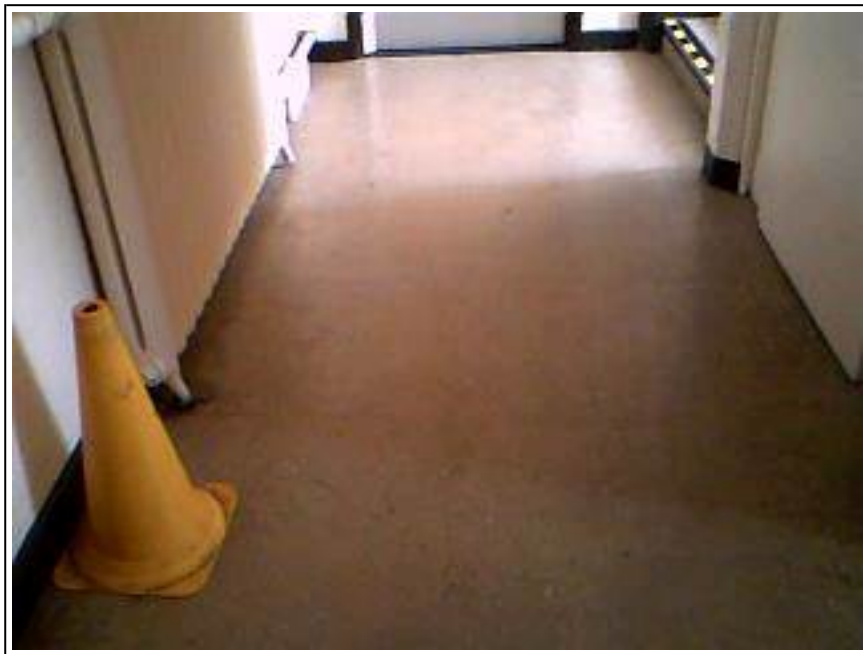
Sample Ref	FI	Location	Description	Qty	Analysis Result	Total M.A.S	Licensed Material Y/N
REFER (AD006131)	Ground Floor	Lobby. 019	Floor - Vinyl floor tiles and bitumen adhesive - Well Bound Material	6m ²	Chrysotile	2	N

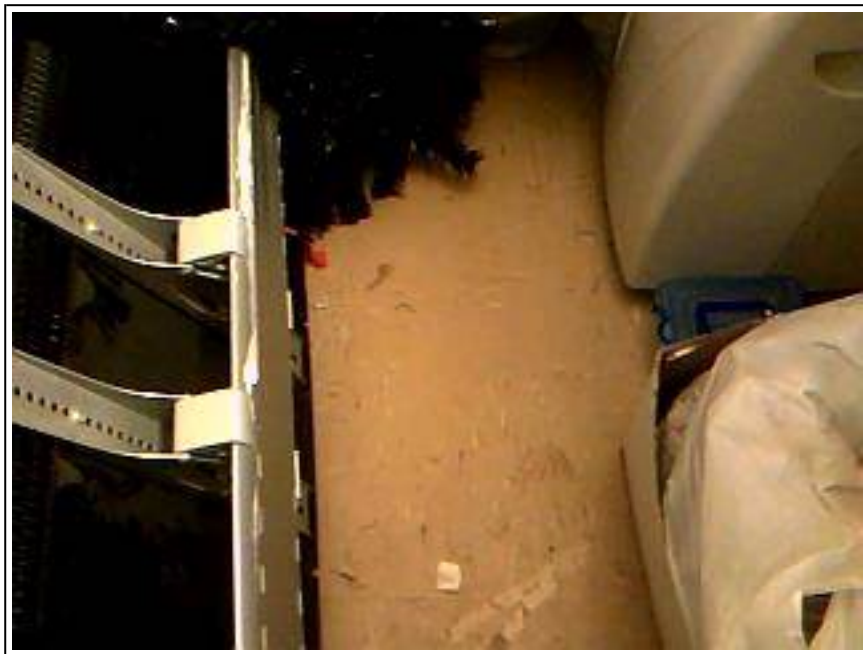
Sample Ref	FI	Location	Description	Qty	Analysis Result	Total M.A.S	Licensed Material Y/N
REFER (AD006131)	Ground Floor	Understairs Cupboard. 020	Floor - Vinyl floor tiles and bitumen adhesive - Well Bound Material	4m ²	Chrysotile	2	N

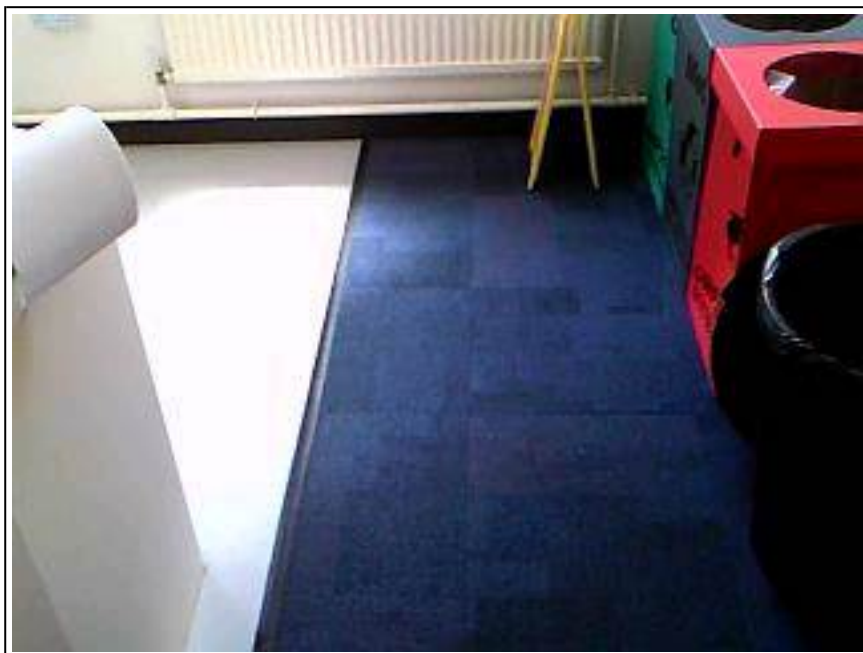
Sample Ref	FI	Location	Description	Qty	Analysis Result	Total M.A.S	Licensed Material Y/N
AD006132	Ground Floor	Kitchen. 021	Floor (below carpet/lino) - Bitumen adhesive - Well Bound Material	9m ²	NADIS		N

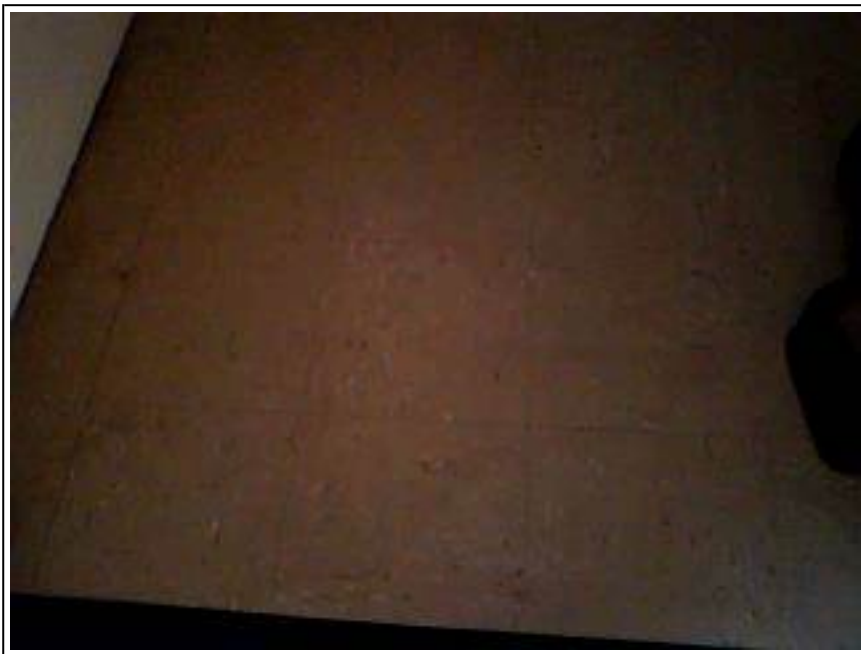
Sample Ref	FI	Location	Description	Qty	Analysis Result	Total M.A.S	Licensed Material Y/N
REFER (AD006131)	Ground Floor	Lobby. 023	Floor (part under carpet tiles) - Vinyl floor tiles and bitumen adhesive - Well Bound Material	4m ²	Chrysotile	2	N

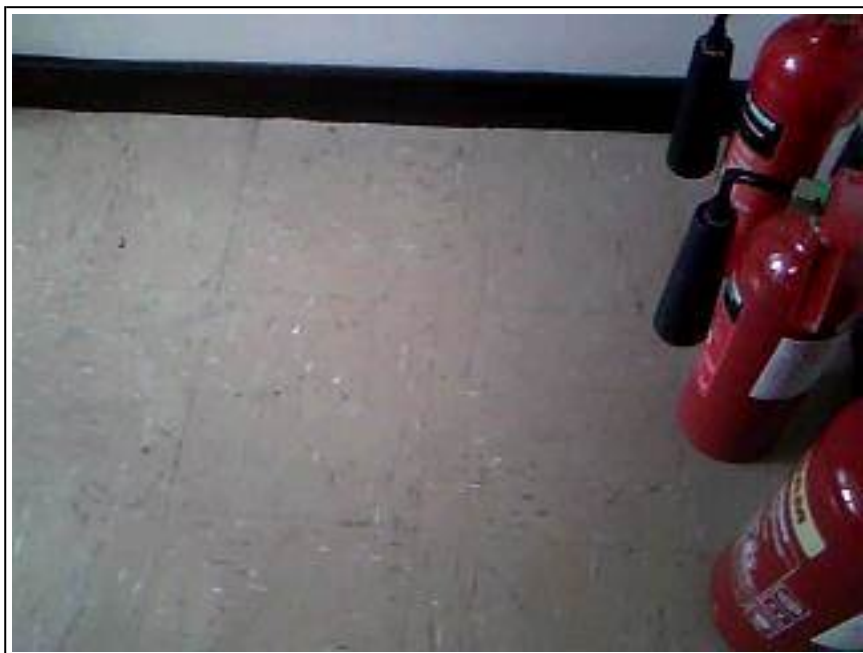
Sample Ref	FI	Location	Description	Qty	Analysis Result	Total M.A.S	Licensed Material Y/N
REFER (AD006131)	Ground Floor	Fire Escape. 024	Floor - Vinyl floor tiles and bitumen adhesive - Well Bound Material	3m ²	Chrysotile	2	N

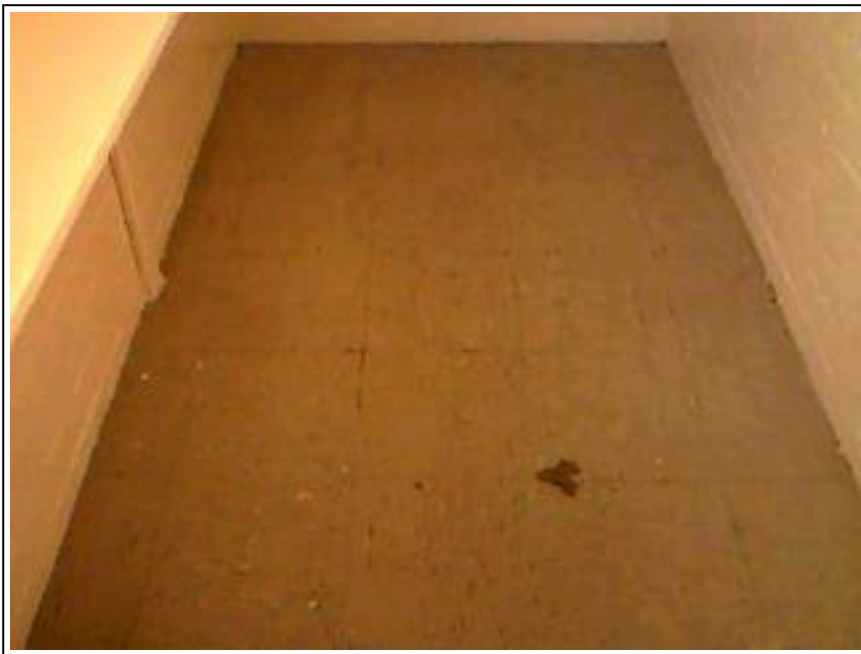
Sample Ref	FI	Location	Description	Qty	Analysis Result	Total M.A.S	Licensed Material Y/N
REFER (AD006131)	Ground Floor	Understairs Cupboard. 025	Floor - Vinyl floor tiles and bitumen adhesive - Well Bound Material	3m ²	Chrysotile	2	N

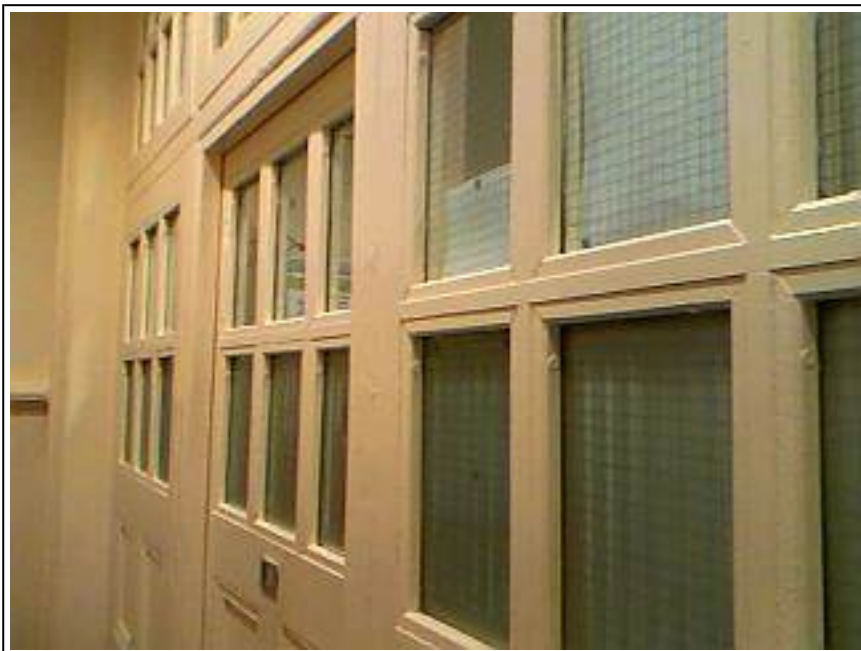
Sample Ref	Fl	Location	Description	Qty	Analysis Result	Total M.A.S	Licensed Material Y/N
AD006133	Ground Floor	Circulation. 033	Internal windows and door - Beading - Insulating Board	<1m ²	NADIS		N

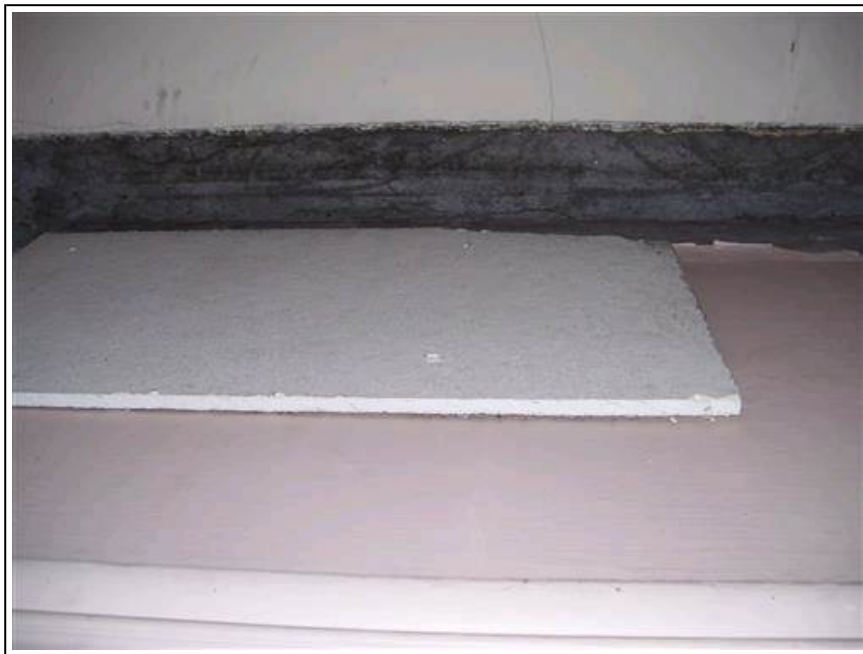
Sample Ref	FI	Location	Description	Qty	Analysis Result	Total M.A.S	Licensed Material Y/N
AD006134	Ground Floor	Meeting Room. 036	Ceiling void - Insulation board - Insulating Board	<1m ²	NADIS		N

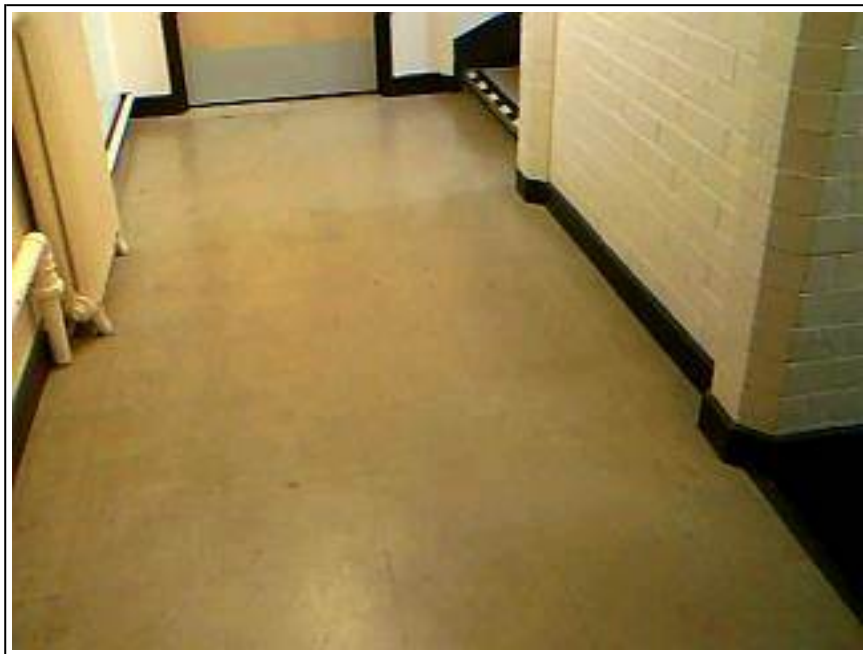
Sample Ref	FI	Location	Description	Qty	Analysis Result	Total M.A.S	Licensed Material Y/N
AD006135	Ground Floor	Lobby. 041	Floor - Vinyl floor tiles and bitumen adhesive - Well Bound Material	7m ²	NADIS		N

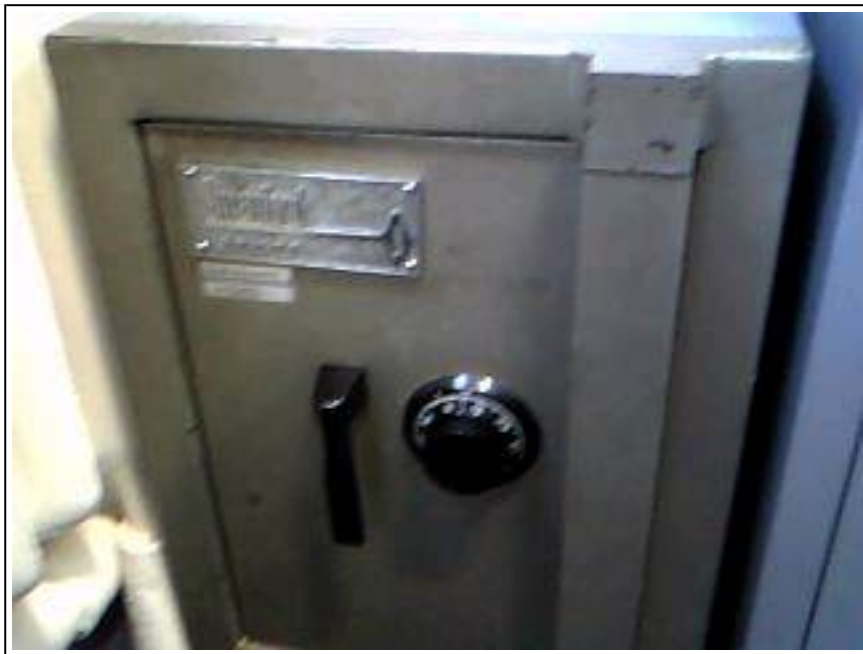
Sample Ref	Fl	Location	Description	Qty	Analysis Result	Total M.A.S	Licensed Material Y/N
Presumed	1st Floor	Office. 105	Within floor safe - Presumed insulation board lining - AIB	1m ²	Crocidolite (or unknown)	6	Y

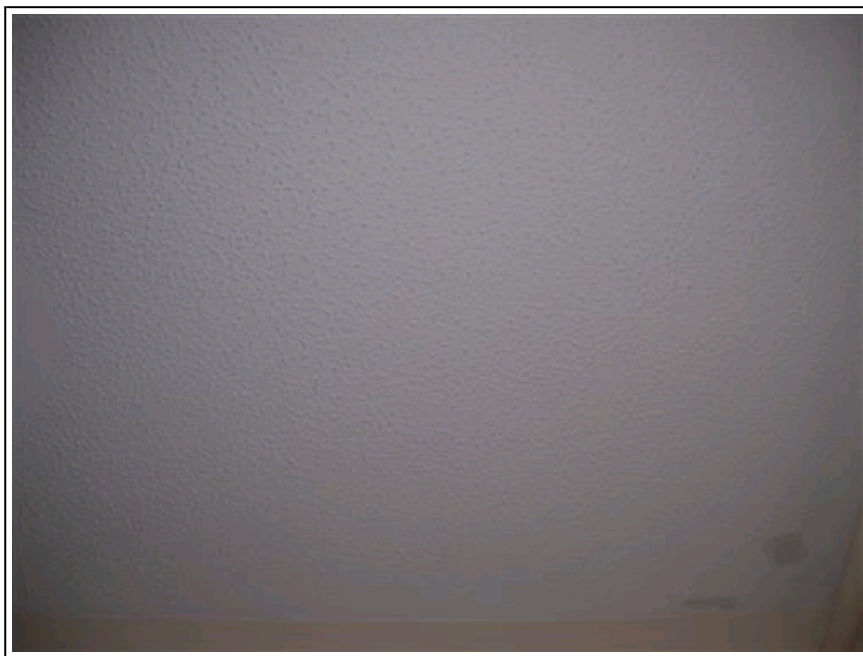
Sample Ref	Fl	Location	Description	Qty	Analysis Result	Total M.A.S	Licensed Material Y/N
AD006136	Mezzanine	W/C Lobby. M02	Ceiling - Decorative coating - Textured Coating	2m ²	NADIS		N

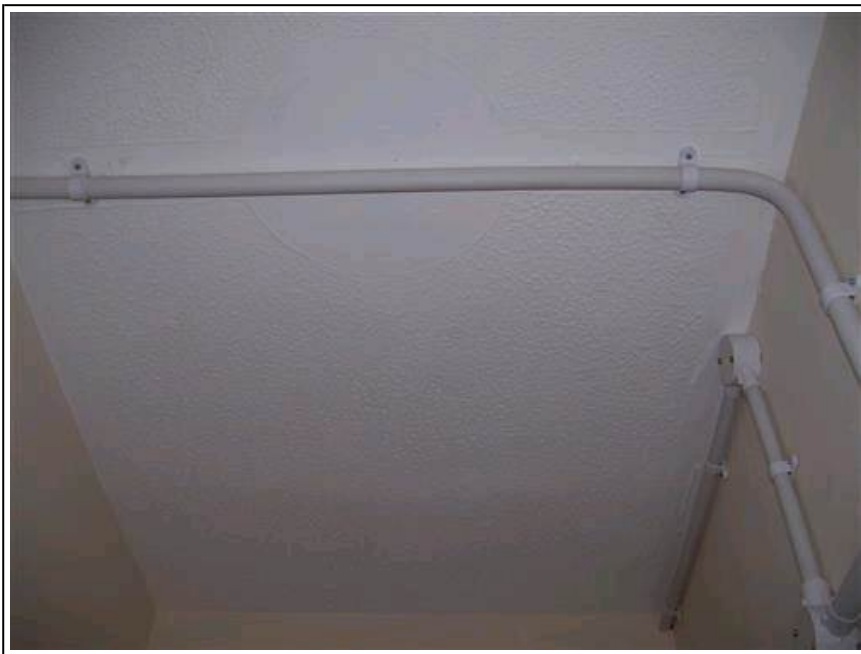
Sample Ref	FI	Location	Description	Qty	Analysis Result	Total M.A.S	Licensed Material Y/N
REFER (AD006136)	Mezzanine	W/C Lobby. M06	Ceiling - Decorative coating - Textured Coating	2m ²	NADIS		N
