## **INTRUSIVE INVESTIGATIONS**

**SPACEPORT BUILDING, SEACOMBE**

**JOB NO: Q20 - 004**

**Date: 17<sup>th</sup> February 2020**

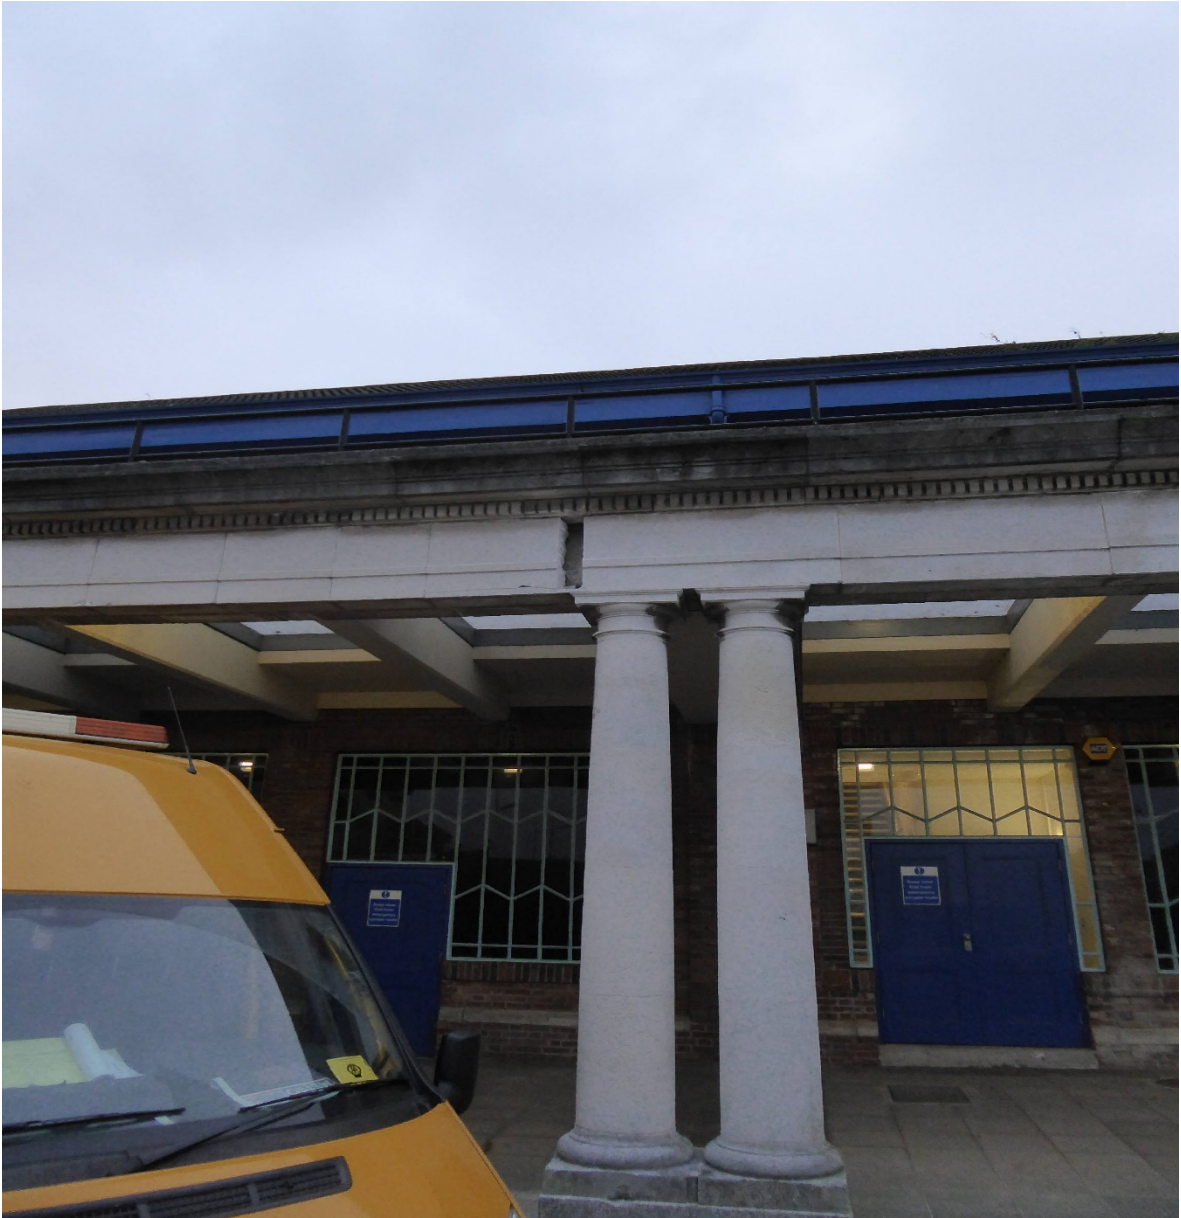
| PHOTOGRAPH SHEET – ONE | |

| PHOTOGRAPH SHEET – ONE | |
|---|---|
| Description: | General view showing the first location where intrusive investigations were carried out in order to establish the underlying construction and condition of same. |

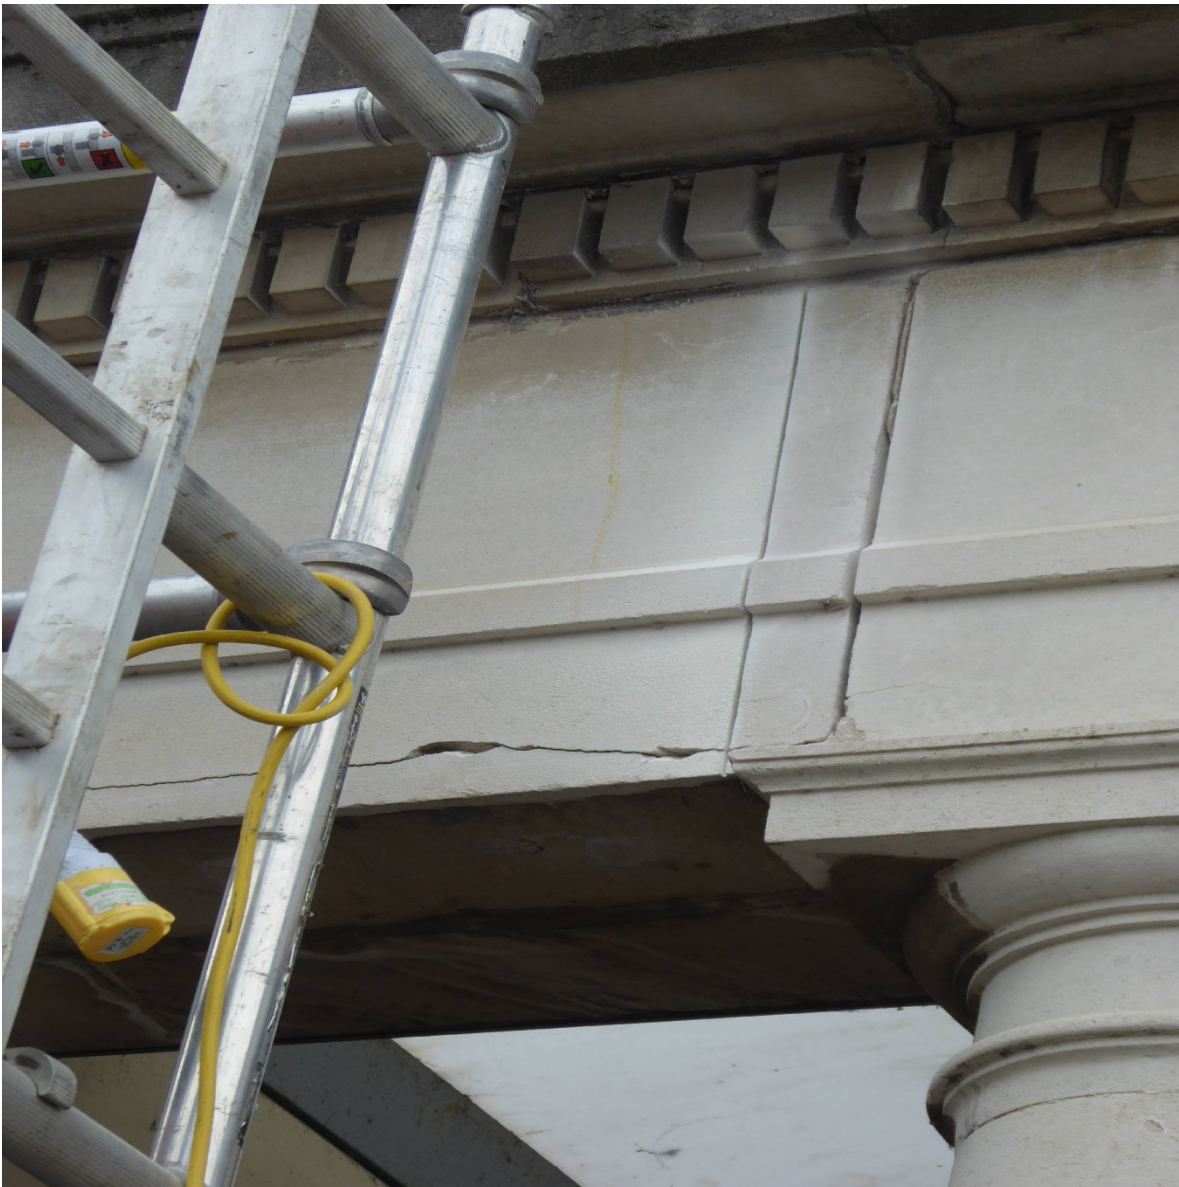
| PHOTOGRAPH SHEET – TWO | |
|---|---|
| Description: | Close up view of that area as shown in the previous photograph which was selected for the intrusive investigation. Note it is an area where damage is clearly evident in the lower section of the Portland stone facing where it is anticipated that the bottom flange of the embedded RSJ steel section is located |

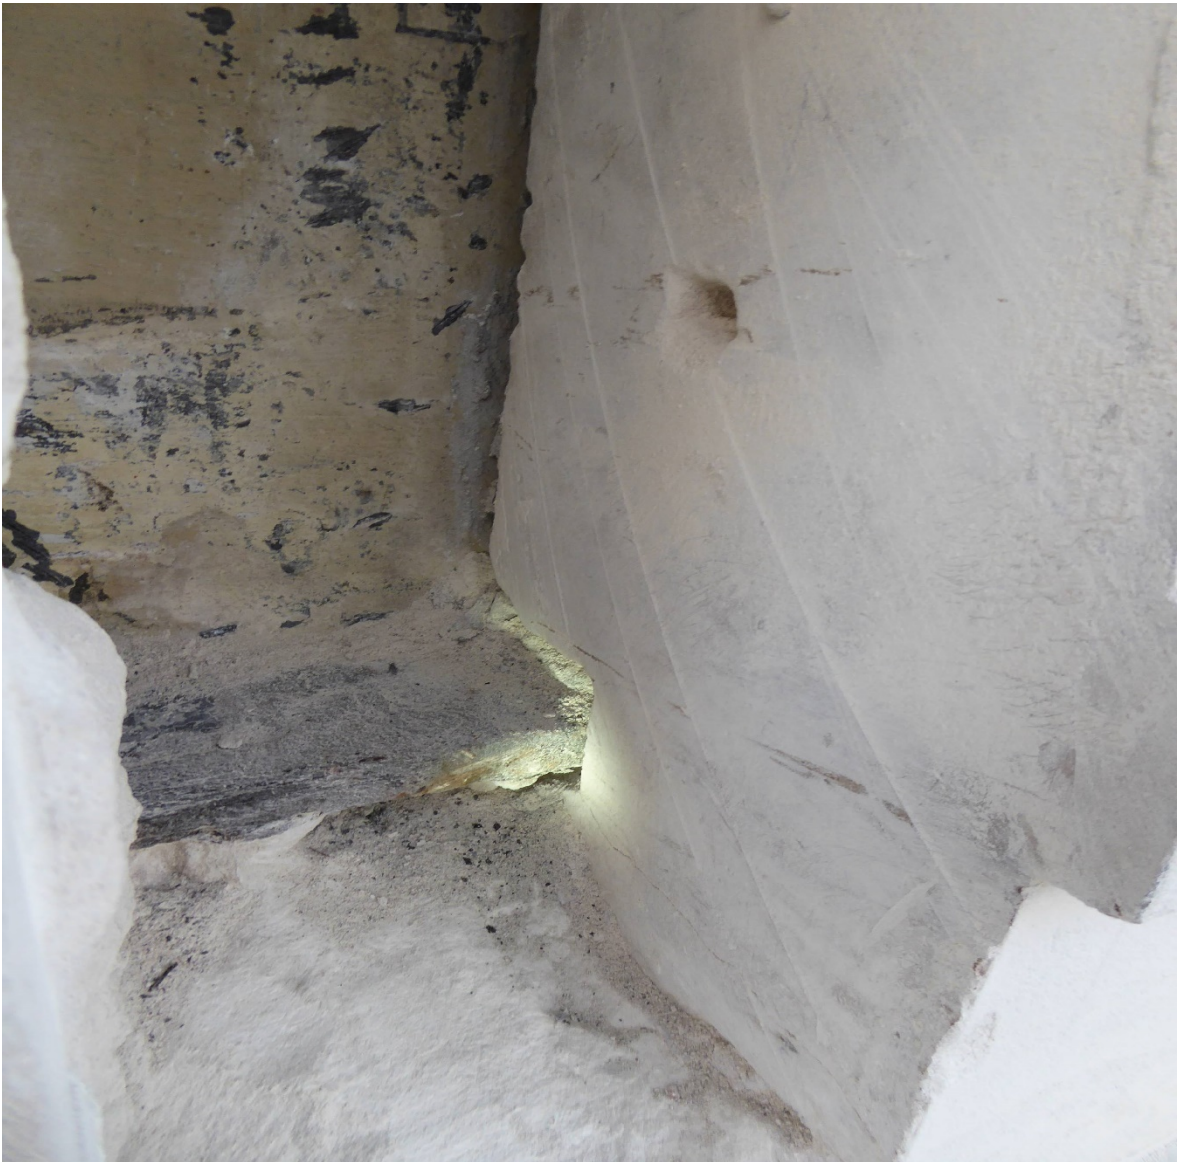
| PHOTOGRAPH SHEET – THREE | |
|---|---|
| Description: | Further close up view of that area as shown in the previous photograph where the removal of a vertical section of the Portland stone was removed in order to fully reveal the underlying construction detail. The lower section of the RSJ steel web and flange were found to be heavily corroded. A crack was evident in the freshly exposed edge of the Portland stone in the location where the bottom flange was located, which extended to the outer face. |

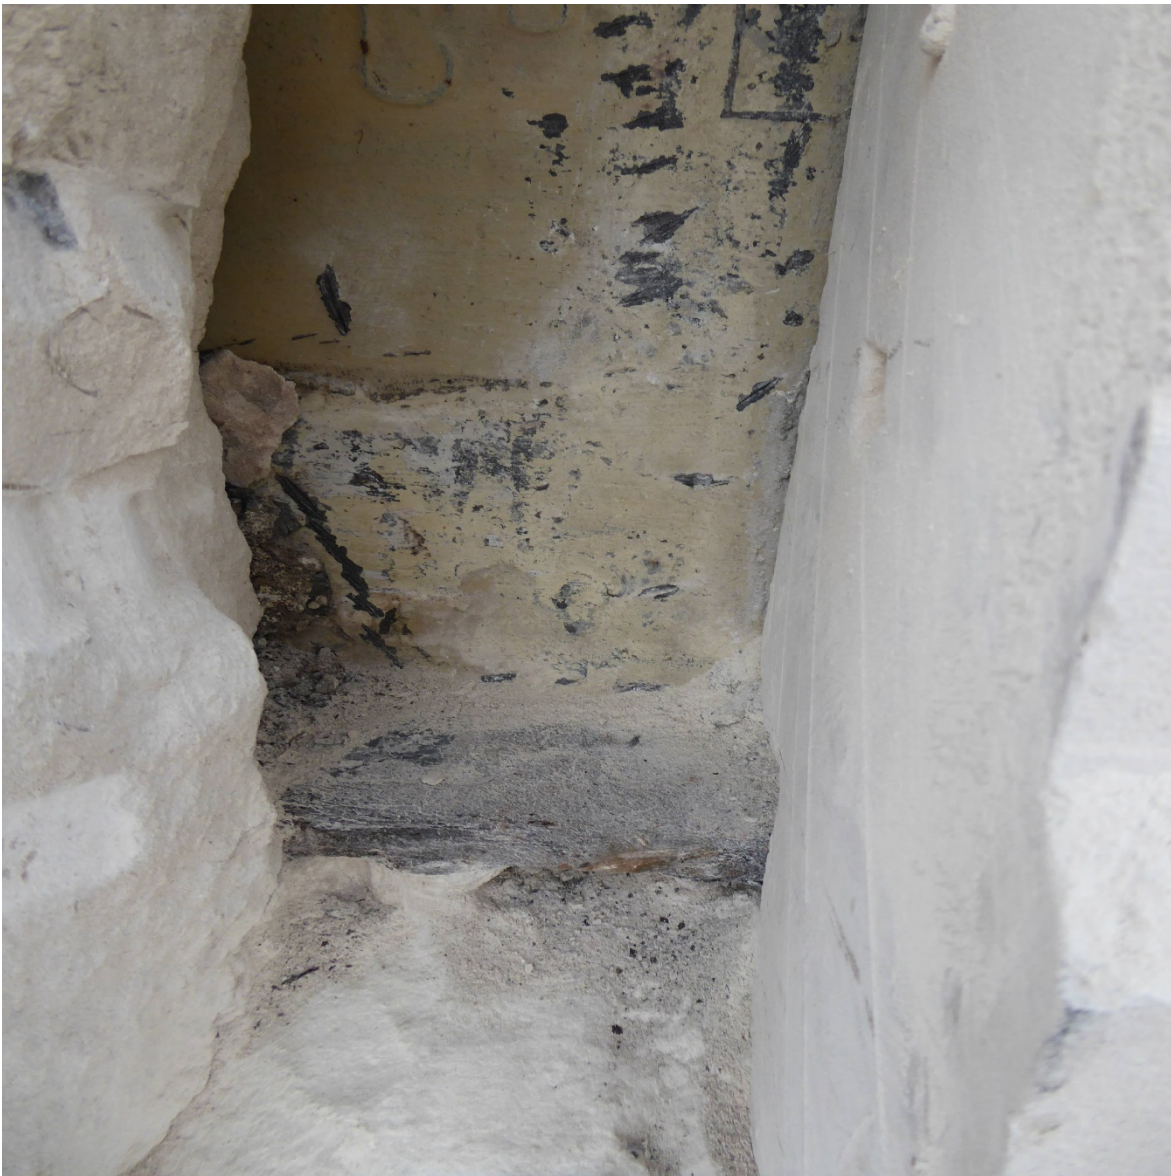
| PHOTOGRAPH SHEET – FOUR | |
|---|---|
| Description: | Further close up view of the previous photograph revealed that the depth of corrosion to the bottom flange and web of the RSJ was some 15 to 20mm. Whilst grout was evident both in the location of the top and bottom flange no grout was evident to the rear face of the Portland stone were abutting the web of the RSJ. A one-meter long tracer probe was inserted in the gap between the rear face of the Portland stone and the front face of the web of the RSJ in both directions with little or no restriction. We consider that this condition is likely to be widespread. |

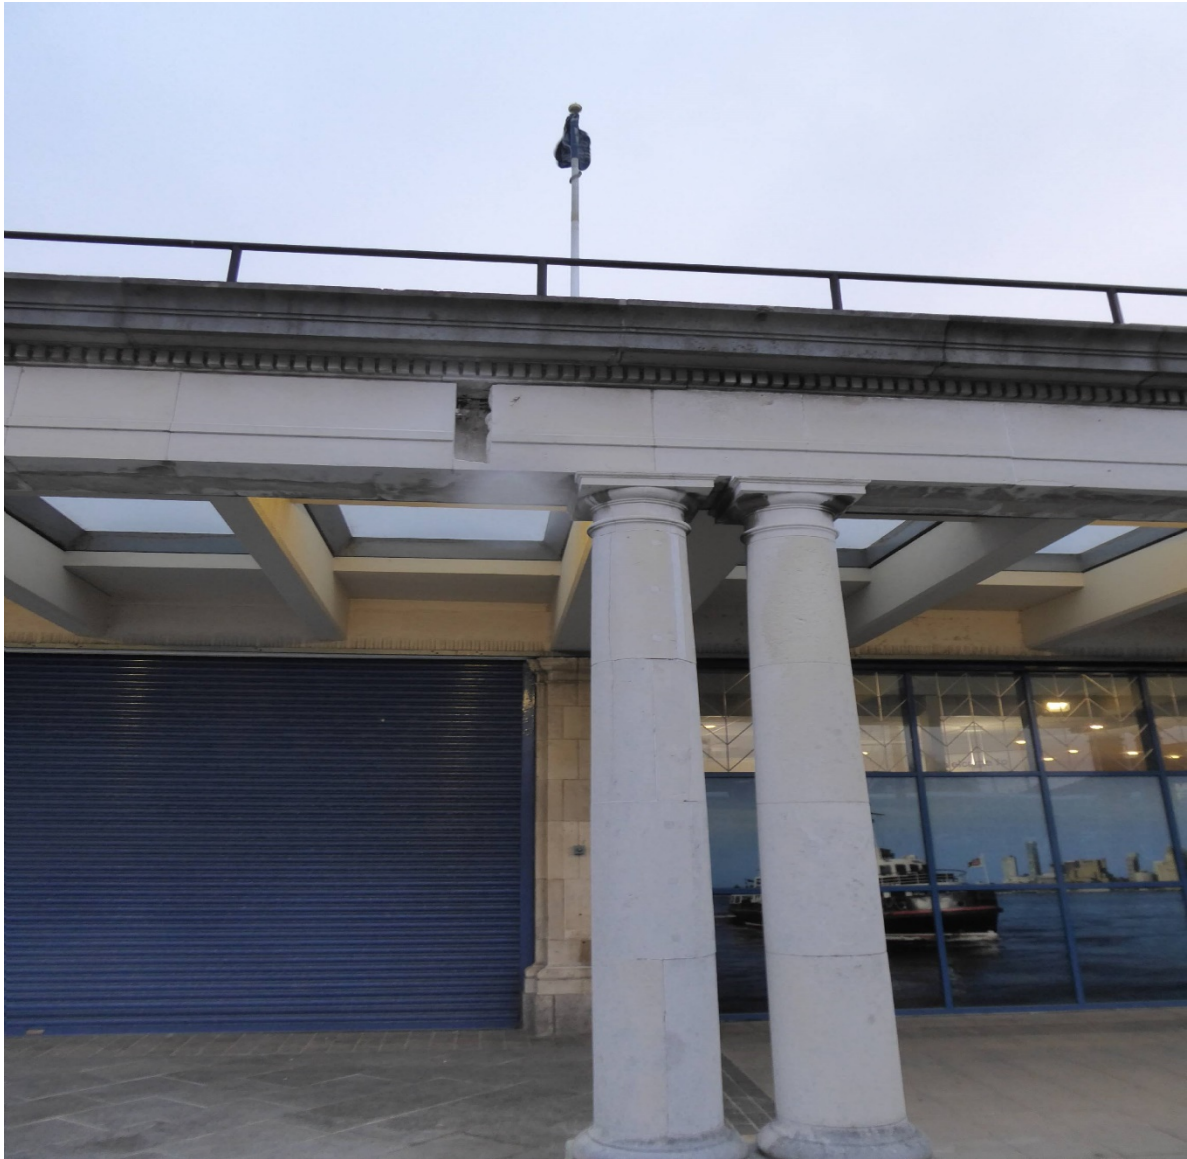
| PHOTOGRAPH SHEET – FIVE | |
|---|---|
| Description: | General view showing the second location where intrusive investigations were carried out in order to establish the underlying construction and condition of same. Note that this area was selected in order to provide a balance view as to condition as no damage to the stone Portland stone facing was evident. |

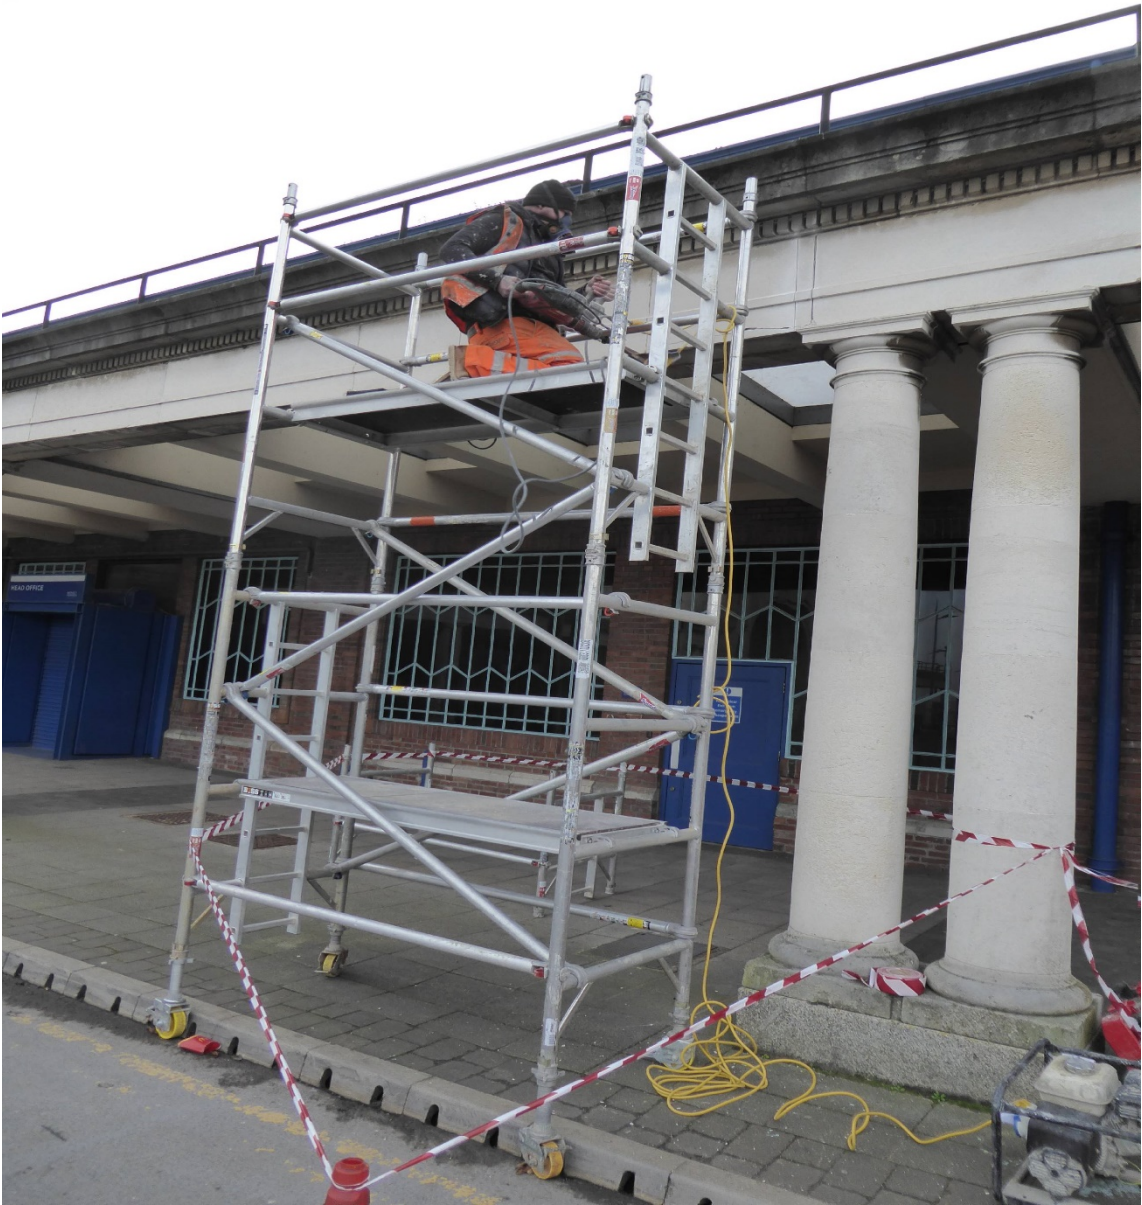
| PHOTOGRAPH SHEET – SIX | |

| PHOTOGRAPH SHEET – SIX | |
|---|---|
| Description: | Close up view of location 2 showing where removal of the Portland stone facing was being carried out. |

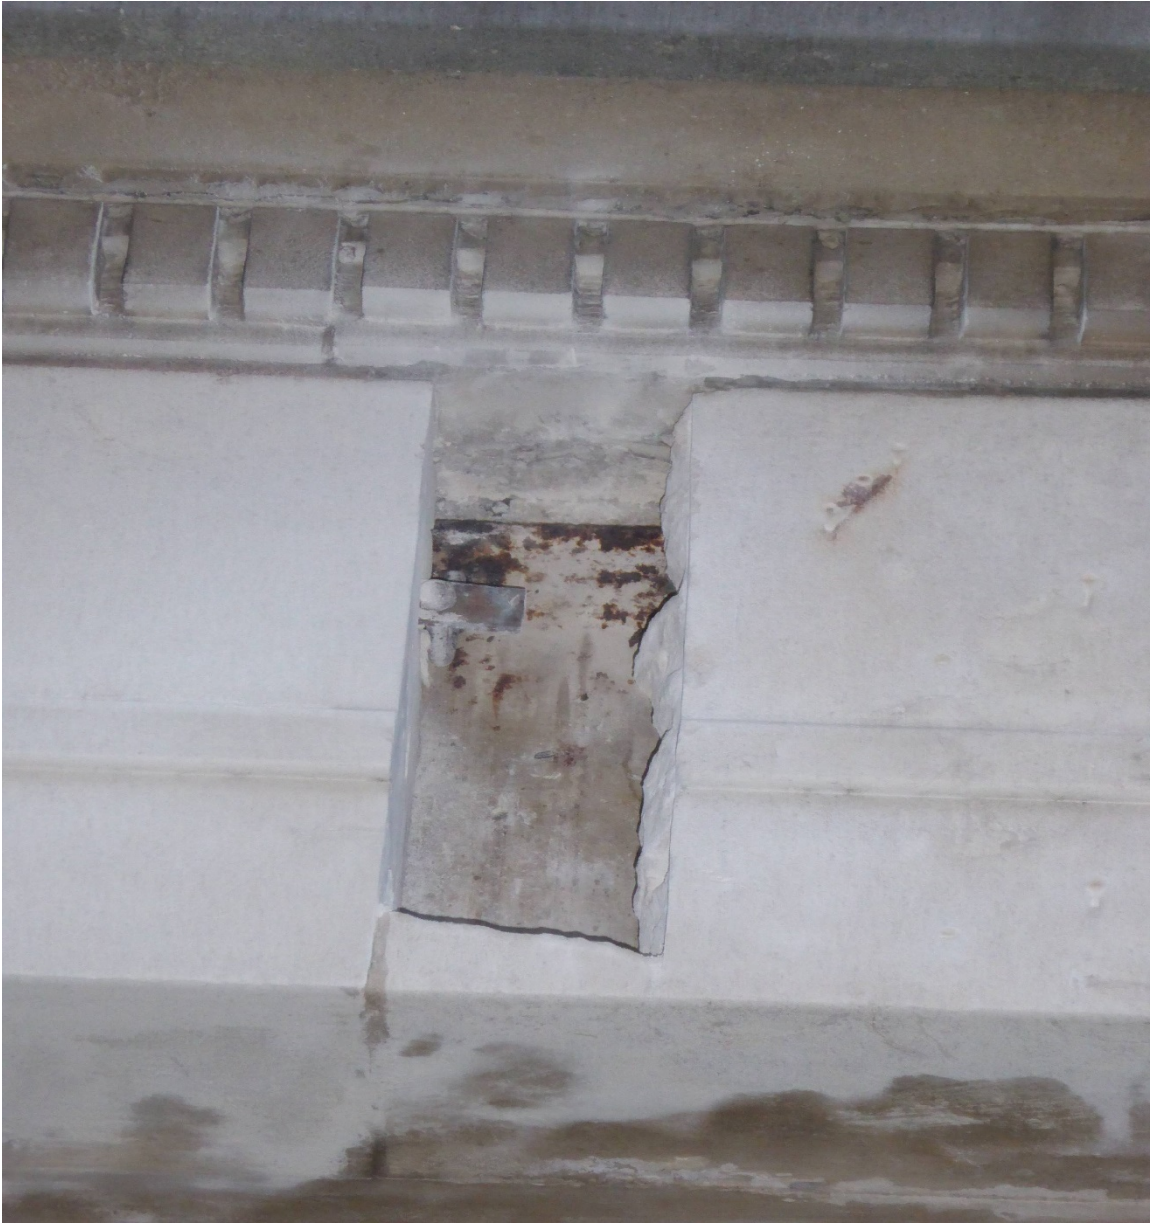
| PHOTOGRAPH SHEET – SEVEN | |

| PHOTOGRAPH SHEET – SEVEN | |
|---|---|
| Description: | Close up view of that area shown in the previous photograph after completion of the intrusive investigation in order to reveal the underlying condition. |

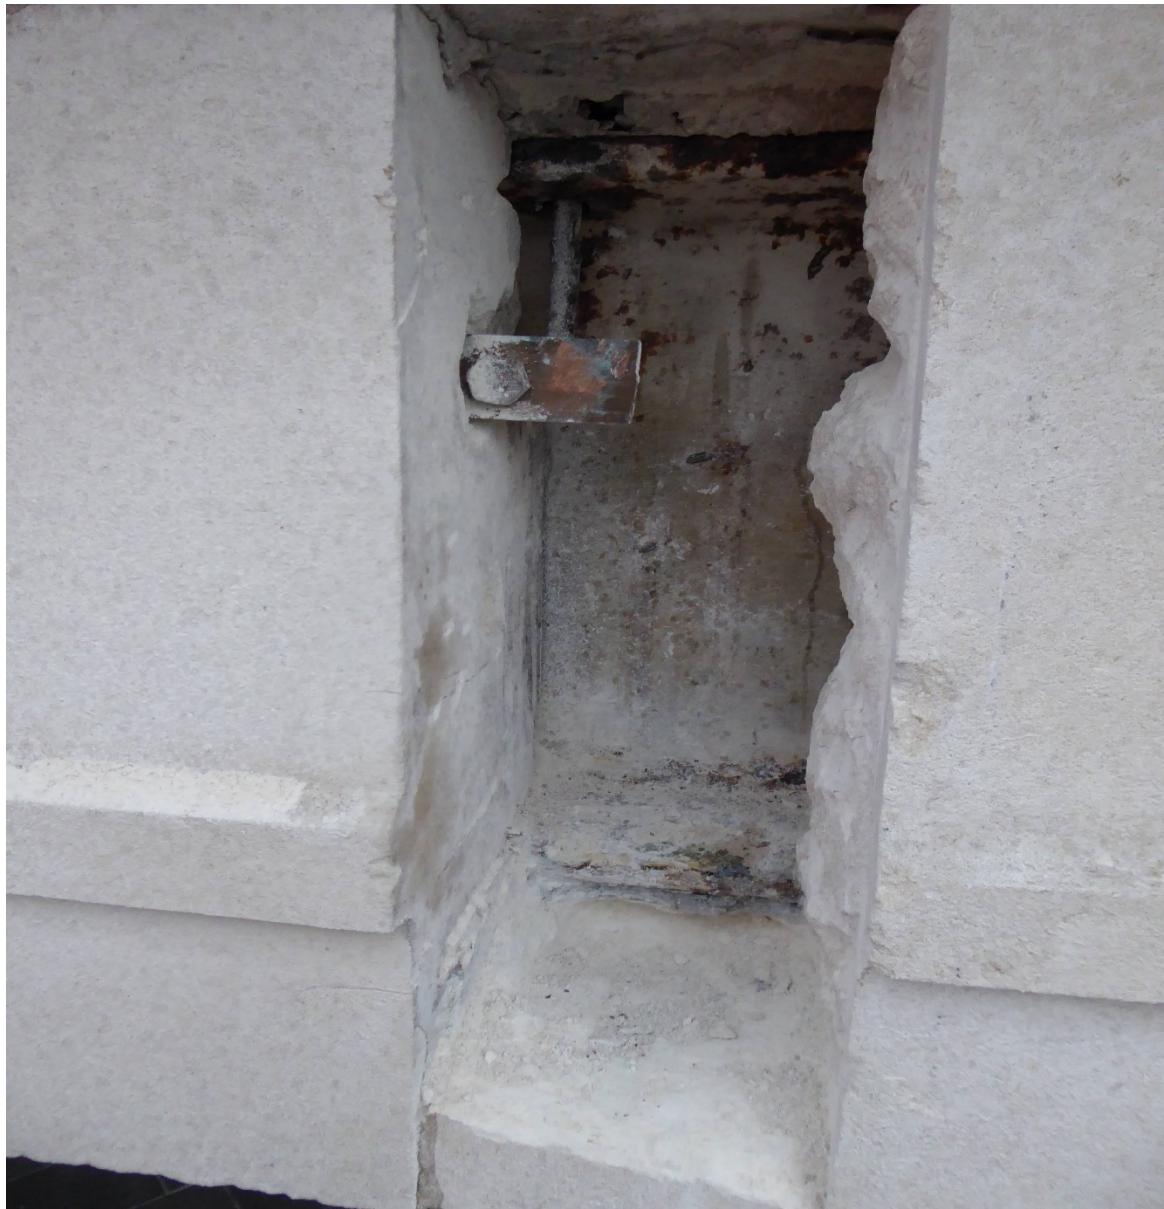
**PHOTOGRAPH SHEET – EIGHT**

A further close up view of the previous photograph showing the location, type and condition of metal fixing used in the vertical joint in the Portland stone facing. Also note that the condition of the underlying RSJ steel section was in better condition than that found in Location 1. Whilst corrosion was evident on the top and bottom flange it was considered as being minimal considering the age of the structure and the environmental conditions present, no corrosion was evident on the web of the RSJ. As in location 1 grout was evident both in the location of the top and bottom flange with minimal grout evident to the rear face of the Portland stone were abutting the web of the RSJ. A one-meter long tracer probe was inserted in the gap between the rear face of the Portland stone and the front face of the web of the RSJ in both directions with little or no restriction. We consider that this condition is likely to be widespread.

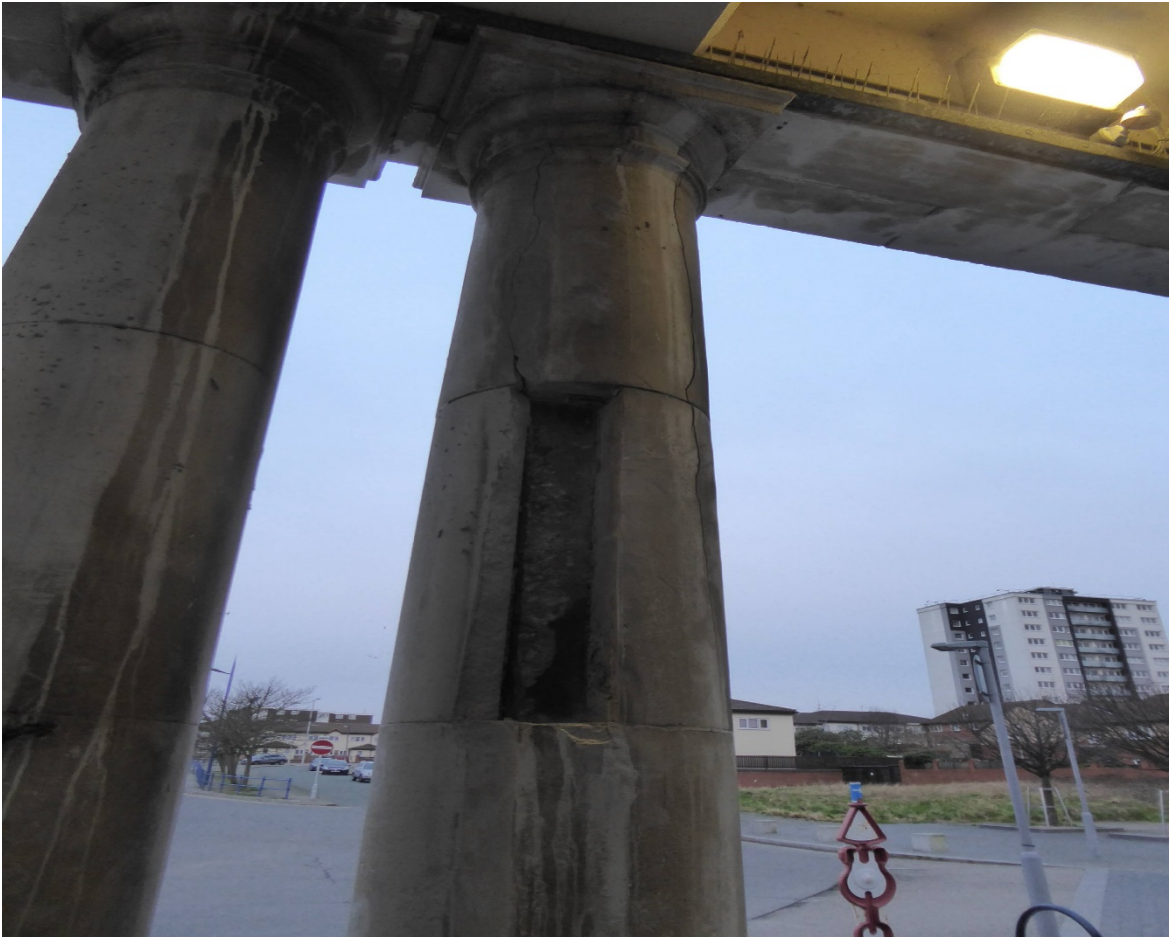
| PHOTOGRAPH SHEET – NINE | |

| PHOTOGRAPH SHEET – NINE | |
|---|---|
| Description: | Close up view of a column adjacent to location 2 where intrusive investigations were carried out to reveal the underlying construction. |

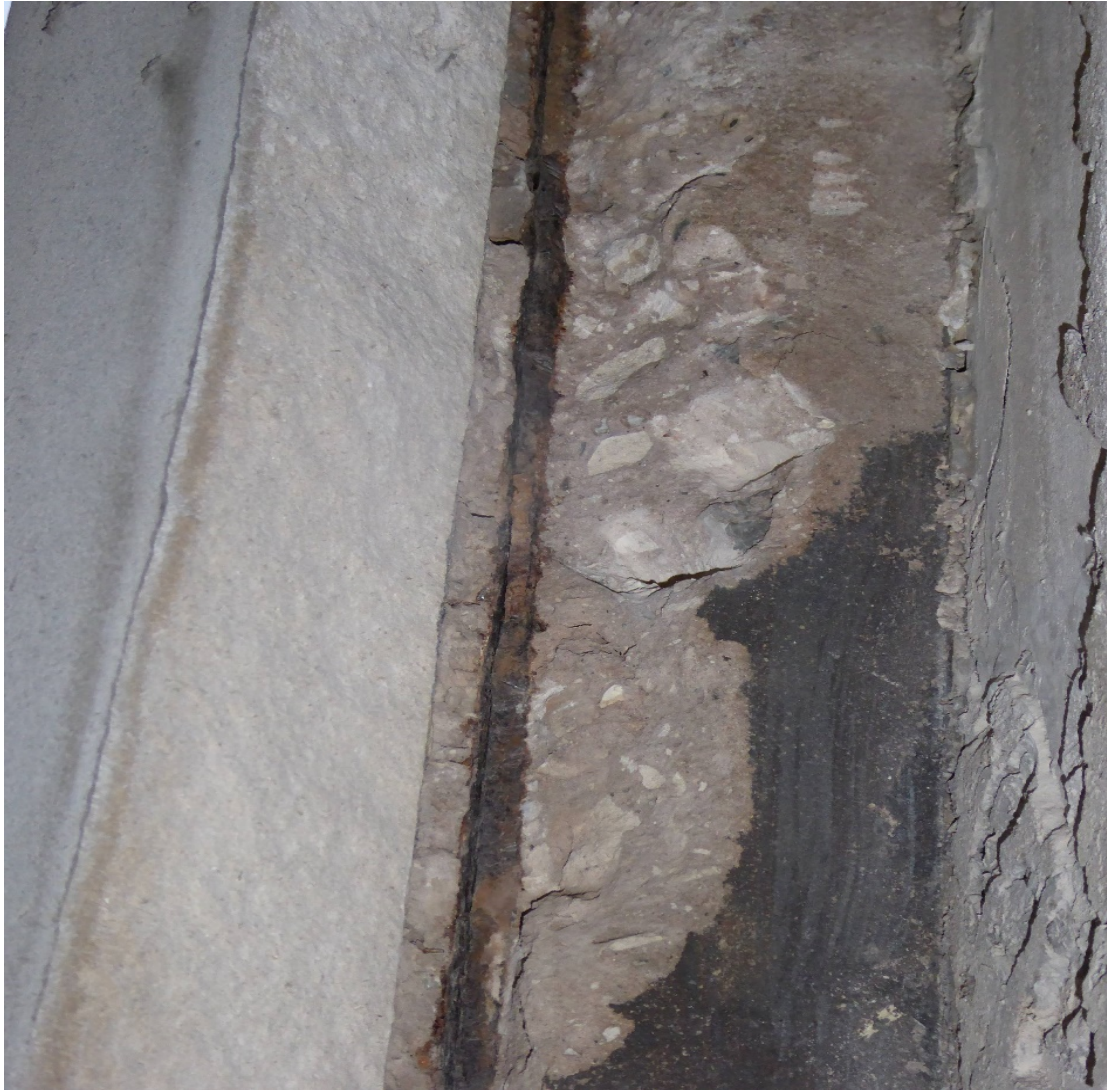
**PHOTOGRAPH SHEET – TEN**

Close up view of that area of the column as shown in the previous photograph where the intrusive investigations were carried out. Note that the construction comprised of a central core of steel encased concrete (presumably reinforcing bar) with a Portland stone outer face.

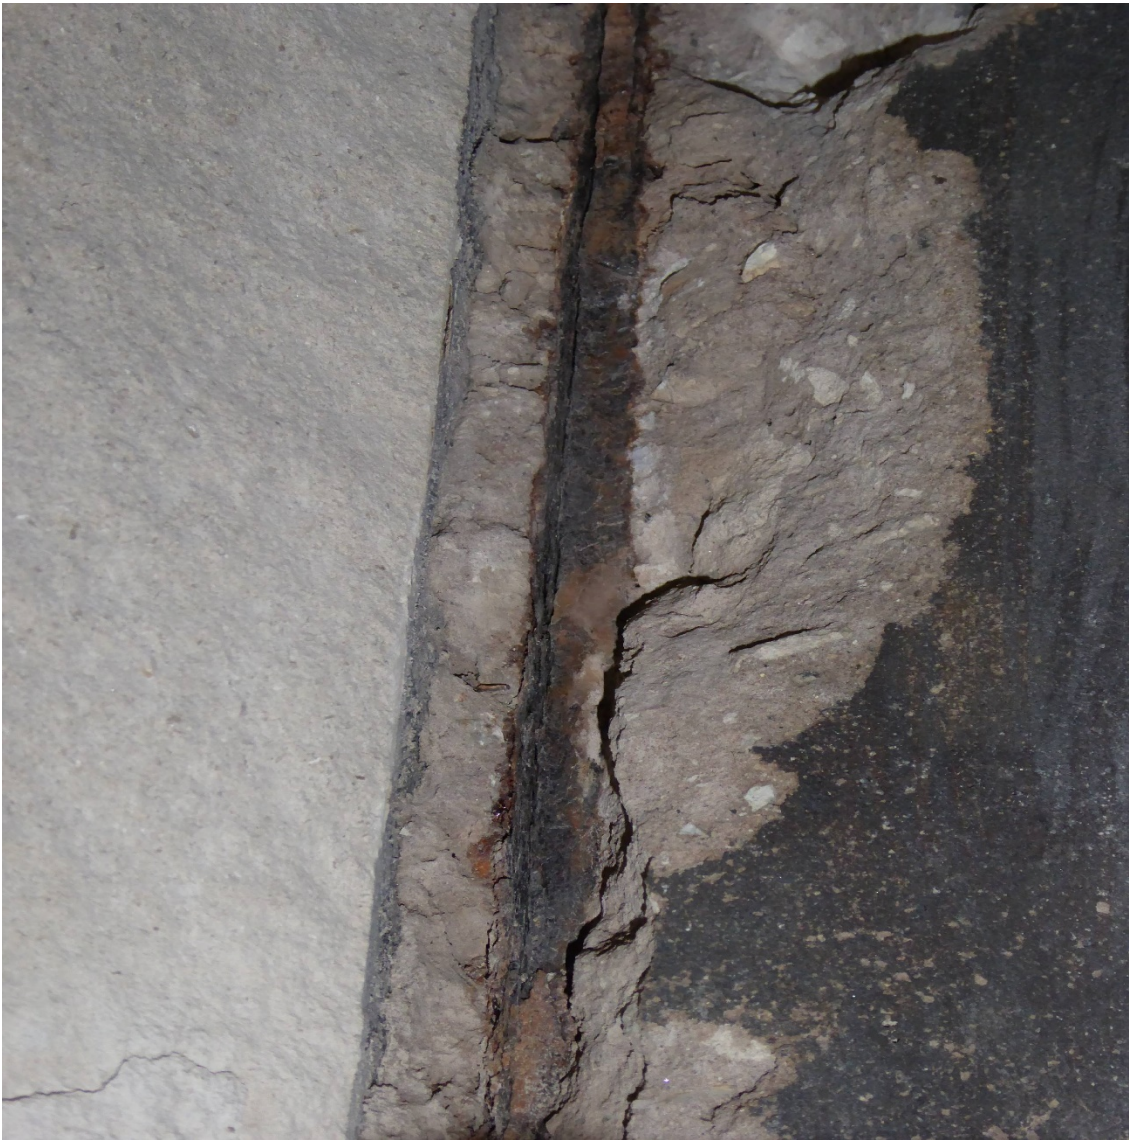
| PHOTOGRAPH SHEET – ELEVEN | |

| PHOTOGRAPH SHEET – ELEVEN | |
|---|---|
| Description: | Close up view of the steel reinforcing bar as shown in the previous photograph. Note the presence of heavy corrosion which is likely to have resulted in loss of cross-sectional area. |

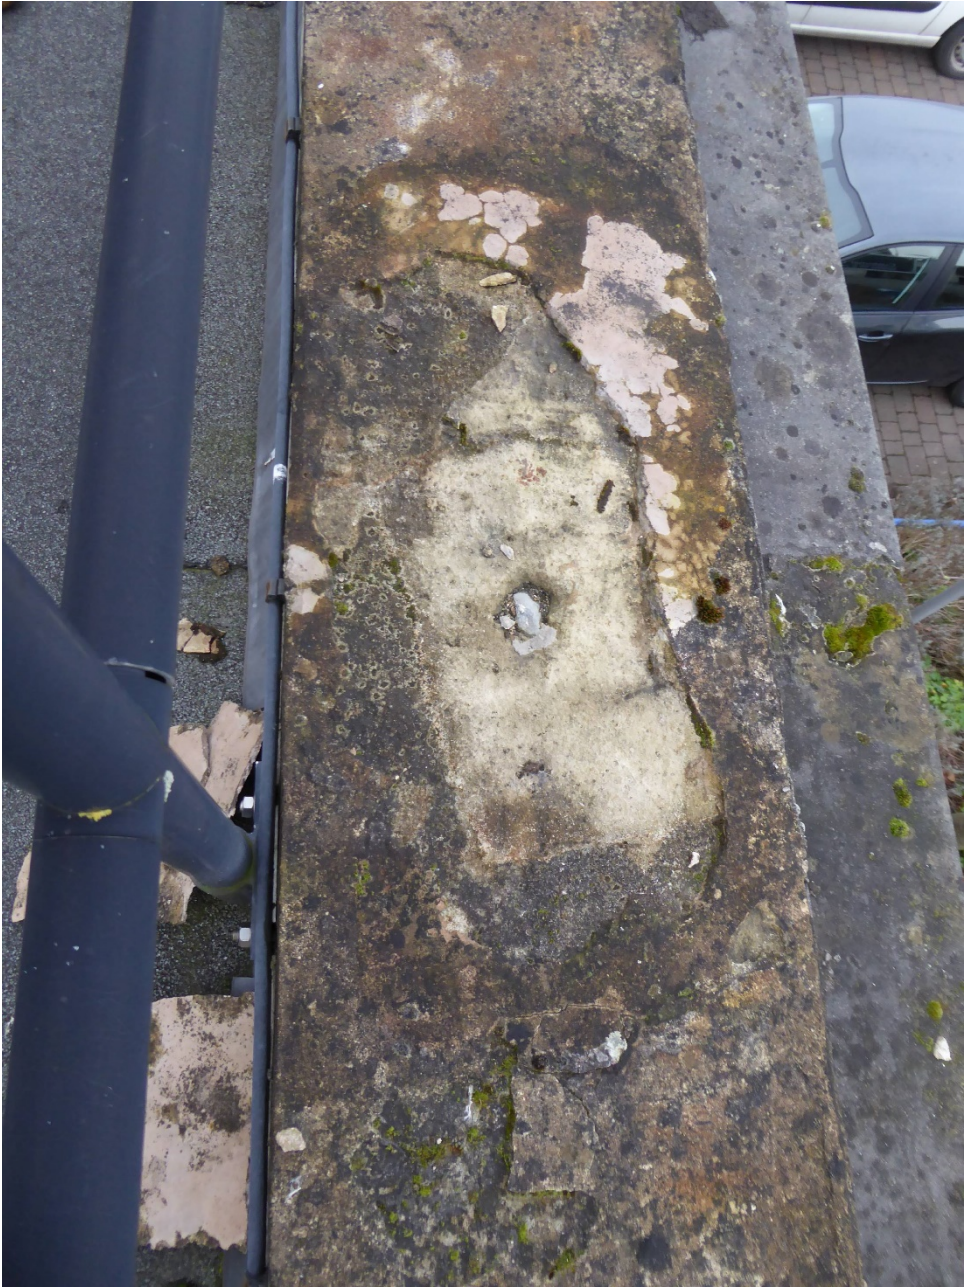
| PHOTOGRAPH SHEET – TWELVE | |

| PHOTOGRAPH SHEET – TWELVE | |
|---|---|
| Description: | Close up view of the concrete cap located on the top of the Portland stone cornice. Note the damage evident. This condition is not isolated. |

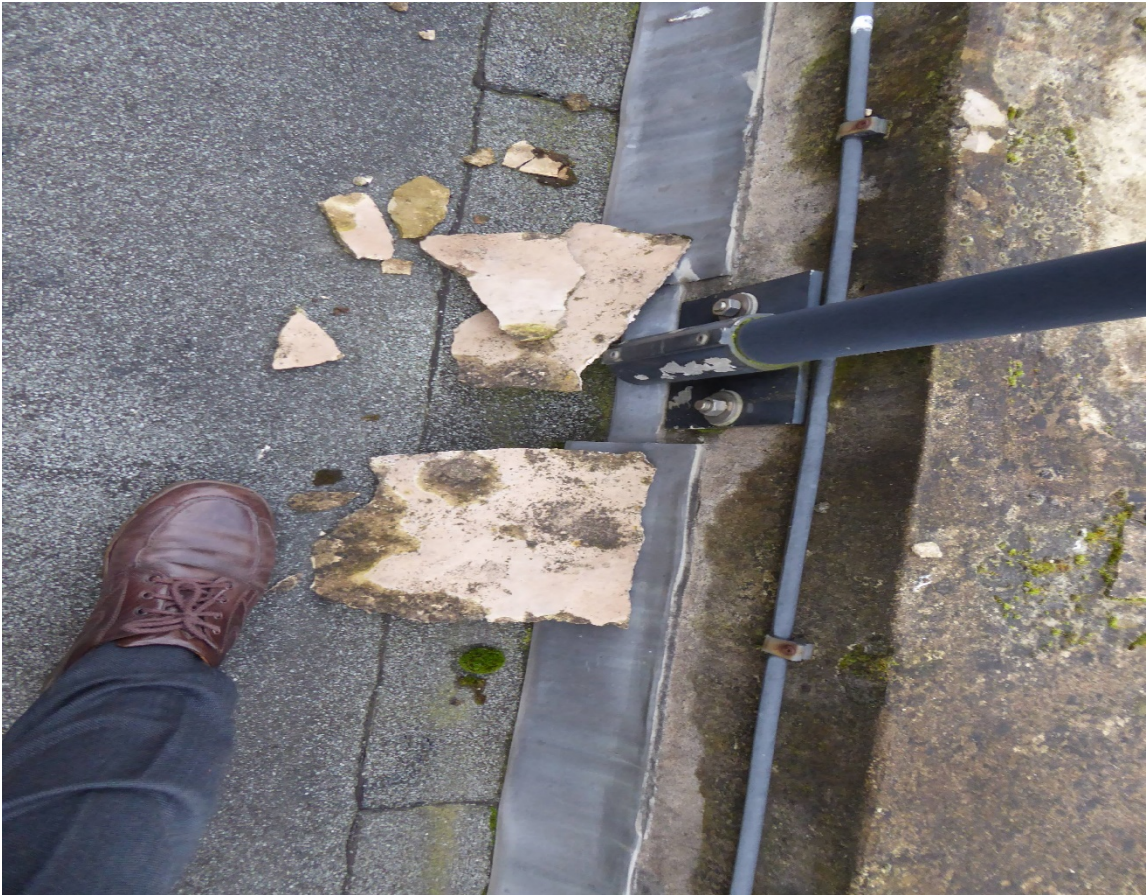
**PHOTOGRAPH SHEET – THIRTEEN**

| Description: | Close up view of the render coating which has been applied to the concrete cap as shown in the previous photograph. These sections of render were removed with little more than finger pressure. This condition is widespread. |

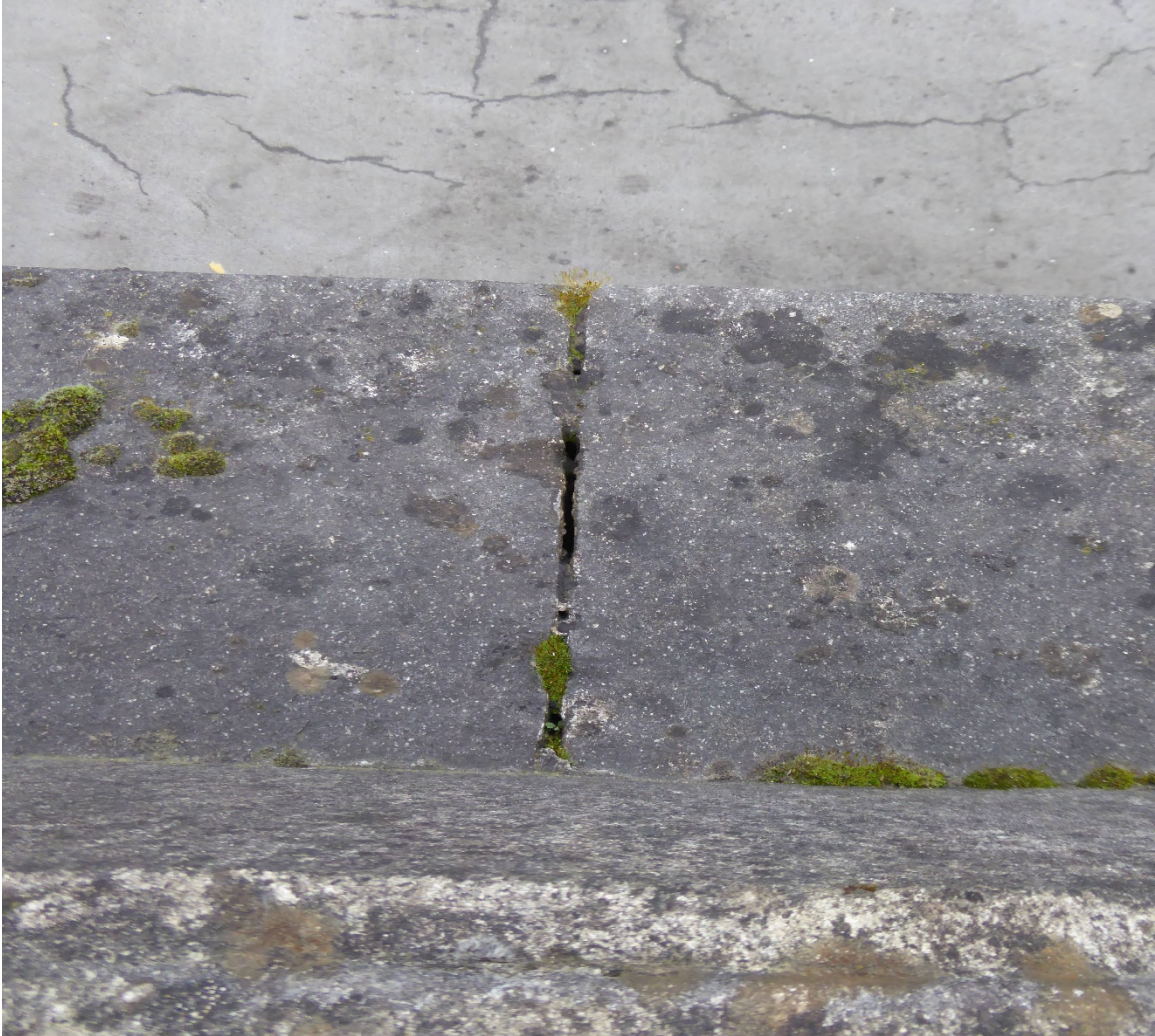
| PHOTOGRAPH SHEET – FOURTEEN | |
|---|---|
| Description: | Close up view of the top of the Portland stone cornice at joint locations. Note that the mortar pointing has completely eroded allowing easy access for rainwater and other deleterious materials to gain access to the underlying construction. This condition is typical and widespread. |

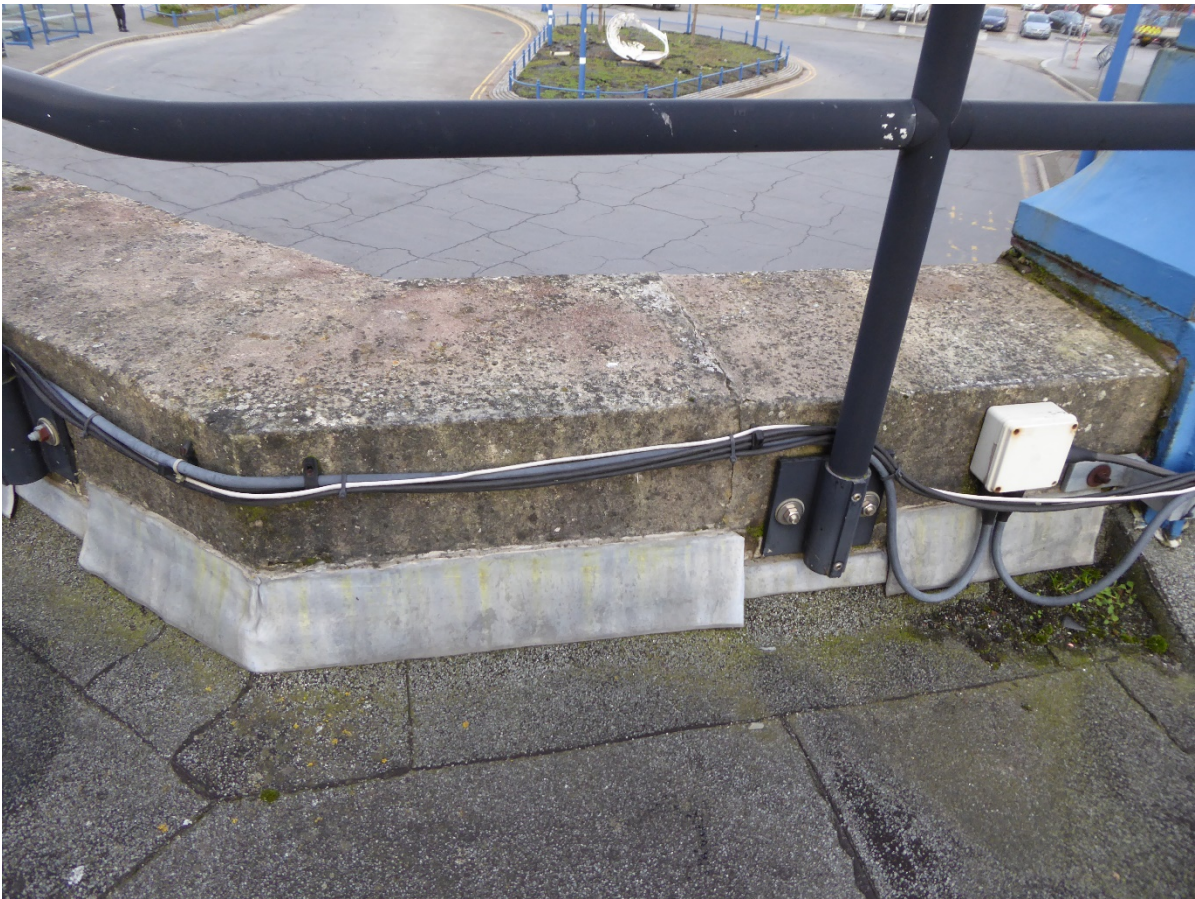
| PHOTOGRAPH SHEET – FIFTEEN | |

| PHOTOGRAPH SHEET – FIFTEEN | |
|---|---|
| Description: | Close up view of the lead flashing to the rear of the Portland stone cornice. Note this lead flashing is not continuous and terminates at handrail palm plate fixing locations. This condition is typical at all handrail fixing positions. |

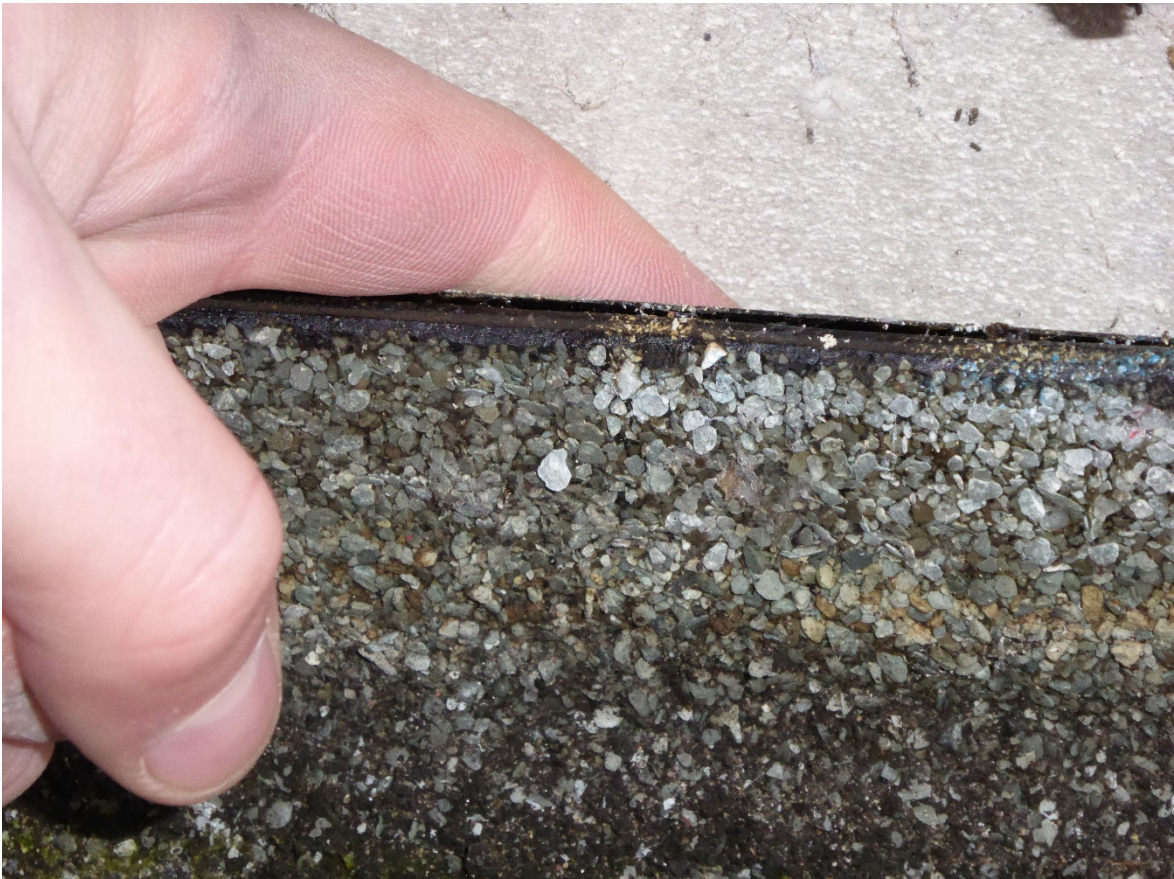
| PHOTOGRAPH SHEET – SIXTEEN | |
|---|---|
| Description: | Upon lifting the lead flashing as shown in the previous photograph we found that the felt had not been bonded/secured to the rear of the Portland stone cornice thus allowing easy access of rainwater and other deleterious materials to the underlying construction. This condition is typical at all handrail palm plate locations |
