## **Asbestos Refurbishment/Demolition Survey for**

Oxford City Council

Museum of Oxford

Development Survey Services Ltd	Project Number:	J028078/DA/TG
	Survey Date:	06 September 2016
	Printed On:	12 September 2016
	Page:	Page 1 of 1

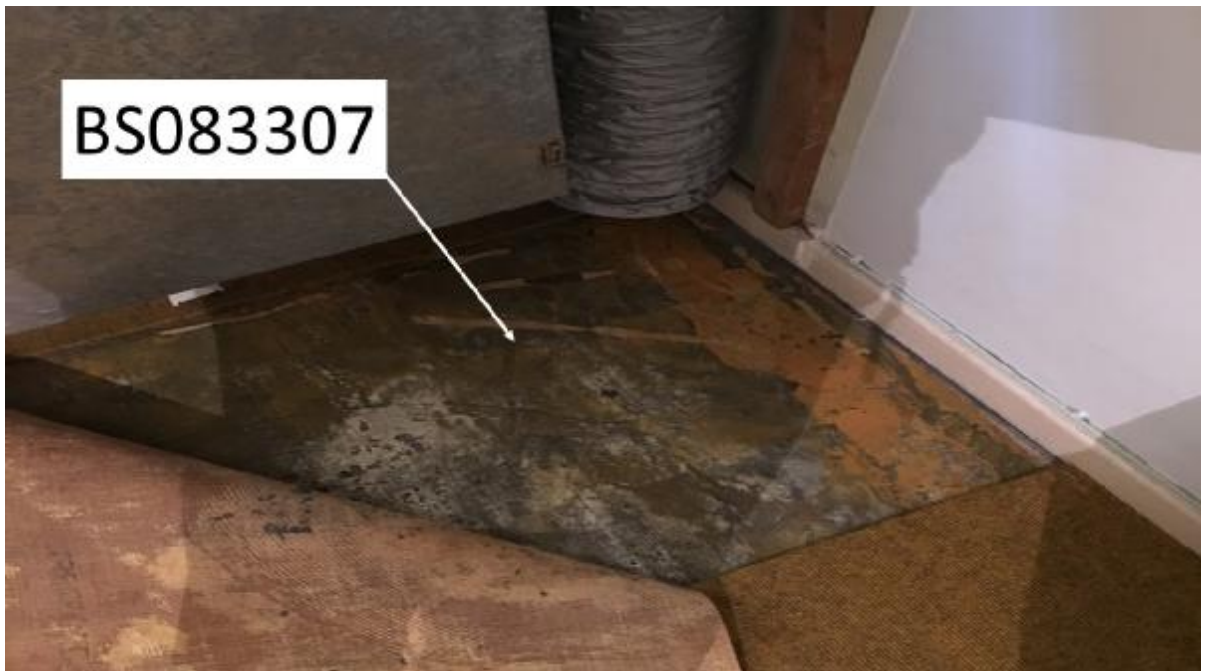
Location ID:	1151	Survey Type:	RDS
Location Ref:	BS083307	Product Type:	NADIS
Product:	Adhesive residue to floor	Damage:	NADIS
Area:	Museum	Treatment:	NADIS
Floor:	Ground floor	Asbestos Type:	NADIS
Room:	Exhibit area	Identification:	Identified
Surveyor Name:	Dominic Ayres and Terrence Glenister	Quantity:	
Drawing Ref:			
Asbestos ?	No		
Date:	12 September 2016		
Next Inspection:	Not Applicable

Material Risk Score:	0
Material Risk Band:	NADIS
Priority Risk Score:	N/A

Action: No Action Required

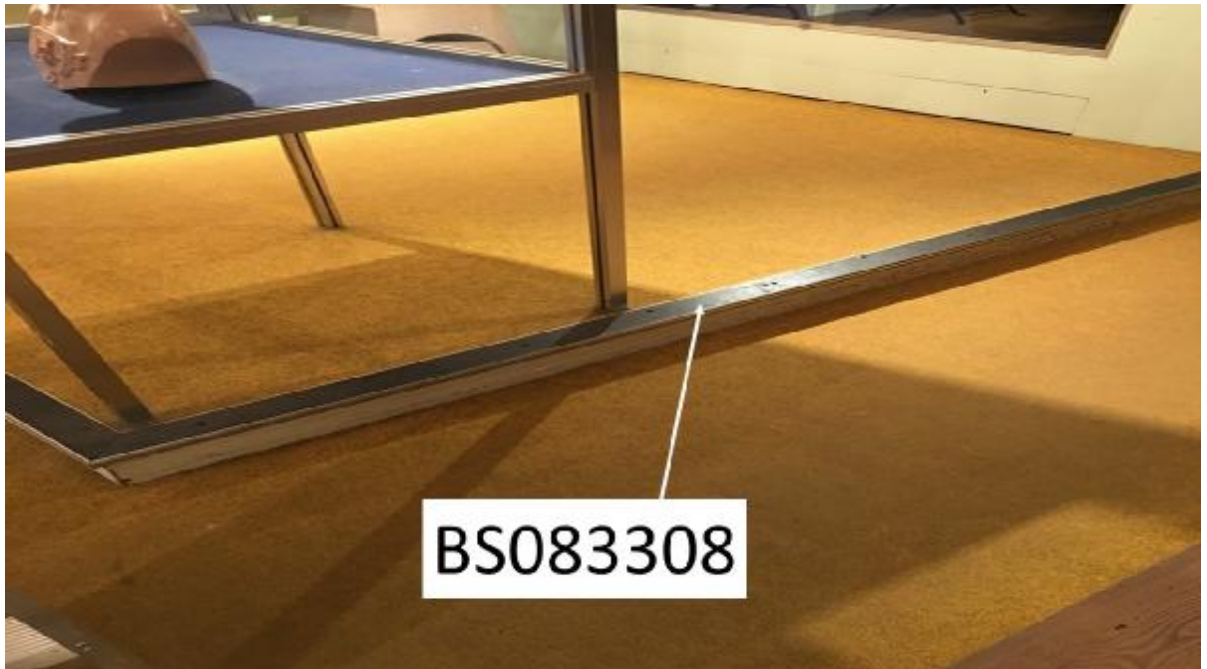
Location ID:	1153	Survey Type:	RDS
Location Ref:	BS083308	Product Type:	Plastics
Product:	Stair nosing	Damage:	Low damage
Area:	Museum	Treatment:	Resins
Floor:	Ground floor	Asbestos Type:	Chrysotile
Room:	Raised platform	Identification:	Identified
Surveyor Name:	Dominic Ayres and Terrence Glenister	Quantity:	
Drawing Ref:			
Asbestos ?	Yes		
Date:	12 September 2016		
Next Inspection:	12 September 2017

Material Risk Score:	3
Material Risk Band:	Very Low Risk
Priority Risk Score:	5

Action: No Action Required

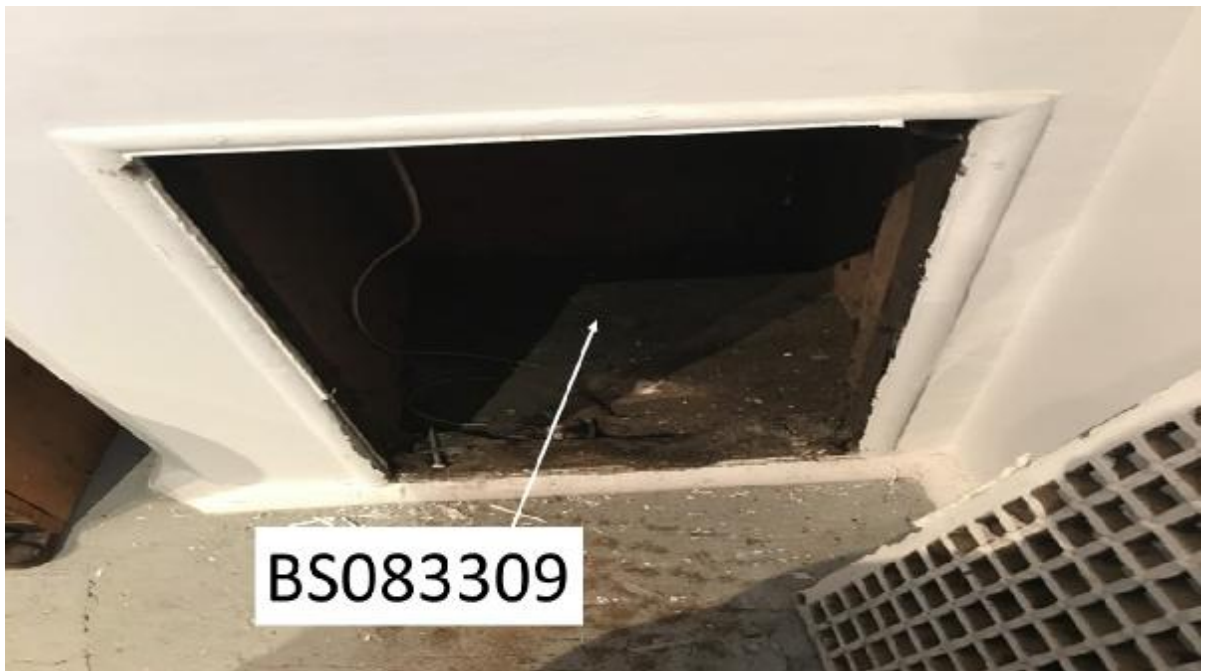
Location ID:	1154	Survey Type:	RDS
Location Ref:	BS083309	Product Type:	NADIS
Product:	Dust sample	Damage:	NADIS
Area:	Museum	Treatment:	NADIS
Floor:	Ground floor	Asbestos Type:	NADIS
Room:	Inside ducting	Identification:	Identified
Surveyor Name:	Dominic Ayres and Terrence Glenister	Quantity:	
Drawing Ref:			
Asbestos ?	No		
Date:	12 September 2016		
Next Inspection:	Not Applicable

Material Risk Score:	0
Material Risk Band:	NADIS
Priority Risk Score:	N/A

Action: No Action Required

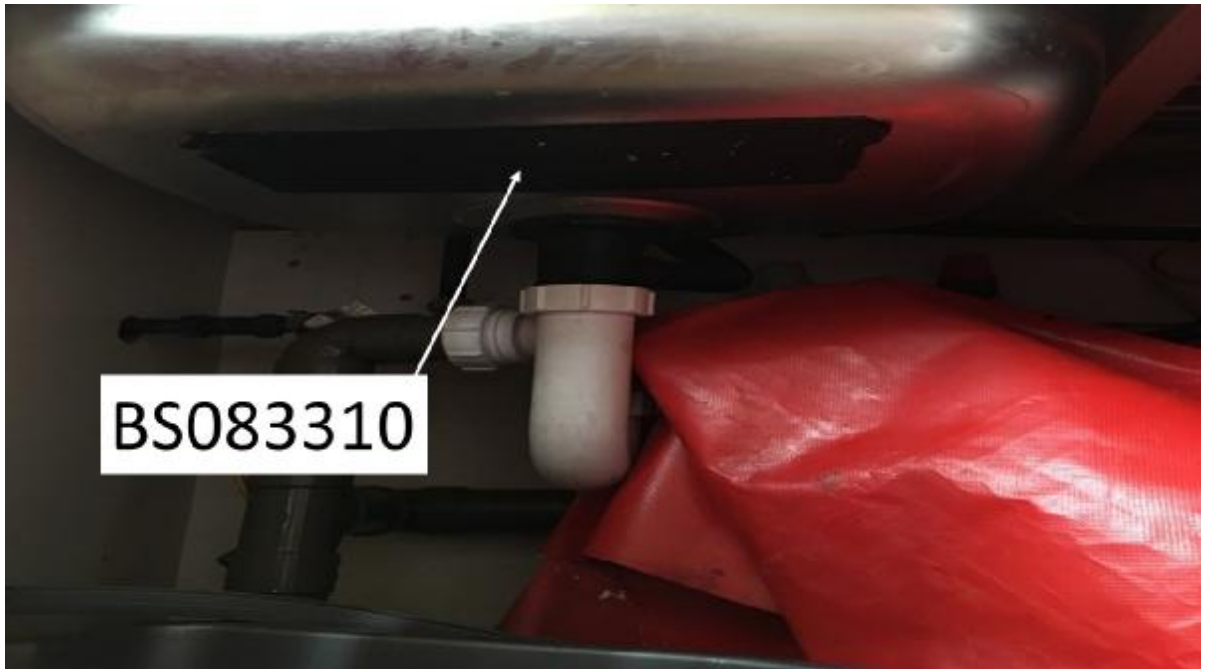
Location ID:	1155	Survey Type:	RDS
Location Ref:	BS083310	Product Type:	NADIS
Product:	Sink Pad	Damage:	NADIS
Area:	Museum	Treatment:	NADIS
Floor:	Ground floor	Asbestos Type:	NADIS
Room:	Ladies room	Identification:	Identified
Surveyor Name:	Dominic Ayres and Terrence Glenister	Quantity:	
Drawing Ref:			
Asbestos ?	No		
Date:	12 September 2016		
Next Inspection:	Not Applicable

Material Risk Score:	0
Material Risk Band:	NADIS
Priority Risk Score:	N/A

Action: No Action Required

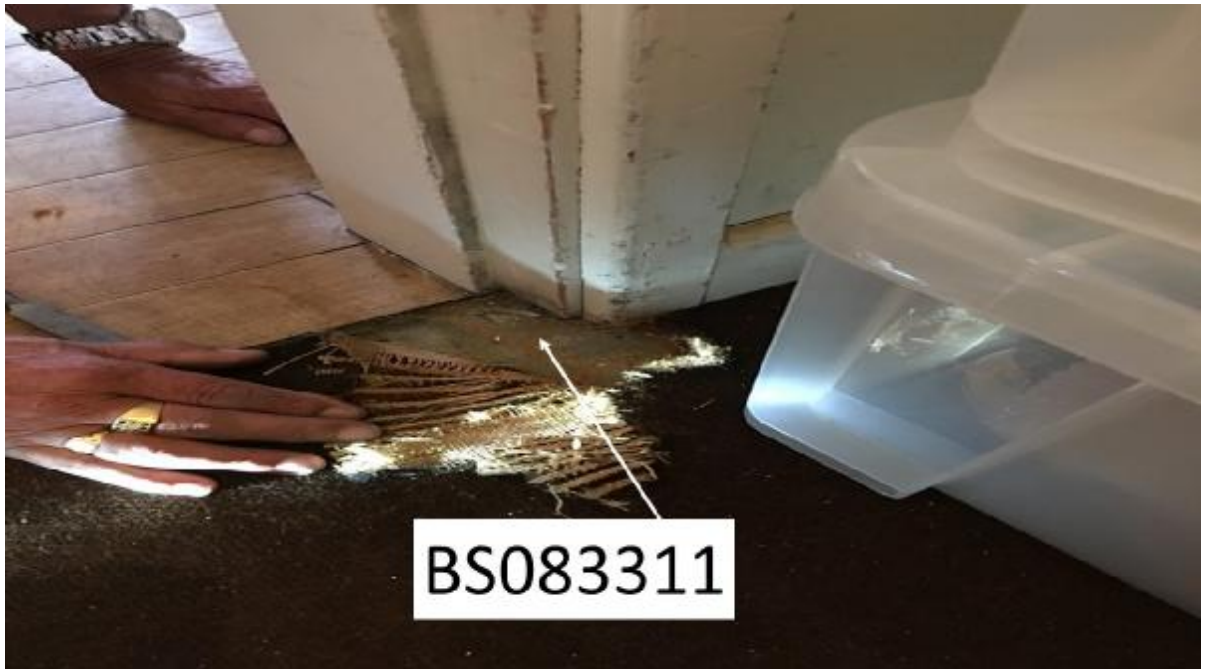
Location ID:	1156	Survey Type:	RDS
Location Ref:	BS083311	Product Type:	NADIS
Product:	Vinyl Flooring	Damage:	NADIS
Area:	Museum	Treatment:	NADIS
Floor:	Ground floor	Asbestos Type:	NADIS
Room:	Cupboard	Identification:	Identified
Surveyor Name:	Dominic Ayres and Terrence Glenister		Quantity:
Drawing Ref:			
Asbestos ?	No		
Date:	12 September 2016		
Next Inspection:	Not Applicable

No Action Required

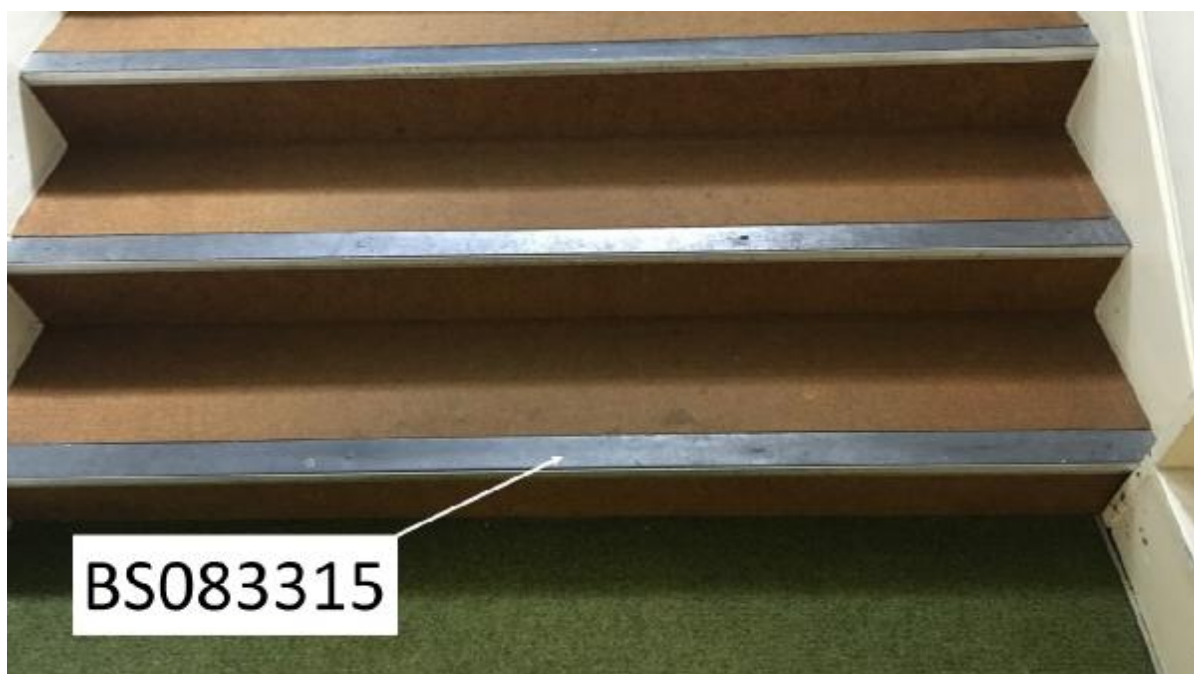
Location ID:	1160	Survey Type:	RDS
Location Ref:	BS083315	Product Type:	NADIS
Product:	Stair nosing	Damage:	NADIS
Area:	Museum	Treatment:	NADIS
Floor:	Basement	Asbestos Type:	NADIS
Room:	Staircase	Identification:	Identified
Surveyor Name:	Dominic Ayres and Terrence Glenister	Quantity:	
Drawing Ref:			
Asbestos ?	No		
Date:	12 September 2016		
Next Inspection:	Not Applicable

Material Risk Score:	0
Material Risk Band:	NADIS
Priority Risk Score:	N/A

Action: No Action Required

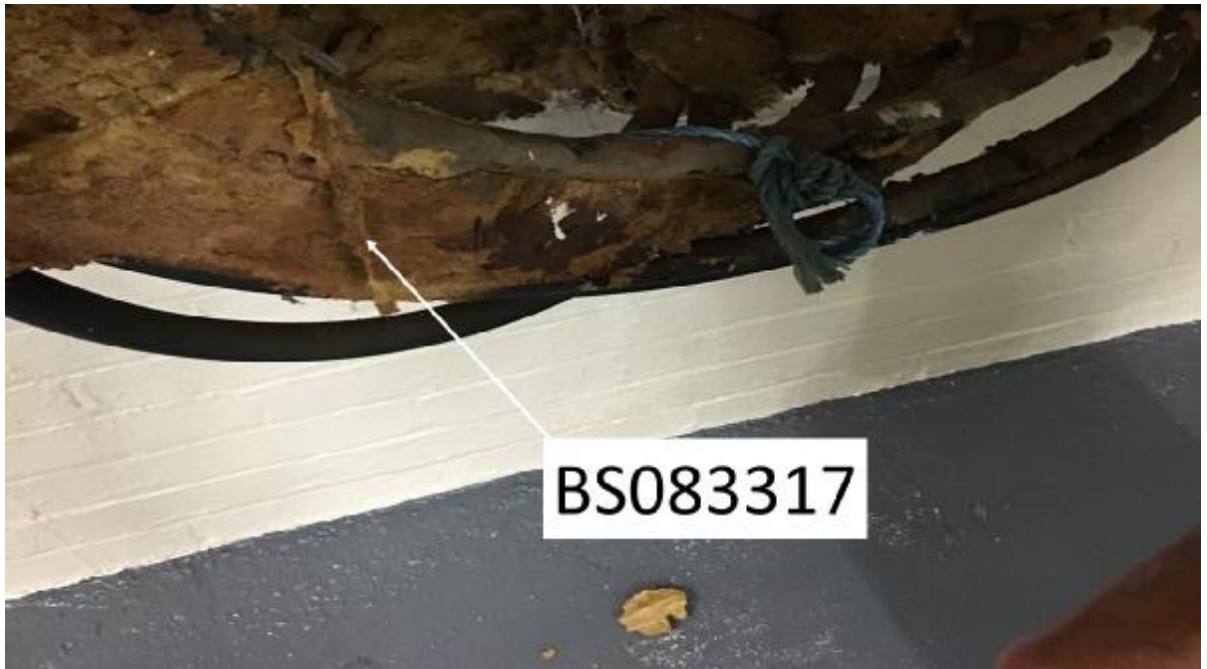
Location ID:	1162	Survey Type:	RDS
Location Ref:	BS083317	Product Type:	NADIS
Product:	String to cables	Damage:	NADIS
Area:	Museum	Treatment:	NADIS
Floor:	Basement	Asbestos Type:	NADIS
Room:	Pump room	Identification:	Identified
Surveyor Name:	Dominic Ayres and Terrence Glenister	Quantity:	
Drawing Ref:			
Asbestos ?	No		
Date:	12 September 2016		
Next Inspection:	Not Applicable

Material Risk Score:	0
Material Risk Band:	NADIS
Priority Risk Score:	N/A

Action: No Action Required

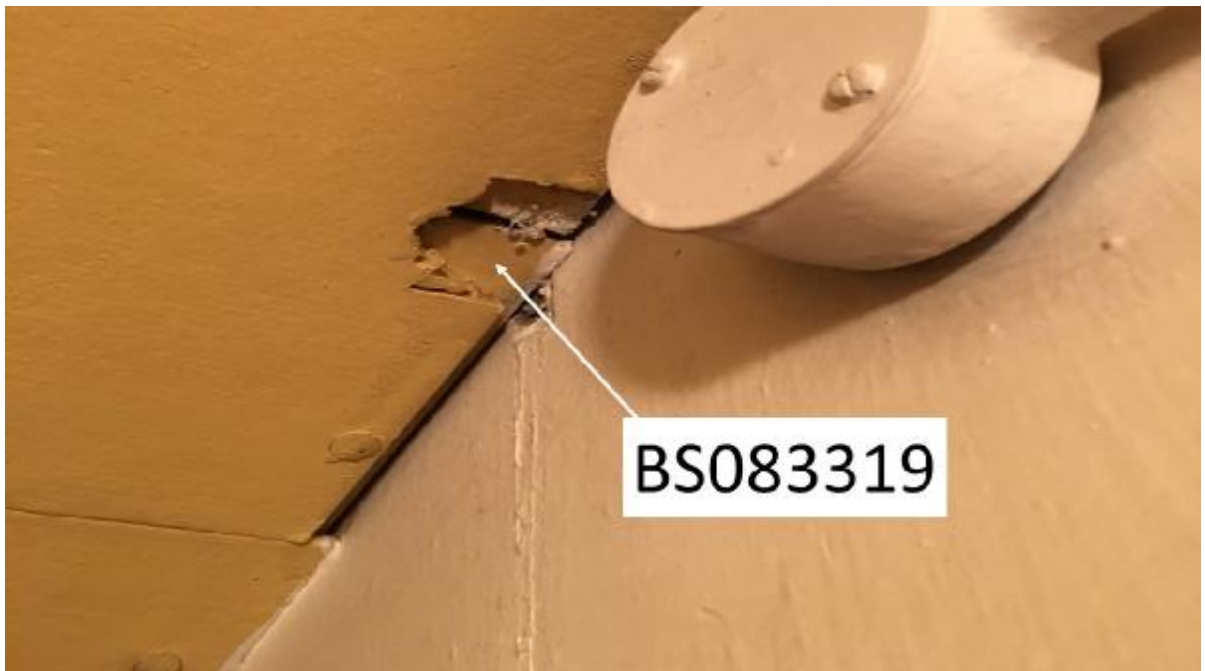
Location ID:	1164	Survey Type:	RDS
Location Ref:	BS083319	Product Type:	Asbestos cement
Product:	Cement Soffit	Damage:	Low damage
Area:	Museum	Treatment:	Asbestos cement sheets etc
Floor:	Basement	Asbestos Type:	Chrysotile
Room:	Stairwell	Identification:	Identified
Surveyor Name:	Dominic Ayres and Terrence Glenister	Quantity:	
Drawing Ref:			
Asbestos ?	Yes		
Date:	12 September 2016		
Next Inspection:	12 September 2017

Material Risk Score:	4
Material Risk Band:	Very Low Risk
Priority Risk Score:	2

Action: Removal

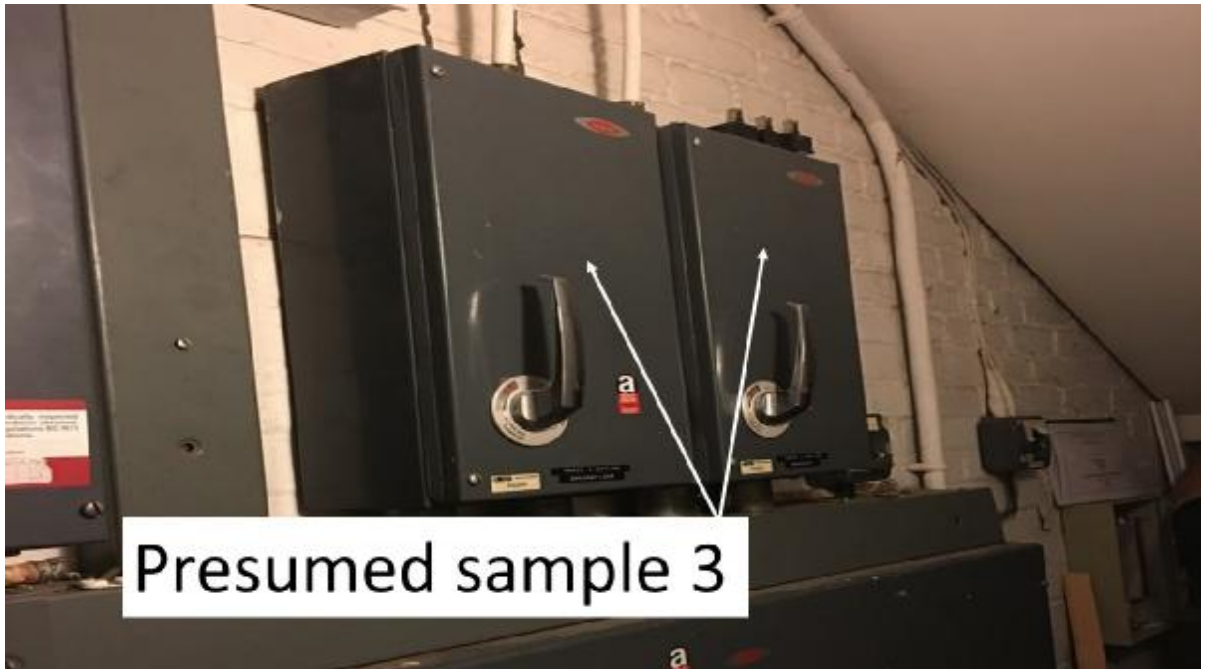
Location ID:	1167	Survey Type:	RDS
Location Ref:	Presumed sample 3	Product Type:	Asbestos Insulating Board
Product:	Flash guards to switchgear	Damage:	No visible damage
Area:	Museum	Treatment:	Unsealed AIB
Floor:	Basement	Asbestos Type:	Chrysotile
Room:	Electrical cupboard	Identification:	Presumed
Surveyor Name:	Dominic Ayres and Terrence Glenister	Quantity:	
Drawing Ref:			
Asbestos ?	Yes		
Date:	12 September 2016		
Next Inspection:	14 March 2017

Priority Risk Score: 2

Action: To be included in management plan

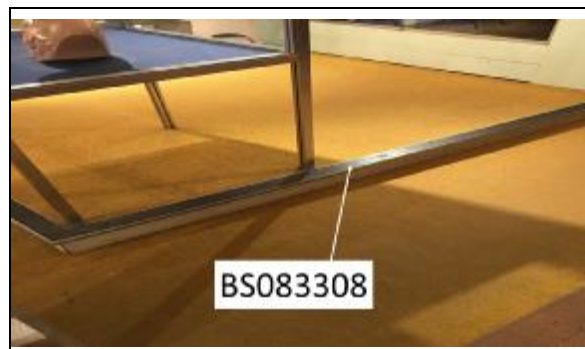
Location ID:	1153
Location Ref:	BS083308
Product:	Stair nosing
Area:	Museum
Floor:	Ground floor
Room:	Raised platform
Surveyor Name:	Dominic Ayres and Terrence Glenister
Drawing Ref:	
Asbestos ?	Yes
Date:	12 September 2016

Priority Assessment Algorithm			
Assessment factor	Variable(s) selected	Score for each variable	Overall score
<b>Normal Occupant Activity:</b>			
Main type of activity in area:	Low disturbance	1	average
Secondary activities for area:	Low disturbance	1	1
<b>Likelihood Of Disturbance:</b>			
Location:	Rooms up to 100 m2	2	average 1
Accessibility:	Occasionally likely to be disturbed	1	
Extent/Amount:	<=10 m² or <=10 m pipe run	1	
<b>Human Exposure Potential:</b>			
Number of occupants:	>10	3	average 3
Frequency of use of area:	Daily	3	
Average time area is in use:	>6 hours	3	
<b>Maintenance Activity:</b>			
Type of maintenance activity:	Minor disturbance	0	average
Frequency of maintenance activity:	Unlikely to be disturbed	0	0

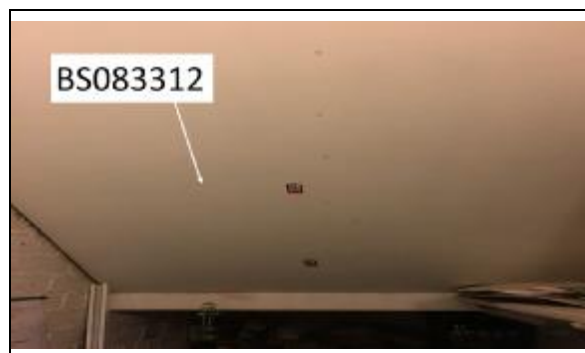
Location ID:	1157
Location Ref:	BS083312
Product:	Cement Soffit
Area:	Museum
Floor:	Basement
Room:	Electrical cupboard
Surveyor Name:	Dominic Ayres and Terrence Glenister
Drawing Ref:	
Asbestos ?	Yes
Date:	12 September 2016

Priority Assessment Algorithm			
Assessment factor	Variable(s) selected	Score for each variable	Overall score
<b>Normal Occupant Activity:</b>			
Main type of activity in area:	Rare disturbance	0	average
Secondary activities for area:	Rare disturbance	0	0
<b>Likelihood Of Disturbance:</b>			
Location:	Rooms up to 100 m2	2	average 1
Accessibility:	Usually inaccessible or unlikely to be disturbed	0	
Extent/Amount:	<=10 m² or <=10 m pipe run	1	
<b>Human Exposure Potential:</b>			
Number of occupants:	1 to 3	1	average 1
Frequency of use of area:	Weekly	2	
Average time area is in use:	>1 to <3 hours	1	
<b>Maintenance Activity:</b>			
Type of maintenance activity:	Minor disturbance	0	average
Frequency of maintenance activity:	Unlikely to be disturbed	0	0

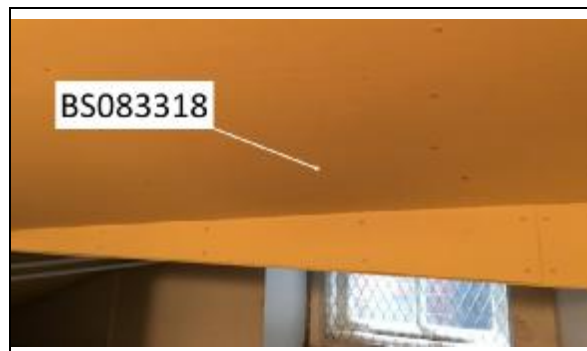
Location ID:	1163
Location Ref:	BS083318
Product:	Cement Soffit
Area:	Museum
Floor:	Basement
Room:	Stairwell
Surveyor Name:	Dominic Ayres and Terrence Glenister
Drawing Ref:	
Asbestos ?	Yes
Date:	12 September 2016

Priority Assessment Algorithm			
Assessment factor	Variable(s) selected	Score for each variable	Overall score
<b>Normal Occupant Activity:</b>			
Main type of activity in area:	Rare disturbance	0	average
Secondary activities for area:	Rare disturbance	0	0
<b>Likelihood Of Disturbance:</b>			
Location:	Rooms up to 100 m2	2	average 1
Accessibility:	Usually inaccessible or unlikely to be disturbed	0	
Extent/Amount:	<=10 m <sup>2</sup> or <=10 m pipe run	1	
<b>Human Exposure Potential:</b>			
Number of occupants:	1 to 3	1	average 1
Frequency of use of area:	Weekly	2	
Average time area is in use:	<1 hour	0	
<b>Maintenance Activity:</b>			
Type of maintenance activity:	Minor disturbance	0	average
Frequency of maintenance activity:	Unlikely to be disturbed	0	0

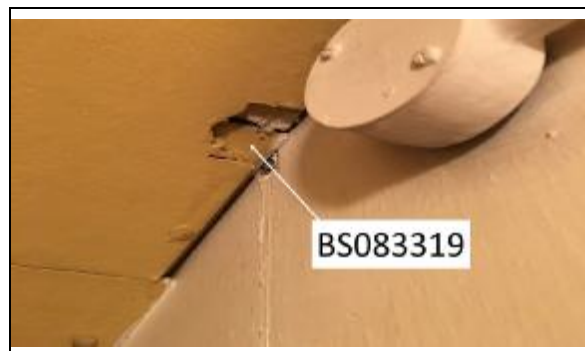
Location ID:	1164
Location Ref:	BS083319
Product:	Cement Soffit
Area:	Museum
Floor:	Basement
Room:	Stairwell
Surveyor Name:	Dominic Ayres and Terrence Glenister
Drawing Ref:	
Asbestos ?	Yes
Date:	12 September 2016

Priority Assessment Algorithm			
Assessment factor	Variable(s) selected	Score for each variable	Overall score
<b>Normal Occupant Activity:</b>			
Main type of activity in area:	Rare disturbance	0	average
Secondary activities for area:	Rare disturbance	0	0
<b>Likelihood Of Disturbance:</b>			
Location:	Rooms up to 100 m2	2	average 1
Accessibility:	Usually inaccessible or unlikely to be disturbed	0	
Extent/Amount:	<=10 m <sup>2</sup> or <=10 m pipe run	1	
<b>Human Exposure Potential:</b>			
Number of occupants:	1 to 3	1	average 1
Frequency of use of area:	Weekly	2	
Average time area is in use:	<1 hour	0	
<b>Maintenance Activity:</b>			
Type of maintenance activity:	Minor disturbance	0	average
Frequency of maintenance activity:	Unlikely to be disturbed	0	0

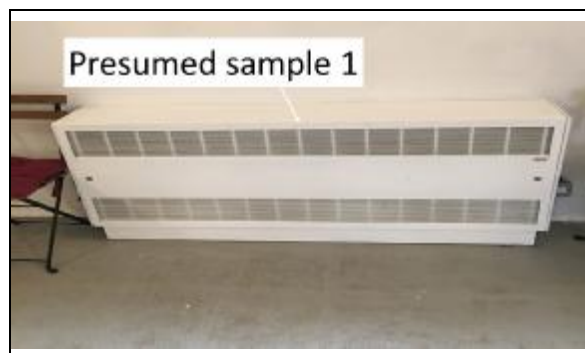
Location ID:	1165
Location Ref:	Presumed sample 1
Product:	Storage heater
Area:	Museum
Floor:	Ground floor
Room:	Steamer room
Surveyor Name:	Dominic Ayres and Terrence Glenister
Drawing Ref:	
Asbestos ?	Yes
Date:	12 September 2016

Priority Assessment Algorithm			
Assessment factor	Variable(s) selected	Score for each variable	Overall score
<b>Normal Occupant Activity:</b>			
Main type of activity in area:	Low disturbance	1	average
Secondary activities for area:	Low disturbance	1	1
<b>Likelihood Of Disturbance:</b>			
Location:	Rooms up to 100 m2	2	
Accessibility:	Usually inaccessible or unlikely to be disturbed	0	average
Extent/Amount:	Small items strings gaskets	0	1
<b>Human Exposure Potential:</b>			
Number of occupants:	>10	3	
Frequency of use of area:	Daily	3	average
Average time area is in use:	>6 hours	3	3
<b>Maintenance Activity:</b>			
Type of maintenance activity:	Minor disturbance	0	average
Frequency of maintenance activity:	Unlikely to be disturbed	0	0

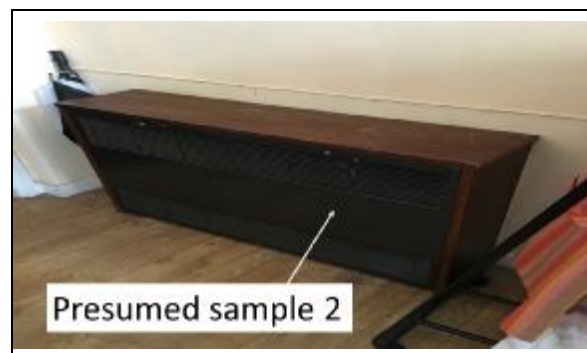
Location ID:	1166
Location Ref:	Presumed sample 2
Product:	Storage heater
Area:	Museum
Floor:	Basement
Room:	Ladies room
Surveyor Name:	Dominic Ayres and Terrence Glenister
Drawing Ref:	
Asbestos ?	Yes
Date:	12 September 2016

Priority Assessment Algorithm			
Assessment factor	Variable(s) selected	Score for each variable	Overall score
<b>Normal Occupant Activity:</b>			
Main type of activity in area:	Rare disturbance	0	average
Secondary activities for area:	Rare disturbance	0	0
<b>Likelihood Of Disturbance:</b>			
Location:	Rooms up to 100 m2	2	average 1
Accessibility:	Usually inaccessible or unlikely to be disturbed	0	
Extent/Amount:	Small items strings gaskets	0	
<b>Human Exposure Potential:</b>			
Number of occupants:	4 to 10	2	average 2
Frequency of use of area:	Daily	3	
Average time area is in use:	>3 to <6 hours	2	
<b>Maintenance Activity:</b>			
Type of maintenance activity:	Minor disturbance	0	average
Frequency of maintenance activity:	Unlikely to be disturbed	0	0

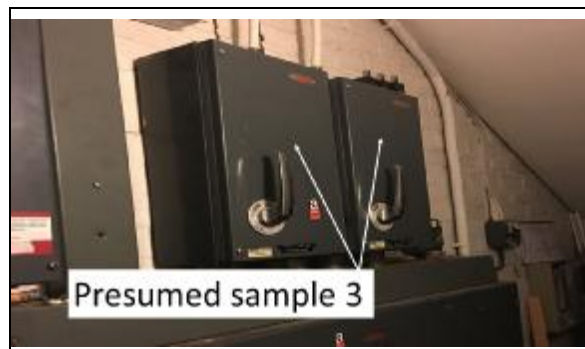
Location ID:	1167
Location Ref:	Presumed sample 3
Product:	Flash guards to switchgear
Area:	Museum
Floor:	Basement
Room:	Electrical cupboard
Surveyor Name:	Dominic Ayres and Terrence Glenister
Drawing Ref:	
Asbestos ?	Yes
Date:	12 September 2016

Priority Assessment Algorithm			
Assessment factor	Variable(s) selected	Score for each variable	Overall score
<b>Normal Occupant Activity:</b>			
Main type of activity in area:	Rare disturbance	0	average
Secondary activities for area:	Rare disturbance	0	0
<b>Likelihood Of Disturbance:</b>			
Location:	Rooms up to 100 m2	2	average 1
Accessibility:	Usually inaccessible or unlikely to be disturbed	0	
Extent/Amount:	Small items strings gaskets	0	
<b>Human Exposure Potential:</b>			
Number of occupants:	1 to 3	1	average 1
Frequency of use of area:	Weekly	2	
Average time area is in use:	>1 to <3 hours	1	
<b>Maintenance Activity:</b>			
Type of maintenance activity:	Minor disturbance	0	average
Frequency of maintenance activity:	Unlikely to be disturbed	0	0
