# Refurbishment & Management Asbestos Survey Report

Bournemouth Christchurch Poole Council

Old Town Hall  
30 High Street  
Christchurch  
BH23 1AJ

The Testing Lab Job Number J111736

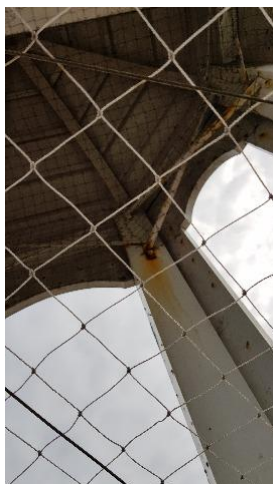
<b><u>CLIENT</u></b>	Bournemouth Christchurch Poole Council	<b><u>SITE</u></b>	Bournemouth Christchurch Poole Council  Old Town Hall 30 High Street  Christchurch BH23 1AJ
<b><u>MATERIAL ASSESSMENT REF</u></b>	S001	<b><u>SURVEY TYPE</u></b>	Refurbishment
<b><u>DATE TAKEN</u></b>	24/05/2019	<b><u>ASBESTOS TYPE</u></b>	Non suspect material
<b><u>BUILDING</u></b>	Main	<b><u>SURFACE TREATMENT</u></b>	Not Selected
<b><u>FLOOR</u></b>	External	<b><u>CONDITION</u></b>	Not Selected
<b><u>ROOM</u></b>	Roof	<b><u>PRODUCT TYPE</u></b>	Not Selected
<b><u>POSITION</u></b>	Roof	<b><u>MATERIAL RISK</u></b>	0 (VL)
<b><u>COMPONENT</u></b>	Roof	<b><u>PRIORITY RISK</u></b>	N/A
<b><u>ACCESSIBILITY</u></b>	N/A	<b><u>QUANTITY</u></b>	Num
<b><u>SURVEYOR</u></b>	Tim Godleman & Dale Brindley	<b><u>ACTION</u></b>	No further action required
<b><u>LAB</u></b>	In-House Database	<b><u>NEXT INSPECTION</u></b>	No further action required

No further action required

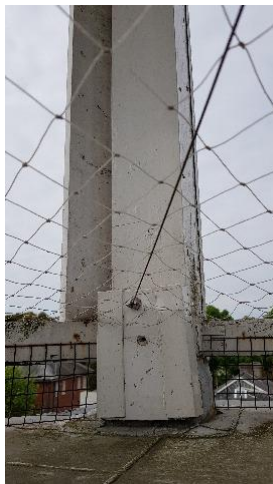
<b><u>CLIENT</u></b>	Bournemouth Christchurch Poole Council	<b><u>SITE</u></b>	Bournemouth Christchurch Poole Council  Old Town Hall 30 High Street  Christchurch BH23 1AJ
<b><u>MATERIAL ASSESSMENT REF</u></b>	S002	<b><u>SURVEY TYPE</u></b>	Refurbishment
<b><u>DATE TAKEN</u></b>	24/05/2019	<b><u>ASBESTOS TYPE</u></b>	Non suspect material
<b><u>BUILDING</u></b>	Main	<b><u>SURFACE TREATMENT</u></b>	Not Selected
<b><u>FLOOR</u></b>	External	<b><u>CONDITION</u></b>	Not Selected
<b><u>ROOM</u></b>	Roof	<b><u>PRODUCT TYPE</u></b>	Not Selected
<b><u>POSITION</u></b>	Roof	<b><u>MATERIAL RISK</u></b>	0 (VL)
<b><u>COMPONENT</u></b>	Roof	<b><u>PRIORITY RISK</u></b>	N/A
<b><u>ACCESSIBILITY</u></b>	N/A	<b><u>QUANTITY</u></b>	Num
<b><u>SURVEYOR</u></b>	Tim Godleman & Dale Brindley	<b><u>ACTION</u></b>	No further action required
<b><u>LAB</u></b>	In-House Database	<b><u>NEXT INSPECTION</u></b>	No further action required

No further action required

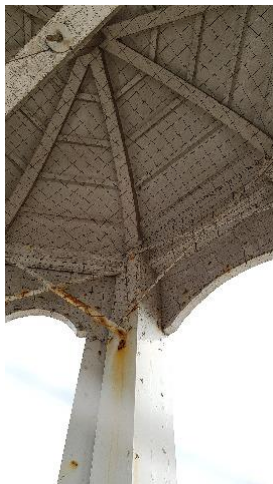
<b><u>CLIENT</u></b>	Bournemouth Christchurch Poole Council	<b><u>SITE</u></b>	Bournemouth Christchurch Poole Council  Old Town Hall 30 High Street  Christchurch BH23 1AJ
<b><u>MATERIAL ASSESSMENT REF</u></b>	S003	<b><u>SURVEY TYPE</u></b>	Refurbishment
<b><u>DATE TAKEN</u></b>	24/05/2019	<b><u>ASBESTOS TYPE</u></b>	Non suspect material
<b><u>BUILDING</u></b>	Main	<b><u>SURFACE TREATMENT</u></b>	Not Selected
<b><u>FLOOR</u></b>	External	<b><u>CONDITION</u></b>	Not Selected
<b><u>ROOM</u></b>	Roof	<b><u>PRODUCT TYPE</u></b>	Not Selected
<b><u>POSITION</u></b>	Roof	<b><u>MATERIAL RISK</u></b>	0 (VL)
<b><u>COMPONENT</u></b>	Roof	<b><u>PRIORITY RISK</u></b>	N/A
<b><u>ACCESSIBILITY</u></b>	N/A	<b><u>QUANTITY</u></b>	Num
<b><u>SURVEYOR</u></b>	Tim Godleman & Dale Brindley	<b><u>ACTION</u></b>	No further action required
<b><u>LAB</u></b>	In-House Database	<b><u>NEXT INSPECTION</u></b>	No further action required

No further action required

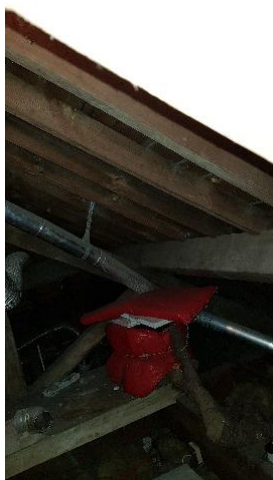
<b><u>CLIENT</u></b>	Bournemouth Christchurch Poole Council	<b><u>SITE</u></b>	Bournemouth Christchurch Poole Council  Old Town Hall 30 High Street  Christchurch BH23 1AJ
<b><u>MATERIAL ASSESSMENT REF</u></b>	S004	<b><u>SURVEY TYPE</u></b>	Refurbishment
<b><u>DATE TAKEN</u></b>	24/05/2019	<b><u>ASBESTOS TYPE</u></b>	Non suspect material
<b><u>BUILDING</u></b>	Main	<b><u>SURFACE TREATMENT</u></b>	Not Selected
<b><u>FLOOR</u></b>	First	<b><u>CONDITION</u></b>	Not Selected
<b><u>ROOM</u></b>	Loft	<b><u>PRODUCT TYPE</u></b>	Not Selected
<b><u>POSITION</u></b>	Roof	<b><u>MATERIAL RISK</u></b>	0 (VL)
<b><u>COMPONENT</u></b>	Roof	<b><u>PRIORITY RISK</u></b>	N/A
<b><u>ACCESSIBILITY</u></b>	N/A	<b><u>QUANTITY</u></b>	Num
<b><u>SURVEYOR</u></b>	Tim Godleman & Dale Brindley	<b><u>ACTION</u></b>	No further action required
<b><u>LAB</u></b>	In-House Database	<b><u>NEXT INSPECTION</u></b>	No further action required

No further action required

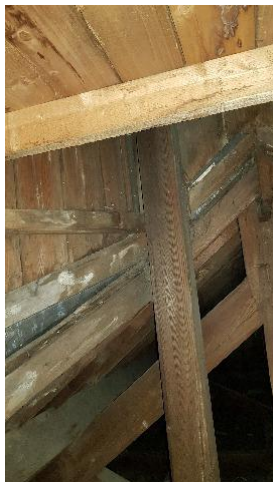
<b><u>CLIENT</u></b>	Bournemouth Christchurch Poole Council	<b><u>SITE</u></b>	Bournemouth Christchurch Poole Council  Old Town Hall 30 High Street  Christchurch BH23 1AJ
<b><u>MATERIAL ASSESSMENT REF</u></b>	S005	<b><u>SURVEY TYPE</u></b>	Refurbishment
<b><u>DATE TAKEN</u></b>	24/05/2019	<b><u>ASBESTOS TYPE</u></b>	Non suspect material
<b><u>BUILDING</u></b>	Main	<b><u>SURFACE TREATMENT</u></b>	Not Selected
<b><u>FLOOR</u></b>	First	<b><u>CONDITION</u></b>	Not Selected
<b><u>ROOM</u></b>	Loft	<b><u>PRODUCT TYPE</u></b>	Not Selected
<b><u>POSITION</u></b>	Roof	<b><u>MATERIAL RISK</u></b>	0 (VL)
<b><u>COMPONENT</u></b>	Roof	<b><u>PRIORITY RISK</u></b>	N/A
<b><u>ACCESSIBILITY</u></b>	N/A	<b><u>QUANTITY</u></b>	Num
<b><u>SURVEYOR</u></b>	Tim Godleman & Dale Brindley	<b><u>ACTION</u></b>	No further action required
<b><u>LAB</u></b>	In-House Database	<b><u>NEXT INSPECTION</u></b>	No further action required

No further action required

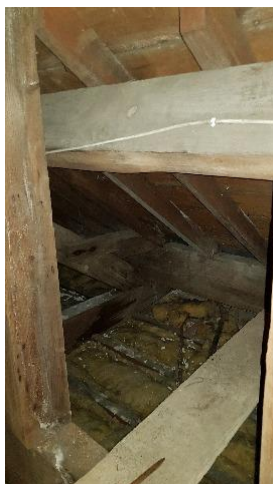
<b><u>CLIENT</u></b>	Bournemouth Christchurch Poole Council	<b><u>SITE</u></b>	Bournemouth Christchurch Poole Council  Old Town Hall 30 High Street  Christchurch BH23 1AJ
<b><u>MATERIAL ASSESSMENT REF</u></b>	S006	<b><u>SURVEY TYPE</u></b>	Refurbishment
<b><u>DATE TAKEN</u></b>	24/05/2019	<b><u>ASBESTOS TYPE</u></b>	Non suspect material
<b><u>BUILDING</u></b>	Main	<b><u>SURFACE TREATMENT</u></b>	Not Selected
<b><u>FLOOR</u></b>	First	<b><u>CONDITION</u></b>	Not Selected
<b><u>ROOM</u></b>	Loft	<b><u>PRODUCT TYPE</u></b>	Not Selected
<b><u>POSITION</u></b>	Beams & Columns	<b><u>MATERIAL RISK</u></b>	0 (VL)
<b><u>COMPONENT</u></b>	Beams & Columns	<b><u>PRIORITY RISK</u></b>	N/A
<b><u>ACCESSIBILITY</u></b>	N/A	<b><u>QUANTITY</u></b>	Num
<b><u>SURVEYOR</u></b>	Tim Godleman & Dale Brindley	<b><u>ACTION</u></b>	No further action required
<b><u>LAB</u></b>	In-House Database	<b><u>NEXT INSPECTION</u></b>	No further action required

No further action required

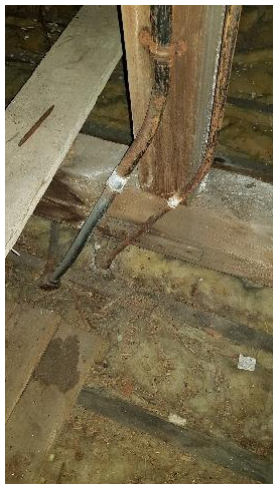
<b><u>CLIENT</u></b>	Bournemouth Christchurch Poole Council	<b><u>SITE</u></b>	Bournemouth Christchurch Poole Council  Old Town Hall 30 High Street  Christchurch BH23 1AJ
<b><u>MATERIAL ASSESSMENT REF</u></b>	S007	<b><u>SURVEY TYPE</u></b>	Refurbishment
<b><u>DATE TAKEN</u></b>	24/05/2019	<b><u>ASBESTOS TYPE</u></b>	Non suspect material
<b><u>BUILDING</u></b>	Main	<b><u>SURFACE TREATMENT</u></b>	Not Selected
<b><u>FLOOR</u></b>	First	<b><u>CONDITION</u></b>	Not Selected
<b><u>ROOM</u></b>	Loft	<b><u>PRODUCT TYPE</u></b>	Not Selected
<b><u>POSITION</u></b>	Floor	<b><u>MATERIAL RISK</u></b>	0 (VL)
<b><u>COMPONENT</u></b>	Floor	<b><u>PRIORITY RISK</u></b>	N/A
<b><u>ACCESSIBILITY</u></b>	N/A	<b><u>QUANTITY</u></b>	Num
<b><u>SURVEYOR</u></b>	Tim Godleman & Dale Brindley	<b><u>ACTION</u></b>	No further action required
<b><u>LAB</u></b>	In-House Database	<b><u>NEXT INSPECTION</u></b>	No further action required

No further action required

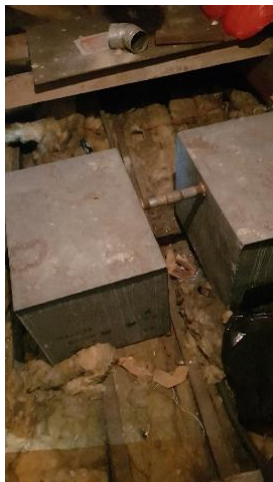
<b><u>CLIENT</u></b>	Bournemouth Christchurch Poole Council	<b><u>SITE</u></b>	Bournemouth Christchurch Poole Council  Old Town Hall 30 High Street  Christchurch BH23 1AJ
<b><u>MATERIAL ASSESSMENT REF</u></b>	S008	<b><u>SURVEY TYPE</u></b>	Refurbishment
<b><u>DATE TAKEN</u></b>	24/05/2019	<b><u>ASBESTOS TYPE</u></b>	Non suspect material
<b><u>BUILDING</u></b>	Main	<b><u>SURFACE TREATMENT</u></b>	Not Selected
<b><u>FLOOR</u></b>	First	<b><u>CONDITION</u></b>	Not Selected
<b><u>ROOM</u></b>	Loft	<b><u>PRODUCT TYPE</u></b>	Not Selected
<b><u>POSITION</u></b>	Water Tank	<b><u>MATERIAL RISK</u></b>	0 (VL)
<b><u>COMPONENT</u></b>	Water Tank	<b><u>PRIORITY RISK</u></b>	N/A
<b><u>ACCESSIBILITY</u></b>	N/A	<b><u>QUANTITY</u></b>	Num
<b><u>SURVEYOR</u></b>	Tim Godleman & Dale Brindley	<b><u>ACTION</u></b>	No further action required
<b><u>LAB</u></b>	In-House Database	<b><u>NEXT INSPECTION</u></b>	No further action required

No further action required

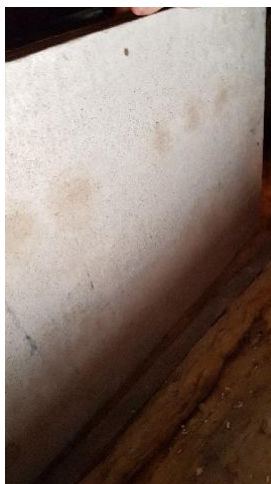
<b><u>CLIENT</u></b>	Bournemouth Christchurch Poole Council	<b><u>SITE</u></b>	Bournemouth Christchurch Poole Council  Old Town Hall 30 High Street  Christchurch BH23 1AJ
<b><u>MATERIAL ASSESSMENT REF</u></b>	S009	<b><u>SURVEY TYPE</u></b>	Refurbishment
<b><u>DATE TAKEN</u></b>	24/05/2019	<b><u>ASBESTOS TYPE</u></b>	NADIS
<b><u>BUILDING</u></b>	Main	<b><u>SURFACE TREATMENT</u></b>	Not Selected
<b><u>FLOOR</u></b>	First	<b><u>CONDITION</u></b>	Not Selected
<b><u>ROOM</u></b>	Loft	<b><u>PRODUCT TYPE</u></b>	Not Selected
<b><u>POSITION</u></b>	Loft Hatch	<b><u>MATERIAL RISK</u></b>	0 (VL)
<b><u>COMPONENT</u></b>	Panel	<b><u>PRIORITY RISK</u></b>	N/A
<b><u>ACCESSIBILITY</u></b>	N/A	<b><u>QUANTITY</u></b>	1 Sqr Mtrs
<b><u>SURVEYOR</u></b>	Tim Godleman & Dale Brindley	<b><u>ACTION</u></b>	No Further Action Required
<b><u>LAB</u></b>	The Testing Lab Ltd	<b><u>NEXT INSPECTION</u></b>	No Further Action Required

No further action required

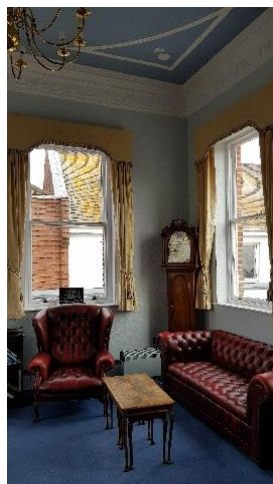
<b><u>CLIENT</u></b>	Bournemouth Christchurch Poole Council	<b><u>SITE</u></b>	Bournemouth Christchurch Poole Council  Old Town Hall 30 High Street  Christchurch BH23 1AJ
<b><u>MATERIAL ASSESSMENT REF</u></b>	S010	<b><u>SURVEY TYPE</u></b>	Management
<b><u>DATE TAKEN</u></b>	24/05/2019	<b><u>ASBESTOS TYPE</u></b>	Non suspect material
<b><u>BUILDING</u></b>	Main	<b><u>SURFACE TREATMENT</u></b>	Not Selected
<b><u>FLOOR</u></b>	First	<b><u>CONDITION</u></b>	Not Selected
<b><u>ROOM</u></b>	Small Hall	<b><u>PRODUCT TYPE</u></b>	Not Selected
<b><u>POSITION</u></b>	Ceiling, Walls & Floor	<b><u>MATERIAL RISK</u></b>	0 (VL)
<b><u>COMPONENT</u></b>	Ceiling, Walls & Floor	<b><u>PRIORITY RISK</u></b>	N/A
<b><u>ACCESSIBILITY</u></b>	N/A	<b><u>QUANTITY</u></b>	Num
<b><u>SURVEYOR</u></b>	Tim Godleman & Dale Brindley	<b><u>ACTION</u></b>	No further action required
<b><u>LAB</u></b>	In-House Database	<b><u>NEXT INSPECTION</u></b>	No further action required

No further action required

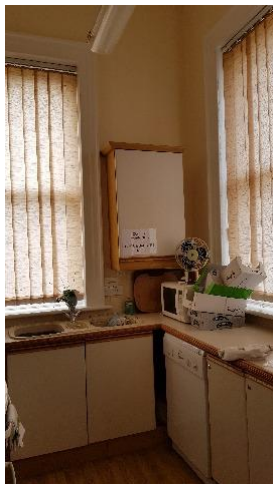
<b><u>CLIENT</u></b>	Bournemouth Christchurch Poole Council	<b><u>SITE</u></b>	Bournemouth Christchurch Poole Council  Old Town Hall 30 High Street  Christchurch BH23 1AJ
<b><u>MATERIAL ASSESSMENT REF</u></b>	S011	<b><u>SURVEY TYPE</u></b>	Management
<b><u>DATE TAKEN</u></b>	24/05/2019	<b><u>ASBESTOS TYPE</u></b>	Non suspect material
<b><u>BUILDING</u></b>	Main	<b><u>SURFACE TREATMENT</u></b>	Not Selected
<b><u>FLOOR</u></b>	First	<b><u>CONDITION</u></b>	Not Selected
<b><u>ROOM</u></b>	Kitchen	<b><u>PRODUCT TYPE</u></b>	Not Selected
<b><u>POSITION</u></b>	Ceiling, Walls & Floor	<b><u>MATERIAL RISK</u></b>	0 (VL)
<b><u>COMPONENT</u></b>	Ceiling, Walls & Floor	<b><u>PRIORITY RISK</u></b>	N/A
<b><u>ACCESSIBILITY</u></b>	N/A	<b><u>QUANTITY</u></b>	Num
<b><u>SURVEYOR</u></b>	Tim Godleman & Dale Brindley	<b><u>ACTION</u></b>	No further action required
<b><u>LAB</u></b>	In-House Database	<b><u>NEXT INSPECTION</u></b>	No further action required

No further action required

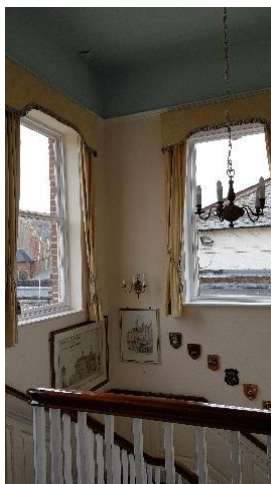
<b><u>CLIENT</u></b>	Bournemouth Christchurch Poole Council	<b><u>SITE</u></b>	Bournemouth Christchurch Poole Council  Old Town Hall 30 High Street  Christchurch BH23 1AJ
<b><u>MATERIAL ASSESSMENT REF</u></b>	S012	<b><u>SURVEY TYPE</u></b>	Management
<b><u>DATE TAKEN</u></b>	24/05/2019	<b><u>ASBESTOS TYPE</u></b>	Non suspect material
<b><u>BUILDING</u></b>	Main	<b><u>SURFACE TREATMENT</u></b>	Not Selected
<b><u>FLOOR</u></b>	First	<b><u>CONDITION</u></b>	Not Selected
<b><u>ROOM</u></b>	Landing & Stairs	<b><u>PRODUCT TYPE</u></b>	Not Selected
<b><u>POSITION</u></b>	Ceiling, Walls & Floor	<b><u>MATERIAL RISK</u></b>	0 (VL)
<b><u>COMPONENT</u></b>	Ceiling, Walls & Floor	<b><u>PRIORITY RISK</u></b>	N/A
<b><u>ACCESSIBILITY</u></b>	N/A	<b><u>QUANTITY</u></b>	Num
<b><u>SURVEYOR</u></b>	Tim Godleman & Dale Brindley	<b><u>ACTION</u></b>	No further action required
<b><u>LAB</u></b>	In-House Database	<b><u>NEXT INSPECTION</u></b>	No further action required

No further action required

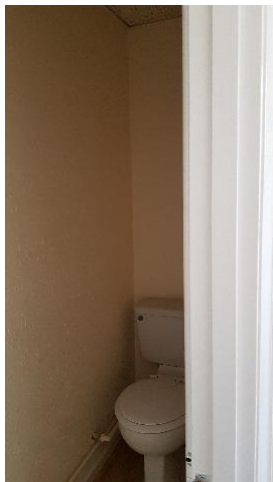
<b><u>CLIENT</u></b>	Bournemouth Christchurch Poole Council	<b><u>SITE</u></b>	Bournemouth Christchurch Poole Council  Old Town Hall 30 High Street  Christchurch BH23 1AJ
<b><u>MATERIAL ASSESSMENT REF</u></b>	S013	<b><u>SURVEY TYPE</u></b>	Management
<b><u>DATE TAKEN</u></b>	24/05/2019	<b><u>ASBESTOS TYPE</u></b>	Non suspect material
<b><u>BUILDING</u></b>	Main	<b><u>SURFACE TREATMENT</u></b>	Not Selected
<b><u>FLOOR</u></b>	Ground	<b><u>CONDITION</u></b>	Not Selected
<b><u>ROOM</u></b>	Male W.C	<b><u>PRODUCT TYPE</u></b>	Not Selected
<b><u>POSITION</u></b>	Ceiling, Walls & Floor	<b><u>MATERIAL RISK</u></b>	0 (VL)
<b><u>COMPONENT</u></b>	Ceiling, Walls & Floor	<b><u>PRIORITY RISK</u></b>	N/A
<b><u>ACCESSIBILITY</u></b>	N/A	<b><u>QUANTITY</u></b>	Num
<b><u>SURVEYOR</u></b>	Tim Godleman & Dale Brindley	<b><u>ACTION</u></b>	No further action required
<b><u>LAB</u></b>	In-House Database	<b><u>NEXT INSPECTION</u></b>	No further action required

No further action required

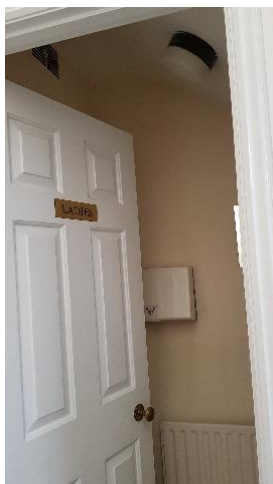
<b><u>CLIENT</u></b>	Bournemouth Christchurch Poole Council	<b><u>SITE</u></b>	Bournemouth Christchurch Poole Council  Old Town Hall 30 High Street  Christchurch BH23 1AJ
<b><u>MATERIAL ASSESSMENT REF</u></b>	S014	<b><u>SURVEY TYPE</u></b>	Management
<b><u>DATE TAKEN</u></b>	24/05/2019	<b><u>ASBESTOS TYPE</u></b>	Non suspect material
<b><u>BUILDING</u></b>	Main	<b><u>SURFACE TREATMENT</u></b>	Not Selected
<b><u>FLOOR</u></b>	Ground	<b><u>CONDITION</u></b>	Not Selected
<b><u>ROOM</u></b>	Female W.C	<b><u>PRODUCT TYPE</u></b>	Not Selected
<b><u>POSITION</u></b>	Ceiling, Walls & Floor	<b><u>MATERIAL RISK</u></b>	0 (VL)
<b><u>COMPONENT</u></b>	Ceiling, Walls & Floor	<b><u>PRIORITY RISK</u></b>	N/A
<b><u>ACCESSIBILITY</u></b>	N/A	<b><u>QUANTITY</u></b>	Num
<b><u>SURVEYOR</u></b>	Tim Godleman & Dale Brindley	<b><u>ACTION</u></b>	No further action required
<b><u>LAB</u></b>	In-House Database	<b><u>NEXT INSPECTION</u></b>	No further action required

No further action required

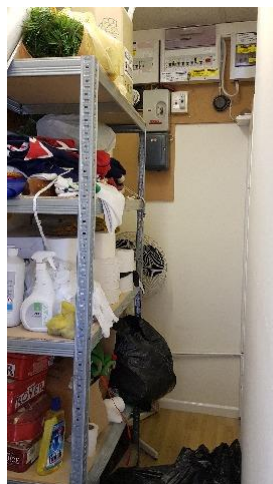
<b><u>CLIENT</u></b>	Bournemouth Christchurch Poole Council	<b><u>SITE</u></b>	Bournemouth Christchurch Poole Council  Old Town Hall 30 High Street  Christchurch BH23 1AJ
<b><u>MATERIAL ASSESSMENT REF</u></b>	S015	<b><u>SURVEY TYPE</u></b>	Management
<b><u>DATE TAKEN</u></b>	24/05/2019	<b><u>ASBESTOS TYPE</u></b>	Non suspect material
<b><u>BUILDING</u></b>	Main	<b><u>SURFACE TREATMENT</u></b>	Not Selected
<b><u>FLOOR</u></b>	Ground	<b><u>CONDITION</u></b>	Not Selected
<b><u>ROOM</u></b>	Store	<b><u>PRODUCT TYPE</u></b>	Not Selected
<b><u>POSITION</u></b>	Ceiling, Walls & Floor	<b><u>MATERIAL RISK</u></b>	0 (VL)
<b><u>COMPONENT</u></b>	Ceiling, Walls & Floor	<b><u>PRIORITY RISK</u></b>	N/A
<b><u>ACCESSIBILITY</u></b>	N/A	<b><u>QUANTITY</u></b>	Num
<b><u>SURVEYOR</u></b>	Tim Godleman & Dale Brindley	<b><u>ACTION</u></b>	No further action required
<b><u>LAB</u></b>	In-House Database	<b><u>NEXT INSPECTION</u></b>	No further action required

No further action required

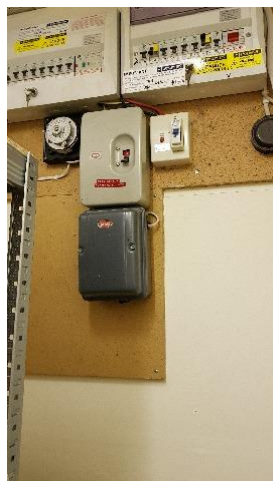
Record ID	Location	No Access Justification
S016	Main, Ground, Store, Electrics	A risk assessment identified high risk exposure to the surveyor normally due to high voltage or other hazardous materials being present.

<b><u>CLIENT</u></b>	Bournemouth Christchurch Poole Council	<b><u>SITE</u></b>	Bournemouth Christchurch Poole Council  Old Town Hall 30 High Street  Christchurch BH23 1AJ
<b><u>MATERIAL ASSESSMENT REF</u></b>	S016	<b><u>SURVEY TYPE</u></b>	Management
<b><u>DATE TAKEN</u></b>	24/05/2019	<b><u>ASBESTOS TYPE</u></b>	No Access
<b><u>BUILDING</u></b>	Main	<b><u>SURFACE TREATMENT</u></b>	No Access
<b><u>FLOOR</u></b>	Ground	<b><u>CONDITION</u></b>	No Access
<b><u>ROOM</u></b>	Store	<b><u>PRODUCT TYPE</u></b>	No Access
<b><u>POSITION</u></b>	Electrics	<b><u>MATERIAL RISK</u></b>	12 (H)
<b><u>COMPONENT</u></b>	Electrics	<b><u>PRIORITY RISK</u></b>	N/A
<b><u>ACCESSIBILITY</u></b>	N/A	<b><u>QUANTITY</u></b>	Num
<b><u>SURVEYOR</u></b>	Tim Godleman & Dale Brindley	<b><u>ACTION</u></b>	Further investigation may be required.
<b><u>LAB</u></b>	In-House Database	<b><u>NEXT INSPECTION</u></b>	No Access

A risk assessment identified high risk exposure to the surveyor normally due to high voltage or other hazardous materials being present.

The following areas were not accessed and need to be incorporated within the management plan and/or inspected during the re-inspection campaign, **see Section 2, Site Info/Additional notes for further information.**

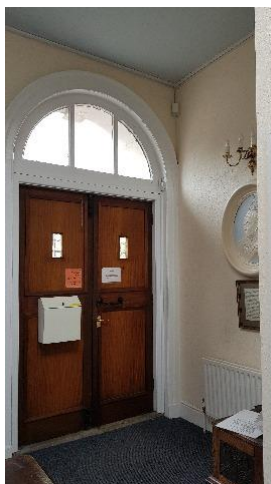
<b><u>CLIENT</u></b>	Bournemouth Christchurch Poole Council	<b><u>SITE</u></b>	Bournemouth Christchurch Poole Council  Old Town Hall 30 High Street  Christchurch BH23 1AJ
<b><u>MATERIAL ASSESSMENT REF</u></b>	S017	<b><u>SURVEY TYPE</u></b>	Management
<b><u>DATE TAKEN</u></b>	24/05/2019	<b><u>ASBESTOS TYPE</u></b>	Non suspect material
<b><u>BUILDING</u></b>	Main	<b><u>SURFACE TREATMENT</u></b>	Not Selected
<b><u>FLOOR</u></b>	Ground	<b><u>CONDITION</u></b>	Not Selected
<b><u>ROOM</u></b>	Lobby	<b><u>PRODUCT TYPE</u></b>	Not Selected
<b><u>POSITION</u></b>	Ceiling, Walls & Floor	<b><u>MATERIAL RISK</u></b>	0 (VL)
<b><u>COMPONENT</u></b>	Ceiling, Walls & Floor	<b><u>PRIORITY RISK</u></b>	N/A
<b><u>ACCESSIBILITY</u></b>	N/A	<b><u>QUANTITY</u></b>	Num
<b><u>SURVEYOR</u></b>	Tim Godleman & Dale Brindley	<b><u>ACTION</u></b>	No further action required
<b><u>LAB</u></b>	In-House Database	<b><u>NEXT INSPECTION</u></b>	No further action required

No further action required

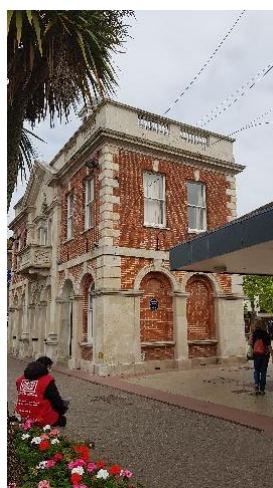
<b><u>CLIENT</u></b>	Bournemouth Christchurch Poole Council	<b><u>SITE</u></b>	Bournemouth Christchurch Poole Council  Old Town Hall 30 High Street  Christchurch BH23 1AJ
<b><u>MATERIAL ASSESSMENT REF</u></b>	S018	<b><u>SURVEY TYPE</u></b>	Management
<b><u>DATE TAKEN</u></b>	24/05/2019	<b><u>ASBESTOS TYPE</u></b>	Non suspect material
<b><u>BUILDING</u></b>	Main	<b><u>SURFACE TREATMENT</u></b>	Not Selected
<b><u>FLOOR</u></b>	External	<b><u>CONDITION</u></b>	Not Selected
<b><u>ROOM</u></b>	All Elevations	<b><u>PRODUCT TYPE</u></b>	Not Selected
<b><u>POSITION</u></b>	Roof, Walls External & Rain Water Goods	<b><u>MATERIAL RISK</u></b>	0 (VL)
<b><u>COMPONENT</u></b>	Roof, Walls External & Rain Water Goods	<b><u>PRIORITY RISK</u></b>	N/A
<b><u>ACCESSIBILITY</u></b>	N/A	<b><u>QUANTITY</u></b>	Num
<b><u>SURVEYOR</u></b>	Tim Godleman & Dale Brindley	<b><u>ACTION</u></b>	No further action required
<b><u>LAB</u></b>	In-House Database	<b><u>NEXT INSPECTION</u></b>	No further action required

No further action required
