Armco
Asbestos Surveys

TECHNICAL REPORT

PROPERTY ADDRESS: M&S Store, Castle Quay Shopping Centre, Banbury, OX16 5UN

REPORT TYPE: Asbestos Refurbishment/Demolition Survey

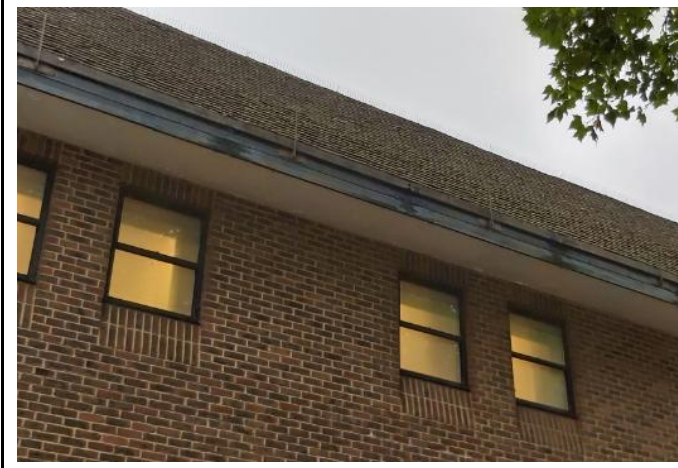
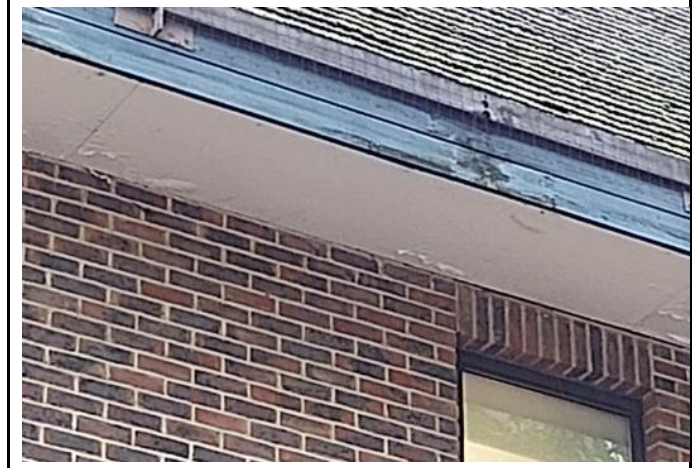
Room Number	R001
Ref Number	366587
Date Sampled	03/09/2020

ACM		
Asbestos Type Description:	Chrysotile	Comments Strongly Presumed - Sampled on previous survey.
Material Type	Cement Product	
Quantity:	20lin m	
Room Number:	R001	
Room Description:	External	
Item:	Soffit	
Floor Level:	M&S Store, Castle Quays, Banbury, External

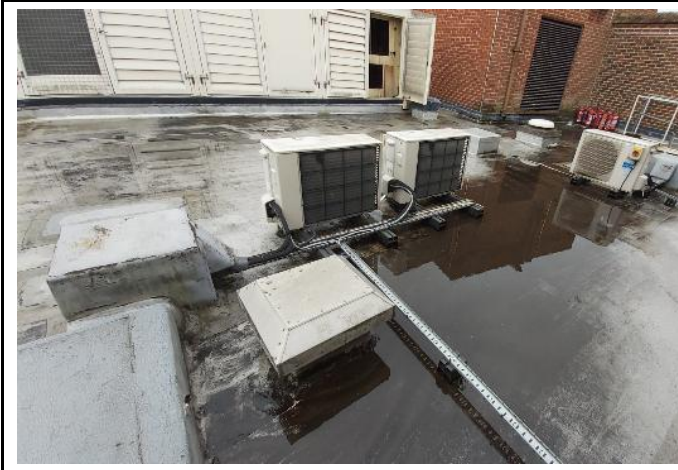
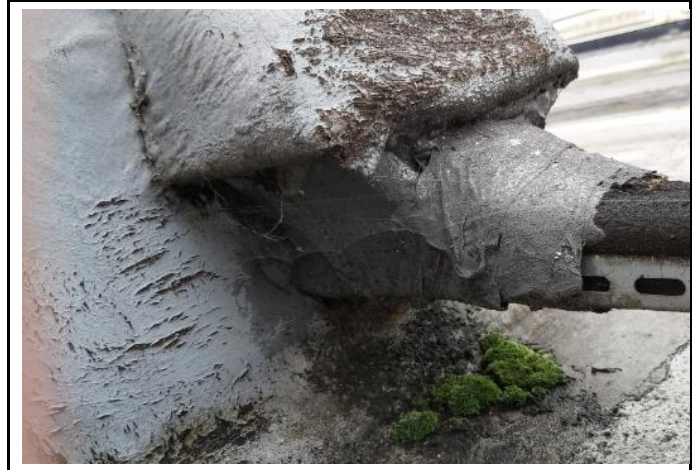
Room Number	R001
Ref Number	366729
Date Sampled	03/09/2020

ACM		
Asbestos Type Description:	Chrysotile	Comments Strongly Presumed - Mastic seal within plastic insert through concrete slab - Sampled on previous survey. All roofs have been checked and all plant & machinery has been checked.
Material Type	Bituminous Product	
Quantity:	2No	
Room Number:	R001	
Room Description:	External	
Item:	Roof	
Floor Level:	M&S Store, Castle Quays, Banbury, External

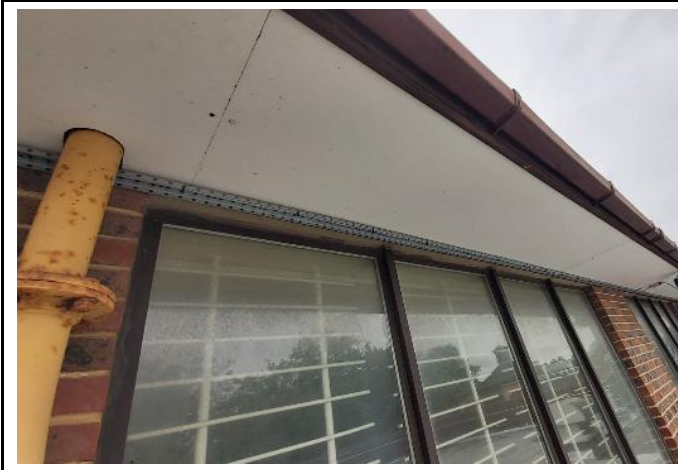
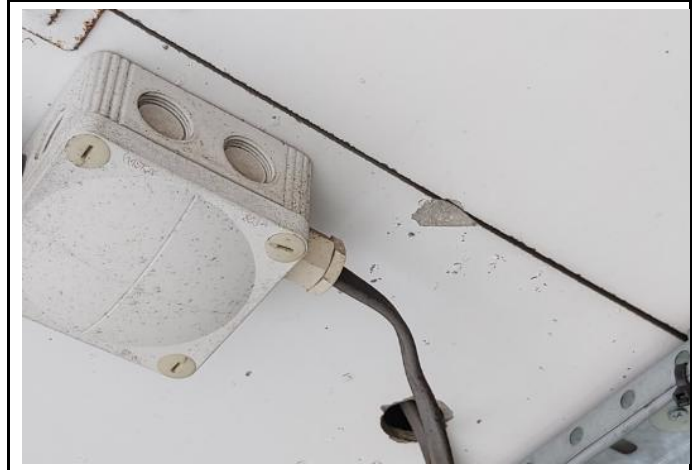
Room Number	R001
Ref Number	366734
Date Sampled	03/09/2020

ACM		
Asbestos Type Description:	Chrysotile	Comments Strongly Presumed - Sampled on previous survey.
Material Type	Cement Product	
Quantity:	20lin m	
Room Number:	R001	
Room Description:	External	
Item:	Soffit	
Floor Level:	M&S Store, Castle Quays, Banbury, External

366734 Strongly Presumed002	External R001 Soffit	Cement Product 20lin m	Chrysotile	3	Remove Add to asbestos register and Monitor - Removal/repair works should be undertaken by a competent contractor following an appropriate risk assessment which includes adequate disposal to landfill.
366742 S013	1st Floor Main Store R024 Wall Cavity	Vinyl Products 12lin m	Chrysotile	3	Remove Add to asbestos register and Monitor - Removal/repair works should be undertaken by a competent contractor following an appropriate risk assessment which includes adequate disposal to landfill.
366743 S014	1st Floor Main Store R024 Wall Cavity	Bituminous Product 12lin m	Chrysotile	3	Remove Add to asbestos register and Monitor - Removal/repair works should be undertaken by a competent contractor following an appropriate risk assessment which includes adequate disposal to landfill.
366744 S015	1st Floor Main Store R024 Floor	Bituminous Product 250m ²	Chrysotile	3	Remove Add to asbestos register and Monitor - Removal/repair works should be undertaken by a competent contractor following an appropriate risk assessment which includes adequate disposal to landfill.

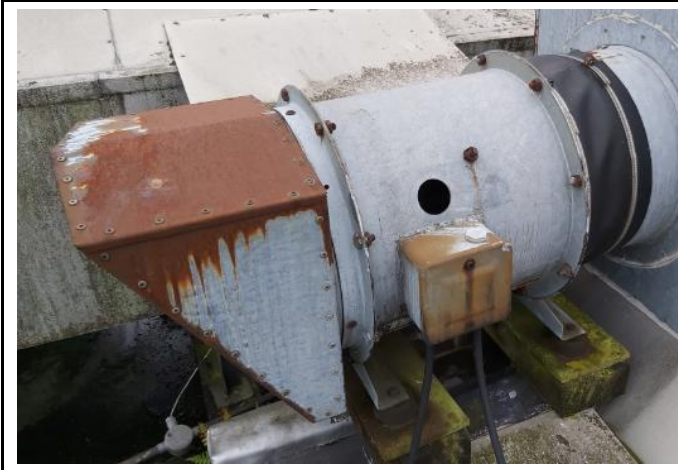
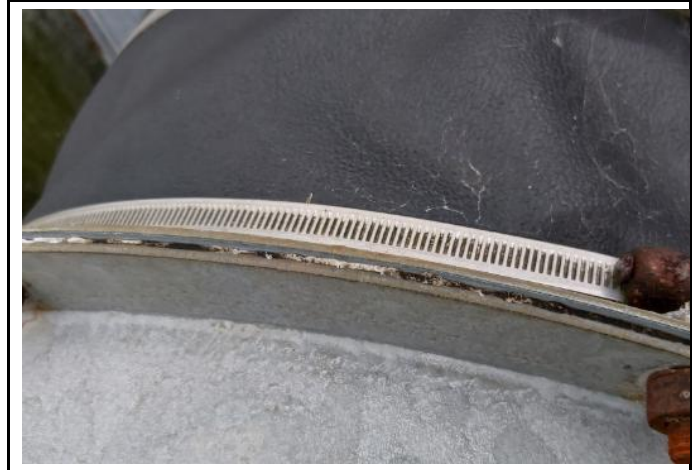
Room Number	R001
Ref Number	366736
Date Sampled	03/09/2020

ACM		
Asbestos Type Description:	Chrysotile	Comments
Material Type	Gaskets (compressed)	
Quantity:	2No	
Room Number:	R001	
Room Description:	External	
Item:	Motor	
Floor Level:	M&S Store, Castle Quays, Banbury, External

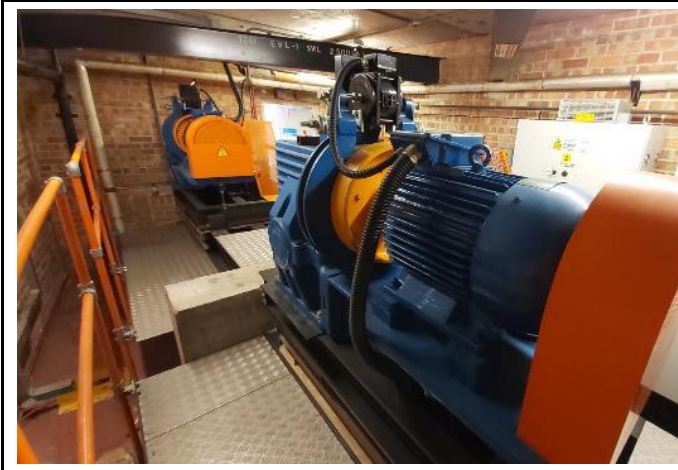
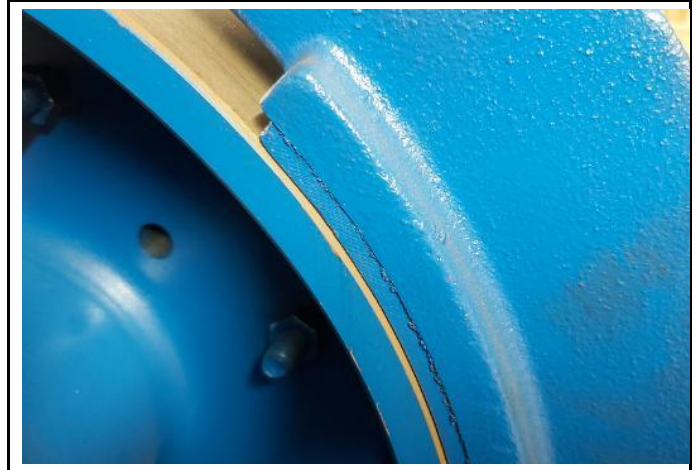
Room Number	R002
Ref Number	366728
Date Sampled	03/09/2020

ACM		
Asbestos Type Description:	Chrysotile	Comments Brake shoes to lift motor.
Material Type	Friction Material	
Quantity:	4No	
Room Number:	R002	
Room Description:	Lift Motor room	
Item:	Lift Motor	
Floor Level:	M&S Store, Castle Quays, Banbury, 3rd Floor

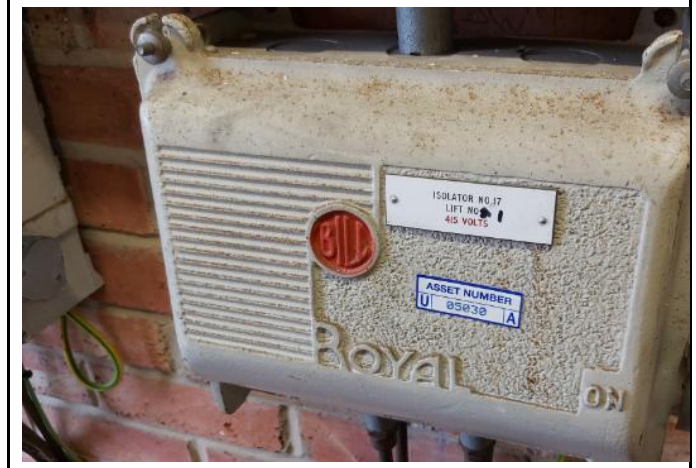
Room Number	R002
Ref Number	366735
Date Sampled	03/09/2020

ACM		
Asbestos Type Description:	Chrysotile	Comments
Material Type	Gaskets (rope/woven)	Presumed flash guards to fuses.
Quantity:	2No	
Room Number:	R002	
Room Description:	Lift Motor room	
Item:	Fuse Boxes	
Floor Level:	M&S Store, Castle Quays, Banbury, 3rd Floor

M&S Store, Castle Quays, Banbury					
Reference Number Sample Number	Location	Material Type Quantity	Asbestos Type	Priority Risk Score	Comments / Recommendations
366735 Presumed002	3rd Floor Lift Motor room R002 Fuse Boxes	Gaskets (rope/woven) 2No	Chrysotile	4	Remove Add to asbestos register and Monitor - Removal/repair works should be undertaken by a competent contractor following an appropriate risk assessment which includes adequate disposal to landfill.
366587 Strongly Presumed003	External R001 Soffit	Cement Product 20lin m	Chrysotile	3	Remove Add to asbestos register and Monitor - Removal/repair works should be undertaken by a competent contractor following an appropriate risk assessment which includes adequate disposal to landfill.
366728 Presumed001	3rd Floor Lift Motor room R002 Lift Motor	Friction Material 4No	Chrysotile	3	Remove Add to asbestos register and Monitor - Removal/repair works should be undertaken by a competent contractor following an appropriate risk assessment which includes adequate disposal to landfill.

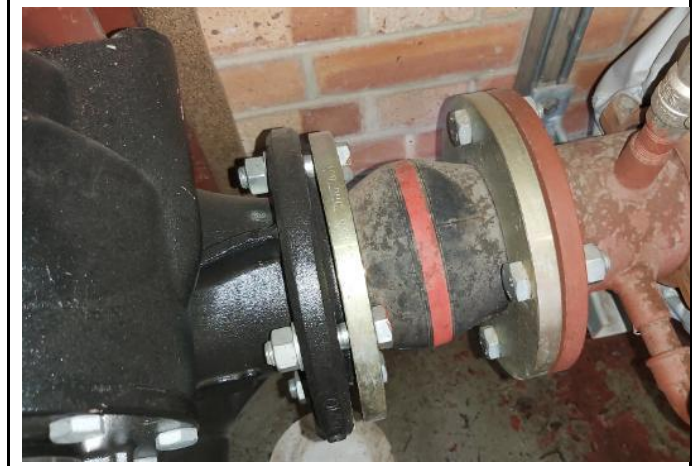
Room Number	R005
Ref Number	366586
Date Sampled	03/09/2020

ACM		
Asbestos Type Description:	Chrysotile	Comments Presume asbestos to all pipe flanges throughout the building.
Material Type	Gaskets (compressed)	
Quantity:	ENKNo	
Room Number:	R005	
Room Description:	Plant Room	
Item:	Pipes	
Floor Level:	M&S Store, Castle Quays, Banbury, 2nd Floor

366586 Presumed003	2nd Floor Plant Room R005 Pipes	Gaskets (compressed) ENKNo	Chrysotile	2	Remove Add to asbestos register and Monitor - Removal/repair works should be undertaken by a competent contractor following an appropriate risk assessment which includes adequate disposal to landfill.
366729 Strongly Presumed001	External R001 Roof	Bituminous Product 2No	Chrysotile	2	Remove Add to asbestos register and Monitor - Removal/repair works should be undertaken by a competent contractor following an appropriate risk assessment which includes adequate disposal to landfill.
366736 S003	External R001 Motor	Gaskets (compressed) 2No	Chrysotile	2	Remove Add to asbestos register and Monitor - Removal/repair works should be undertaken by a competent contractor following an appropriate risk assessment which includes adequate disposal to landfill.
366895 As Sample S014	1st Floor Store R036 Floor	Bituminous Product 80m ²	Chrysotile	2	Remove Add to asbestos register and Monitor - Removal/repair works should be undertaken by a competent contractor following an appropriate risk assessment which includes adequate disposal to landfill.

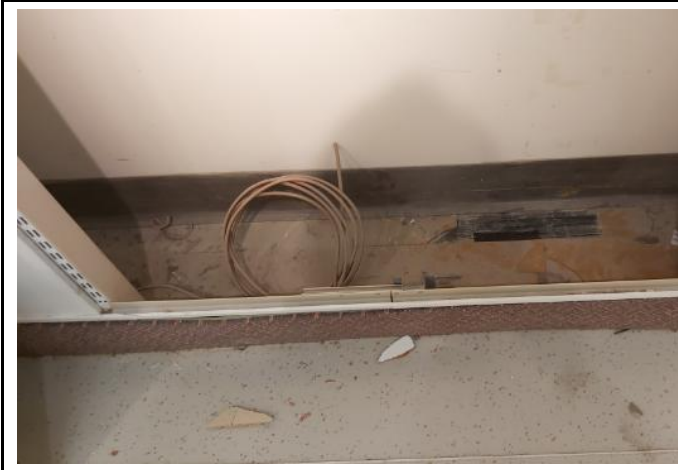
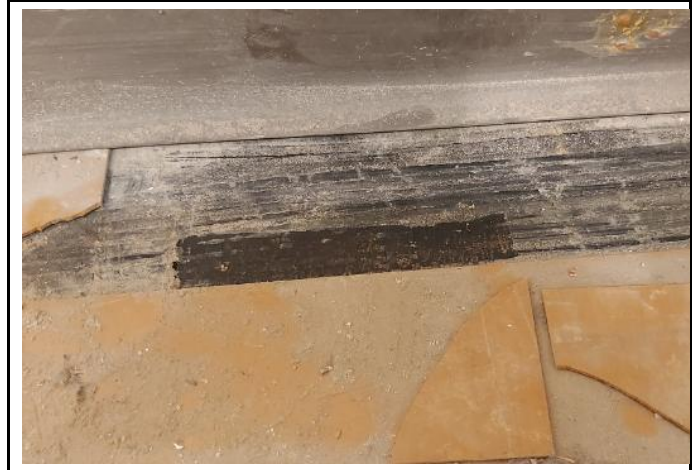
Room Number	R024
Ref Number	366742
Date Sampled	03/09/2020

ACM		
Asbestos Type Description:	Chrysotile	Comments
Material Type	Vinyl Products	Brown Floor Tiles in wall cavity
Quantity:	12lin m	
Room Number:	R024	
Room Description:	Main Store	
Item:	Wall Cavity	
Floor Level:	M&S Store, Castle Quays, Banbury, 1st Floor

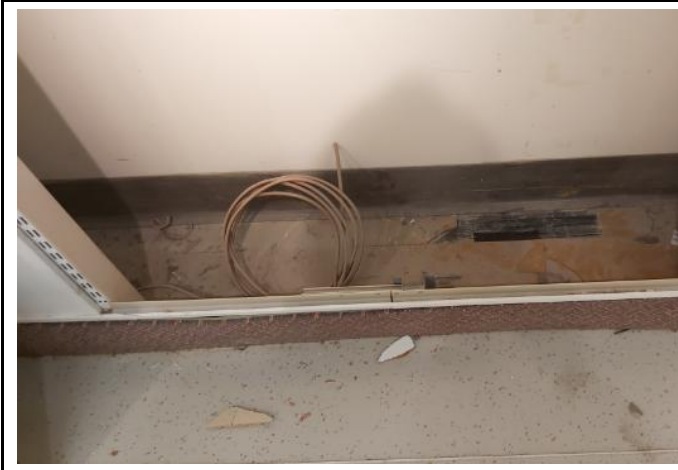
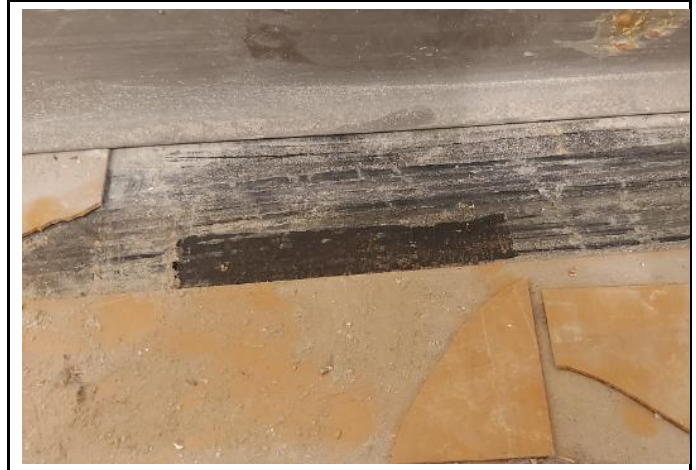
Room Number	R024
Ref Number	366743
Date Sampled	03/09/2020

ACM		
Asbestos Type Description:	Chrysotile	Comments
Material Type	Bituminous Product	Bitumen Adhesive in wall cavity
Quantity:	12lin m	
Room Number:	R024	
Room Description:	Main Store	
Item:	Wall Cavity	
Floor Level:	M&S Store, Castle Quays, Banbury, 1st Floor

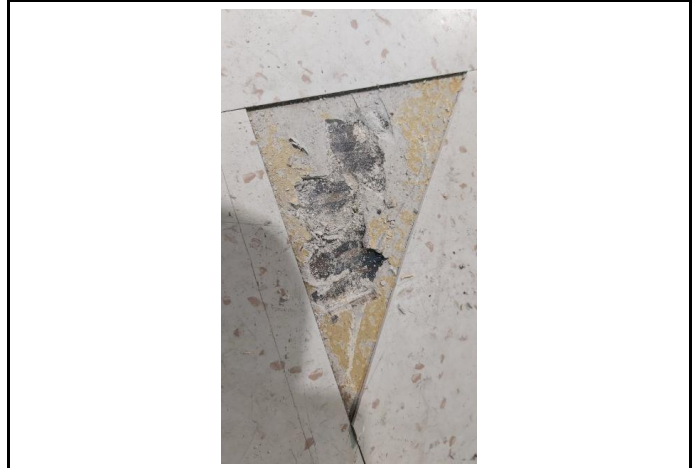
Room Number	R024
Ref Number	366744
Date Sampled	03/09/2020

ACM		
Asbestos Type Description:	Chrysotile	Comments
Material Type	Bituminous Product	Bitumen Adhesive below modern Vinyl
Quantity:	250m ²	
Room Number:	R024	
Room Description:	Main Store	
Item:	Floor	
Floor Level:	M&S Store, Castle Quays, Banbury, 1st Floor

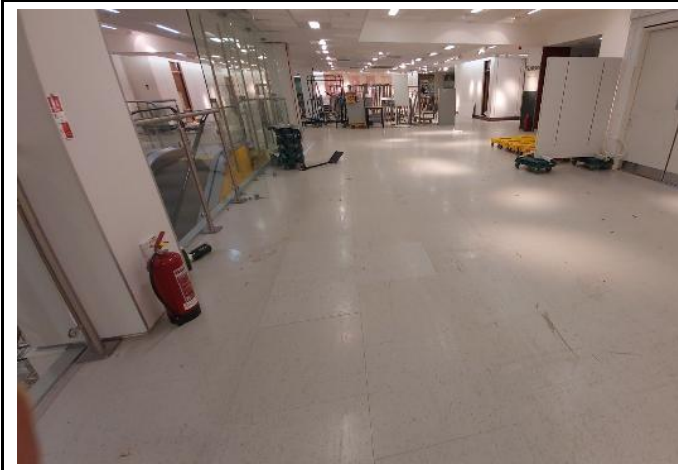
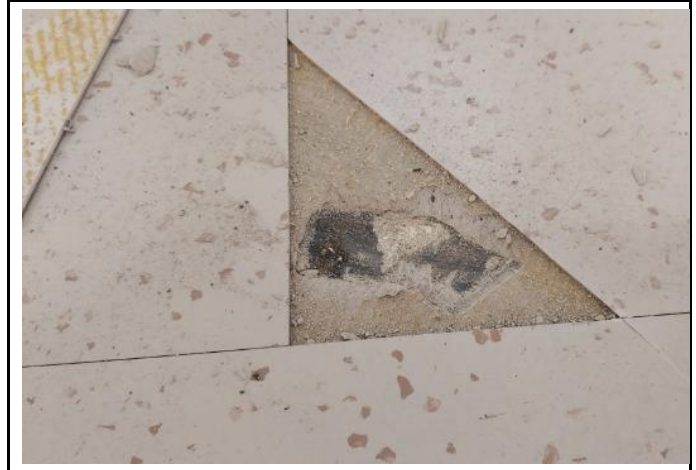
Room Number	R024
Ref Number	366765
Date Sampled	03/09/2020

ACM		
Asbestos Type Description:	Chrysotile	Comments Bitumen Adhesive below modern Vinyl
Material Type	Bituminous Product	
Quantity:	250m ²	
Room Number:	R024	
Room Description:	Main Store	
Item:	Floor	
Floor Level:	M&S Store, Castle Quays, Banbury, 1st Floor

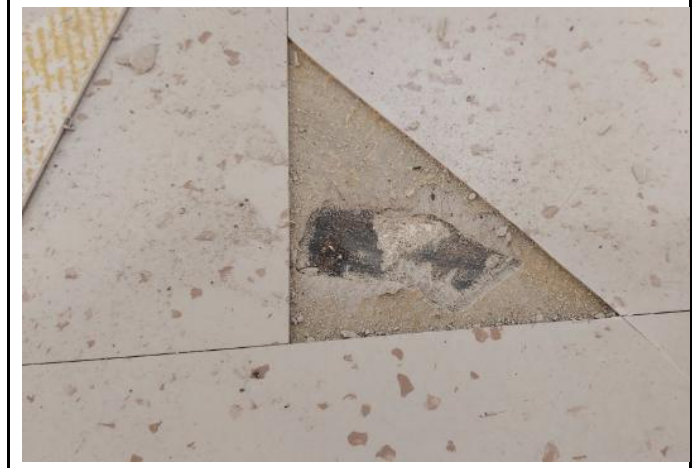
Room Number	R025
Ref Number	366751
Date Sampled	03/09/2020

ACM		
Asbestos Type Description:	Chrysotile	Comments Presume Bitumen Adhesive below modern Vinyl & carpet
Material Type	Bituminous Product	
Quantity:	10m ²	
Room Number:	R025	
Room Description:	Changing Rooms	
Item:	Floor	
Floor Level:	M&S Store, Castle Quays, Banbury, 1st Floor

366751 As Sample S016	1st Floor Changing Rooms R025 Floor	Bituminous Product 10m ²	Chrysotile	3	Remove Add to asbestos register and Monitor - Removal/repair works should be undertaken by a competent contractor following an appropriate risk assessment which includes adequate disposal to landfill.
366764 As Sample S016	1st Floor Changing Rooms R026 Floor	Bituminous Product 5m ²	Chrysotile	3	Remove Add to asbestos register and Monitor - Removal/repair works should be undertaken by a competent contractor following an appropriate risk assessment which includes adequate disposal to landfill.
366765 S016	1st Floor Main Store R024 Floor	Bituminous Product 250m ²	Chrysotile	3	Remove Add to asbestos register and Monitor - Removal/repair works should be undertaken by a competent contractor following an appropriate risk assessment which includes adequate disposal to landfill.
366766 S018	1st Floor Cupboard R027 Floor	Vinyl Products 1m ²	Chrysotile	3	Remove Add to asbestos register and Monitor - Removal/repair works should be undertaken by a competent contractor following an appropriate risk assessment which includes adequate disposal to landfill.

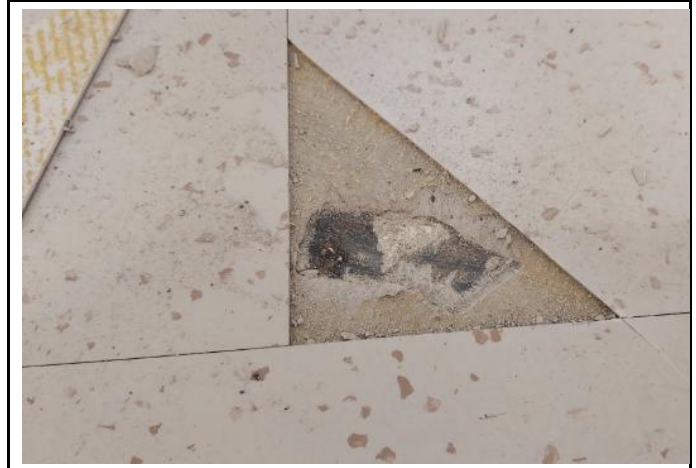
Room Number	R026
Ref Number	366764
Date Sampled	03/09/2020

ACM		
Asbestos Type Description:	Chrysotile	Comments Presume Bitumen Adhesive below modern Vinyl.
Material Type	Bituminous Product	
Quantity:	5m²	
Room Number:	R026	
Room Description:	Changing Rooms	
Item:	Floor	
Floor Level:	M&S Store, Castle Quays, Banbury, 1st Floor

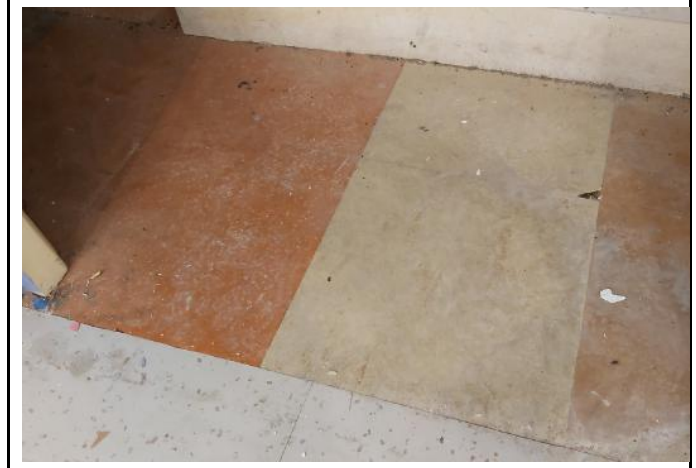
Room Number	R027
Ref Number	366766
Date Sampled	03/09/2020

ACM		
Asbestos Type Description:	Chrysotile	Comments Brown Floor Tiles & Bitumen Adhesive
Material Type	Vinyl Products	
Quantity:	1m ²	
Room Number:	R027	
Room Description:	Cupboard	
Item:	Floor	
Floor Level:	M&S Store, Castle Quays, Banbury, 1st Floor

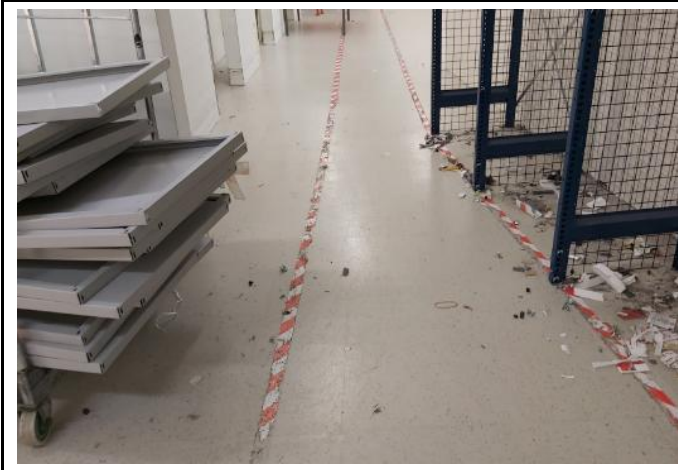
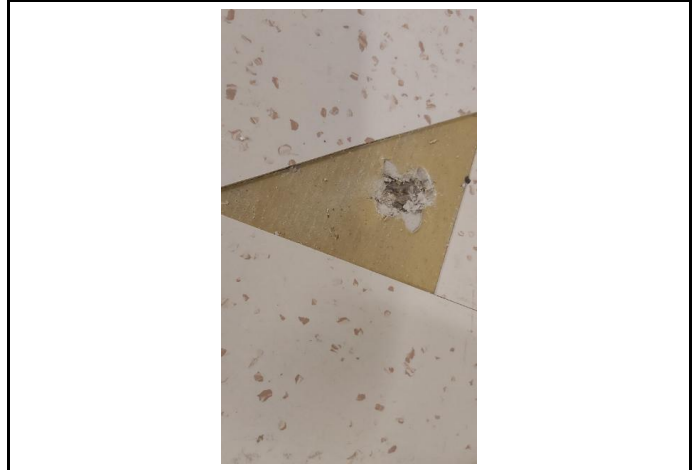
Room Number	R036
Ref Number	366895
Date Sampled	03/09/2020

ACM		
Asbestos Type Description:	Chrysotile	Comments
Material Type	Bituminous Product	Bitumen Adhesive
Quantity:	80m ²	
Room Number:	R036	
Room Description:	Store	
Item:	Floor	
Floor Level:	M&S Store, Castle Quays, Banbury, 1st Floor

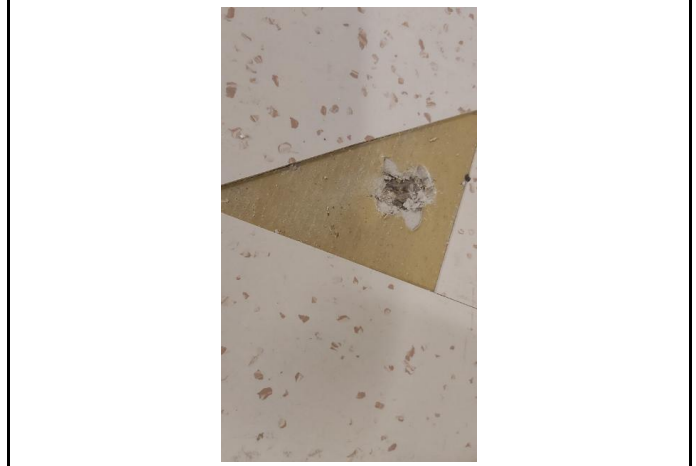
Room Number	R037
Ref Number	366896
Date Sampled	03/09/2020

ACM		
Asbestos Type Description:	Chrysotile	Comments
Material Type	Bituminous Product	Bitumen Adhesive
Quantity:	80m ²	
Room Number:	R037	
Room Description:	Store	
Item:	Floor	
Floor Level:	M&S Store, Castle Quays, Banbury, 1st Floor

366896 As Sample S014	1st Floor Store R037 Floor	Bituminous Product 80m ²	Chrysotile	2	Remove Add to asbestos register and Monitor - Removal/repair works should be undertaken by a competent contractor following an appropriate risk assessment which includes adequate disposal to landfill.
366897 As Sample S014	1st Floor Cafe R038 Floor	Bituminous Product 150m ²	Chrysotile	2	Remove Add to asbestos register and Monitor - Removal/repair works should be undertaken by a competent contractor following an appropriate risk assessment which includes adequate disposal to landfill.
366898 As Sample S014	1st Floor Kitchen R039 Floor	Bituminous Product 25m ²	Chrysotile	2	Remove Add to asbestos register and Monitor - Removal/repair works should be undertaken by a competent contractor following an appropriate risk assessment which includes adequate disposal to landfill.

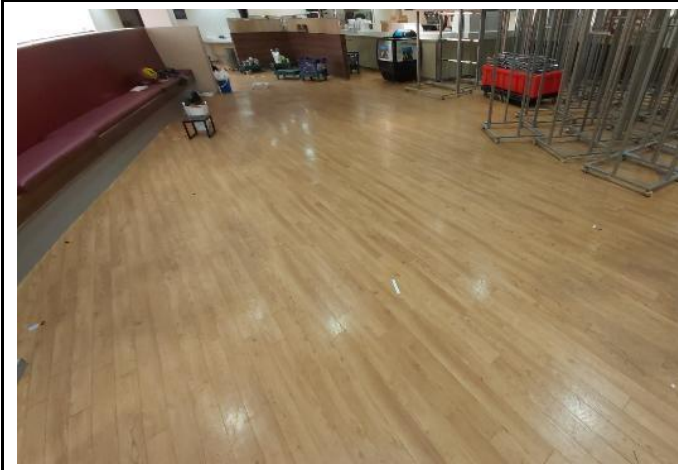
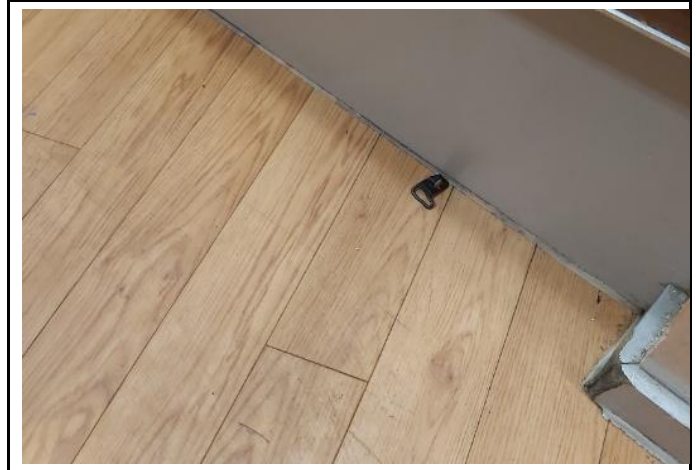
Room Number	R038
Ref Number	366897
Date Sampled	03/09/2020

ACM		
Asbestos Type Description:	Chrysotile	Comments
Material Type	Bituminous Product	Bitumen Adhesive
Quantity:	150m ²	
Room Number:	R038	
Room Description:	Cafe	
Item:	Floor	
Floor Level:	M&S Store, Castle Quays, Banbury, 1st Floor

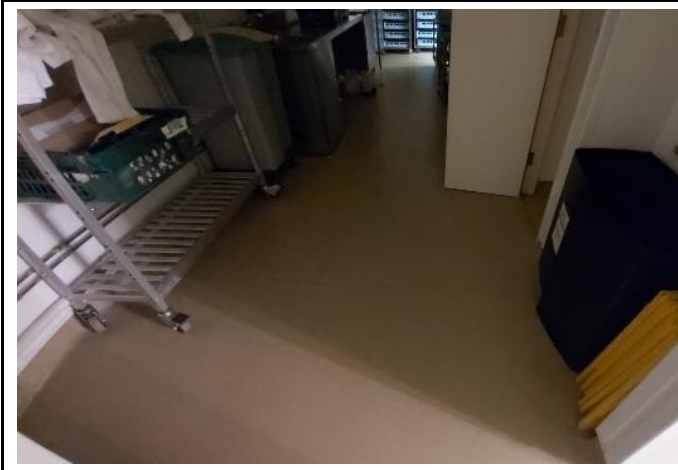
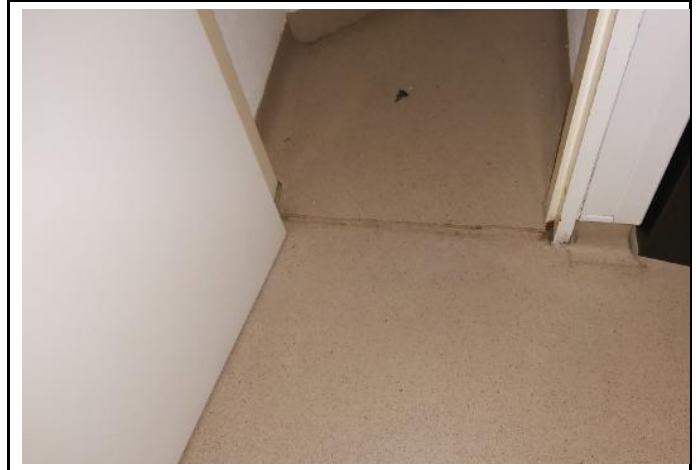
Room Number	R039
Ref Number	366898
Date Sampled	03/09/2020

ACM		
Asbestos Type Description:	Chrysotile	Comments
Material Type	Bituminous Product	Bitumen Adhesive
Quantity:	25m ²	
Room Number:	R039	
Room Description:	Kitchen	
Item:	Floor	
Floor Level:	M&S Store, Castle Quays, Banbury, 1st Floor

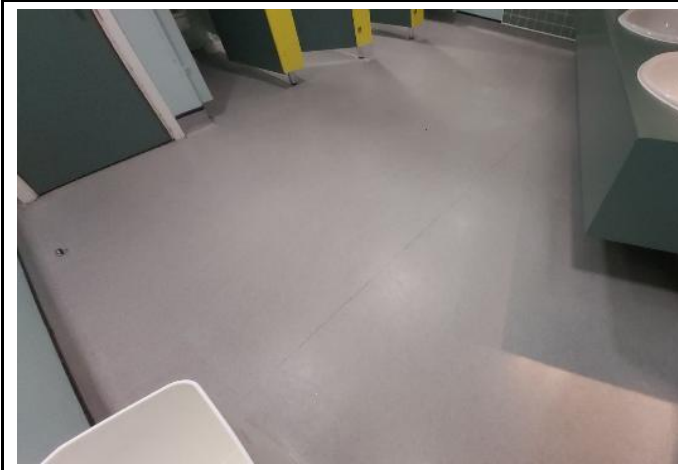
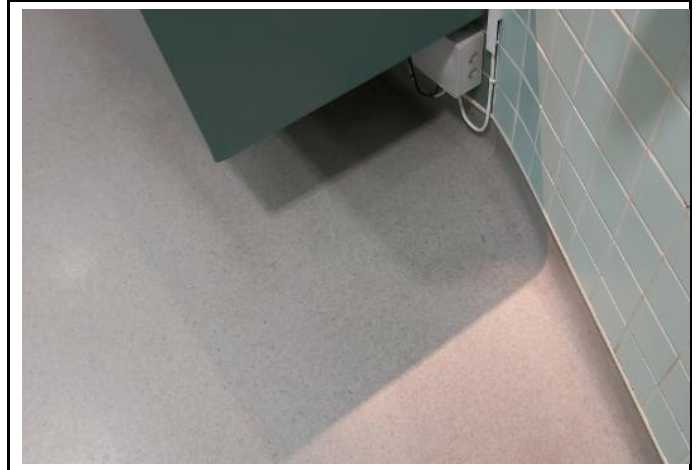
Room Number	R040
Ref Number	366906
Date Sampled	03/09/2020

ACM		
Asbestos Type Description:	Chrysotile	Comments
Material Type	Bituminous Product	Bitumen Adhesive
Quantity:	35m ²	
Room Number:	R040	
Room Description:	Toilet	
Item:	Floor	
Floor Level:	M&S Store, Castle Quays, Banbury, 1st Floor

366906 As Sample S014	1st Floor Toilet R040 Floor	Bituminous Product 35m ²	Chrysotile	2	Remove Add to asbestos register and Monitor - Removal/repair works should be undertaken by a competent contractor following an appropriate risk assessment which includes adequate disposal to landfill.
366907 As Sample S014	1st Floor Toilet R041 Floor	Bituminous Product 4m ²	Chrysotile	2	Remove Add to asbestos register and Monitor - Removal/repair works should be undertaken by a competent contractor following an appropriate risk assessment which includes adequate disposal to landfill.
366908 As Sample S014	1st Floor Toilet R042 Floor	Bituminous Product 4m ²	Chrysotile	2	Remove Add to asbestos register and Monitor - Removal/repair works should be undertaken by a competent contractor following an appropriate risk assessment which includes adequate disposal to landfill.
366909 As Sample S014	1st Floor Toilet R043 Floor	Bituminous Product 35m ²	Chrysotile	2	Remove Add to asbestos register and Monitor - Removal/repair works should be undertaken by a competent contractor following an appropriate risk assessment which includes adequate disposal to landfill.

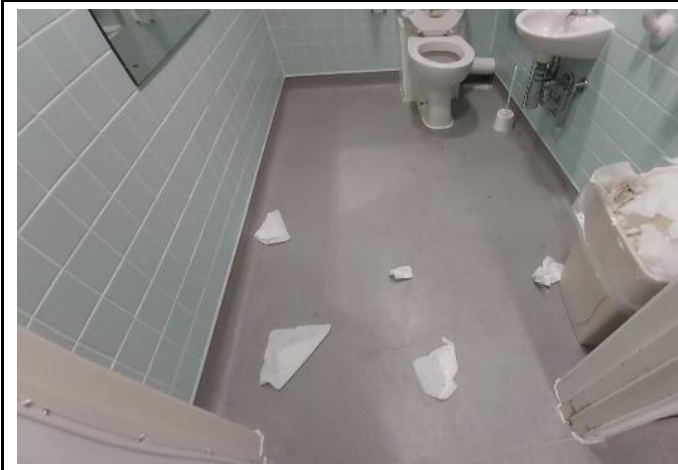
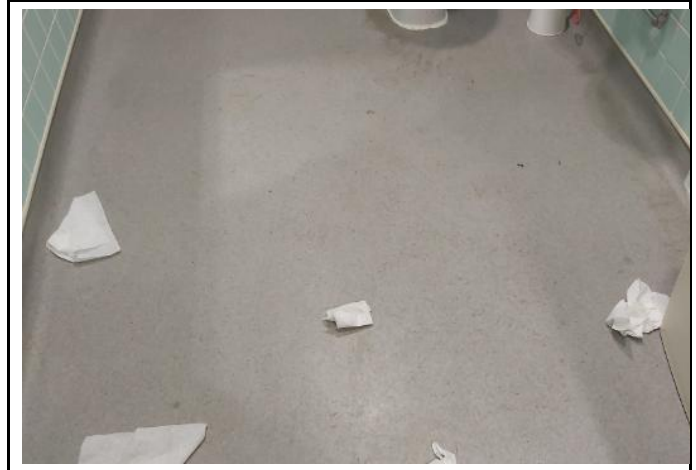
Room Number	R041
Ref Number	366907
Date Sampled	03/09/2020

ACM		
Asbestos Type Description:	Chrysotile	Comments
Material Type	Bituminous Product	Bitumen Adhesive
Quantity:	4m ²	
Room Number:	R041	
Room Description:	Toilet	
Item:	Floor	
Floor Level:	M&S Store, Castle Quays, Banbury, 1st Floor

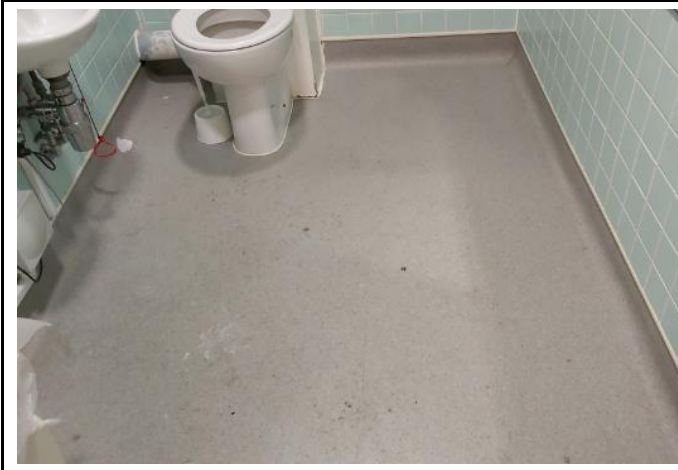
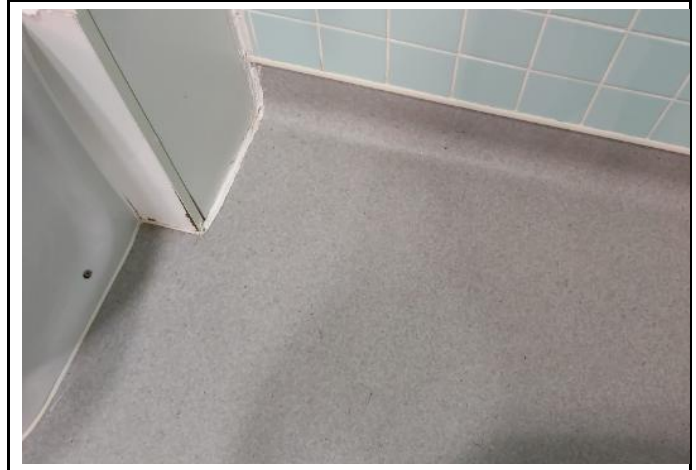
Room Number	R042
Ref Number	366908
Date Sampled	03/09/2020

ACM		
Asbestos Type Description:	Chrysotile	Comments Bitumen Adhesive
Material Type	Bituminous Product	
Quantity:	4m ²	
Room Number:	R042	
Room Description:	Toilet	
Item:	Floor	
Floor Level:	M&S Store, Castle Quays, Banbury, 1st Floor

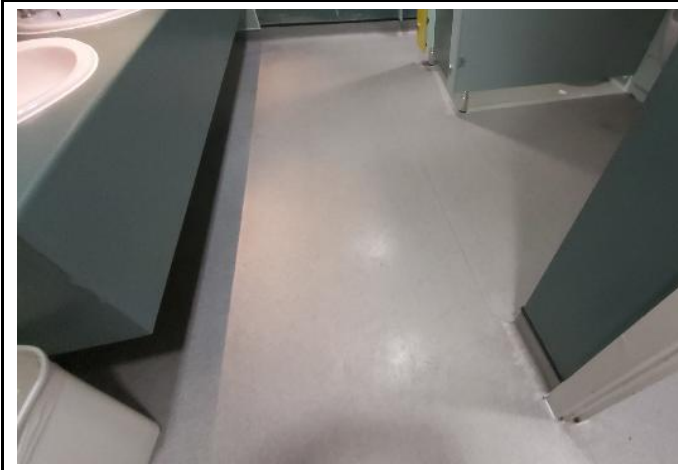
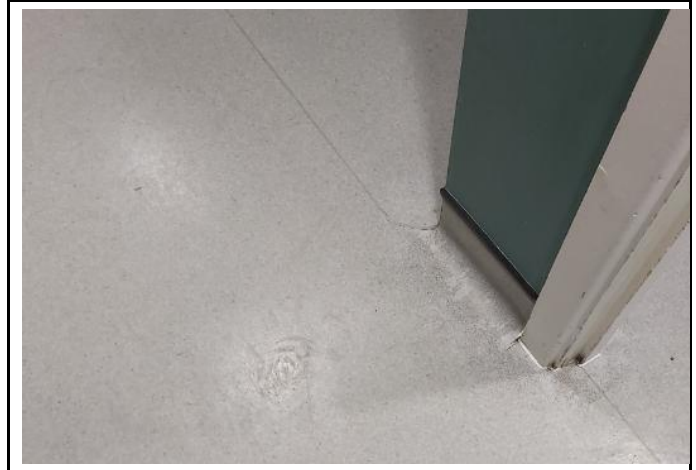
Room Number	R043
Ref Number	366909
Date Sampled	03/09/2020

ACM		
Asbestos Type Description:	Chrysotile	Comments
Material Type	Bituminous Product	Bitumen Adhesive
Quantity:	35m ²	
Room Number:	R043	
Room Description:	Toilet	
Item:	Floor	
Floor Level:	M&S Store, Castle Quays, Banbury, 1st Floor

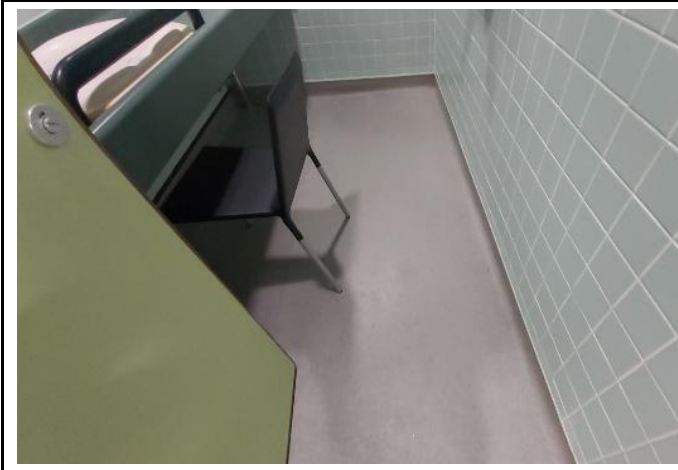
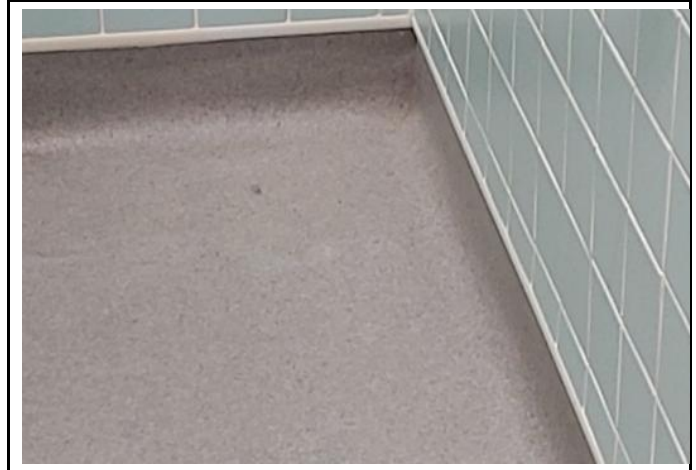
Room Number	R044
Ref Number	366910
Date Sampled	03/09/2020

ACM		
Asbestos Type Description:	Chrysotile	Comments Bitumen Adhesive.
Material Type	Bituminous Product	
Quantity:	6m ²	
Room Number:	R044	
Room Description:	Toilet	
Item:	Floor	
Floor Level:	M&S Store, Castle Quays, Banbury, 1st Floor

366910 As Sample S014	1st Floor Toilet R044 Floor	Bituminous Product 6m ²	Chrysotile	2	Remove Add to asbestos register and Monitor - Removal/repair works should be undertaken by a competent contractor following an appropriate risk assessment which includes adequate disposal to landfill.
366918 S019	1st Floor Store R045 Floor	Vinyl Products 350m ²	Chrysotile	2	Remove Add to asbestos register and Monitor - Removal/repair works should be undertaken by a competent contractor following an appropriate risk assessment which includes adequate disposal to landfill.
366931 As Sample S023	1st Floor Plant Room R047 Floor	Vinyl Products 1m ²	Chrysotile	2	Remove Add to asbestos register and Monitor - Removal/repair works should be undertaken by a competent contractor following an appropriate risk assessment which includes adequate disposal to landfill.
366932 As Sample S022	1st Floor Plant Room R047 Floor	Vinyl Products 1m ²	Chrysotile	2	Remove Add to asbestos register and Monitor - Removal/repair works should be undertaken by a competent contractor following an appropriate risk assessment which includes adequate disposal to landfill.

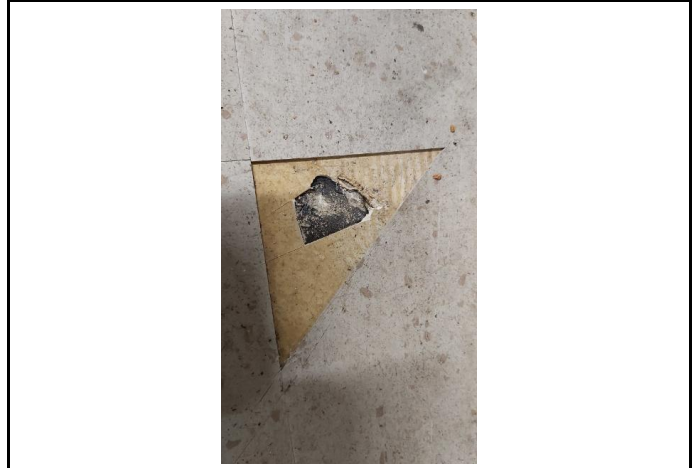
Room Number	R045
Ref Number	366918
Date Sampled	03/09/2020

ACM		
Asbestos Type Description:	Chrysotile	Comments White floor tiles and Bitumen Adhesive below modern Vinyl
Material Type	Vinyl Products	
Quantity:	350m ²	
Room Number:	R045	
Room Description:	Store	
Item:	Floor	
Floor Level:	M&S Store, Castle Quays, Banbury, 1st Floor

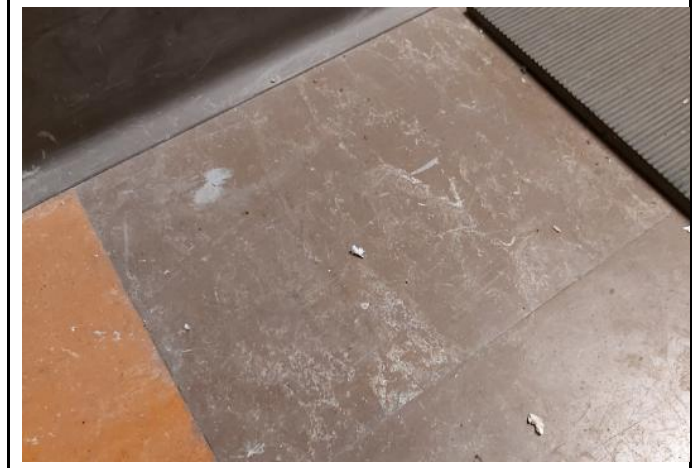
Room Number	R046
Ref Number	366933
Date Sampled	04/09/2020

ACM		
Asbestos Type Description:	Chrysotile	Comments
Material Type	Vinyl Products	Brown Tiles & Bitumen
Quantity:	4m ²	
Room Number:	R046	
Room Description:	Plant Room	
Item:	Floor	
Floor Level:	M&S Store, Castle Quays, Banbury, 1st Floor

366933 S020	1st Floor Plant Room R046 Floor	Vinyl Products 4m ²	Chrysotile	2	Remove Add to asbestos register and Monitor - Removal/repair works should be undertaken by a competent contractor following an appropriate risk assessment which includes adequate disposal to landfill.
366934 S021	1st Floor Plant Room R046 Floor	Vinyl Products 4m ²	Chrysotile	2	Remove Add to asbestos register and Monitor - Removal/repair works should be undertaken by a competent contractor following an appropriate risk assessment which includes adequate disposal to landfill.
366935 S023	1st Floor Plant Room R046 Floor	Vinyl Products 4m ²	Chrysotile	2	Remove Add to asbestos register and Monitor - Removal/repair works should be undertaken by a competent contractor following an appropriate risk assessment which includes adequate disposal to landfill.

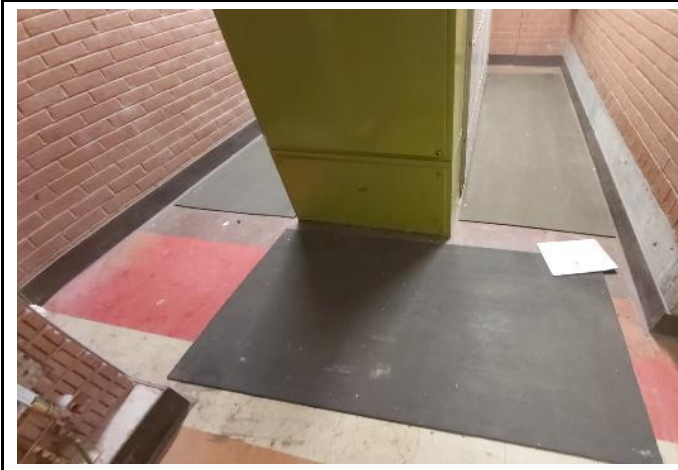
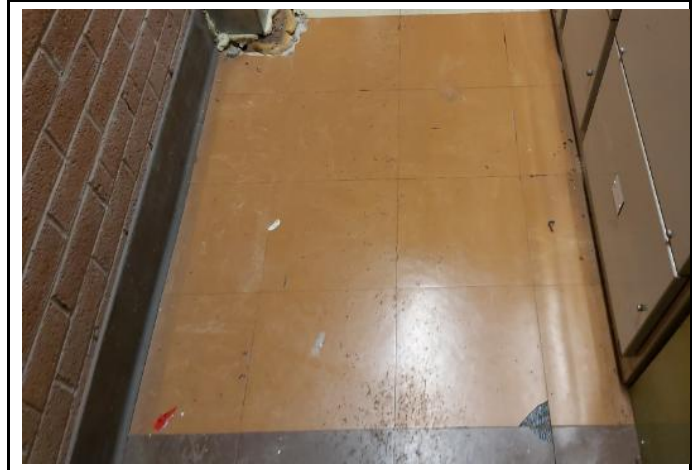
Room Number	R046
Ref Number	366934
Date Sampled	04/09/2020

ACM		
Asbestos Type Description:	Chrysotile	Comments Orange Tiles & Bitumen
Material Type	Vinyl Products	
Quantity:	4m ²	
Room Number:	R046	
Room Description:	Plant Room	
Item:	Floor	
Floor Level:	M&S Store, Castle Quays, Banbury, 1st Floor

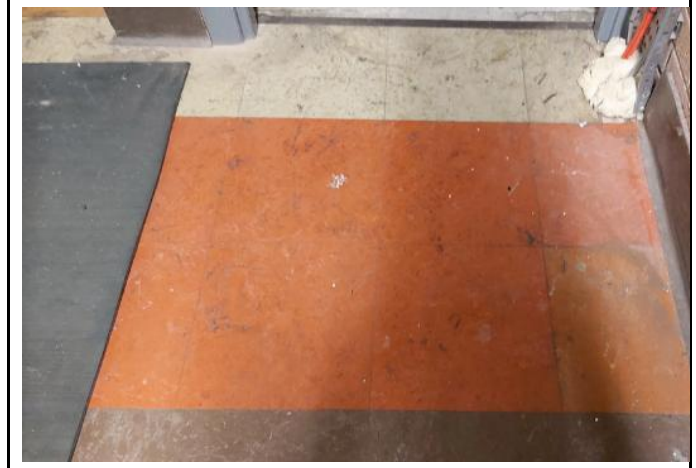
Room Number	R046
Ref Number	366935
Date Sampled	04/09/2020

ACM		
Asbestos Type Description:	Chrysotile	Comments Red Tiles & Bitumen
Material Type	Vinyl Products	
Quantity:	4m ²	
Room Number:	R046	
Room Description:	Plant Room	
Item:	Floor	
Floor Level:	M&S Store, Castle Quays, Banbury, 1st Floor

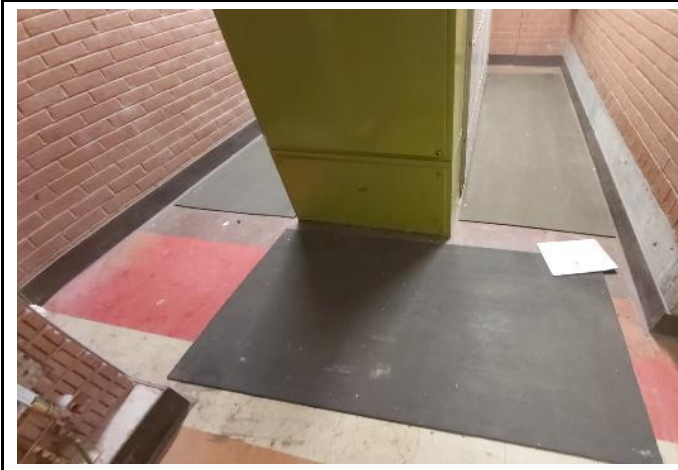
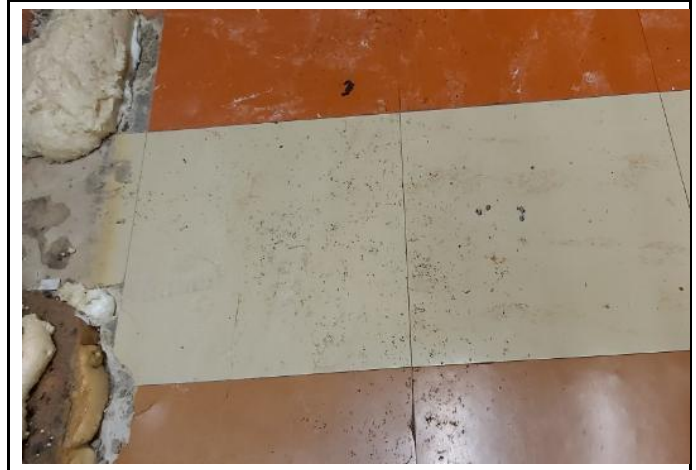
Room Number	R046
Ref Number	366958
Date Sampled	04/09/2020

ACM		
Asbestos Type Description:	Chrysotile	Comments
Material Type	Vinyl Products	White Tiles & Bitumen
Quantity:	4m ²	
Room Number:	R046	
Room Description:	Plant Room	
Item:	Floor	
Floor Level:	M&S Store, Castle Quays, Banbury, 1st Floor

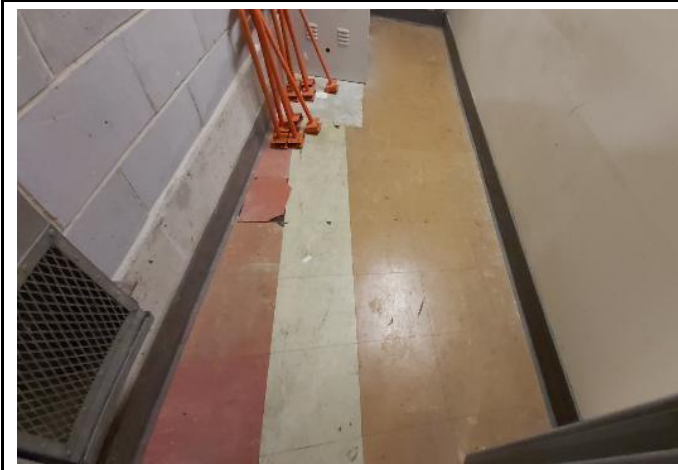
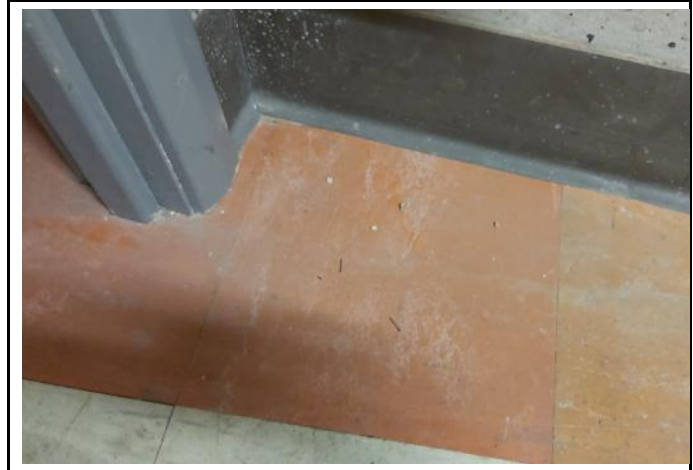
Room Number	R047
Ref Number	366931
Date Sampled	04/09/2020

ACM		
Asbestos Type Description:	Chrysotile	Comments Red Tiles & Bitumen
Material Type	Vinyl Products	
Quantity:	1m ²	
Room Number:	R047	
Room Description:	Plant Room	
Item:	Floor	
Floor Level:	M&S Store, Castle Quays, Banbury, 1st Floor

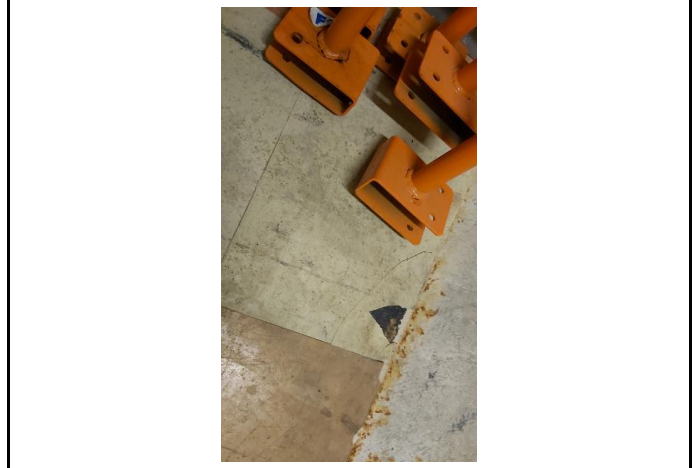
Room Number	R047
Ref Number	366932
Date Sampled	04/09/2020

ACM		
Asbestos Type Description:	Chrysotile	Comments
Material Type	Vinyl Products	White Tiles & Bitumen
Quantity:	1m ²	
Room Number:	R047	
Room Description:	Plant Room	
Item:	Floor	
Floor Level:	M&S Store, Castle Quays, Banbury, 1st Floor

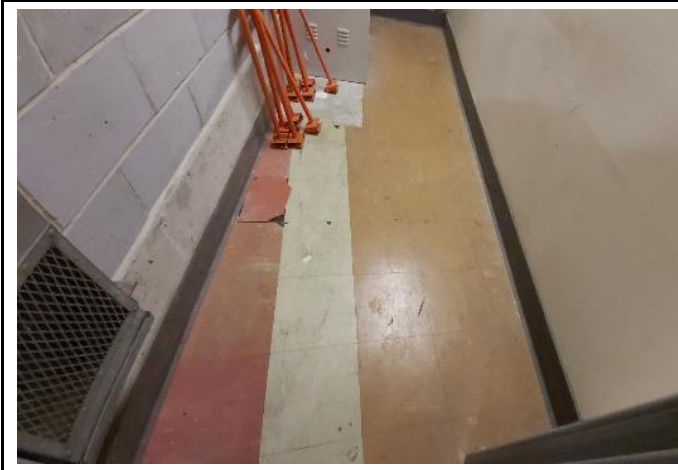
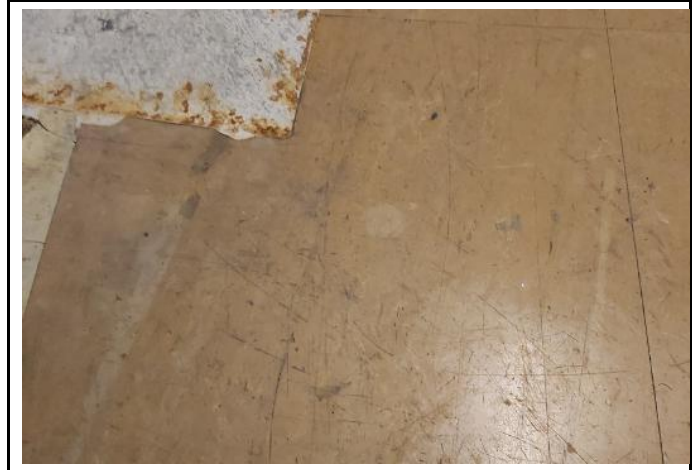
Room Number	R047
Ref Number	366976
Date Sampled	04/09/2020

ACM		
Asbestos Type Description:	Chrysotile	Comments Orange Tiles & Bitumen
Material Type	Vinyl Products	
Quantity:	4m ²	
Room Number:	R047	
Room Description:	Plant Room	
Item:	Floor	
Floor Level:	M&S Store, Castle Quays, Banbury, 1st Floor

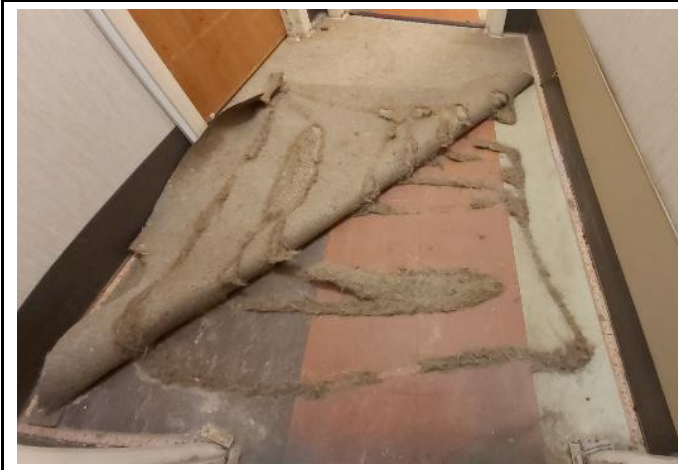
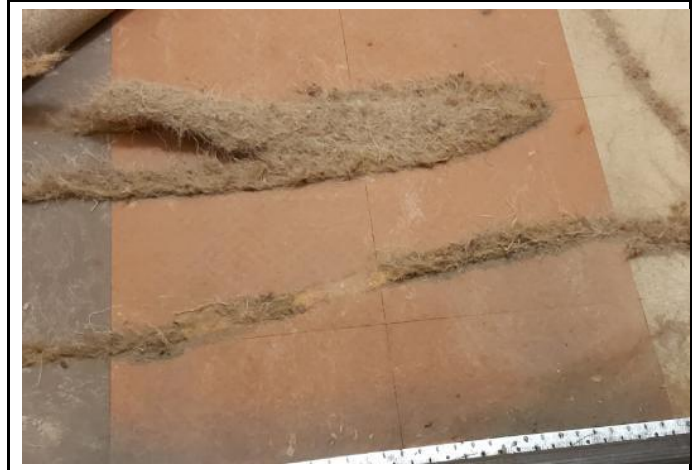
Room Number	R050
Ref Number	366955
Date Sampled	04/09/2020

ACM		
Asbestos Type Description:	Chrysotile	Comments Orange Tiles & Bitumen
Material Type	Vinyl Products	
Quantity:	1m ²	
Room Number:	R050	
Room Description:	Corridor	
Item:	Floor	
Floor Level:	M&S Store, Castle Quays, Banbury, 1st Floor

366955 As Sample S021	1st Floor Corridor R050 Floor	Vinyl Products 1m ²	Chrysotile	2	Remove Add to asbestos register and Monitor - Removal/repair works should be undertaken by a competent contractor following an appropriate risk assessment which includes adequate disposal to landfill.
366956 As Sample S020	1st Floor Corridor R050 Floor	Vinyl Products 1m ²	Chrysotile	2	Remove Add to asbestos register and Monitor - Removal/repair works should be undertaken by a competent contractor following an appropriate risk assessment which includes adequate disposal to landfill.
366957 As Sample S022	1st Floor Corridor R050 Floor	Vinyl Products 1m ²	Chrysotile	2	Remove Add to asbestos register and Monitor - Removal/repair works should be undertaken by a competent contractor following an appropriate risk assessment which includes adequate disposal to landfill.
366958 S022	1st Floor Plant Room R046 Floor	Vinyl Products 4m ²	Chrysotile	2	Remove Add to asbestos register and Monitor - Removal/repair works should be undertaken by a competent contractor following an appropriate risk assessment which includes adequate disposal to landfill.
