Armco
Asbestos Surveys

TECHNICAL REPORT

PROPERTY ADDRESS: M&S Store, Castle Quay Shopping Centre, Banbury, OX16 5UN

REPORT TYPE: Asbestos Refurbishment/Demolition Survey

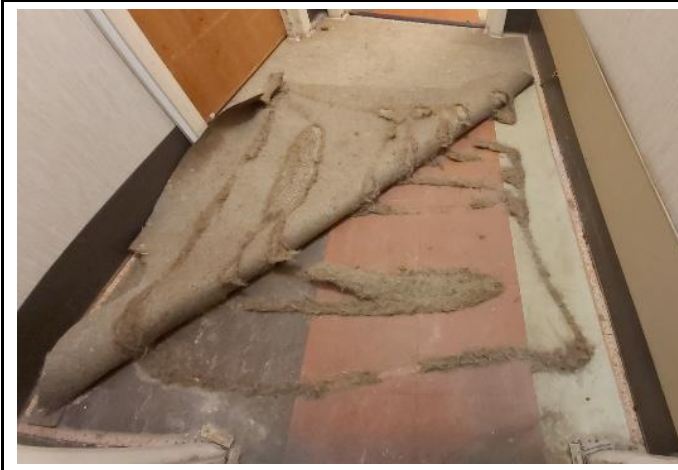
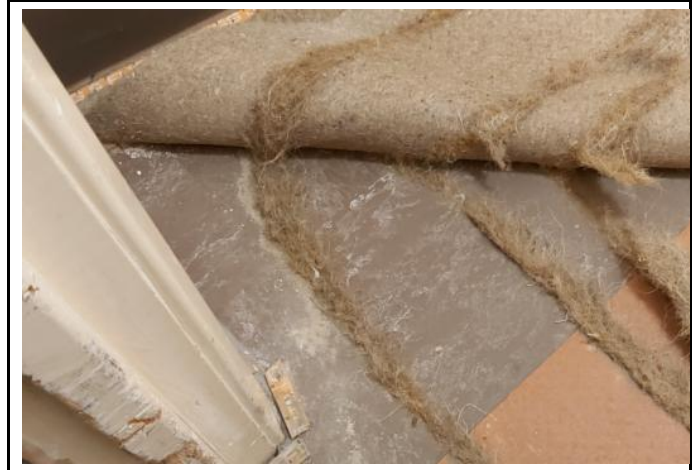
Room Number	R050
Ref Number	366956
Date Sampled	04/09/2020

ACM		
Asbestos Type Description:	Chrysotile	Comments
Material Type	Vinyl Products	Brown Tiles & Bitumen
Quantity:	1m ²	
Room Number:	R050	
Room Description:	Corridor	
Item:	Floor	
Floor Level:	M&S Store, Castle Quays, Banbury, 1st Floor

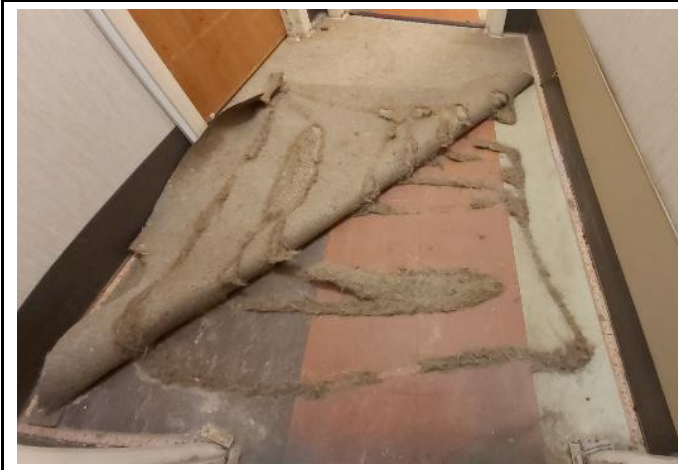
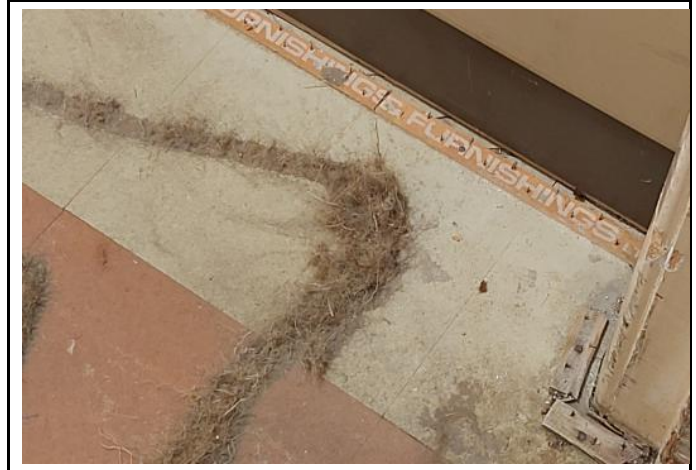
ACM		
Asbestos Type Description:	Chrysotile	Comments White Tiles & Bitumen
Material Type	Vinyl Products	
Quantity:	1m ²	
Room Number:	R050	
Room Description:	Corridor	
Item:	Floor	
Floor Level:	M&S Store, Castle Quays, Banbury, 1st Floor

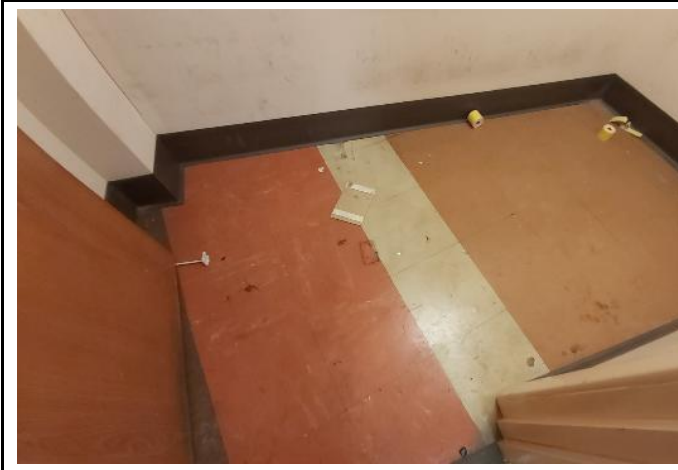
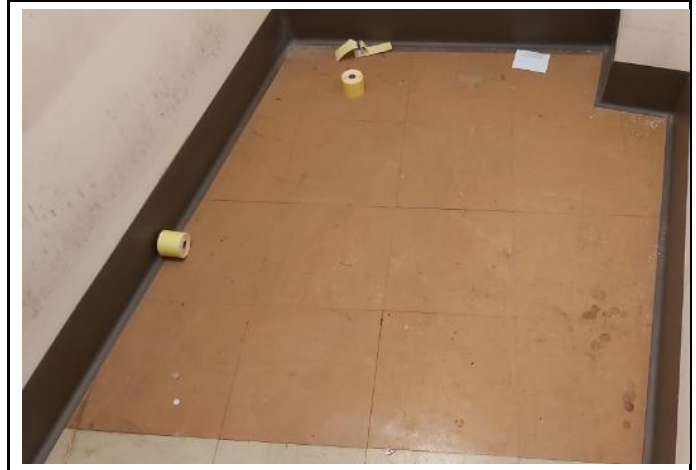
ACM		
Asbestos Type Description:	Chrysotile	Comments Orange Tiles & Bitumen
Material Type	Vinyl Products	
Quantity:	1m ²	
Room Number:	R052	
Room Description:	Store	
Item:	Floor	
Floor Level:	M&S Store, Castle Quays, Banbury, 1st Floor

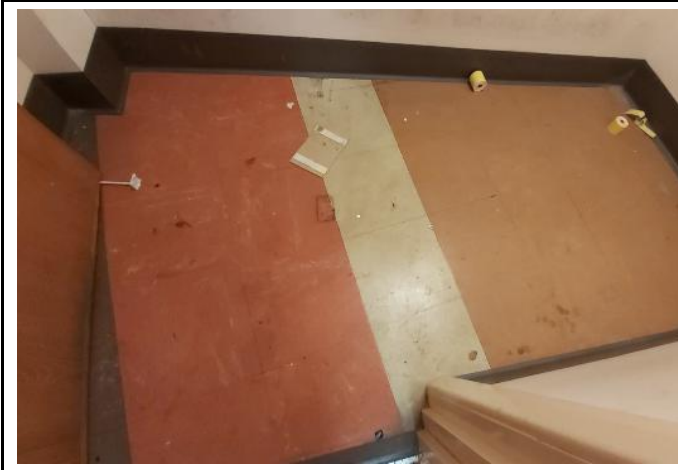
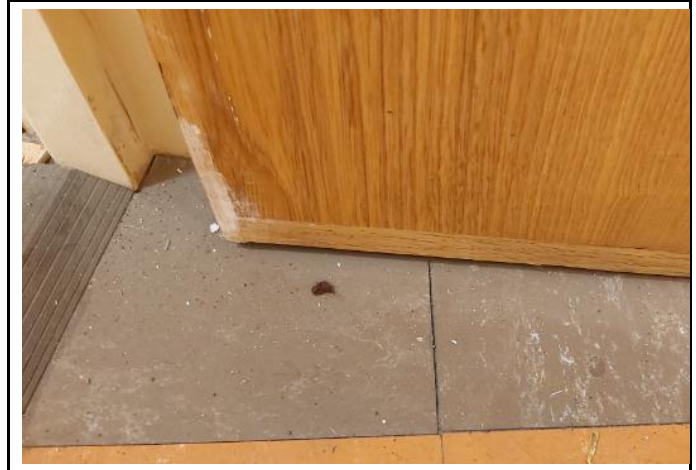
ACM		
Asbestos Type Description:	Chrysotile	Comments
Material Type	Vinyl Products	Brown Tiles & Bitumen
Quantity:	1m ²	
Room Number:	R052	
Room Description:	Store	
Item:	Floor	
Floor Level:	M&S Store, Castle Quays, Banbury, 1st Floor

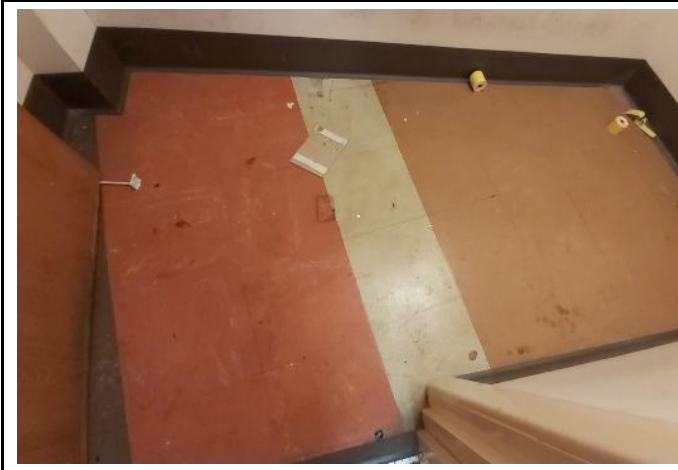
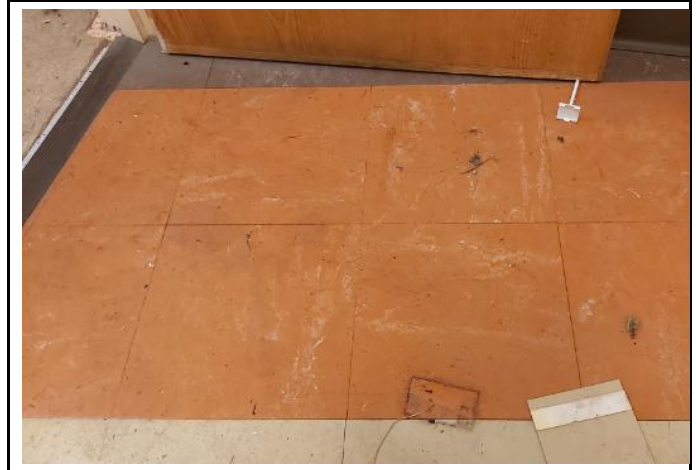
ACM		
Asbestos Type Description:	Chrysotile	Comments
Material Type	Vinyl Products	Tiles & Bitumen
Quantity:	1m ²	
Room Number:	R052	
Room Description:	Store	
Item:	Floor	
Floor Level:	M&S Store, Castle Quays, Banbury, 1st Floor

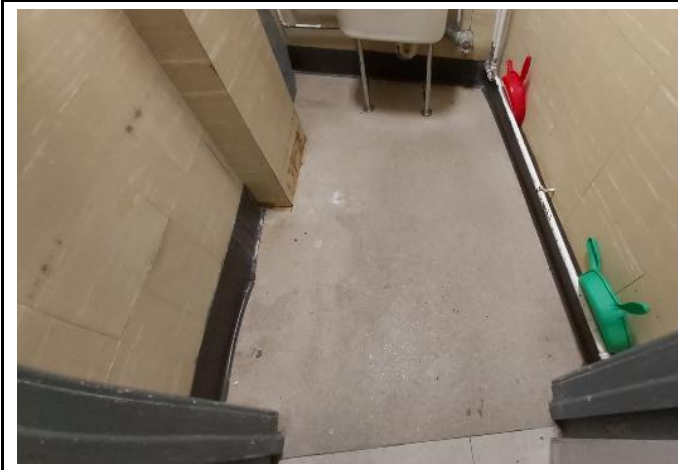
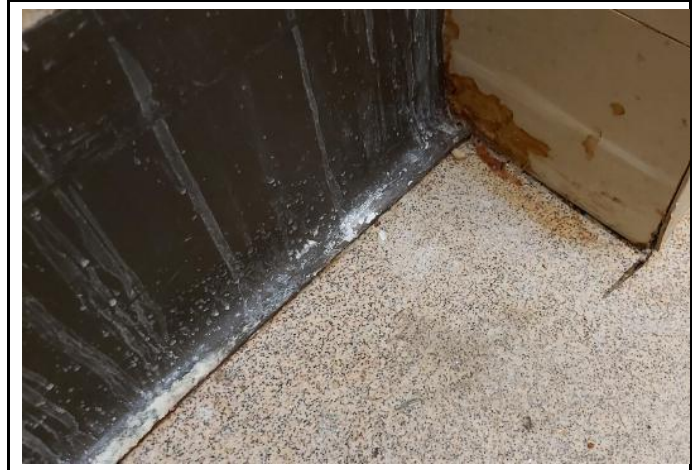
ACM		
Asbestos Type Description:	Chrysotile	Comments White floor tiles and Bitumen Adhesive below modern Vinyl
Material Type	Vinyl Products	
Quantity:	2m ²	
Room Number:	R053	
Room Description:	Cleaners Cupboard	
Item:	Floor	
Floor Level:	M&S Store, Castle Quays, Banbury, 1st Floor

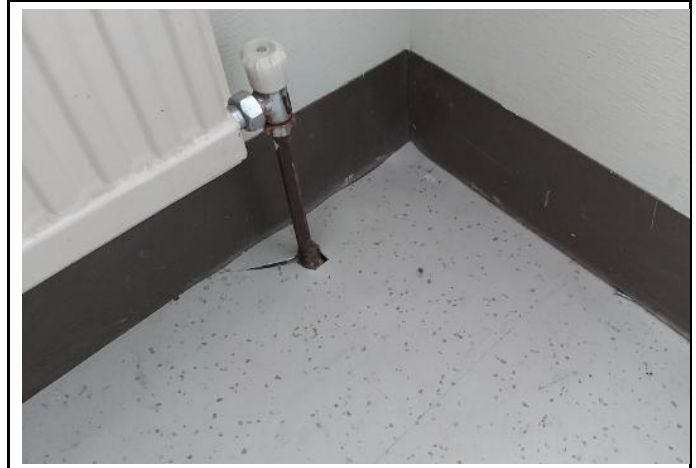
ACM		
Asbestos Type Description:	Chrysotile	Comments White floor tiles and Bitumen Adhesive below modern Vinyl
Material Type	Vinyl Products	
Quantity:	25m ²	
Room Number:	R060	
Room Description:	Store	
Item:	Floor	
Floor Level:	M&S Store, Castle Quays, Banbury, 1st Floor

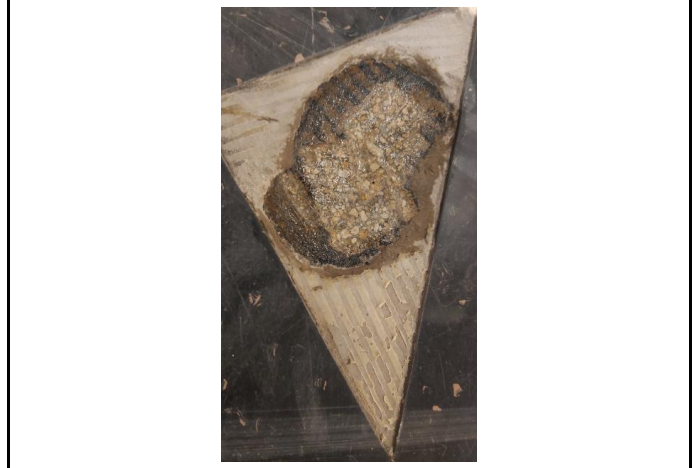
ACM		
Asbestos Type Description:	Chrysotile	Comments Bitumen Adhesive below Screeding
Material Type	Bituminous Product	
Quantity:	500m ²	
Room Number:	R061	
Room Description:	Main Store	
Item:	Floor	
Floor Level:	M&S Store, Castle Quays, Banbury, Ground Floor

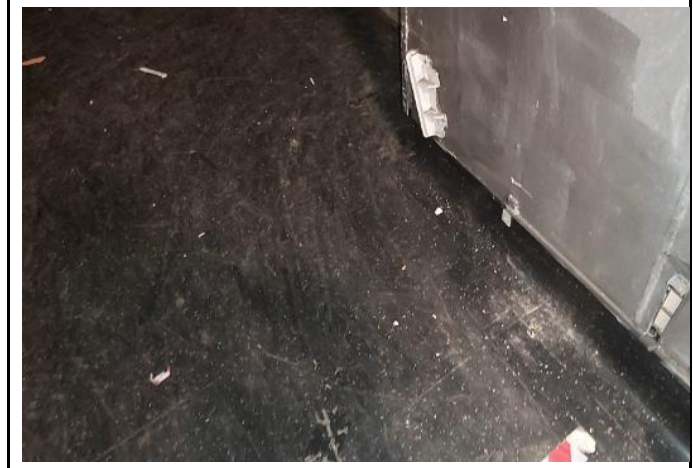
ACM		
Asbestos Type Description:	Chrysotile	Comments Bitumen Adhesive below Screeding
Material Type	Bituminous Product	
Quantity:	10m ²	
Room Number:	R071	
Room Description:	Lift Lobby	
Item:	Floor	
Floor Level:	M&S Store, Castle Quays, Banbury, Ground Floor

367128 As Sample S031	Ground Floor Lift Lobby R071 Floor	Bituminous Product 10m ²	Chrysotile	2	Remove Add to asbestos register and Monitor - Removal/repair works should be undertaken by a competent contractor following an appropriate risk assessment which includes adequate disposal to landfill.
367201 S038	Ground Floor Store R079 Floor	Vinyl Products 3m ²	Chrysotile	2	Remove Add to asbestos register and Monitor - Removal/repair works should be undertaken by a competent contractor following an appropriate risk assessment which includes adequate disposal to landfill.

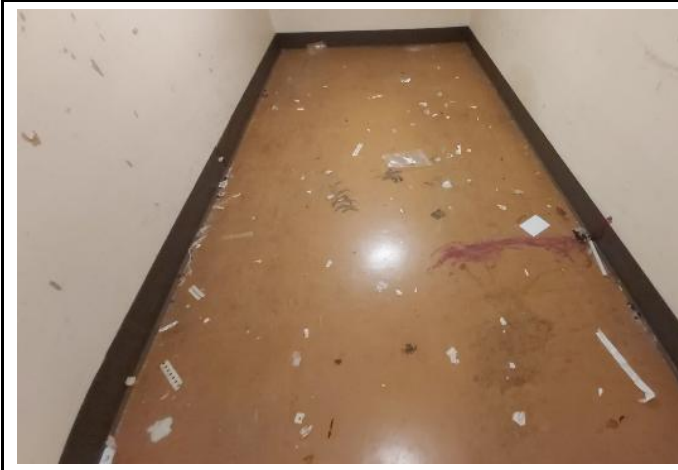
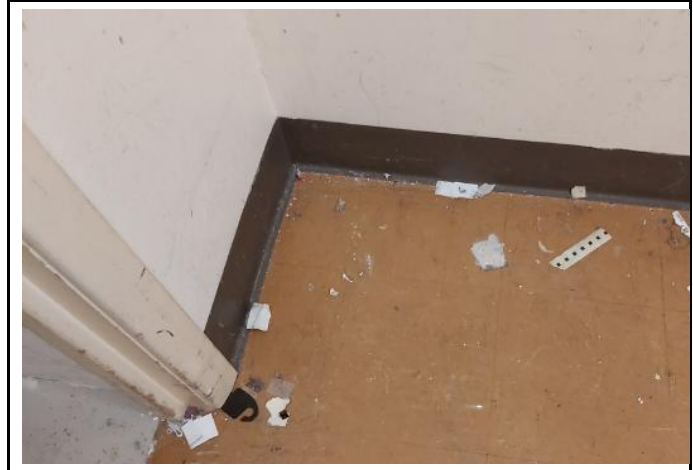
ACM		
Asbestos Type Description:	Chrysotile	Comments
Material Type	Vinyl Products	Floor Tiles
Quantity:	3m²	
Room Number:	R079	
Room Description:	Store	
Item:	Floor	
Floor Level:	M&S Store, Castle Quays, Banbury, Ground Floor
