PRE-CONSTRUCTION INFORMATION PACK

Maintenance Project

Paulerspury, C.E. Primary School
High Street
Paulerspury
Towcester
Northants
NN12 7NA

Ref: 6931-04-200828-MC-TB

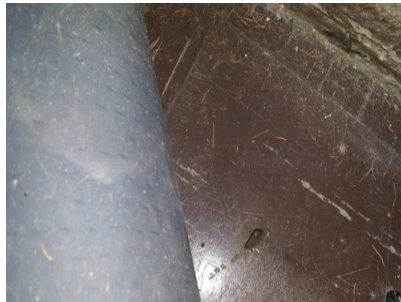
Building	Level	Location	Item / Product Examined	Sample No.	Material Description	Fibre Type	Material Score	Extent	Risk Level Assessment	Initial Control Recommendation	Photograph
Paulerspury C.E Primary School	0	001/ entrance	sub floor	124074-1	Asbestos-containing vinyl tile and adhesive	Chrysotile	3	18 Sqm.	R3	Reinspect Periodically

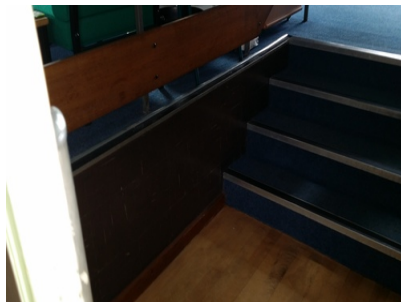
Paulerspury C.E Primary School	0	001/ entrance	cladding to wall of raised floor	124074-1	Asbestos-containing vinyl tile and adhesive	Chrysotile	3	1 Sqm.	R3	Reinspect Periodically

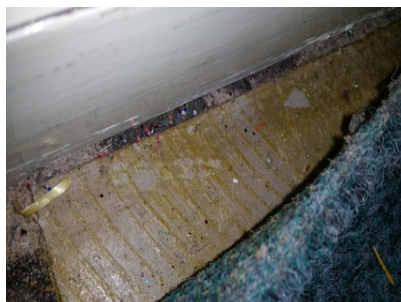
Paulerspury C.E Primary School	0	003/ classroom 03	sub floor	124074-2	Asbestos-containing vinyl tile and adhesive	Chrysotile	3	20 Sqm.	R3	Reinspect Periodically

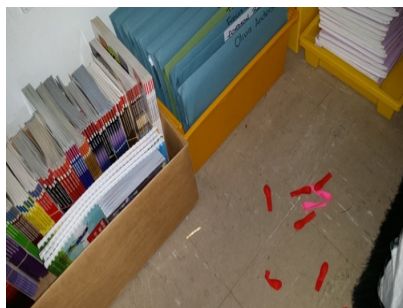
Building	Level	Location	Item / Product Examined	Sample No.	Material Description	Fibre Type	Material Score	Extent	Risk Level Assessment	Initial Control Recommendation	Photograph
Paulerspury C.E Primary School	0	004/store 04	floor covering	124074-5	Asbestos-containing vinyl tile and adhesive	Chrysotile	3	4 Sqm.	R3	Reinspect Periodically

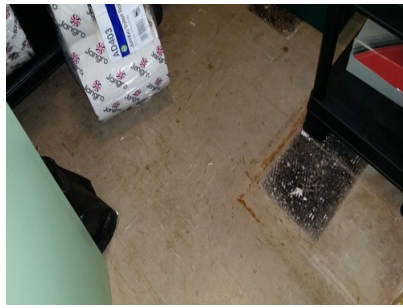
Paulerspury C.E Primary School	0	010/electric store 10	floor covering	124074-8	Asbestos-containing vinyl tile and adhesive	Chrysotile	3	4 Sqm.	R3	Reinspect Periodically

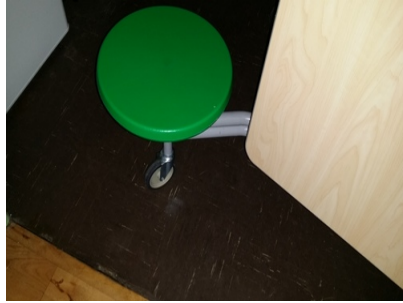
Paulerspury C.E Primary School	0	012/P.E. store 24	floor covering	124074-1	Asbestos-containing vinyl tile and adhesive	Chrysotile	3	5 Sqm.	R3	Reinspect Periodically

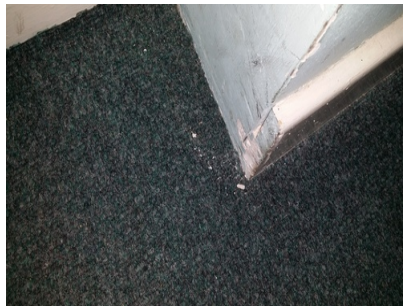
Building	Level	Location	Item / Product Examined	Sample No.	Material Description	Fibre Type	Material Score	Extent	Risk Level Assessment	Initial Control Recommendation	Photograph
Paulerspury C.E Primary School	0	013/resources 23	floor covering	124074-1	Asbestos-containing vinyl tile and adhesive	Chrysotile	3	6 Sqm.	R3	Reinspect Periodically

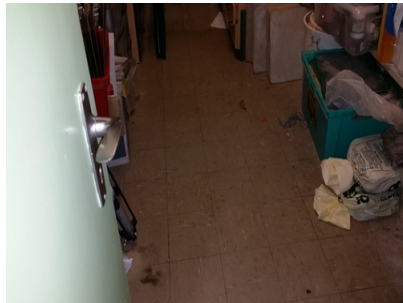
Paulerspury C.E Primary School	0	014/store 22	floor covering	124074-9	Asbestos-containing vinyl tile and adhesive	Chrysotile	3	4 Sqm.	R3	Reinspect Periodically

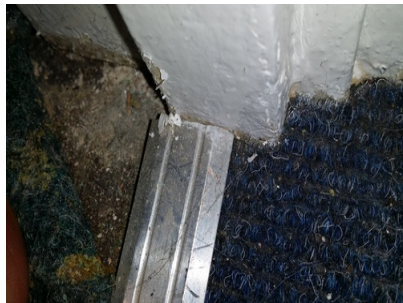
Paulerspury C.E Primary School	0	017/heads office 19	sub floor	124074-1	Asbestos-containing vinyl tile and adhesive	Chrysotile	3	4 Sqm.	R3	Reinspect Periodically

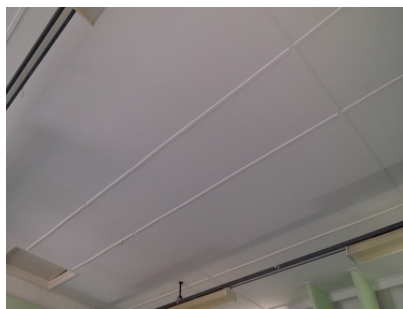
Building	Level	Location	Item / Product Examined	Sample No.	Material Description	Fibre Type	Material Score	Extent	Risk Level Assessment	Initial Control Recommendation	Photograph
Paulerspury C.E Primary School	0	019/ classroom 17	ceiling		Asbestos-containing fibreboard	Presume Amosite	7	22 Sqm.	PRESUME	Reinspect Periodically

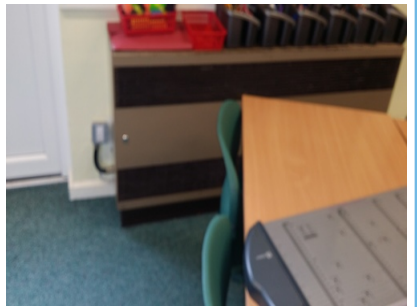
Building	Level	Location	Item / Product Examined	Accessibility	Access Comments	Photograph
Paulerspury C.E Primary School	0	003/classroom 03	heater to wall	Limited Access	live service supply

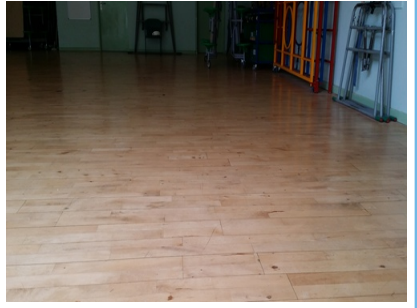
Paulerspury C.E Primary School	0	005/hall 05	beneath floor covering	No Access	fixed laminate flooring

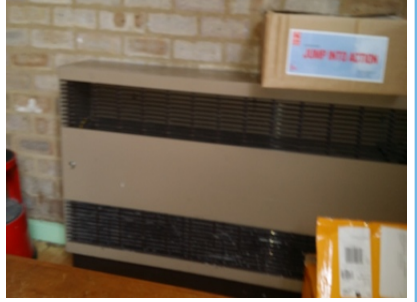
Paulerspury C.E Primary School	0	005/hall 05	heater to wall	No Access	live service supply

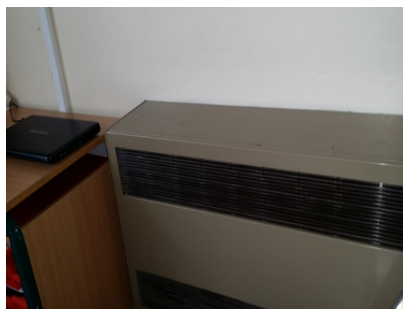
Building	Level	Location	Item / Product Examined	Accessibility	Access Comments	Photograph
Paulerspury C.E Primary School	0	007/classroom 030	heater to wall	Limited Access	live service supply

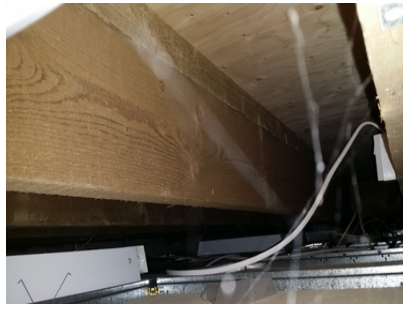
Paulerspury C.E Primary School	0	007/classroom 030 - void above	Entire Location	Limited Access	physically restricted space

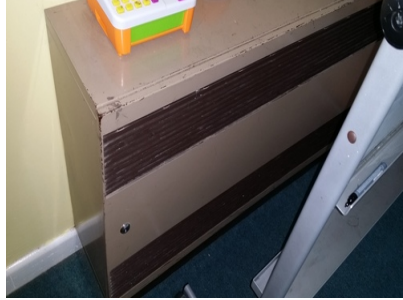
Paulerspury C.E Primary School	0	008/classroom 06	heater to wall	Limited Access	live service supply

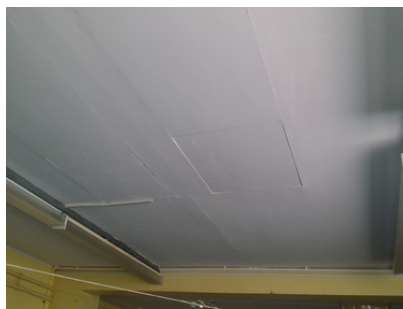
Building	Level	Location	Item / Product Examined	Accessibility	Access Comments	Photograph
Paulerspury C.E Primary School	0	008/classroom 06- void above	Entire Location	No Access	access not authorised - fixed ceiling tiles

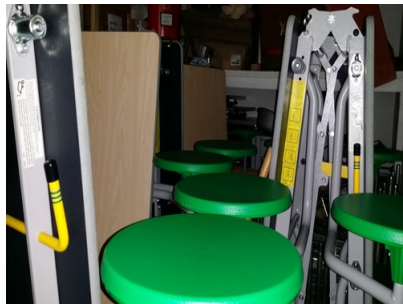
Paulerspury C.E Primary School	0	012/P.E. store 24	Entire Location	Limited Access	physically restricted space

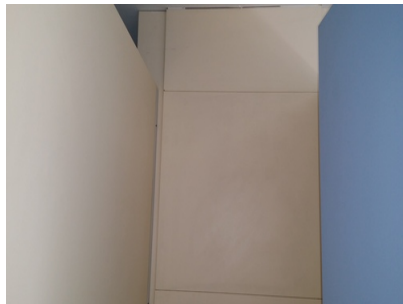
Paulerspury C.E Primary School	0	015/male wc 21	within boxing	No Access	access not authorised due to causing excessive damage

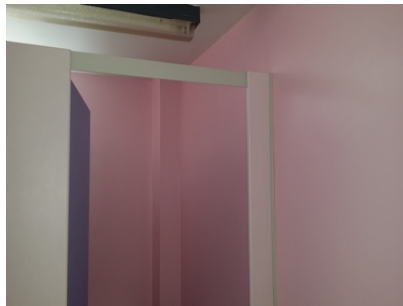
Building	Level	Location	Item / Product Examined	Accessibility	Access Comments	Photograph
Paulerspury C.E Primary School	0	016/female wc 20	within boxing	No Access	access not authorised due to causing excessive damage

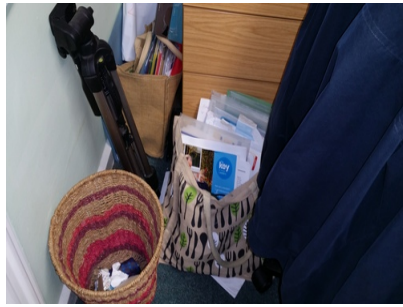
Paulerspury C.E Primary School	0	017/heads office 19	Entire Location	Limited Access	physically restricted space

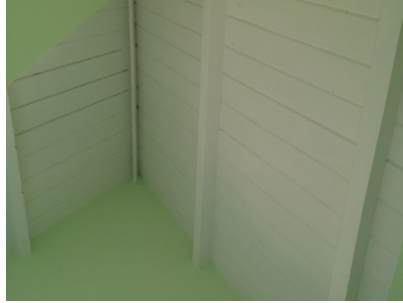
Paulerspury C.E Primary School	0	018/cloaks 18	above ceiling panels	No Access	reasons of height

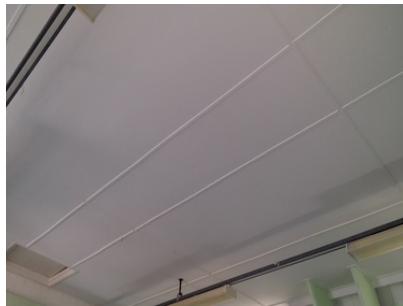
Building	Level	Location	Item / Product Examined	Accessibility	Access Comments	Photograph
Paulerspury C.E Primary School	0	019/classroom 17	ceiling	Limited Access	reasons of height - unable to inspect close to sample/determine if ACM present

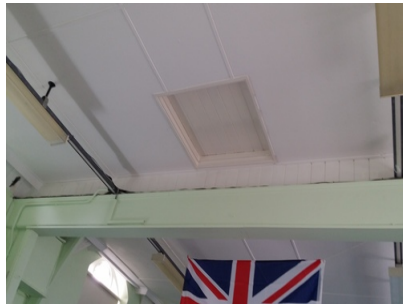
Paulerspury C.E Primary School	0	019/classroom 17 - void above	Entire Location	No Access	reasons of height - unable to gain safe access to hatch

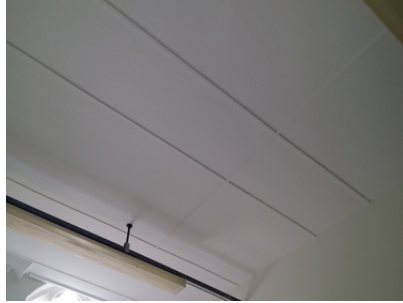
Paulerspury C.E Primary School	0	020/I.T.C. 26	ceiling	Limited Access	reasons of height

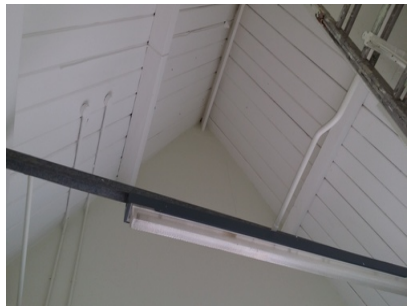
Building	Level	Location	Item / Product Examined	Accessibility	Access Comments	Photograph
Paulerspury C.E Primary School	0	021/cloaks 16	above ceiling panels	No Access	reasons of height

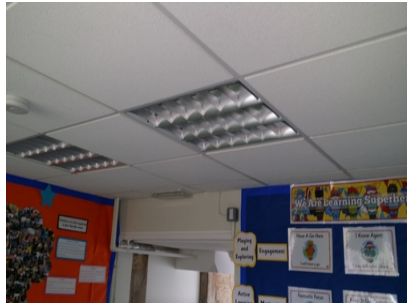
Paulerspury C.E Primary School	0	025/lobby 12 - void above	Entire Location	No Access	access not authorised

not accessed due to not allowed by client
