CONDITION REPORT

THE OLD TOWN HALL ROOF HIGH STREET CHRISTCHURCH BH23 1AB

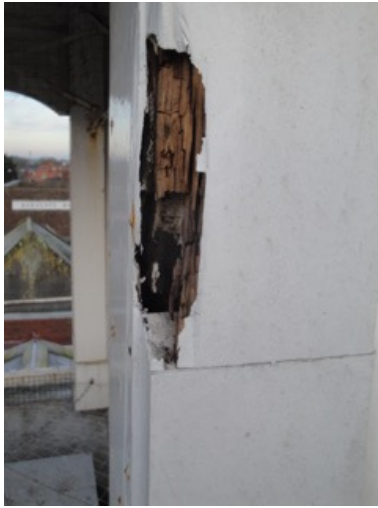
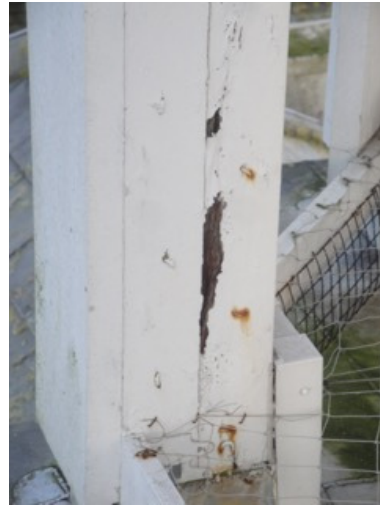
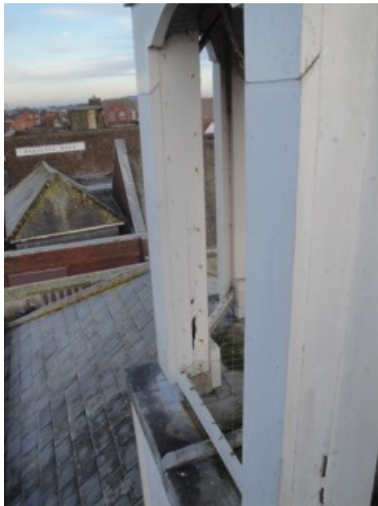
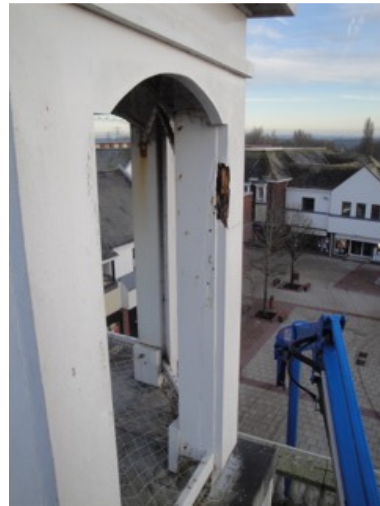
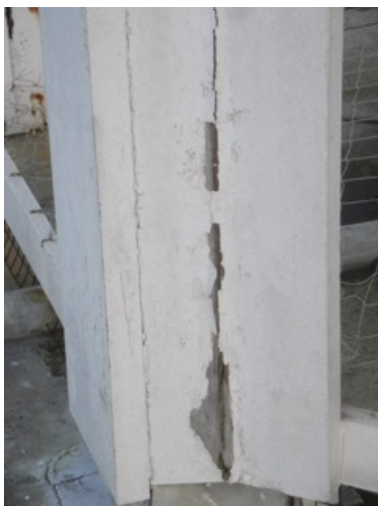
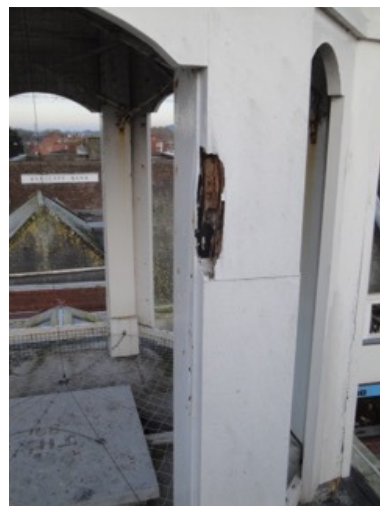
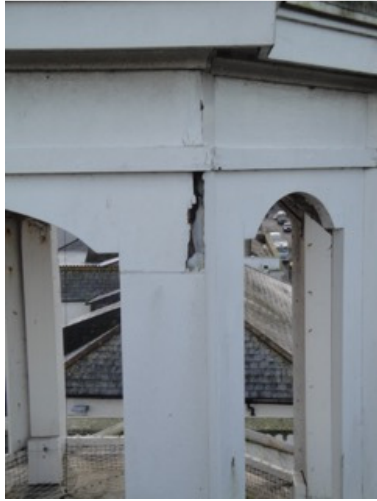
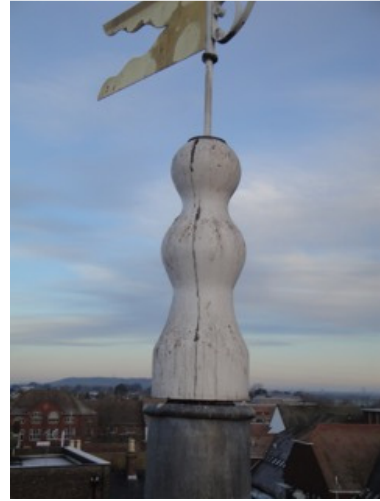
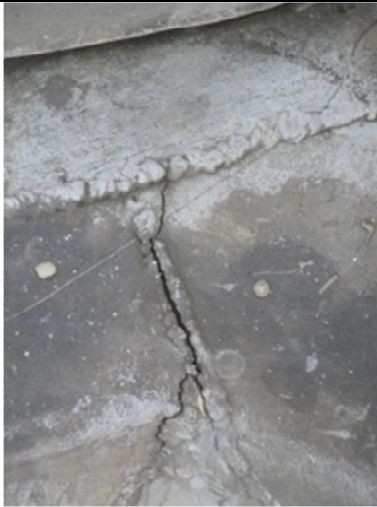
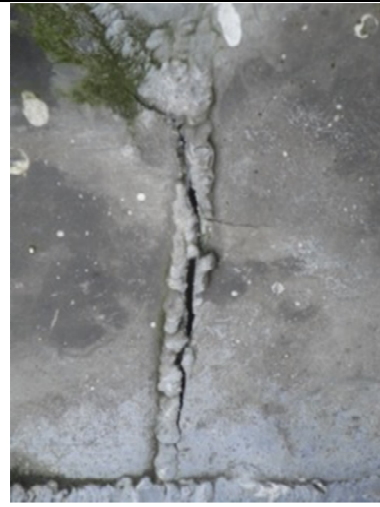
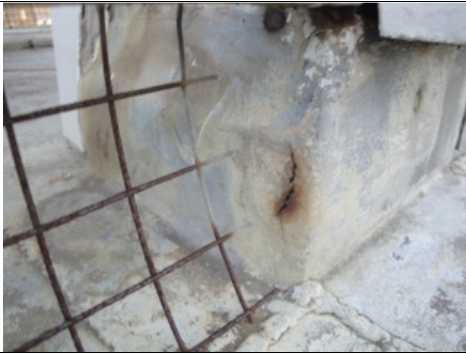
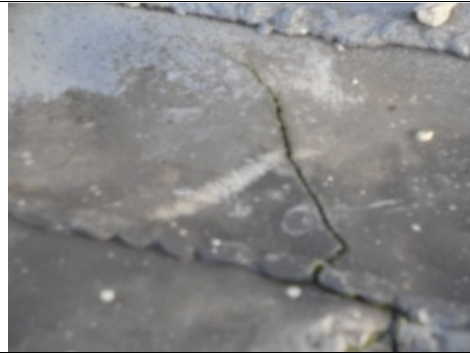
PHOTOGRAPHIC RECORD OF CUPOLA

According to archived records the cupola was replaced in the Autumn of 1988 due to its poor state of repair and threat to public safety. The present cupola appears to be structurally robust, but the recent internal refurbishment works have revealed further problems with water ingress through and around the base of the cupola, resulting in several of the main timber supports having wet rot – wood samples were taken at the time of inspection in January 2016. The leaking leadwork covering the base of the cupola has been repaired on a temporary basis by a local roofing contractor (Byron Spillard) who has had previous experience in dealing with the roof of this building.

Below are photos taken at the time of inspection in January 2016:-

1. Removal of existing leadwork beneath cupola.
2. Repairs to any rotten woodwork by scarfing in new and/or chemical treatment.
3. Inspection and cleaning of existing slates, replacement of any broken items.
4. Replacement of leadwork beneath cupola including valleys of pitched roof adjacent.
5. Re-painting of cupola.

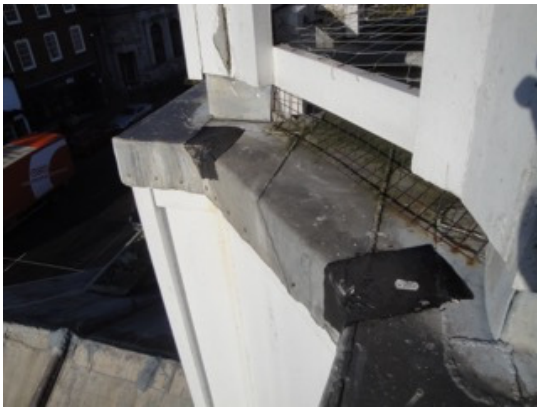
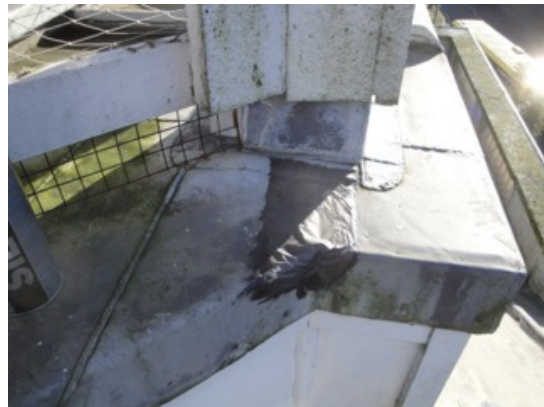
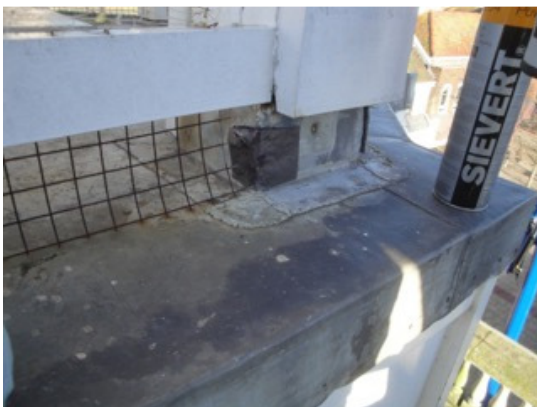
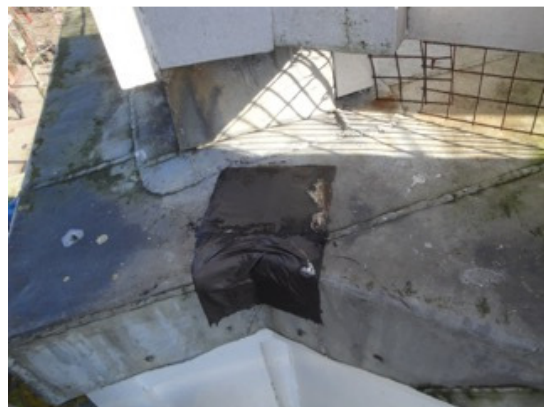
Temporary repairs carried out January 2016:-

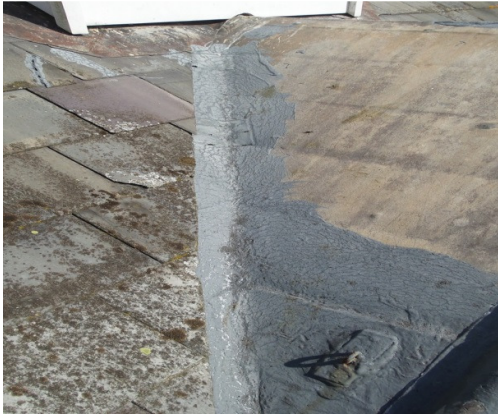
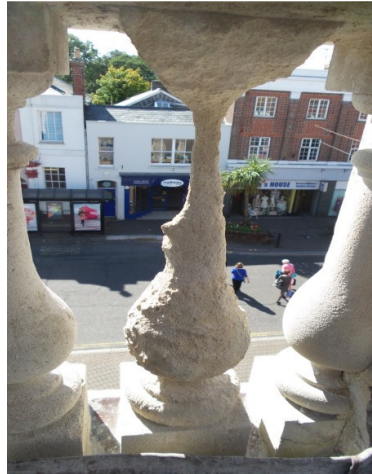
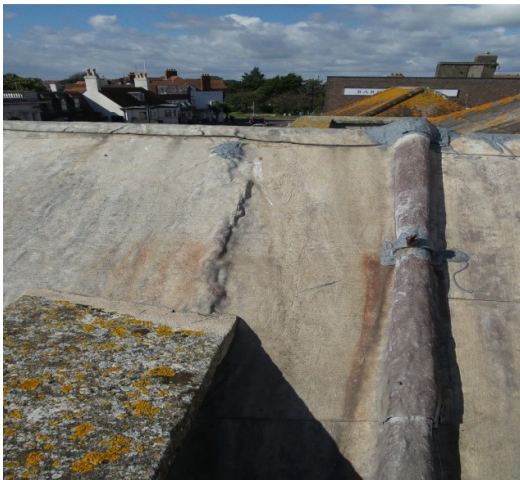
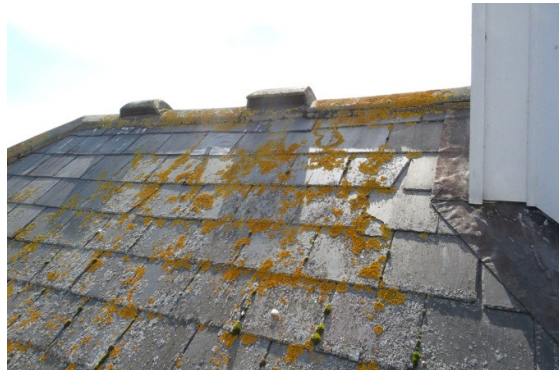
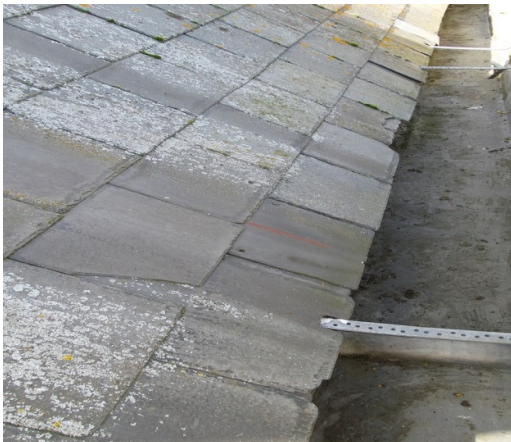
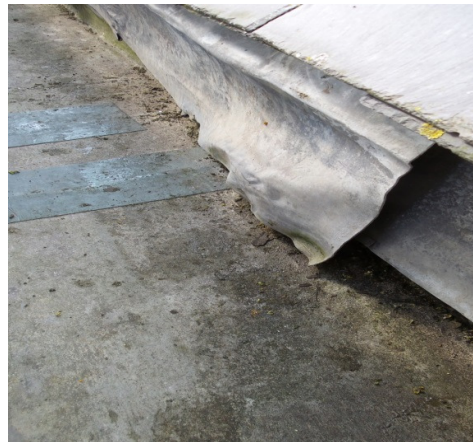
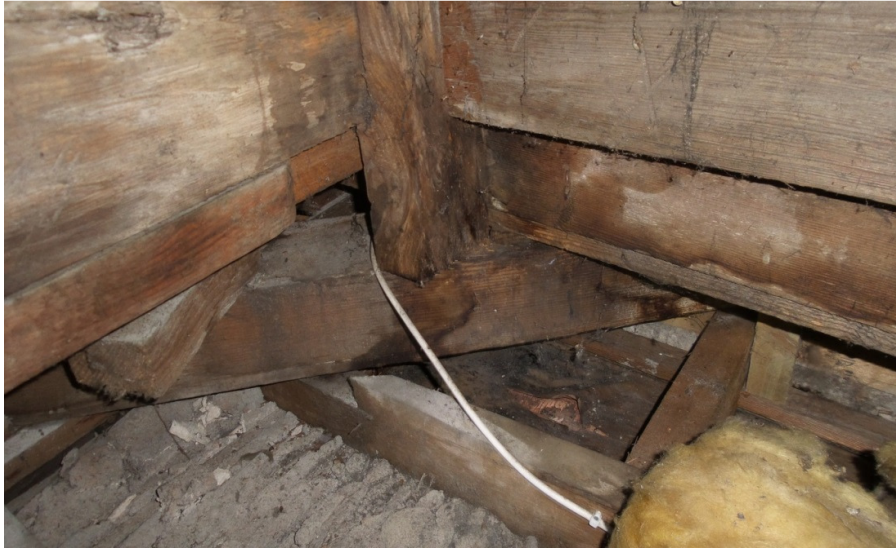
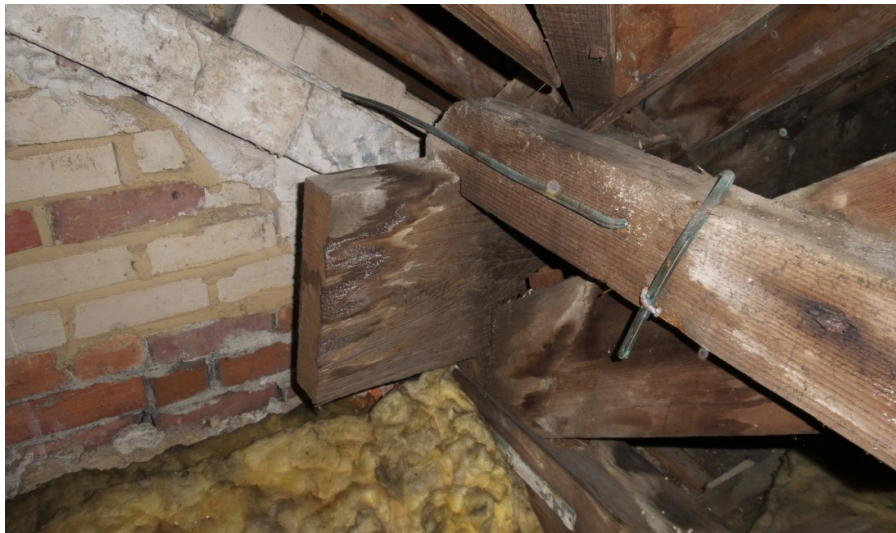
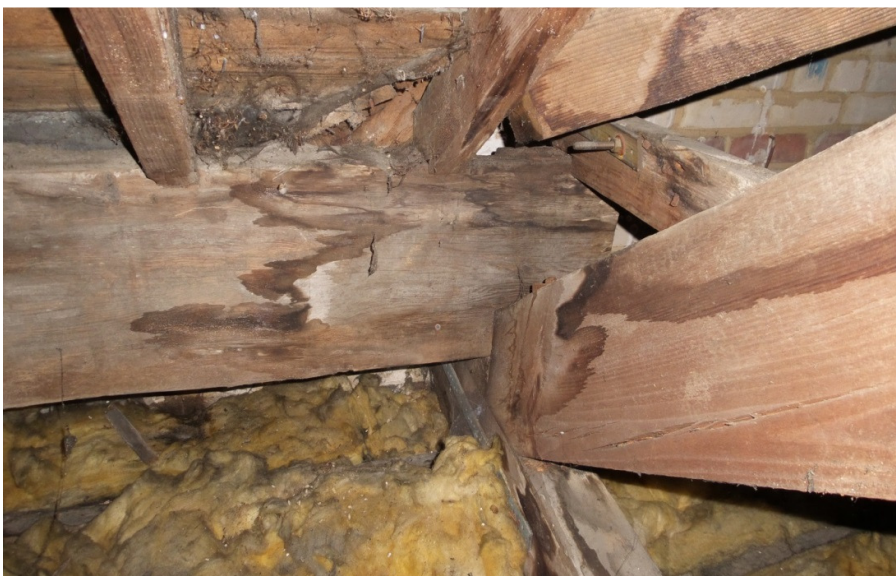
PHOTOGRAPHIC RECORD OF ROOF

Below are photos taken in October 2015:-

The roof appears to have been re-slatted in the recent past using second hand blue slates. The slates are of poor quality and there are many broken, cracked and slipped slates. The south east corner bottom hip tile was loose.

It is presumed that some renewal of lead gutters was undertaken when the roof was last re-slatted. The rear and south side gutters appear to have been renewed. The weight of lead used was incorrect for the lengths involved and is already buckling, which will lead to further cracking and failing.

The leadwork to the front and north gutters, the over flashings, box outlets and the “Surbaisse Pediment” covering, all appear to be original lead and all have cracks, splits and folds, many of which have been soldered over or treated with proprietary sealants.

The roof should be recovered with either new best quality Welsh slates or best quality second hand Welsh blue slates. New or second hand “Old Staffordshire Blue capped” ridges should be used, to replace the inappropriate 1950’s concrete ridges and hips.

The lead work to the whole roof requires renewing. This will necessitate removal of the balusters and copings from the parapet wall to renew over flashings and removal of lower courses of slates to renew over flashings to the box gutter.

1. Removal of existing roof covering and leadwork.
2. Inspection and repairs to exposed roof woodwork – rafters, purlins, joists etc.
3. Inspection and repairs to existing roof insulation.
4. Replacement of slates with good quality Welsh slates.
5. Inspection and repairs to masonry copings and balustrading, including pediment and balcony at first floor level.
6. Replacement of ridge tiles with appropriate product as advised by the Conservation Officer.
7. Replacement of all leadwork in perimeter valley gutters.
8. Careful and considerate cleaning of stonework at high level.
