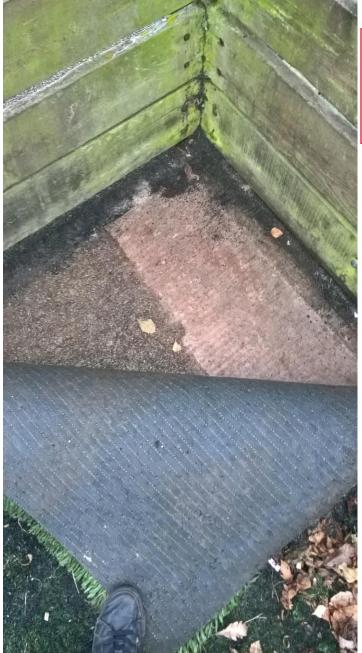
base is concrete / tarmac and in good condition
