ASBESTOS DEMOLITION SURVEY REPORT

**Royal Sands Kiosk
Uphill Road North
Weston-super-Mare
BS23 4NE**

2nd November 2023

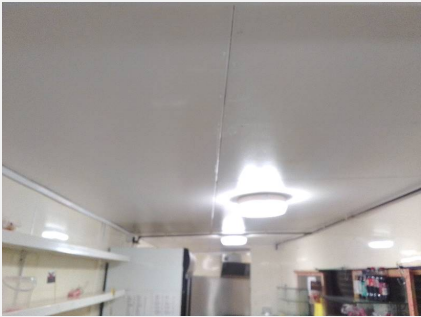
5	EP000826	Ground Floor	Main building Main shop area 001				40 m²	
ID	Material Description		Product Type				Asbestos Type	
AD	Insulation board ceiling panels to all areas including counter		Asbestos Insulating Board				Chrysotile + Amosite	
Accessibility	Product Type	Extent of Damage	Surface Treatment	Asbestos Type	Total	Priority	Recommendation	Comments
Easily disturbed	2	1	1	2	6	Low	Remove

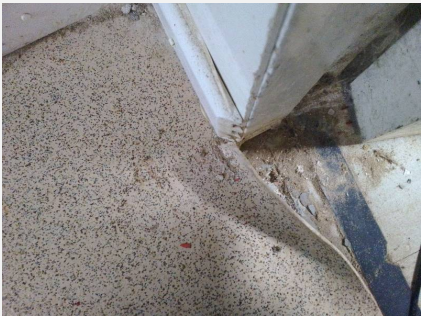
7	EP000828	Ground Floor	Main building Main shop area 001				40 m²	
ID	Material Description		Product Type				Asbestos Type	
AD	Grey Vinyl floor tiles and bitumen adhesive beneath vinyl floor		Bitumen Products				Chrysotile	
Accessibility	Product Type	Extent of Damage	Surface Treatment	Asbestos Type	Total	Priority	Recommendation	Comments
Occasionally likely to be disturbed	1	1	0	1	3	Low	Remove	Asbestos detected in adhesive only.

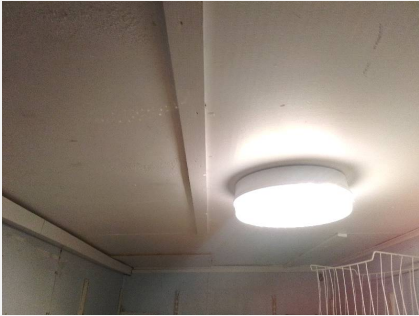
8	As EP000826	Ground Floor	Main building Store room 002				8 m²	
ID	Material Description		Product Type				Asbestos Type	
SPTCA	Insulation board ceiling panels		Asbestos Insulating Board				Chrysotile + Amosite	
Accessibility	Product Type	Extent of Damage	Surface Treatment	Asbestos Type	Total	Priority	Recommendation	Comments
Easily disturbed	2	1	1	2	6	Low	Remove

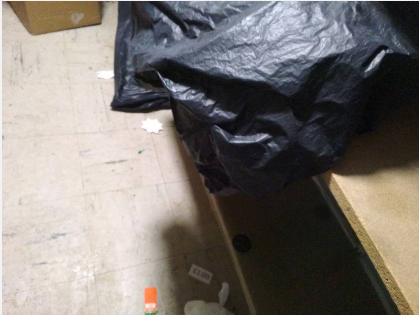
9	EP000829	Ground Floor	Main building Store room 002				8 m²	
ID	Material Description		Product Type				Asbestos Type	
AD	White vinyl floor tiles and bitumen adhesive		Vinyl Floor Tiles & Bitumen Products				Chrysotile	
Accessibility	Product Type	Extent of Damage	Surface Treatment	Asbestos Type	Total	Priority	Recommendation	Comments
Occasionally likely to be disturbed	1	1	0	1	3	Low	Remove

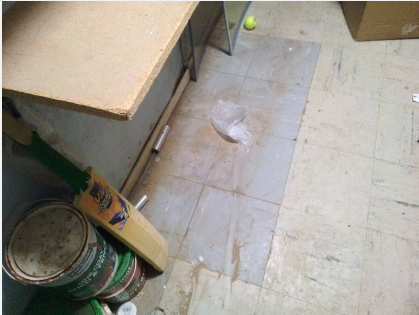
10	EP000830	Ground Floor	Main building Store room 002				1 m²	
ID	Material Description		Product Type				Asbestos Type	
AD	Light grey vinyl floor tiles and bitumen adhesive		Bitumen Products				Chrysotile	
Accessibility	Product Type	Extent of Damage	Surface Treatment	Asbestos Type	Total	Priority	Recommendation	Comments
Occasionally likely to be disturbed	1	1	0	1	3	Low	Remove	Asbestos detected in adhesive only.

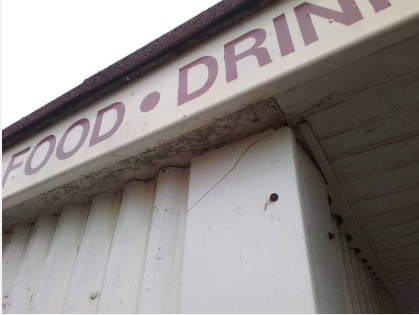
12	EP000832	External	Main building External Areas E01				36 lm	
ID	Material Description		Product Type				Asbestos Type	
AD	Cement Soffits and front Canopy under upvc		Cement Flat Sheet				Chrysotile	
Accessibility	Product Type	Extent of Damage	Surface Treatment	Asbestos Type	Total	Priority	Recommendation	Comments
Easily disturbed	1	1	1	1	4	Low	Remove if affected by proposed refurbishment works

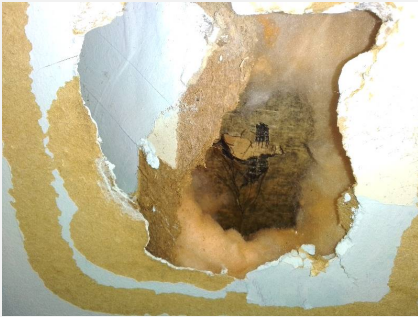
6	EP000827	Ground Floor	Main building Main shop area 001				80 m²	
ID	Material Description		Product Type				Asbestos Type	
NAD	Insulation felt to walls		N/A				No Asbestos Detected	
Accessibility	Product Type	Extent of Damage	Surface Treatment	Asbestos Type	Total	Priority	Recommendation	Comments
N/A	N/A	N/A	N/A	N/A	N/A	N/A	No Action

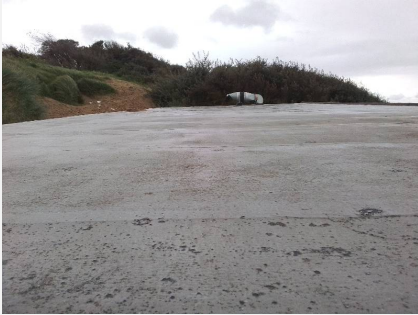
11	EP000831	External	Main building External Areas E01				60 m²	
ID	Material Description		Product Type				Asbestos Type	
NAD	Bitumen felt beneath new felt		N/A				No Asbestos Detected	
Accessibility	Product Type	Extent of Damage	Surface Treatment	Asbestos Type	Total	Priority	Recommendation	Comments
N/A	N/A	N/A	N/A	N/A	N/A	N/A	No Action
