# Survey & Inspection Report

Eura Ref: 4488:

The Hubert Fountain, Ashford, Kent.

**Report prepared by:** William Hatfield Eura Conservation Ltd

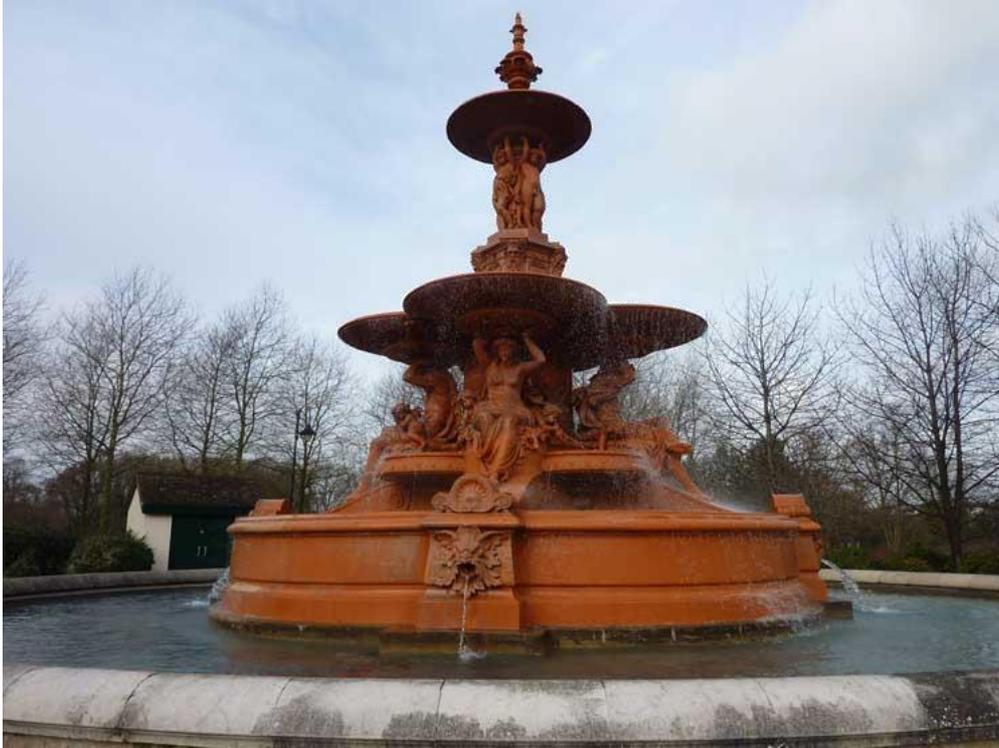
Fig 1: The Hubert Fountain: As viewed looking to the east.

From a distance the Fountain appears to be functional with only a few of the jets are not fully working. The most obvious observation is the change in colour (or discolouration) of the ironwork that has occurred since the major work programme in 1998.

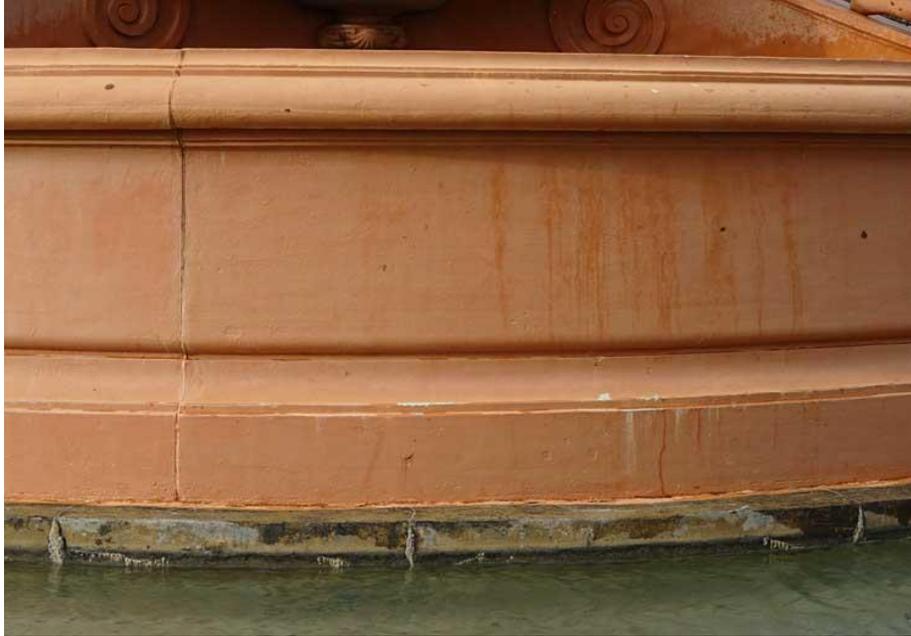
Fig 2. Bowl base outer casing:

Signs of corrosion appearing and a number of paint chips which are likely to result in further and exponential corrosion.

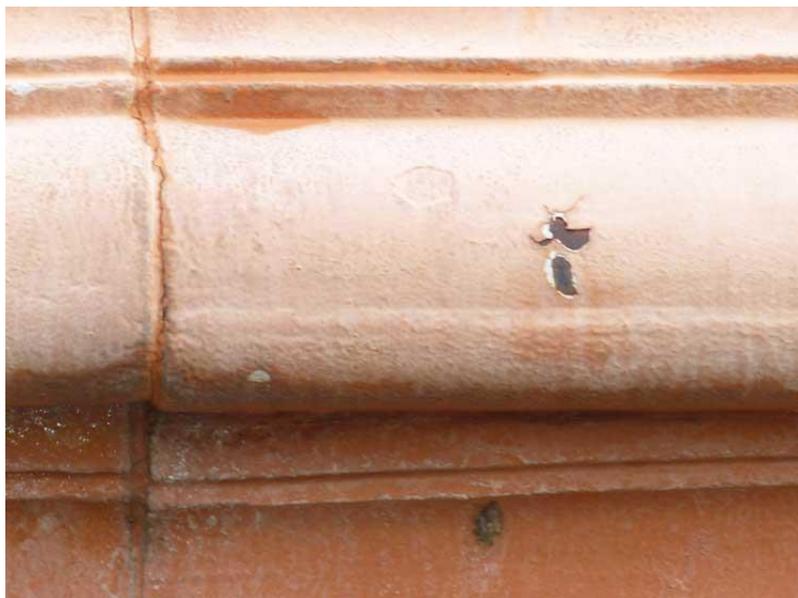
Fig 3. The outer basin rim:

Typical chip, probably caused by a thrown objects, which will likely cause greater concern in the future.

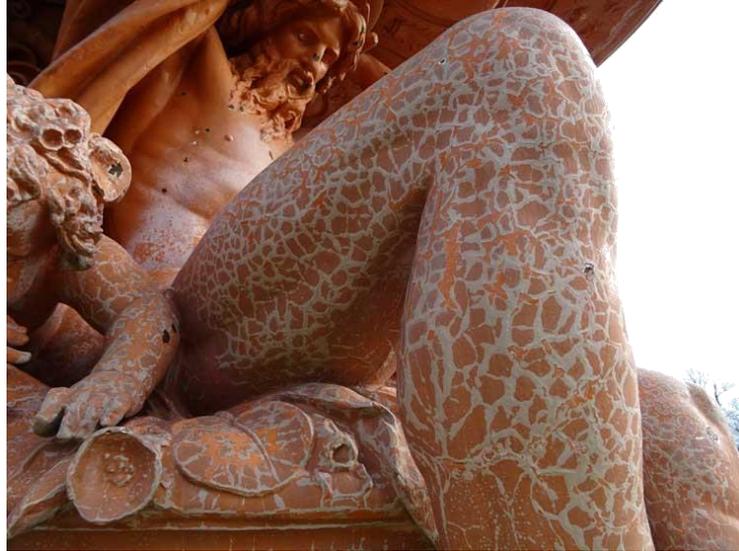
Fig 4. Lower body South West God:

Although not visible in the picture, there are number of small paint chips but more interestingly the outer coating ( two Pac Epoxy resin with a 2% Bronze dust additive) applied in 1998 is showing signs of wear due most likely to the environmental influences and possibly that the finish has come to the end of its functional life.

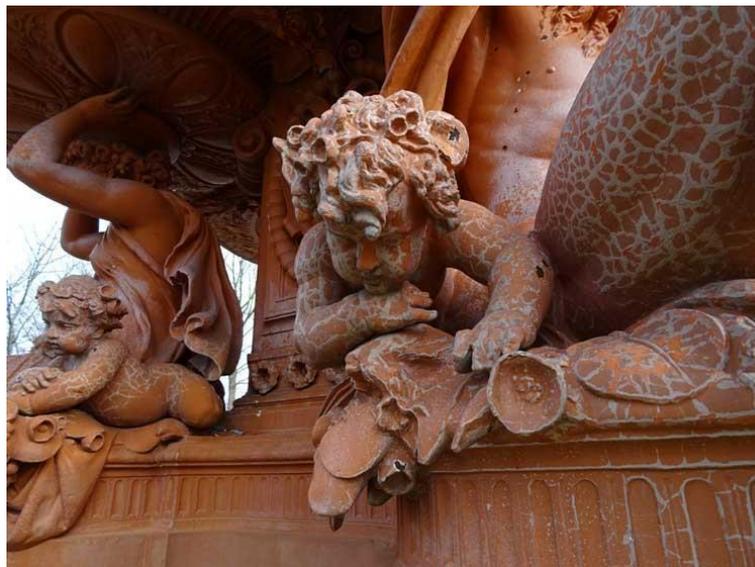
Fig 5. Lower body Small children.

Similar signs of degradation to the paint finish and a large number of paint chips.

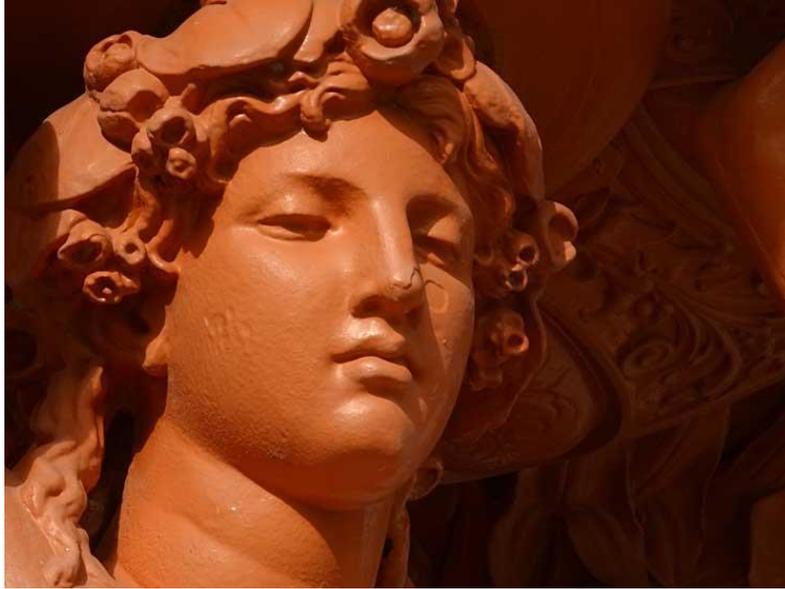
Fig 6. Lower body South East Goddess.

Although the figure looks relatively well preserved, closer inspection reveals that paint repairs have been applied in the recent past to cover a corrosion mark. The match is excellent but unfortunately, unlikely to last.

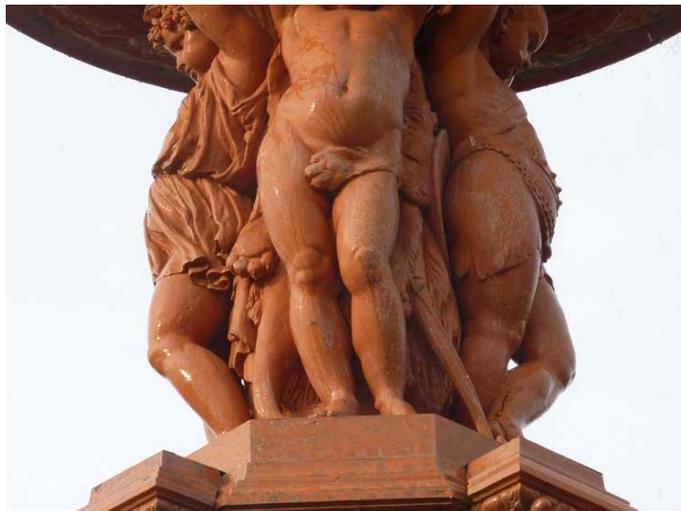
Fig 7. 4 Children (representing the 4 continents of the world)

The initial appearance of the condition is “reasonable” however closer inspection reveals a number of paint chips but fortunately, very little corrosion.

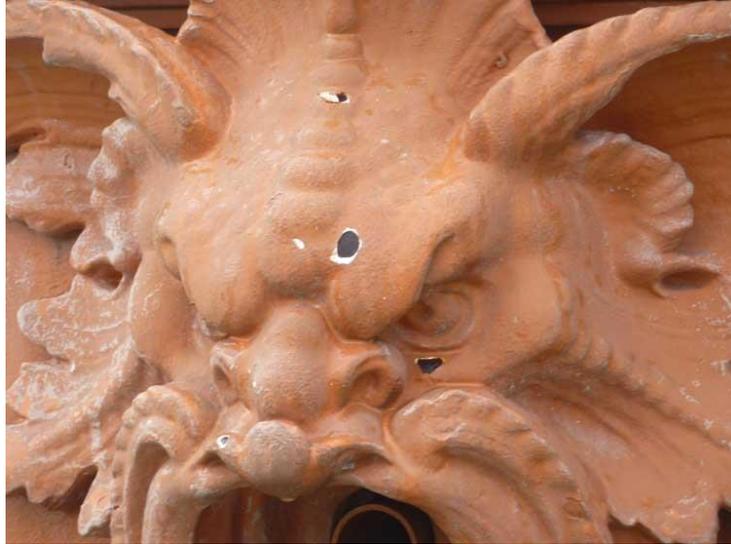
Fig 8. One of the 4 Grottesque heads.

Typical paint chip and some localised corrosion. Not a major problem now but the cumulative collection of paint chips will soon lead to excessive corrosion spots which will only extend over time.

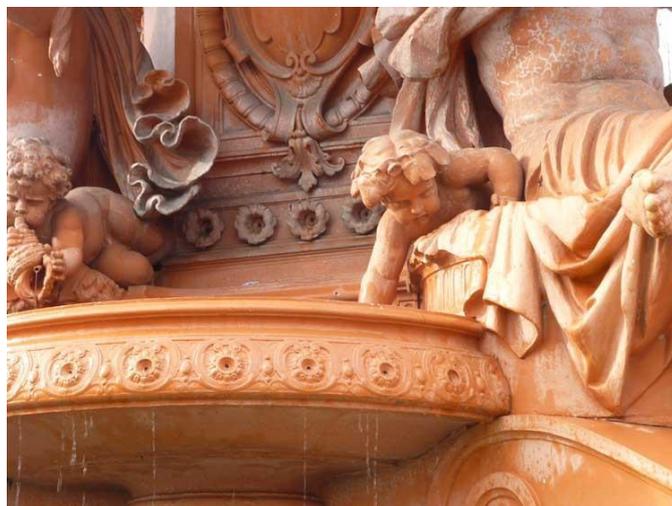
Fig 9. The Lower bowl.

Once again the paint finish in and around the Lower bowl is in a reasonable condition however, internally there is evidence of corrosion around the exposed connecting plates.
