Pre-Refurbishment & Demolition Asbestos Survey for Helme & Partners Limited

External Elevations and Roofed Areas - Suffolk House
154 High Street
Sevenoaks
Kent
TN13 1XE

Service Type	Refurbishment & Demolition survey		
Report Revision Number	1	Surveyors	Rachel Bellamy
TEAMS Job Number	J002837	Survey Date	22 May 2019
Site Address:	External Elevations and Roofed Areas - Suffolk House 154 High Street Sevenoaks Kent TN13 1XE	Bulk Analysis Laboratory	Asbestos Laboratory Services
		Sample Analysis Date	29 May 2019

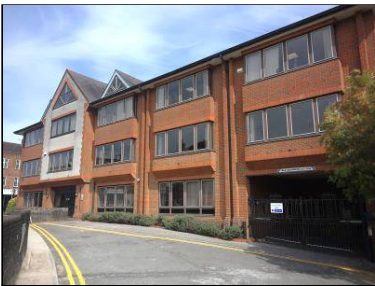
Survey Date:	Lead Surveyor	Survey Type	Floor	Analysis
	22 May 2019	Rachel Bellamy	Refurbishment & Demolition survey	External	N/A
	Building	Room	Item	Quantity	
	External Elevations, Suffolk House 154 High Street	South Elevations E01	No materials to the south elevation were suspected of containing asbestos	N/A	
	Sample No (S,SP,P,As)	Product Type	Surface Treatment	Condition	Accessibility
	Visual (P)	N/A	N/A	N/A	N/A
	Material Risk Score				
	N/A				
Recommended action	No further action required				
Surveyor comments	No Suspected Materials

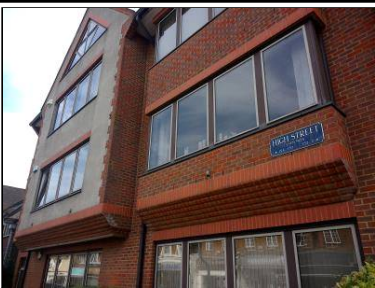
Survey Date:	Lead Surveyor	Survey Type	Floor	Analysis
	22 May 2019	Rachel Bellamy	Refurbishment & Demolition survey	External	N/A
	Building	Room	Item	Quantity	
	External Elevations, Suffolk House 154 High Street	West Elevations E02	No materials to the west elevation were suspected of containing asbestos	N/A	
	Sample No (S,SP,P,As)	Product Type	Surface Treatment	Condition	Accessibility
	Visual (P)	N/A	N/A	N/A	N/A
	Material Risk Score				
	N/A				
Recommended action	No further action required				
Surveyor comments	No Suspected Materials

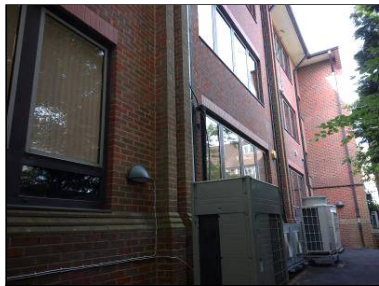
Survey Date:	Lead Surveyor	Survey Type	Floor	Analysis
	22 May 2019	Rachel Bellamy	Refurbishment & Demolition survey	External	N/A
	Building	Room	Item	Quantity	
	External Elevations, Suffolk House 154 High Street	North Elevations E03	No materials to the north elevation were suspected of containing asbestos	N/A	
	Sample No (S,SP,P,As)	Product Type	Surface Treatment	Condition	Accessibility
	Visual (P)	N/A	N/A	N/A	N/A
	Material Risk Score				
N/A					
Recommended action	No further action required				
Surveyor comments	No Suspected Materials

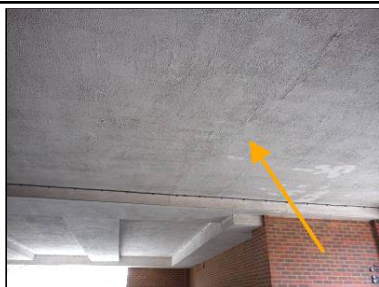
Survey Date:	Lead Surveyor	Survey Type	Floor	Analysis
	22 May 2019	Rachel Bellamy	Refurbishment & Demolition survey	External	No Asbestos Detected (0)
	Building	Room	Item	Quantity	
	External Elevations, Suffolk House 154 High Street	Car Park Canopy E04	Textured Coating to ceiling	148m ²	
	Sample No (S,SP,P,As)	Product Type	Surface Treatment	Condition	Accessibility
	AC002027 (S)	Textured Coating (1)	Surface Sealed (1)	Low Damage (1)	Occasionally likely to be disturbed
	Material Risk Score				
N/A					
Recommended action	No further action required				
Surveyor comments	Non Asbestos textured coating to ceiling - starting to flake off in areas -encapsulate/repair

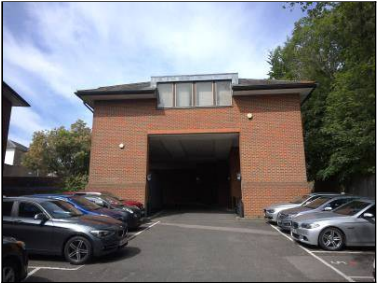
Survey Date:	Lead Surveyor	Survey Type	Floor	Analysis
	22 May 2019	Rachel Bellamy	Refurbishment & Demolition survey	External	N/A
	Building	Room	Item	Quantity	
	External Elevations, Suffolk House 154 High Street	East Elevations E05	No materials to the east elevation were suspected of containing asbestos	N/A	
	Sample No (S,SP,P,As)	Product Type	Surface Treatment	Condition	Accessibility
	Visual (P)	N/A	N/A	N/A	N/A
	Material Risk Score				
N/A					
Recommended action	No further action required				
Surveyor comments	No Suspected Materials

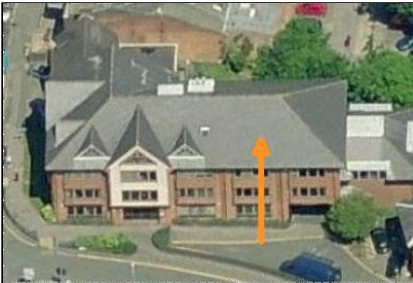
Survey Date:	Lead Surveyor	Survey Type	Floor	Analysis
	22 May 2019	Rachel Bellamy	Refurbishment & Demolition survey	External	No Asbestos Detected (0)
	Building	Room	Item	Quantity	
	External Elevations, Suffolk House 154 High Street	Roofed Areas E06	Roof Tiles to pitched roof area	Throughout	
	Sample No (S,SP,P,As)	Product Type	Surface Treatment	Condition	Accessibility
	AC002028 (S)	Cement (1)	Surface Sealed (1)	Low Damage (1)	Occasionally likely to be disturbed
	Material Risk Score				
N/A					
Recommended action	No further action required				
Surveyor comments	Non Asbestos roof tiles to pitched roof areas

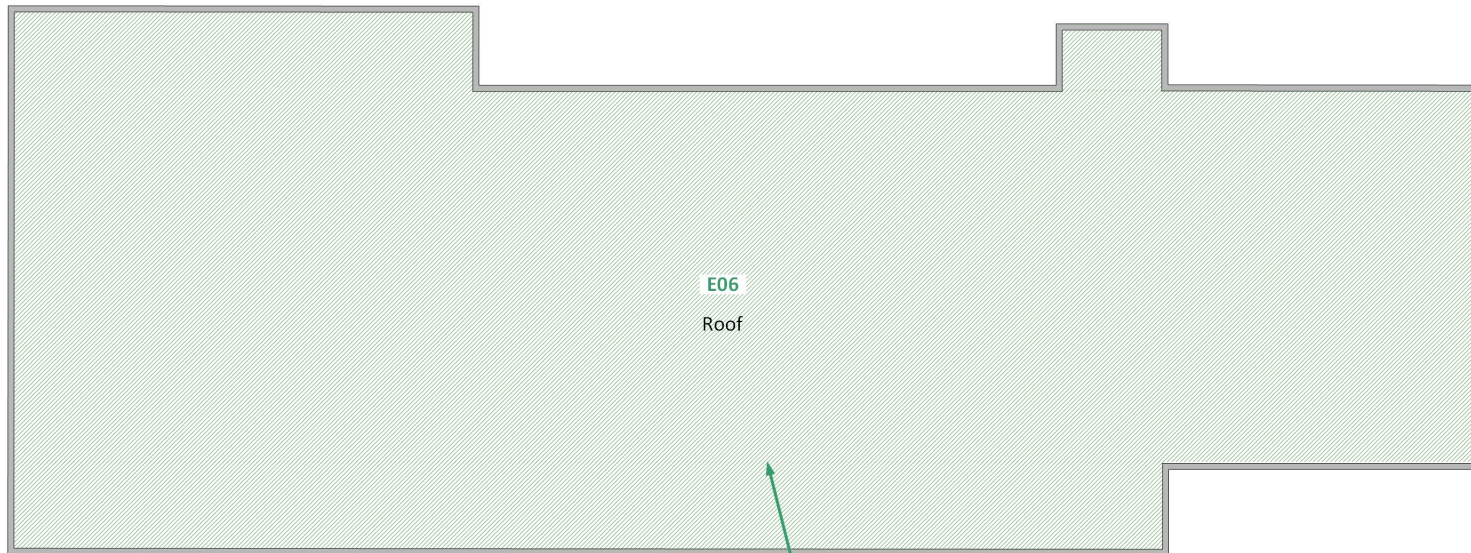
E06
Roof

AC002028
Non Asbestos Cement Roof Tiles
to roofed areas
