Report of 'Type 2' Asbestos Survey
At
Lydiard House
Lydiard Tregoze
Swindon
For
Swindon Borough Council

On
Tuesday 12th December 2006
Project Ref: J10943
UPRN: 10004843255

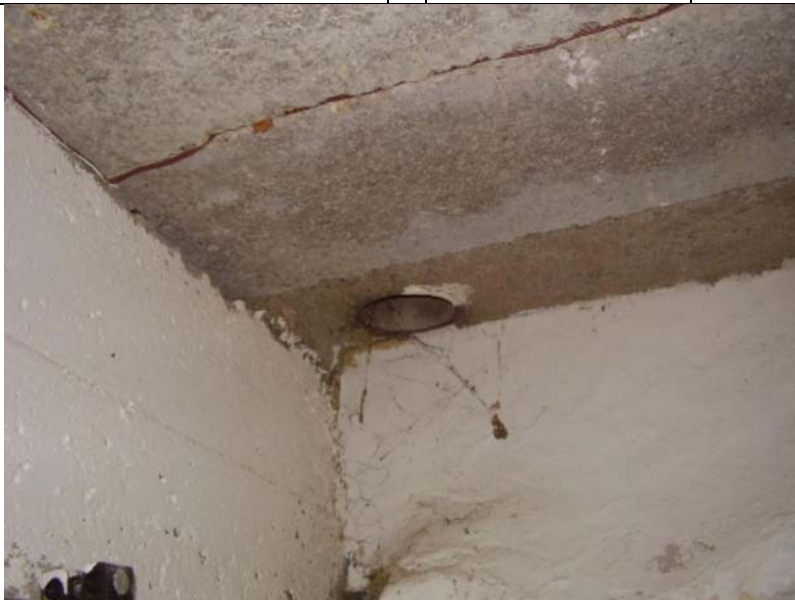
- 9.2.1 Within the A001 basement room there was a cement flue to the concrete ceiling. A sample of the cement was collected (Sample Number B06) and the sample was found to contain Chrysotile (White) asbestos. The asbestos cement was low damaged and was in an unsealed condition. If left undisturbed the asbestos containing cement does not require removal, however, must be managed accordingly. Although not a requirement it may be prudent to consider encapsulation/re-encapsulation and or labelling where practicable to do so.

Swindon Borough Council			
Project Ref	J10943	Building	00 Main Building
Site	Lydiard House Lydiard Tregoze Swindon	Floor	-00 Basement
Location	ENS120	Description	Flue to concrete ceiling
Room/Area	A001	Site Code/UPRN	10004843255

Last Inspection Date	- 12 Dec 2006	Certificate N°	- C15751
Next Inspection Date	- 12 Dec 2007	Sample N°	- B06
Survey Type	- Type 2	Photograph N°	- 07

Position	- Internal (Occupied)	Damage Risk	- Low
Asbestos Type	- Chrysotile	HSE Notifiable	- No
Product Type	- Cement

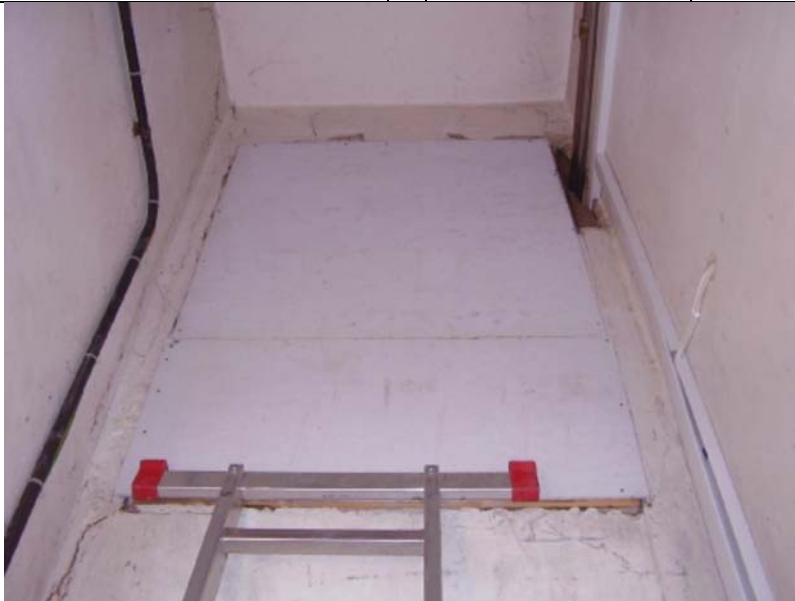
- 9.2.3 Within the A001 basement room there were insulating board panels above the stairs leading into the basement. A sample of the insulating board was collected (Sample Number B08) and the sample was found to contain Amosite (Brown) and Chrysotile (White) asbestos. The asbestos insulating board was medium damaged and was in an unsealed condition. If left undisturbed the asbestos insulating board does not require removal. However, as a minimum the asbestos insulating board should be encapsulated utilising a suitable elastomeric sealant in strict accordance with current and relevant legislation and managed accordingly. Although not a requirement it may be prudent to consider labelling where practicable to do so.

Swindon Borough Council			
Project Ref	J10943	Building	00 Main Building
Site	Lydiard House Lydiard Tregoze Swindon	Floor	-00 Basement
Location	ENS129	Description	Panels above stairs leading down to basement
Room/Area	A001	Site Code/UPRN	10004843255

Last Inspection Date	- 12 Dec 2006	Certificate N°	- C15751
Next Inspection Date	- 12 Dec 2007	Sample N°	- B08
Survey Type	- Type 2	Photograph N°	- 09

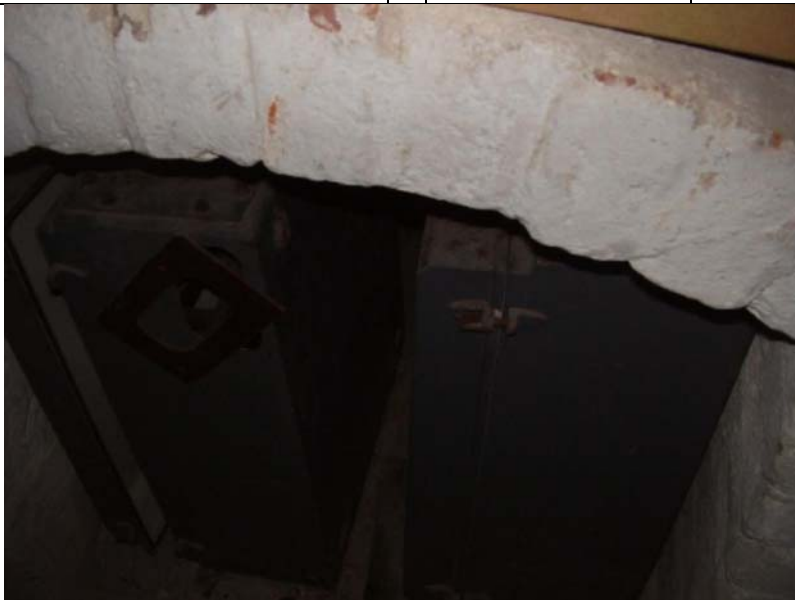
- 9.2.2 Within the A001 basement room there were cement panels within the loose GEC electrical boxes. A sample of the cement was collected (Sample Number B07) and the sample was found to contain Chrysotile (White) asbestos. The asbestos cement was low damaged and was in an unsealed condition. Due to the boxes being redundant and unused the asbestos containing material should be removed in strict accordance with current and relevant legislation notes.

Last Inspection Date	- 12 Dec 2006	Certificate N°	- C15751
Next Inspection Date	- 12 Dec 2007	Sample N°	- B07
Survey Type	- Type 2	Photograph N°	- 08

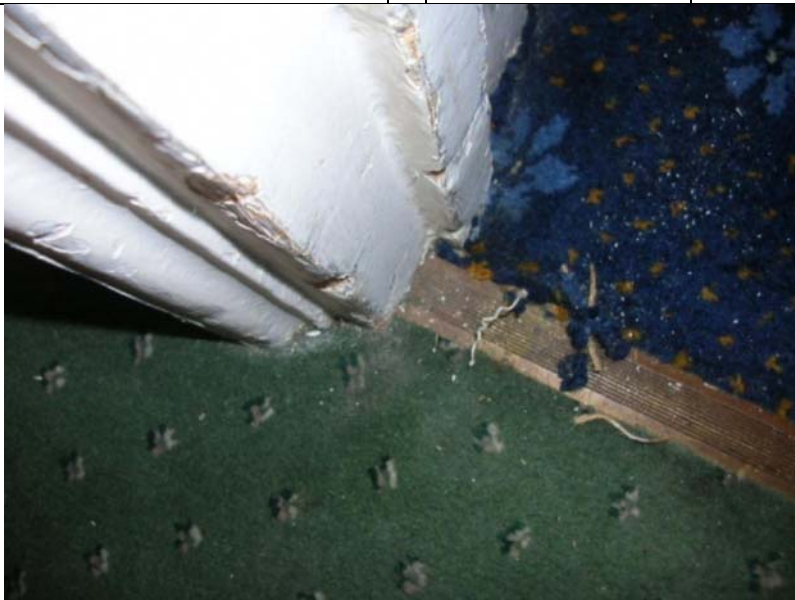
- 9.3.2 Within the B008 circ there were vinyl tiles and associated adhesive below the carpet. A sample of the vinyl and adhesive was collected (Sample Number B30) and the sample was found to contain Chrysotile (White) asbestos. The asbestos vinyl and adhesive was low damaged and was in a self sealed condition. The asbestos containing composite product does not require removal or encapsulation, however, must be managed accordingly. It may be prudent to consider labelling where practicable to do so.

Last Inspection Date	- 19 Dec 2006	Certificate N^o	- C15751
Next Inspection Date	- 19 Dec 2007	Sample N^o	- B30
Survey Type	- Type 2	Photograph N^o	- 40

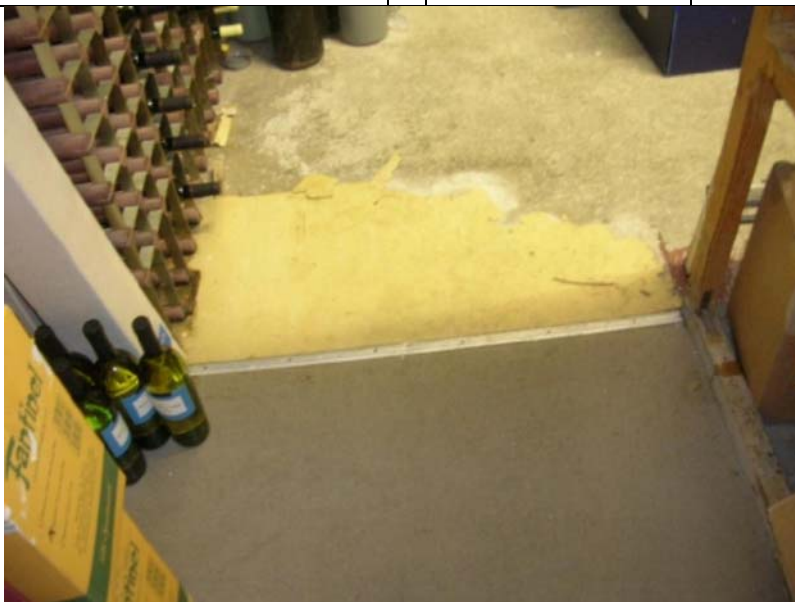
- 9.4.1 Within the B021 bar store there were vinyl tiles that partially covered the floor. A sample of the vinyl was collected (Sample Number B33) and the sample was found to contain Chrysotile (White) asbestos. The asbestos vinyl medium damaged and was in a self sealed condition. The asbestos containing composite product does not require removal or encapsulation, however, must be managed accordingly. It may be prudent to consider labelling where practicable to do so.

Last Inspection Date	- 20 Dec 2006	Certificate N°	- C15751
Next Inspection Date	- 20 Dec 2007	Sample N°	- B33
Survey Type	- Type 2	Photograph N°	- 49

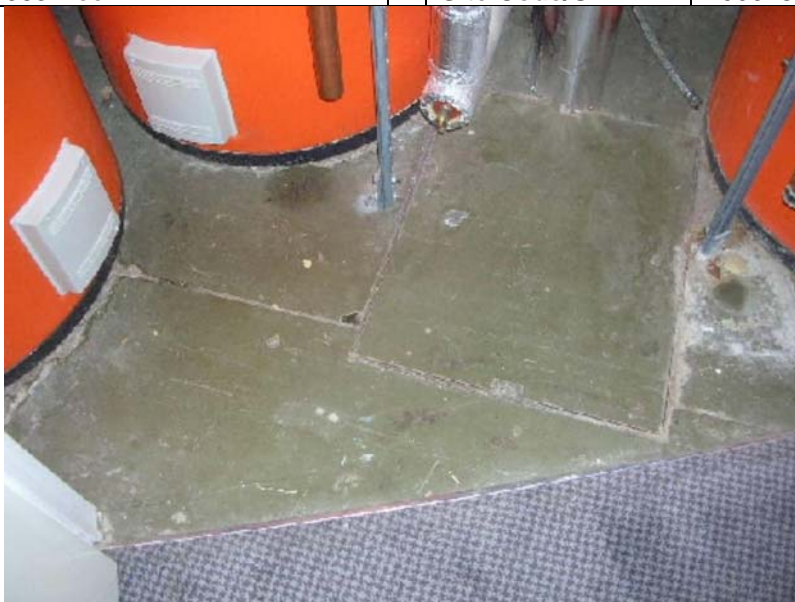
- 9.5.1 Within the B063 room there were vinyl tiles and associated adhesive to the floor. A sample of the vinyl and adhesive was collected (Sample Number B44) and the sample was found to contain Chrysotile (White) asbestos. The asbestos vinyl and adhesive was low damaged and was in a self sealed condition. The asbestos containing composite product does not require removal or encapsulation, however, must be managed accordingly. It may be prudent to consider labelling where practicable to do so.

Last Inspection Date	- 25 May 2007	Certificate N°	- C15751
Next Inspection Date	- 25 May 2008	Sample N°	- B44
Survey Type	- Type 2	Photograph N°	- 01

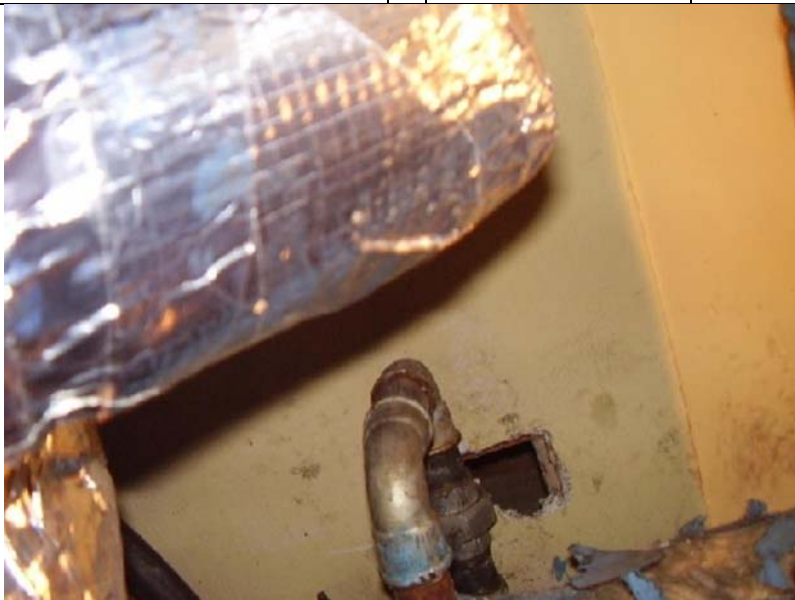
- 9.6.2 Within the B064 boiler room there was an insulating board ceiling. A sample of the insulating board was collected (Sample Number B24) and the sample was found to contain Amosite (Brown) and Chrysotile (White) asbestos. The asbestos insulating board was low damaged and the exposed face was in a sealed condition. If left undisturbed the asbestos insulating board does not require removal, however, should be managed accordingly. Although not a requirement it may be prudent to consider re-encapsulation and or labelling where practicable to do so.

Last Inspection Date	- 18 Dec 2006	Certificate N°	- C15751
Next Inspection Date	- 18 Dec 2007	Sample N°	- B24
Survey Type	- Type 2	Photograph N°	- 36

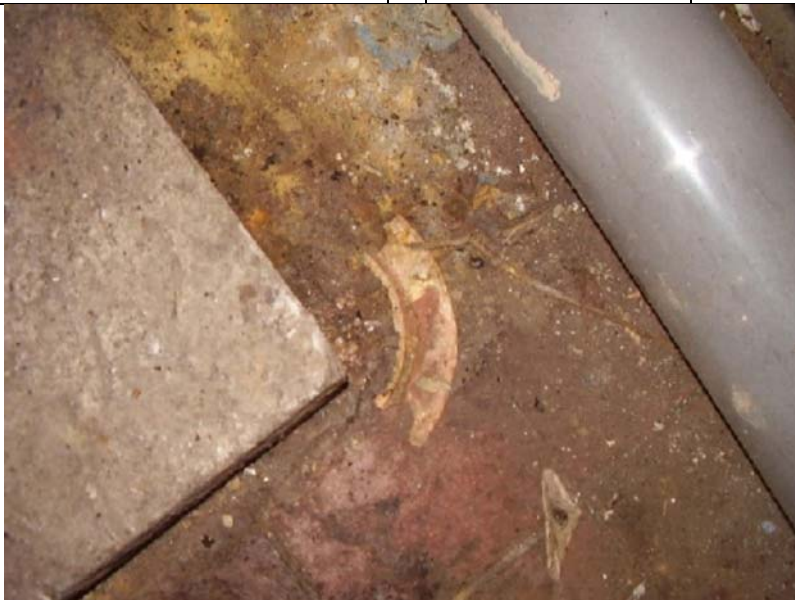
- 9.6.1 Within the B064 boiler room there was gasket debris to the floor. A sample of the gasket debris was collected (Sample Number B23) and the sample was found to contain Chrysotile (White) asbestos. The asbestos gasket debris was highly damaged and was in an unsealed condition. The asbestos containing material should be removed in strict accordance with current and relevant legislation notes.

Last Inspection Date	- 18 Dec 2006	Certificate N°	- C15751
Next Inspection Date	- 18 Dec 2007	Sample N°	- B23
Survey Type	- Type 2	Photograph N°	- 35

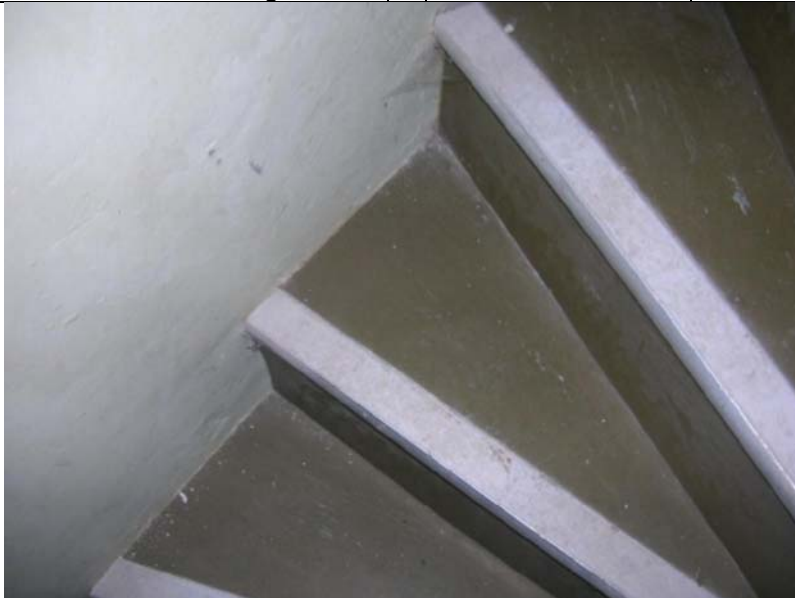
- 9.7.1 To the B070 stairs there was resin nosing to the steps. A sample of the resin was collected (Sample Number B35) and the sample was found to contain Chrysotile (White) asbestos. The asbestos resin was low damaged and was in a self sealed condition. The asbestos containing composite product does not require removal or encapsulation, however, must be managed accordingly. It may be prudent to consider labelling where practicable to do so.
- 9.7.2 To the B070 stairs there was vinyl flooring to the steps. A sample of the vinyl was collected (Sample Number B36) and the sample was found to contain Chrysotile (White) asbestos. The asbestos vinyl low damaged and was in a self sealed condition. The asbestos containing composite product does not require removal or encapsulation, however, must be managed accordingly. It may be prudent to consider labelling where practicable to do so.

Last Inspection Date	- 20 Dec 2006	Certificate N°	- C15751
Next Inspection Date	- 20 Dec 2007	Sample N°	- B35
Survey Type	- Type 2	Photograph N°	- 51

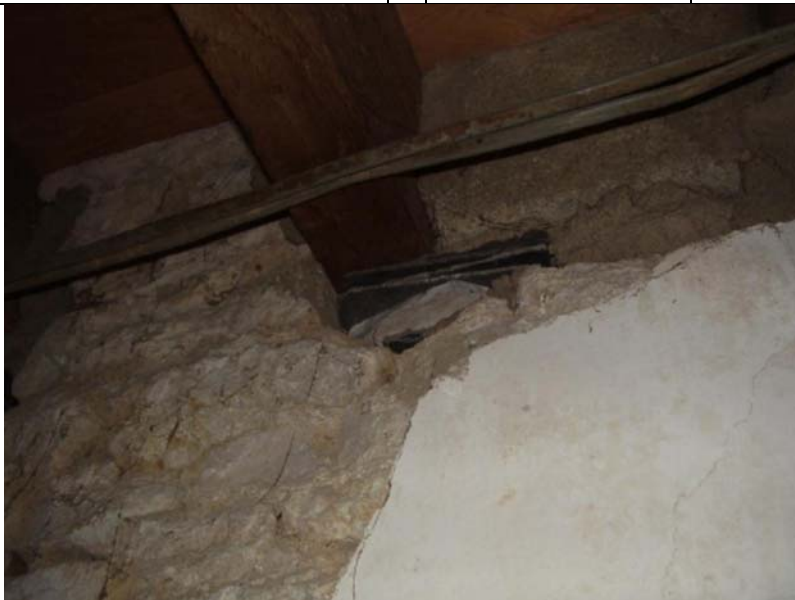
- 9.8.1 Within the B077 circ there were cement packers under the timber joists in the ceiling void. A sample of the cement was collected (Sample Number B12) and the sample was found to contain Chrysotile (White) asbestos. The asbestos cement was medium damaged and was in an unsealed condition. The asbestos containing cement should be removed or repaired utilising a suitable non asbestos substitute. If repaired, it should be managed accordingly. Although not a requirement, it may be prudent to consider encapsulation/re-encapsulation and or labelling where practicable to do so.

Last Inspection Date	- 14 Dec 2006	Certificate N°	- C15751
Next Inspection Date	- 14 Dec 2007	Sample N°	- B12
Survey Type	- Type 2	Photograph N°	- 14

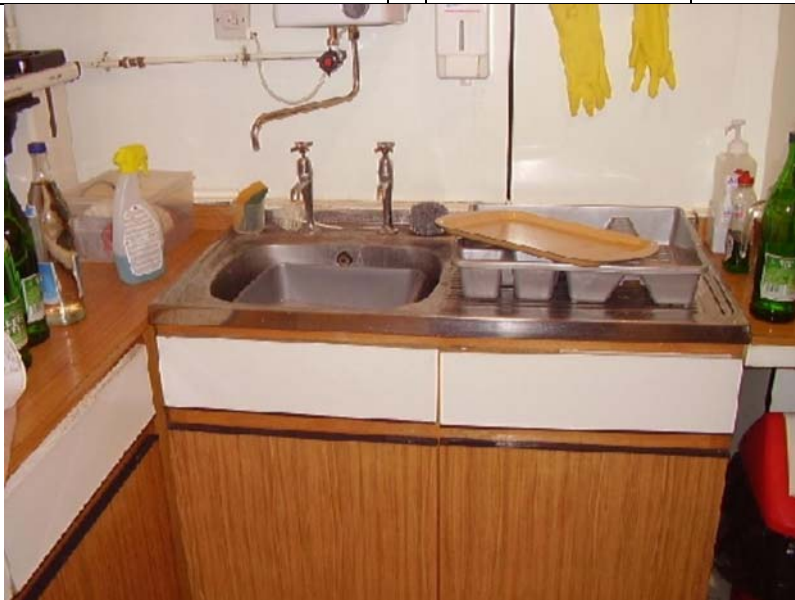
9.9.2 Within the C039 kitchen there was a mastic pad to the underside of the sink. A sample of the mastic was collected (Sample Number B21) and the sample was found to contain Chrysotile (White) asbestos. The asbestos mastic was low damaged and was in a self sealed condition. The asbestos containing composite product does not require removal or encapsulation, however, must be managed accordingly. It may be prudent to consider labelling where practicable to do so.

Last Inspection Date	- 18 Dec 2006	Certificate N^o	- C15751
Next Inspection Date	- 18 Dec 2007	Sample N^o	- B21
Survey Type	- Type 2	Photograph N^o	- 27

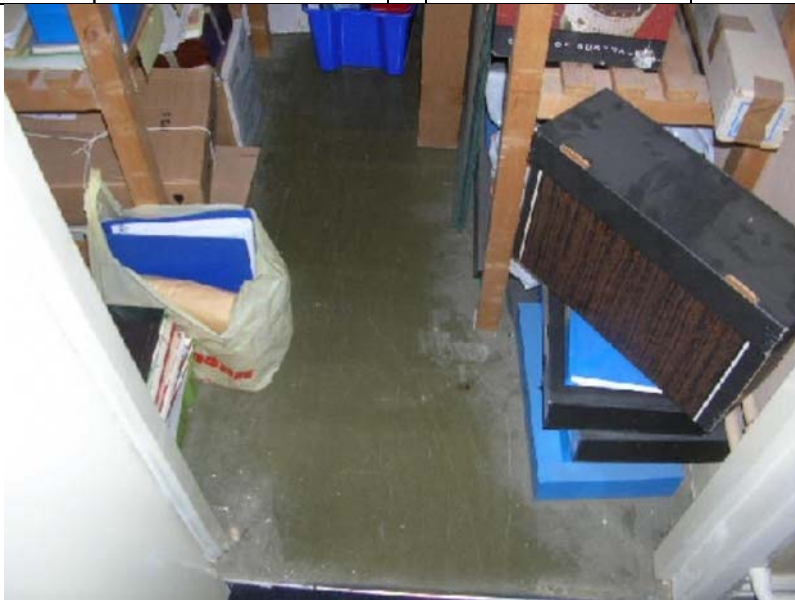
9.10.1 Within the C041 cupboard there were vinyl tiles to the floor. A sample of the vinyl was collected (Sample Number B51) and the sample was found to contain Chrysotile (White) asbestos. The asbestos vinyl low damaged and was in a self sealed condition. The asbestos containing composite product does not require removal or encapsulation, however, must be managed accordingly. It may be prudent to consider labelling where practicable to do so.

Last Inspection Date	- 25 May 2007	Certificate N°	- C15751
Next Inspection Date	- 25 May 2008	Sample N°	- B51
Survey Type	- Type 2	Photograph N°	- 16

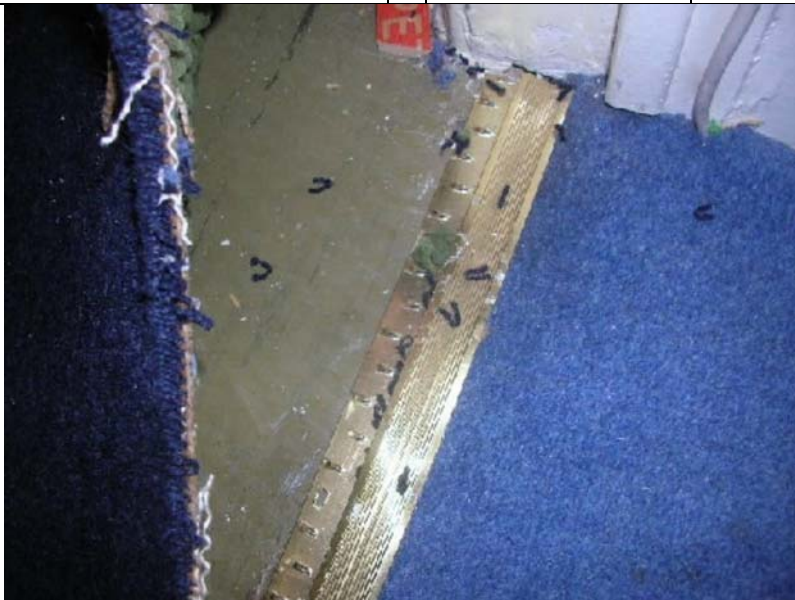
9.11.1 Within the C044 corridor there were vinyl tiles beneath the carpet. A sample of the vinyl was collected (Sample Number B52) and the sample was found to contain Chrysotile (White) asbestos. The asbestos vinyl low damaged and was in a self sealed condition. The asbestos containing composite product does not require removal or encapsulation, however, must be managed accordingly. It may be prudent to consider labelling where practicable to do so.

Last Inspection Date	- 25 May 2007	Certificate N°	- C15751
Next Inspection Date	- 25 May 2008	Sample N°	- B52
Survey Type	- Type 2	Photograph N°	- 17

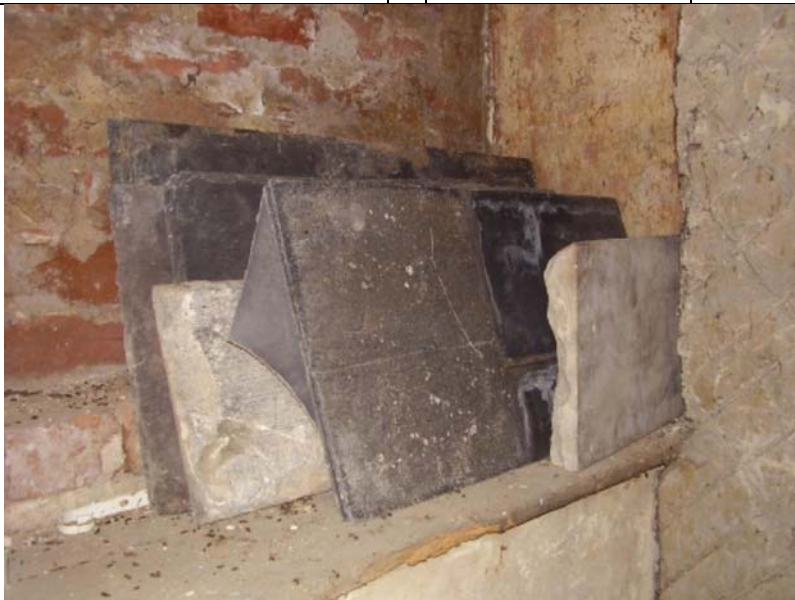
9.12.1 Within the 04 circ there were loose slate (cement) roof tiles. A sample of the slate was collected (Sample Number B02) and the sample was found to contain Chrysotile (White) asbestos. The asbestos slate was medium damaged and was in an unsealed condition. The asbestos containing material should be removed in strict accordance with current and relevant legislation notes.

Last Inspection Date	- 12 Dec 2006	Certificate N^o.	- C15751
Next Inspection Date	- 12 Dec 2007	Sample N^o.	- B02
Survey Type	- Type 2	Photograph N^o.	- 02

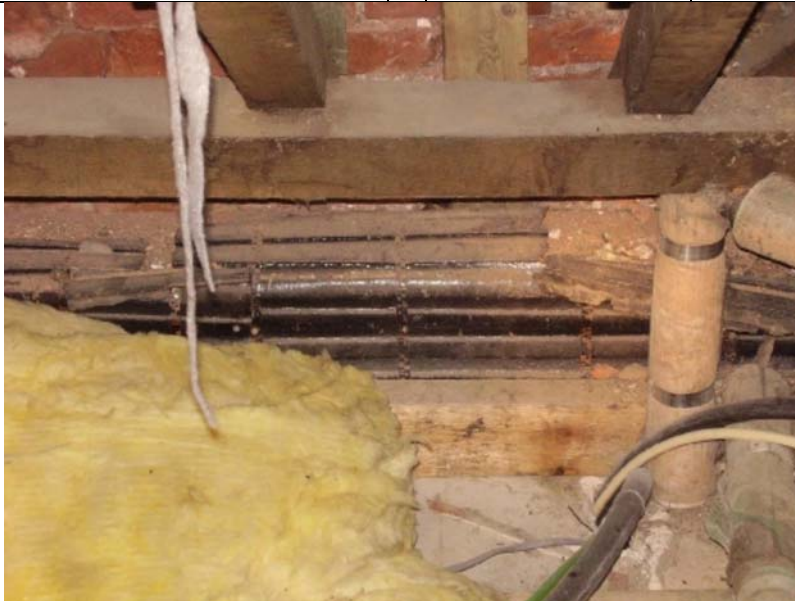
- 9.13.1 Within the 05 loft there were cement packers below the walkway floor. A sample of the cement was collected (Sample Number B04) and the sample was found to contain Chrysotile (White) asbestos. The asbestos cement was medium damaged and was in a part sealed condition. If left undisturbed the asbestos containing cement does not require removal, however, must be managed accordingly. Although not a requirement it may be prudent to consider encapsulation/re-encapsulation and or labelling where practicable to do so.

Last Inspection Date	- 13 Dec 2006	Certificate N°	- C15751
Next Inspection Date	- 13 Dec 2007	Sample N°	- B04
Survey Type	- Type 2	Photograph N°	- 05

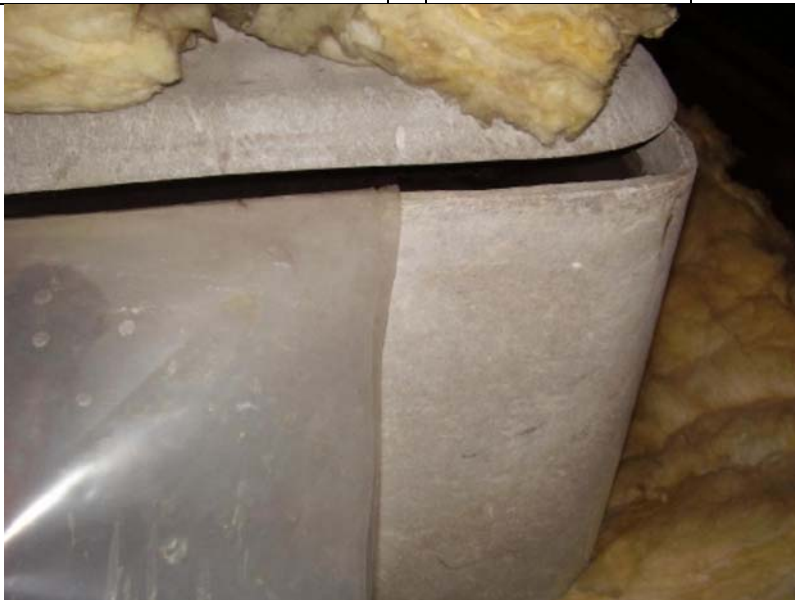
- 9.14.1 Within the 06 loft there were cement water tanks. A sample of the cement was collected (Sample Number B15) and the sample was found to contain Chrysotile (White) and Crocidolite (Blue) asbestos. The asbestos cement was low damaged and was in an unsealed condition. If left undisturbed the asbestos containing cement does not require removal, however, must be managed accordingly. Although not a requirement it may be prudent to consider encapsulation/re-encapsulation and or labelling where practicable to do so.

Last Inspection Date	- 12 Dec 2006	Certificate N°	- C15751
Next Inspection Date	- 12 Dec 2007	Sample N°	- B15
Survey Type	- Type 2	Photograph N°	- 16
