**MANAGEMENT ASBESTOS SURVEY**

1 LUNEDALE  
WOODCOCK DRIVE  
PLATT BRIDGE  
WIGAN  
WN2 5NW

FEBRUARY 2014

Report prepared for:	Wigan & Leigh Housing Unity House Westwood Park Drive Wigan WN3 4HE
Report reference:	P-58896
Issue date:	February 2014
Survey completed by: Mr B. Peebles Environmental Consultant	 
Approved by: Mr S. Brookes Environmental Consultant

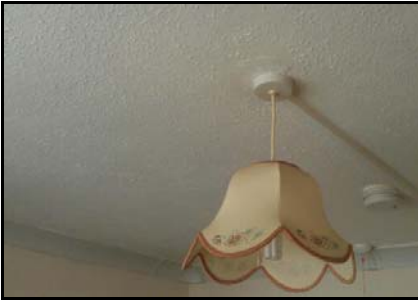
<b>Location</b>	8421420~1 Lunedale, Woodcock Drive - Lounge - Textured coating to ceiling

<b>Item No:</b>	3	<b>Laboratory sample no:</b>	P-58896 / SP AS 002	
<b>Accessibility:</b>	Normally accessible			
<b>Installation:</b>	Textured coating (1)			
<b>Approx extent (m<sup>2</sup> unless stated)</b>	10			
<b>Asbestos Type:</b>	SP: Chrysotile(1)			
<b>Condition:</b>	Low Damage (1)	<b>Surface Treatment:</b>	Sealed (1)	
<b>Risk Assessment (H/M/L/VL)</b>	Very Low (4)	<b>Recommendation:</b>	Satisfactory condition, inspect periodically

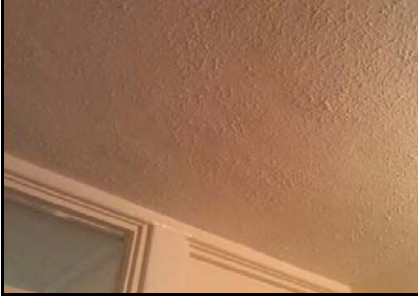
<b>Location</b>	8421420~1 Lunedale, Woodcock Drive - Hallway and associated store cupboard - Textured coating to ceiling

<b>Item No:</b>	4	<b>Laboratory sample no:</b>	P-58896 / SP AS 002	
<b>Accessibility:</b>	Normally accessible			
<b>Installation:</b>	Textured coating (1)			
<b>Approx extent (m<sup>2</sup> unless stated)</b>	8			
<b>Asbestos Type:</b>	SP: Chrysotile(1)			
<b>Condition:</b>	Low Damage (1)	<b>Surface Treatment:</b>	Sealed (1)	
<b>Risk Assessment (H/M/L/VL)</b>	Very Low (4)	<b>Recommendation:</b>	Satisfactory condition, inspect periodically

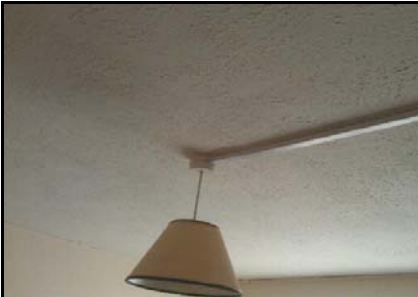
<b>Location</b>	8421420~1 Lunedale, Woodcock Drive - Bedroom - Textured coating to ceiling

<b>Item No:</b>	5	<b>Laboratory sample no:</b>	P-58896 / SP AS 002	
<b>Accessibility:</b>	Normally accessible			
<b>Installation:</b>	Textured coating (1)			
<b>Approx extent (m<sup>2</sup> unless stated)</b>	10			
<b>Asbestos Type:</b>	SP: Chrysotile(1)			
<b>Condition:</b>	Low Damage (1)	<b>Surface Treatment:</b>	Sealed (1)	
<b>Risk Assessment (H/M/L/VL)</b>	Very Low (4)	<b>Recommendation:</b>	Satisfactory condition, inspect periodically

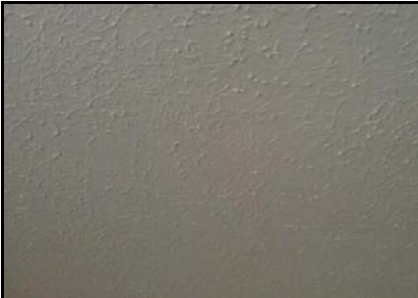
<b>Location</b>	8421420~1 Lunedale, Woodcock Drive - Bathroom - Textured coating to ceiling

<b>Item No:</b>	6	<b>Laboratory sample no:</b>	P-58896 / SP AS 002	
<b>Accessibility:</b>	Normally accessible			
<b>Installation:</b>	Textured coating (1)			
<b>Approx extent (m<sup>2</sup> unless stated)</b>	5			
<b>Asbestos Type:</b>	SP: Chrysotile(1)			
<b>Condition:</b>	Low Damage (1)	<b>Surface Treatment:</b>	Sealed (1)	
<b>Risk Assessment (H/M/L/VL)</b>	Very Low (4)	<b>Recommendation:</b>	Satisfactory condition, inspect periodically

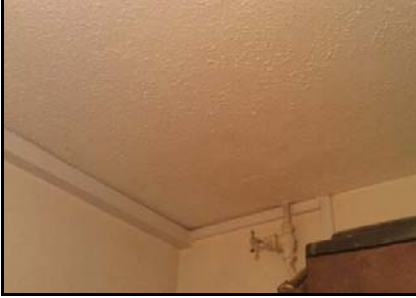
<b>Location</b>		8421420~1 Lunedale, Woodcock Drive - Water tank store cupboard - Textured coating to ceiling

<b>Item No:</b>	7	<b>Laboratory sample no:</b>	P-58896 / SP AS 002	
<b>Accessibility:</b>		Normally accessible		
<b>Installation:</b>		Textured coating (1)		
<b>Approx extent (m<sup>2</sup> unless stated)</b>		3		
<b>Asbestos Type:</b>		SP: Chrysotile(1)		
<b>Condition:</b>		Low Damage (1)	<b>Surface Treatment:</b> Sealed (1)	
<b>Risk Assessment (H/M/L/VL)</b>		Very Low (4)	<b>Recommendation:</b> Satisfactory condition, inspect periodically

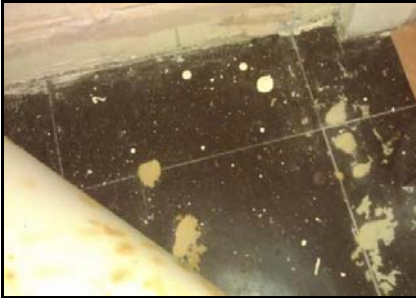
<b>Location</b>		8421420~1 Lunedale, Woodcock Drive - Water tank cupboard - Brown floor tiles and bitumen

<b>Item No:</b>	8	<b>Laboratory sample no:</b>	SP-58896 / 003	
<b>Accessibility:</b>		Easily accessible		
<b>Installation:</b>		Floor tile(s) & bitumen (1)		
<b>Approx extent (m<sup>2</sup> unless stated)</b>		10		
<b>Asbestos Type:</b>		SP: Chrysotile(1)		
<b>Condition:</b>		Low Damage (1)	<b>Surface Treatment:</b> Composite (0)	
<b>Risk Assessment (H/M/L/VL)</b>		Very Low (3)	<b>Recommendation:</b> Satisfactory condition, inspect periodically

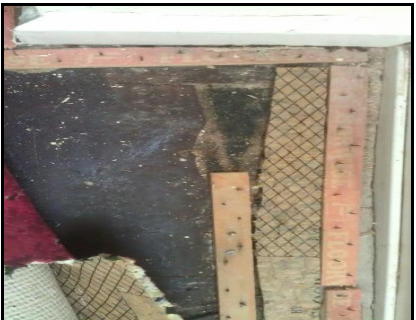
<b>Location</b>		8421420~1 Lunedale, Woodcock Drive - Lounge - Brown floor tiles and bitumen beneath carpet

<b>Item No:</b>	9	<b>Laboratory sample no:</b>	P-58896 / 003	
<b>Accessibility:</b>		Easily accessible		
<b>Installation:</b>		Floor tile(s) & bitumen (1)		
<b>Approx extent (m<sup>2</sup> unless stated)</b>		16		
<b>Asbestos Type:</b>		Chrysotile(1)		
<b>Condition:</b>		Low Damage (1)	<b>Surface Treatment:</b> Composite (0)	
<b>Risk Assessment (H/M/L/VL)</b>		Very Low (3)	<b>Recommendation:</b> Satisfactory condition, inspect periodically

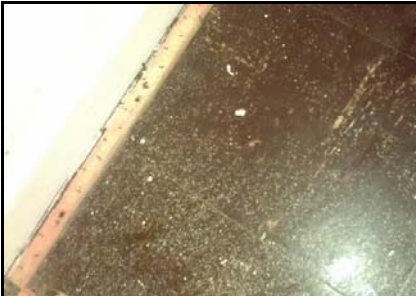
<b>Location</b>		8421420~1 Lunedale, Woodcock Drive - Bedroom - Brown floor tiles and bitumen

<b>Item No:</b>	10	<b>Laboratory sample no:</b>	P-58896 / SP AS 003	
<b>Accessibility:</b>		Easily accessible		
<b>Installation:</b>		Floor tile(s) & bitumen (1)		
<b>Approx extent (m<sup>2</sup> unless stated)</b>		16		
<b>Asbestos Type:</b>		SP: Chrysotile(1)		
<b>Condition:</b>		Low Damage (1)	<b>Surface Treatment:</b> Composite (0)	
<b>Risk Assessment (H/M/L/VL)</b>		Very Low (3)	<b>Recommendation:</b> Satisfactory condition, inspect periodically

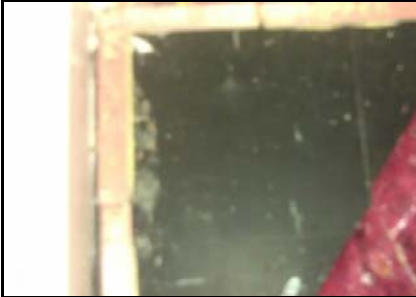
<b>Location</b>		8421420~1 Lunedale, Woodcock Drive - Hallway and associated store cupboard - Black floor tiles and bitumen

<b>Item No:</b>	11	<b>Laboratory sample no:</b>	P-58896 / 004	
<b>Accessibility:</b>		Easily accessible		
<b>Installation:</b>		Floor tile(s) & bitumen (1)		
<b>Approx extent (m<sup>2</sup> unless stated)</b>		10		
<b>Asbestos Type:</b>		Chrysotile(1)		
<b>Condition:</b>		Low Damage (1)	<b>Surface Treatment:</b> Composite (0)	
<b>Risk Assessment (H/M/L/VL)</b>		Very Low (3)	<b>Recommendation:</b> Satisfactory condition, inspect periodically
