# Roof Survey Report

Darwen Town Hall  
Croft Street, DARWEN  
BB3 1BG, England

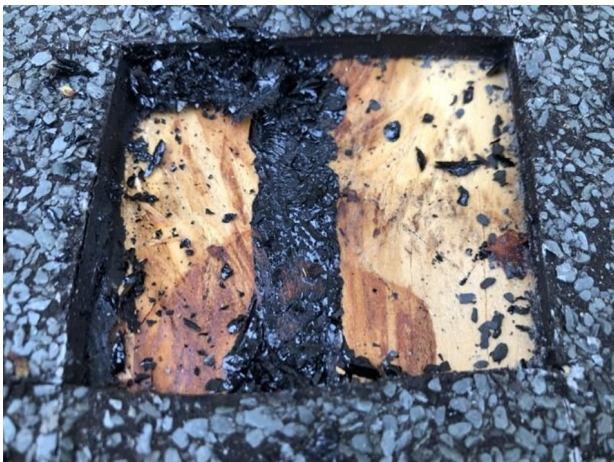
The waterproofing has been installed directly to the plywood decking with no insulation present. This will need to be upgraded.

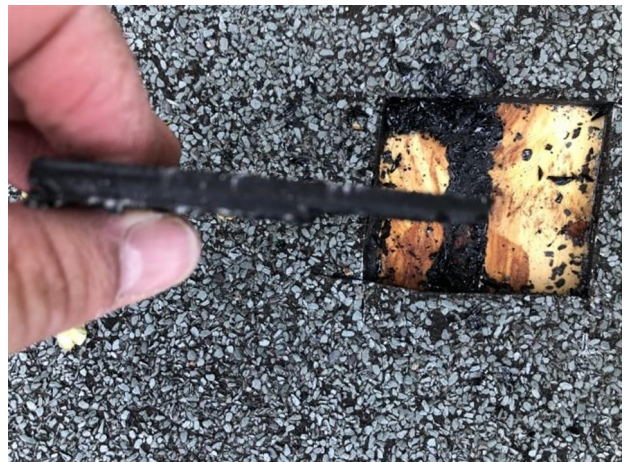
View of the two layers of waterproofing which is beginning to fail.

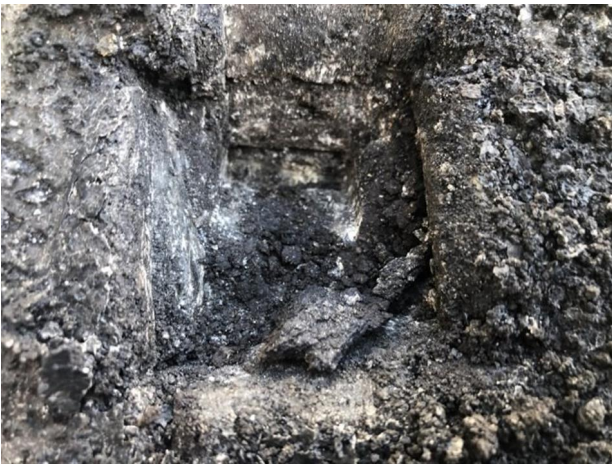
The asphalt is 25mm in thickness and is installed onto a concrete deck. This can be overlaid following suitable preparation.

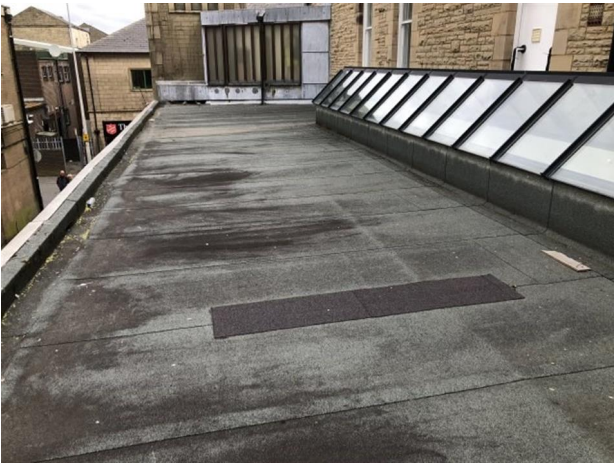
**General view of roof area 1 showing the various repairs.**

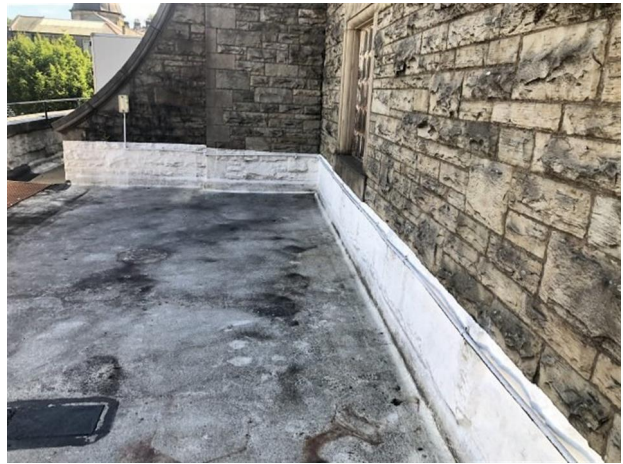
**Example of the waterproofing on roof area 2. The coating is wearing away and the asphalt is slumping.**

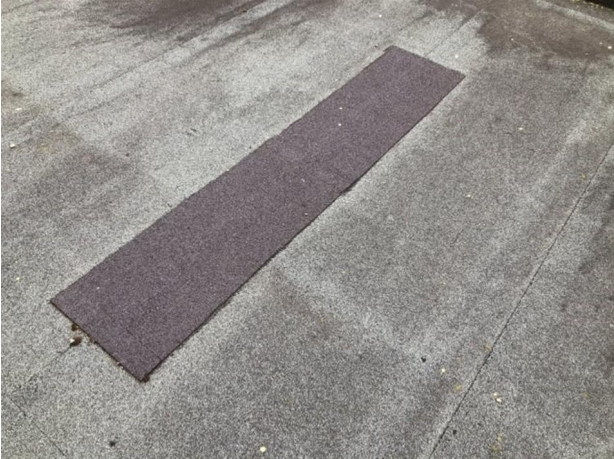
Numerous repairs have been undertaken on both roofs.

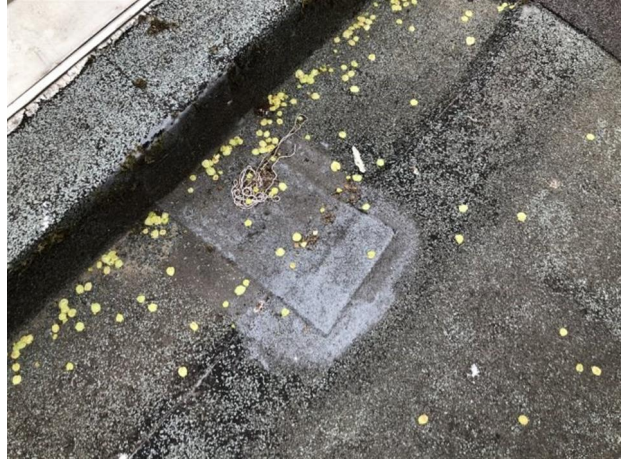
Further evidence of the repairs.

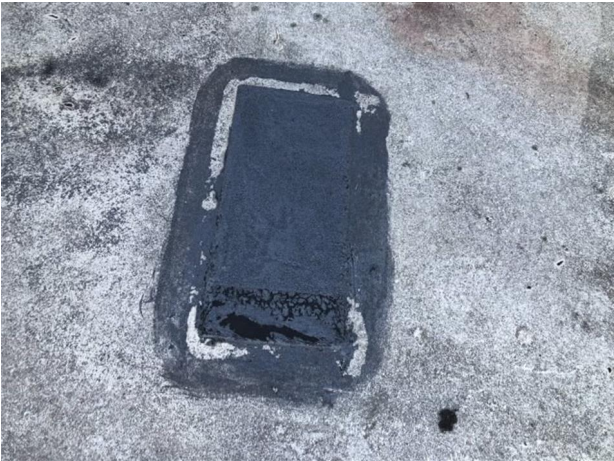
Repairs to the cracks in the asphalt on roof area 1. These will need to be removed and infilled using LiquiPaste.

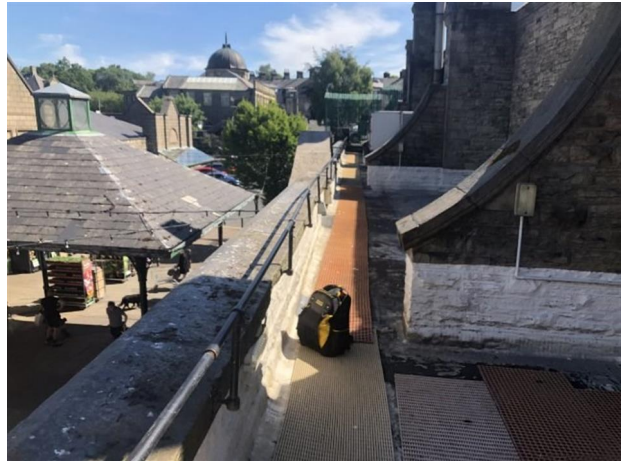
A new 1m wide walkway is to be formed in a contrasting colour of the liquid system.

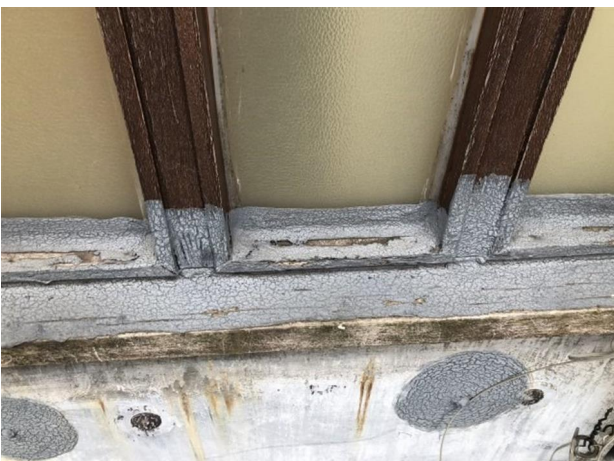
The timber window frames on roof area 1 are in a poor condition. Ideally these should be replaced.

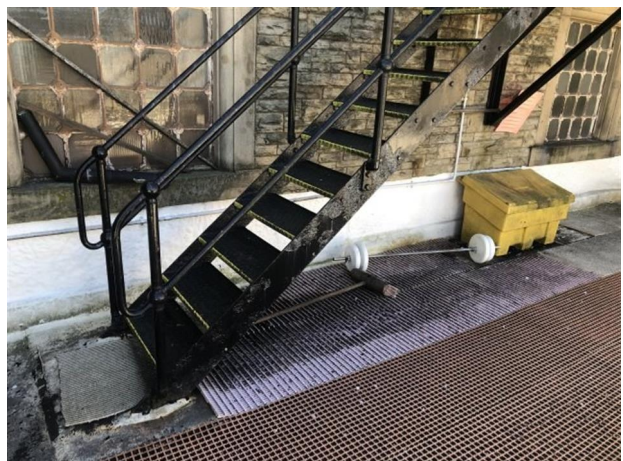
The stairwell will need to be raised temporarily on roof 2.

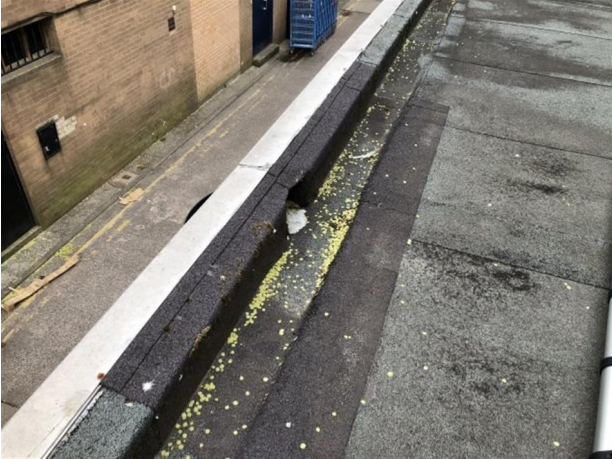
There are numerous chutes on roof area 1. A new gutter is to be formed and the chutes opened up and lined with lead.

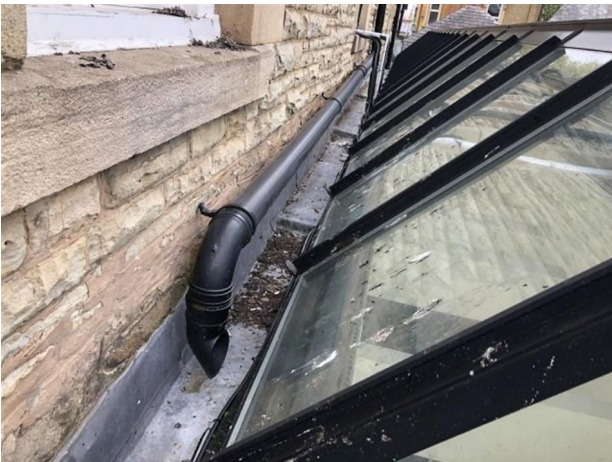
There is a gutter at the back of the structural glazing on roof 1. This is in a good condition and can be left in situ. New 60mm gutters can be formed next to these to take the water to the external chutes.

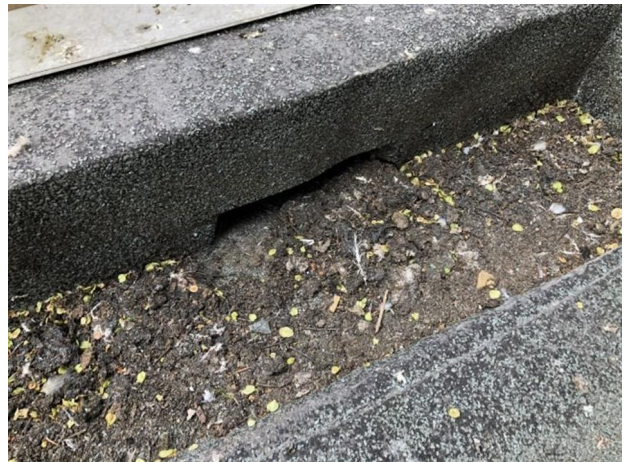
The chutes are narrow on roof 1 and opening these up will rectify this. This will ensure that they do not get blocked.

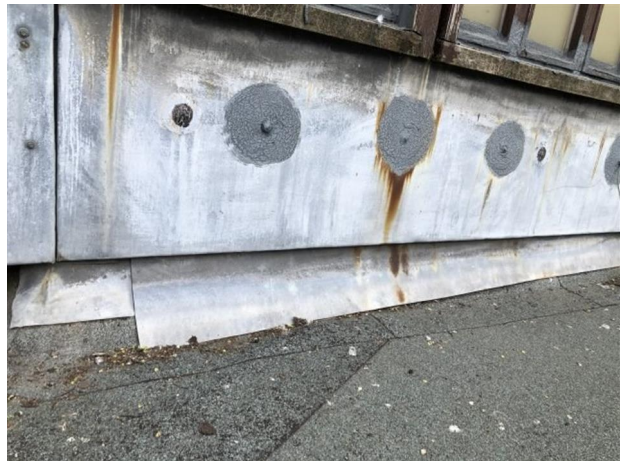
**Repairs have been carried out to the lead cladding. Modification may be required to ensure that the height of 150mm can be achieved in these areas.**

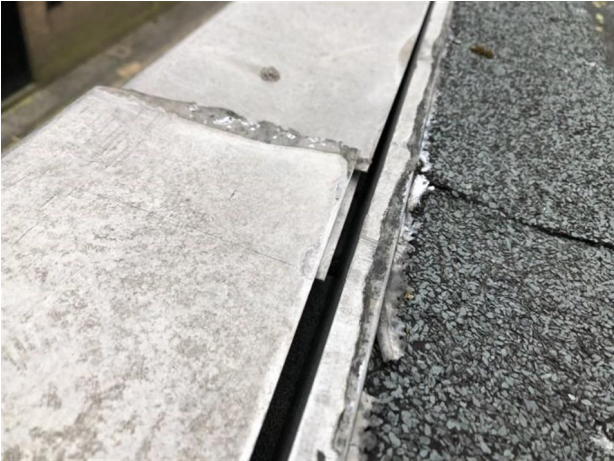
The metal capping on roof area 1 is in a very poor condition. This will need to be removed, the perimeter raised using timber and a new GRP trim installed.

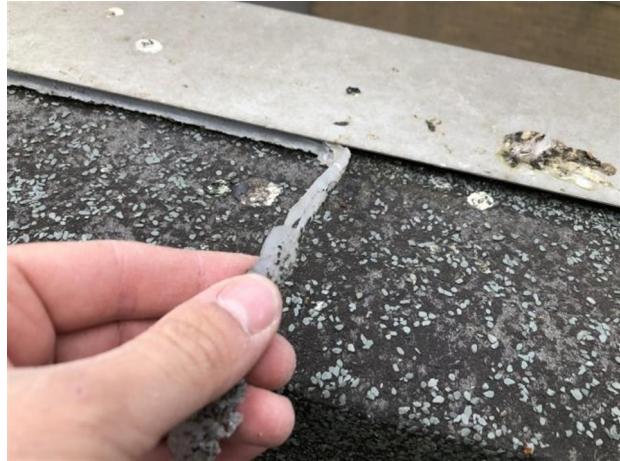
The waterproofing integrity is reliant on a sealant which has perished.

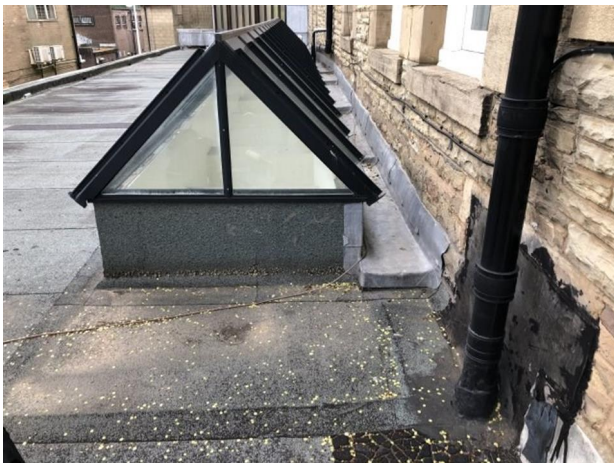
**General view of the structural glazing unit on roof 1.**
