## **ASBESTOS SURVEY REPORT**

Darwen Town Hall, Croft Street, Darwen, BB3 1BQ

**Blackburn with Darwen Borough Council**

<b>Survey Number:</b>	J006109
<b>Survey Type:</b>	Refurbishment/Demolition Survey
<b>Survey Date/s:</b>	19th March 2020
<b>Surveyors:</b>	Grant Guest
<b>Report Date:</b>	24 March 2020
<b>Authorised By:</b>	Grant Guest Senior Surveyor & Technical Manager
<b>Authorised Signature:</b>

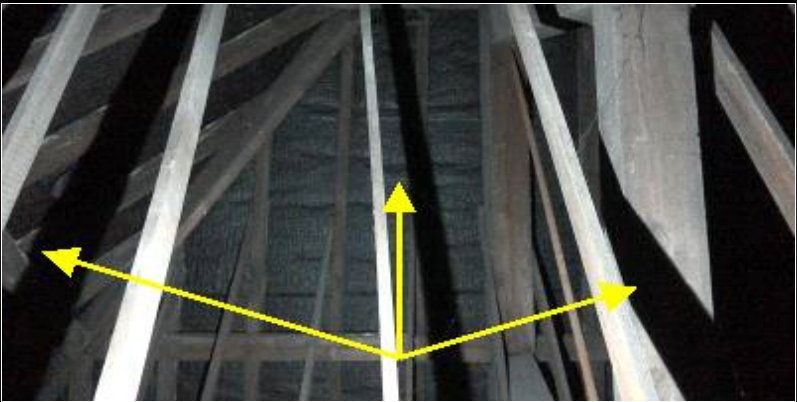
Inspection Reference 1	Building	Darwen Town Hall	Item Description	Bituminous Roofing Felt	Surveyed By Grant Guest
	Floor	Roof Void	Product Description	N/A	
	Room / Area	Roof Void 1 / R.001	Quantity	N/A	
	Item Location	Roof Underlay	Sample Reference	AE001171	Survey Date
	Accessibility	N/A	Status	Identified	19/03/2020

Inspection Frequency	N/A	
Comments		
<b>MMMF Insulation quilt over lath and plaster ceiling, timber roof void hatch.</b>

Recommended Action	No further action required	<b>Photograph</b>

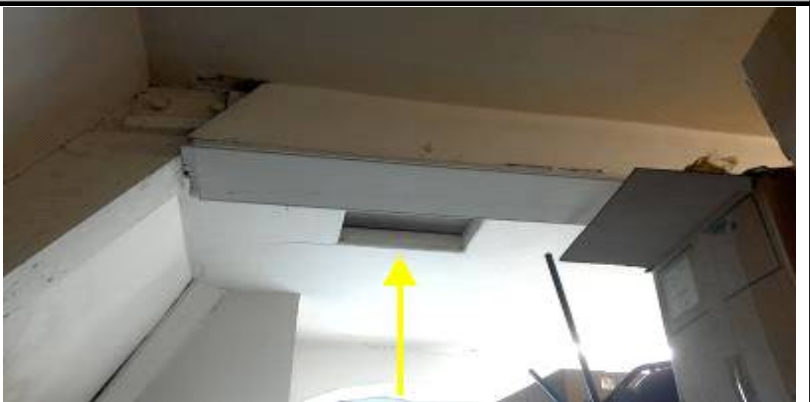
Inspection Reference 2	Building	Darwen Town Hall	Item Description	Plaster	Surveyed By Grant Guest
	Floor	Roof Void	Product Description	N/A	
	Room / Area	Roof Void 1 / R.001	Quantity	N/A	
	Item Location	To Lath and Plaster Ceiling	Sample Reference	AE001172	Survey Date
	Accessibility	N/A	Status	Identified	19/03/2020

Recommended Action	No further action required	<b>Photograph</b>

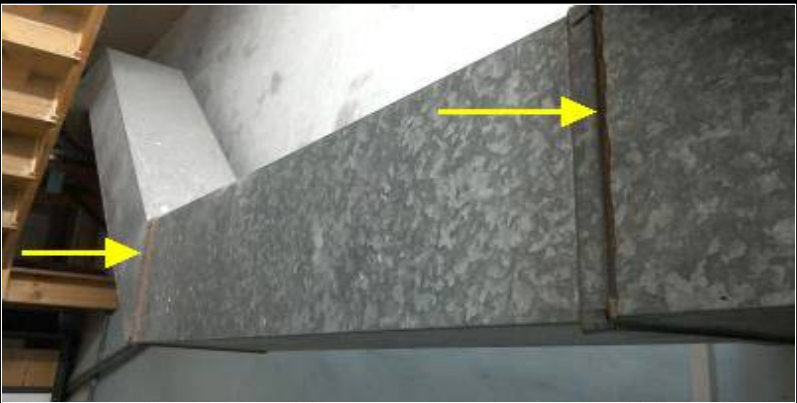
<b>Inspection Reference</b>	<b>Building</b>	Darwen Town Hall	<b>Item Description</b>	Red Mastic	<b>Surveyed By</b>
	<b>Floor</b>	1st Floor	<b>Product Description</b>	N/A	
3	<b>Room / Area</b>	Roof Void1 Entrance Stairwell / 1.001	<b>Quantity</b>	N/A	<b>Survey Date</b>
	<b>Item Location</b>	Ducting Perimeter Joints	<b>Sample Reference</b>	AE001173	
	<b>Accessibility</b>	N/A	<b>Status</b>	Identified

<b>Inspection Frequency</b>	N/A	
<b>Comments</b>		
<b>Sample requested by client, not part of the scope of works.</b>

<b>Recommended Action</b>	No further action required	<b>Photograph</b>

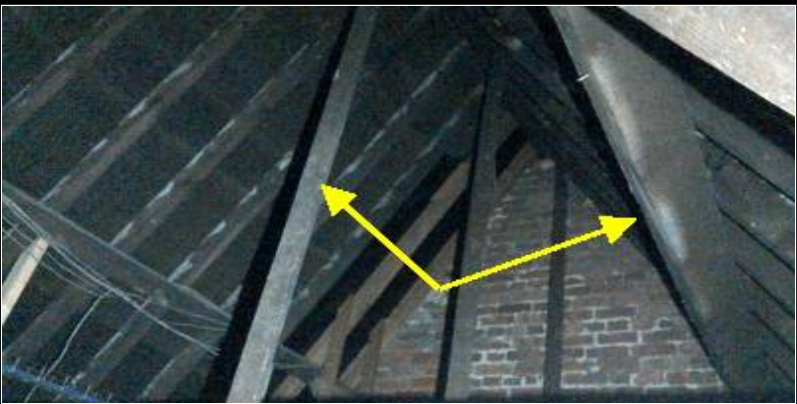
<b>Inspection Reference</b>	<b>Building</b>	Darwen Town Hall	<b>Item Description</b>	Bituminous Roofing Felt	<b>Surveyed By</b>
	<b>Floor</b>	Roof Void	<b>Product Description</b>	N/A	
4	<b>Room / Area</b>	Roof Void 2 / R.002	<b>Quantity</b>	N/A	<b>Survey Date</b>
	<b>Item Location</b>	Roof Underlay	<b>Sample Reference</b>	As AE001171	
	<b>Accessibility</b>	N/A	<b>Status</b>	Strongly Presumed

<b>Inspection Frequency</b>	N/A	
<b>Comments</b>		
<b>MMMF Insulation quilt over lath and plaster ceiling, brick roof apex walls, timber roof void hatch.</b>

<b>Recommended Action</b>	No further action required	<b>Photograph</b>

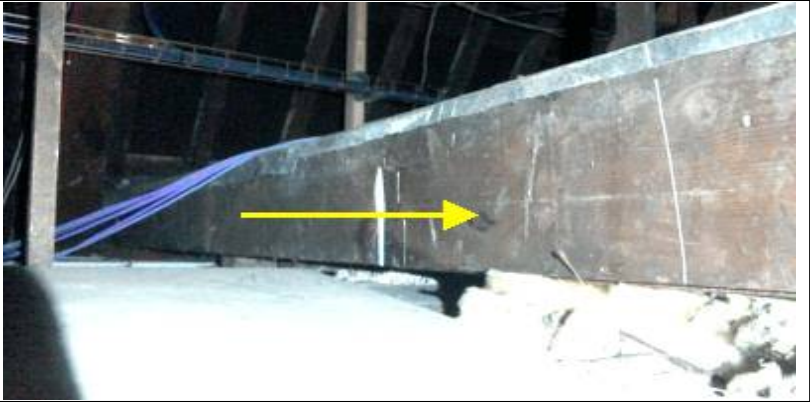
Inspection Reference	Building	Darwen Town Hall	Item Description	No suspect material found	Surveyed By
	Floor	Roof Void	Product Description	N/A	
5	Room / Area	Roof Void 2 / R.002	Quantity	N/A	Grant Guest
	Item Location	Internal Gutter	Sample Reference	Visual 5	
	Accessibility	N/A	Status	No suspect materials found	
19/03/2020

Comments		
Lead lined timber internal box gutter.

Recommended Action	No further action required	Photograph
Inspection Frequency	N/A

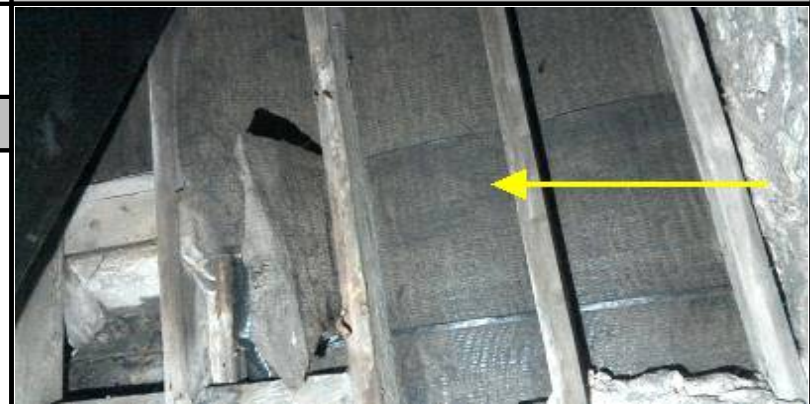
Comments		
Modern plastic roof underlay above the sampled bituminous roofing felt, timber floor boards, sealed vertical timber boxing, timber boards to underside of roof hips, partly plastered stone walls and timber roof trusses.

Recommended Action	No further action required	Photograph
Inspection Frequency	N/A

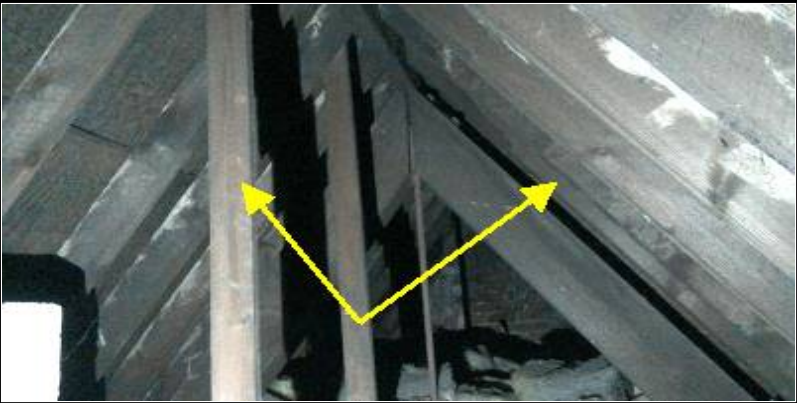
Comments		
<p>MMMF Insulation quilt over lath and plaster ceiling, plasterboard ceiling top, brick roof apex wall, block walls to lift, lath and plaster wall, timber roof void hatch.</p>

Recommended Action	No further action required	Photograph
Inspection Frequency	N/A

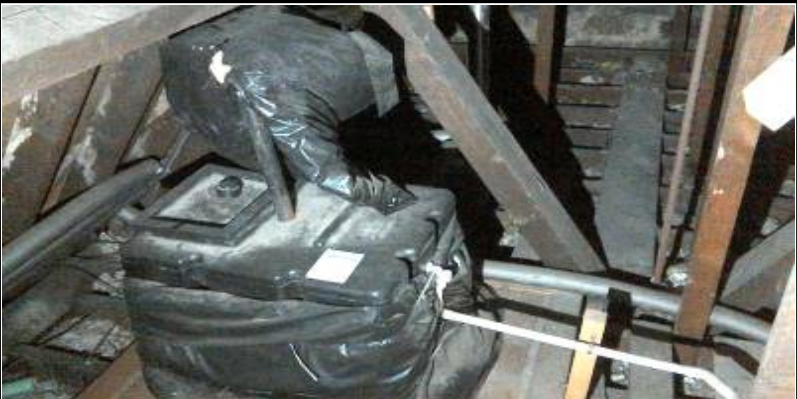
Inspection Reference	Building	Darwen Town Hall	Item Description	No suspect material found	Surveyed By	
	Floor	Roof Void	Product Description	N/A		Grant Guest
8	Room / Area	Roof Void 3 / R.004	Quantity	N/A	Survey Date	
	Item Location	Water Tank and Pipework	Sample Reference	Visual 8		19/03/2020
	Accessibility	N/A	Status	No suspect materials found

Comments		
<p>Foam and foil backed MMMF insulation lagging pipework, plastic water tank sat on a timber panel.</p>

Recommended Action	No further action required	Photograph
Inspection Frequency	N/A

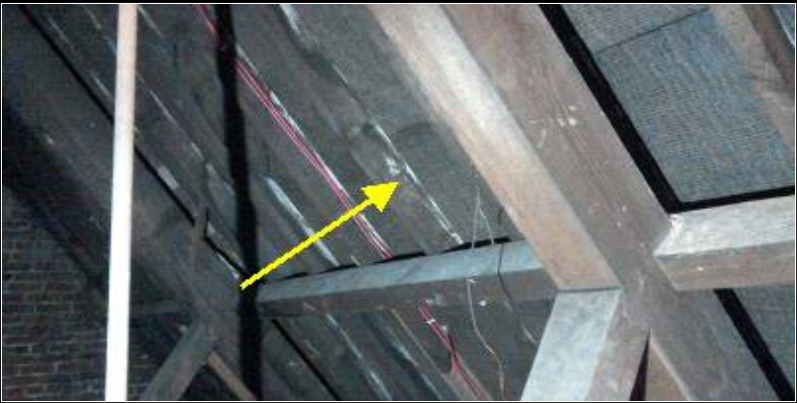
Comments		
MMMF Insulation quilt over lath and plaster ceiling, brick roof apex walls, timber roof void hatch.

Recommended Action	No further action required	Photograph
Inspection Frequency	N/A

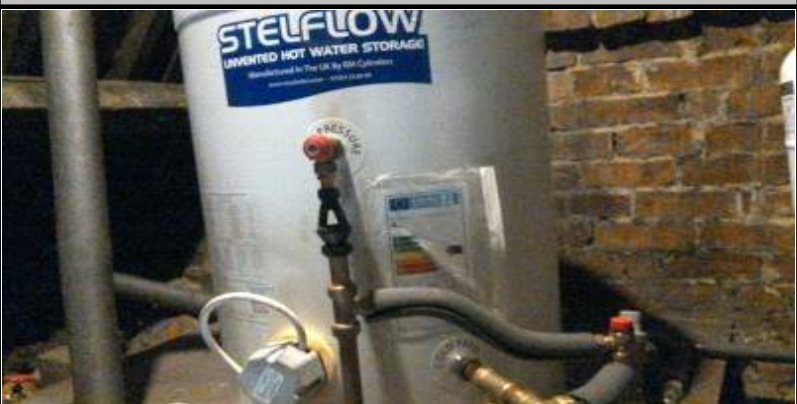
Inspection Reference	Building	Darwen Town Hall	Item Description	No suspect material found	Surveyed By	
	Floor	Roof Void	Product Description	N/A		Grant Guest
10	Room / Area	Roof Void 4 / R.005	Quantity	N/A	Survey Date	
	Item Location	Water Heater and Pipework	Sample Reference	Visual 10		19/03/2020
	Accessibility	N/A	Status	No suspect materials found

Comments		
Modern water heater, foam and hessian insulation lagging pipework.

Recommended Action	No further action required	Photograph
Inspection Frequency	N/A

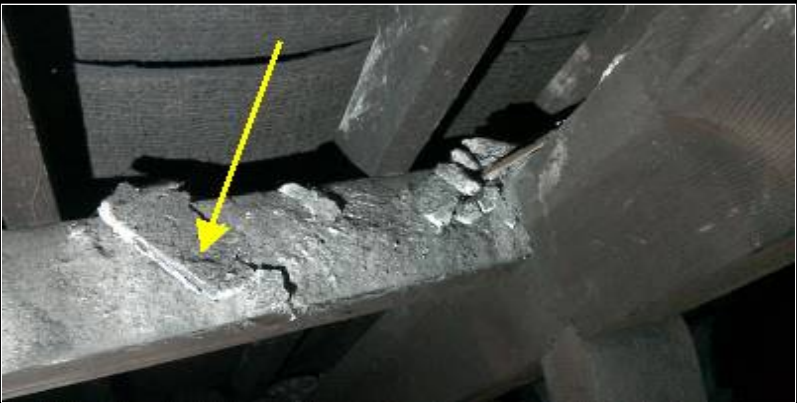
<b>Recommended Action</b>	No further action required	<b>Photograph</b>
<b>Inspection Frequency</b>	N/A	
<b>Comments</b>		
Back pointing debris to timber roof trusses and purlins, a mixture of lime mortar and horse hair.

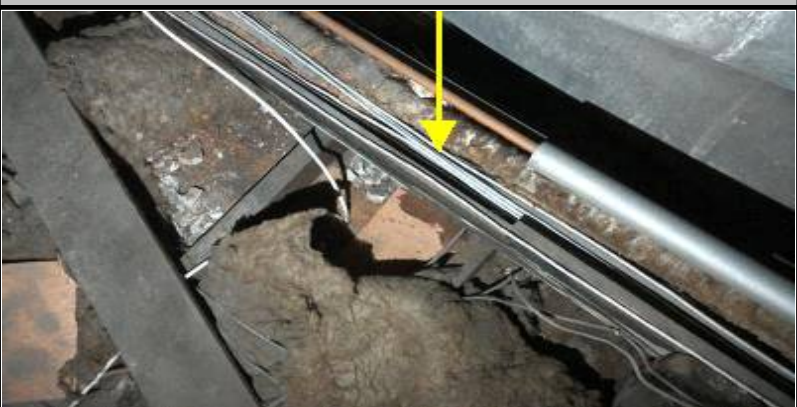
<b>Inspection Reference</b>	<b>Building</b>	Darwen Town Hall	<b>Item Description</b>	Timber Insulation	<b>Surveyed By</b>
	<b>Floor</b>	Roof Void	<b>Product Description</b>	N/A	
12	<b>Room / Area</b>	Roof Void 4 / R.005	<b>Quantity</b>	N/A	<b>Survey Date</b>
	<b>Item Location</b>	Timber Pipework Box	<b>Sample Reference</b>	AE001177	
	<b>Accessibility</b>	N/A	<b>Status</b>	Identified

<b>Recommended Action</b>	No further action required	<b>Photograph</b>
<b>Inspection Frequency</b>	N/A	
<b>Comments</b>		
Reassurance sample of timber type shavings to the timber pipework box as pictured. Hessian type insulation lagging pipework.

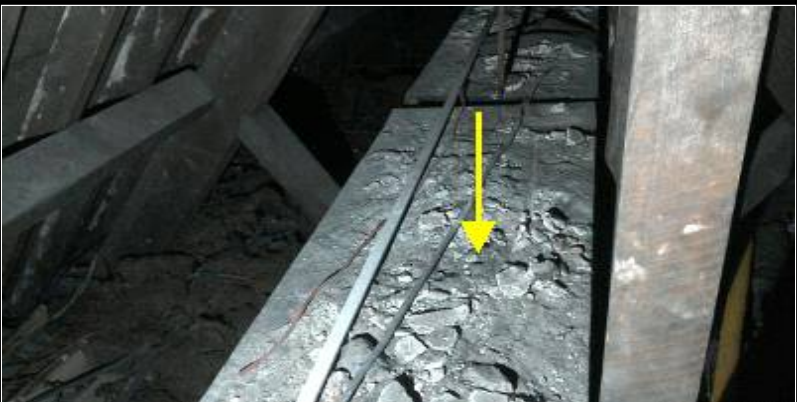
Comments		
<p>Back pointing debris to timber boxing top, roof trusses and purlins, a mixture of lime mortar and horse hair.</p>

Recommended Action	No further action required	Photograph
Inspection Frequency	N/A

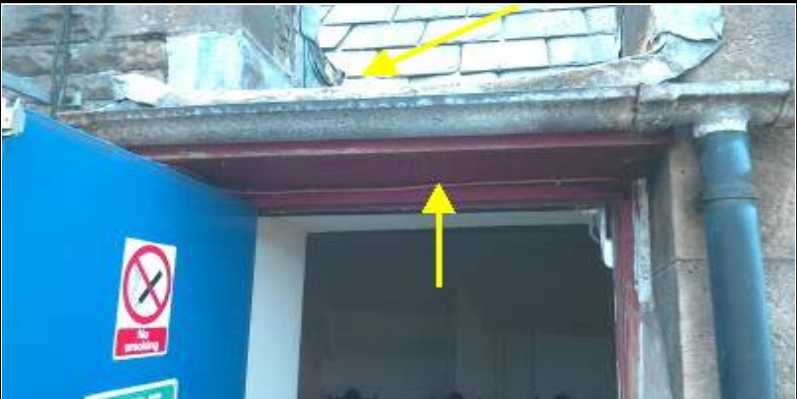
Inspection Reference	Building	Darwen Town Hall	Item Description	No suspect material found	Surveyed By	
	Floor	Roof	Product Description	N/A		Grant Guest
17	Room / Area	Main Roof / 995.001	Quantity	N/A	Survey Date	
	Item Location	Fire Exit Canopy	Sample Reference	Visual 17		19/03/2020
	Accessibility	N/A	Status	No suspect materials found

Inspection Frequency	N/A	
Comments		
<p>Lead lining to a modern bituminous green mineral felt, timber roof deck, timber soffit, aluminium gutter and PVC RWP.</p>

Recommended Action	No further action required	<b>Photograph</b>

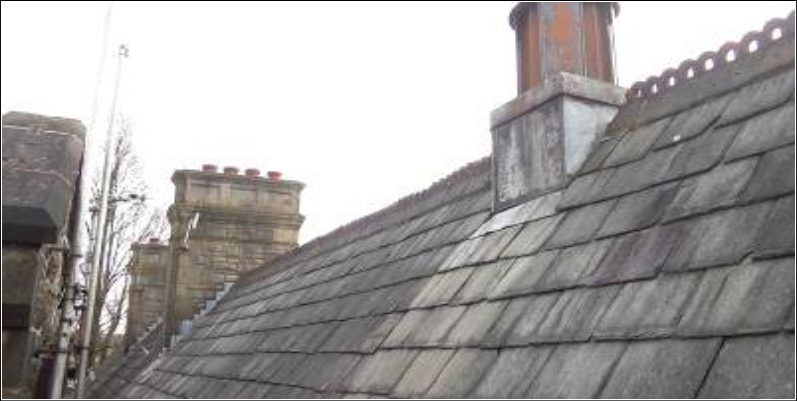
Inspection Reference	Building	Darwen Town Hall	Item Description	No suspect material found	Surveyed By	
	Floor	Roof	Product Description	N/A		
18	Room / Area	Main Roof / 995.001	Quantity	N/A	Grant Guest	
	Item Location	Side Elevation Roof Covering	Sample Reference	Visual 18		Survey Date
	Accessibility	N/A	Status	No suspect materials found		19/03/2020

Inspection Frequency	N/A	
Comments		
Natural slated roof, lead flashing to hips, clay ridges, metal cowl vent.

Recommended Action	No further action required

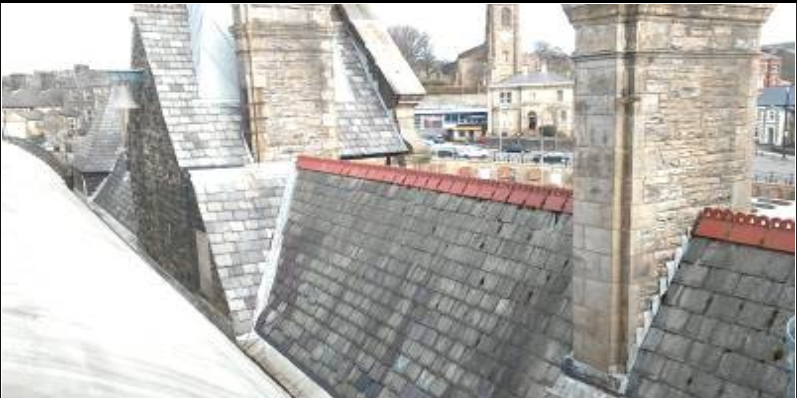
Inspection Reference	Building	Darwen Town Hall	Item Description	No suspect material found	Surveyed By	
	Floor	Roof	Product Description	N/A		
19	Room / Area	Main Roof / 995.001	Quantity	N/A	Grant Guest	
	Item Location	Front Elevation Roof Covering	Sample Reference	Visual 19		Survey Date
	Accessibility	N/A	Status	No suspect materials found		19/03/2020

Inspection Frequency	N/A	
Comments		
Natural slated roof, lead flashing to valleys and clock tower, clay ridges, cast gutters and RWPs.

Recommended Action	No further action required
