Condition Survey

Victorian Cafe

Marine Parade

Weston-super-Mare

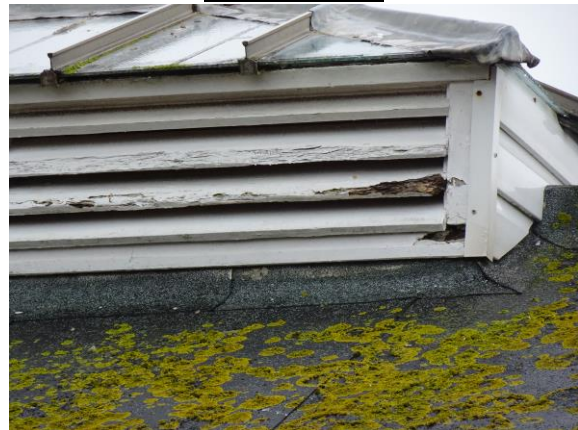
To the centre is a timber and iron traditional lantern light with louvre panel sides for ventilation. The timber, where visible externally is in very poor condition with rot and decay visible. Some sections of timber are in danger of falling out due to the level of rot. Extensive timber repairs are required. On two elevations the timber has been faced with Upvc cladding, there is no record of Listed Building Consent being granted for the use of this material to repair the building and this repair may be in breach of planning.

<u>Element</u>	<u>Comment</u>
Roof window	Rot to roof window

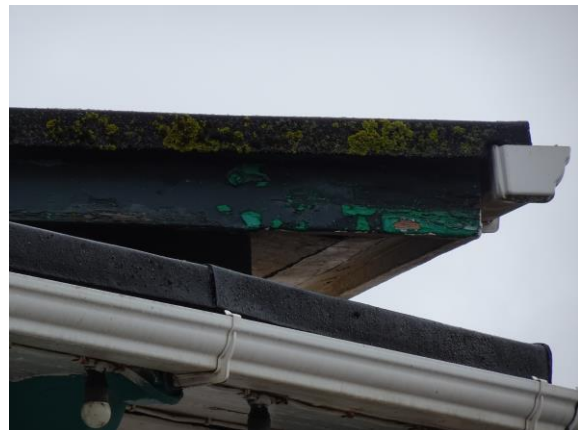
The gutters are Ogee profile white plastic gutters with round plastic downpipes, these originally would have been painted cast iron Ogee profile gutters with either square or round downpipes. There is no record on the accessible electronic planning data base of a Listed Building Consent being submitted and granted for the installation of plastic gutters and downpipes. Further enquiries should be undertaken with the planners, we would anticipate this leading to remedial works due to a potential breach of the listed building consent process.

Roof	Trim in poor decorative order, replacement plastic gutters
------	--

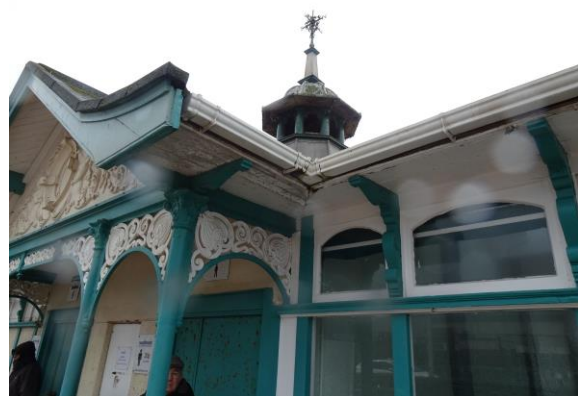
At the perimeter of the roof, there are painted timber soffits, to the front there is a water leak with water coming through the soffit, this has damaged the timber.

Roof	Water damage to soffits, repairs required
------	---

The roof needs to be repaired and the damaged sections of soffit cut and replaced. Generally, the soffits are in poor condition and in need of localised repairs and decoration.

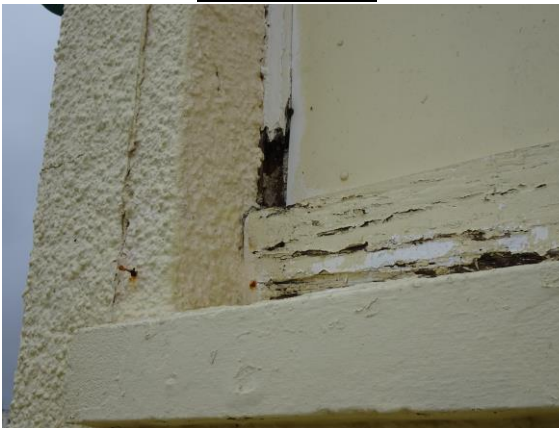
Rot was visible to the external joinery of the building. Remedial works will be required when the building is decorated.

<u>Element</u>	<u>Comment</u>	<u>Photograph</u>
External Elevations	Window sill and frame totally rotted through

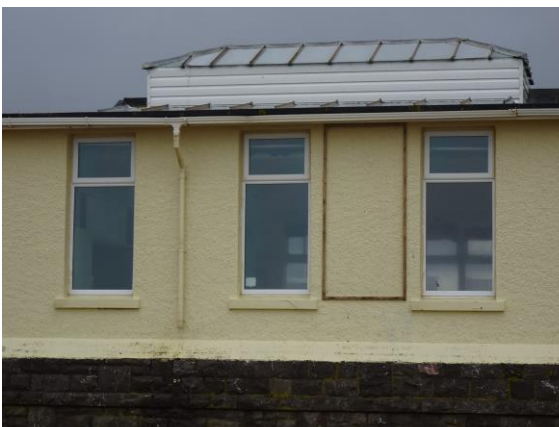
The windows to the rear elevation are white Upvc double glazed windows, these originally would have been painted timber single glazed windows. There is no record on the accessible electronic planning data base of a Listed Building Consent being submitted and granted for the installation of replacement windows. Further enquiries should be undertaken with the planners, we would anticipate this leading to remedial works due to a potential breach of the listed building consent process.

Rear Elevation	Upvc cladding to lantern window on roof, Upvc gutters and downpipes and Upvc windows, all require Listed Building Consent

However, that does need to be confirmed, the building has UPVC double glazed replacement windows, Upvc cladding and Upvc replacement gutters and downpipes, this all require listed building consent and conservation area consent. It should be confirmed that the necessary permissions are in place.

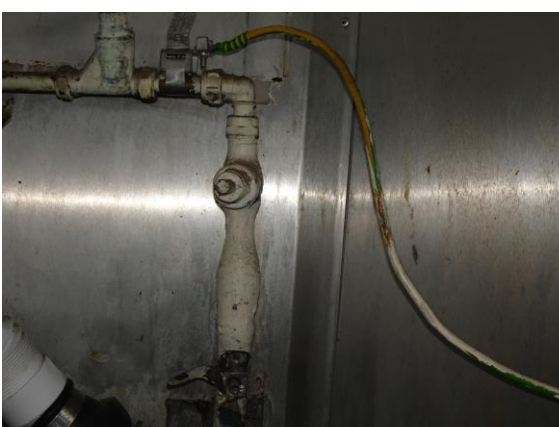
Kitchen	Lead pipe on incoming water main, all lead water pipes should be removed

The incoming water main appears to be a lead main, this will need to be investigated and replacing.

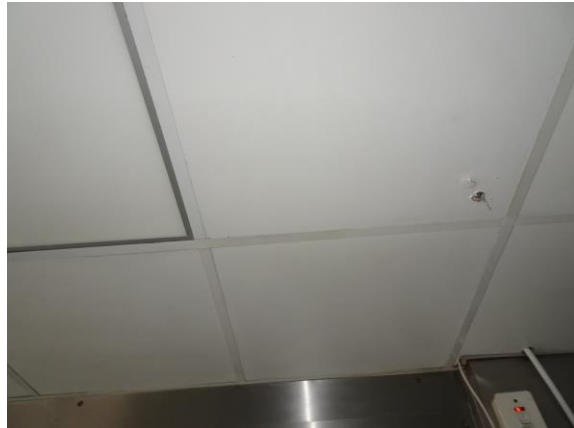
The kitchen ceiling is a lay-in grid ceiling with hygienic tiles and set in lighting units. There are numerous damaged and discoloured tiles, the ceiling is at the end of its serviceable life.

<u>Element</u>	<u>Comment</u>
Ceilings	Worn and damaged ceiling tiles to kitchen

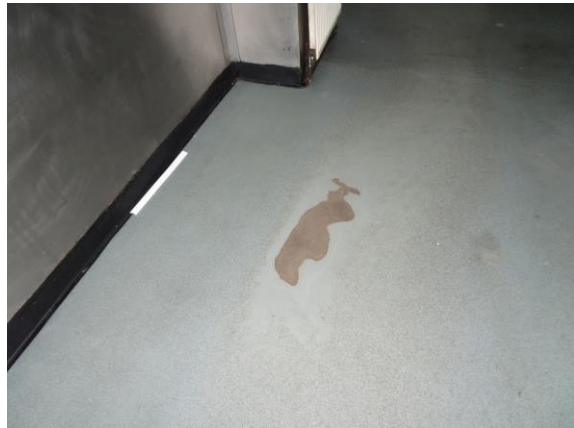
The floor finishes are sheet vinyl flooring, these are at the end of their service life with areas that are totally worn through, splits and failed seams. The floor coverings need to be replaced.

Floors	Sheet flooring to kitchen totally worn through
--------	--

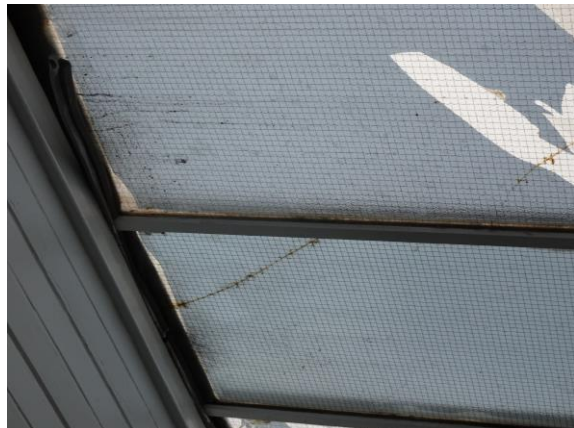
The tower is over the public toilets and not commented on within this report, there are two sets of roof windows over the café. To the rear is a set of metal framed, Georgian wired, flat roof windows set into the slope of the roof, the external face of these was not accessible for inspection. Internally the frame is in reasonable condition, seven out of the nine glazed panels are broken.

Both sets of roof windows have solar film on them, this has failed and is peeling off.

Roof	Broken glass and peeling film to roof window
------	--

An allowance needs to be made to obtain permission for the use of this materials or to remove this material from the roof and reinstate the original structure. It may be that planning will require the removal of this materials.
