# Asbestos Survey Report

**2 Lunedale UPRN 8421421  
Woodcock Drive  
Platt Bridge  
Wigan  
WN2 5NW**

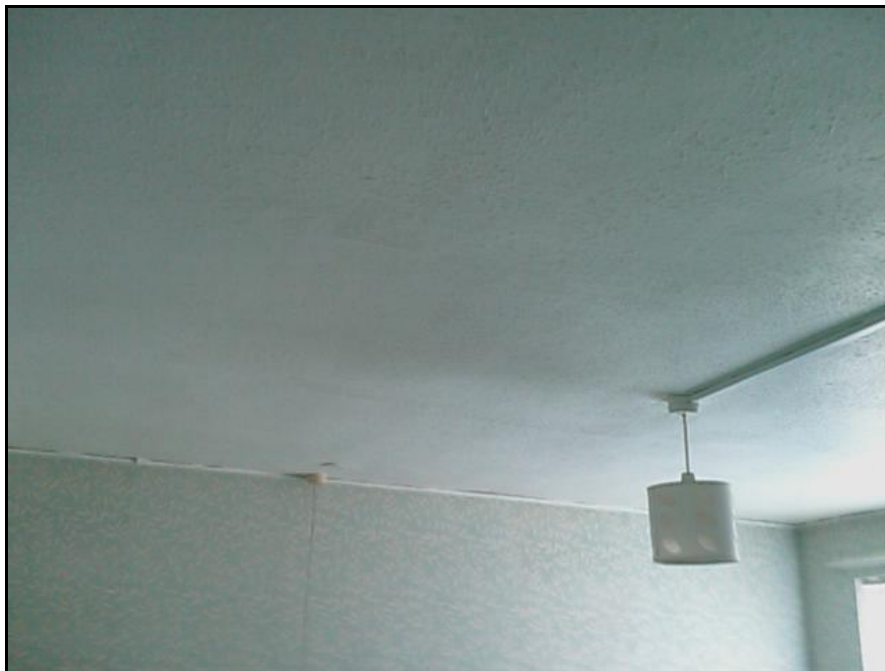
Building	8421421
Floor	Ground Floor
Room/Area	001 - Rooms throughout property
Sample No	1

**Description** Item: Ceilings throughout property.  
Present throughout property

Score
Product Type	Textured coating	1
Extent of Damage	Low Damage	1
Surface Treatment	Composite materials containing asbestos, plastics, resins etc.	0
Asbestos Type	Chrysotile (white)	1
Amount	50 m <sup>2</sup>	
Accessibility	Occasional Disturbance	
Algorithm Score		3

Building	Floor	Room/ Area	Sample	Product Type	Identification	Amount	<b>Summary of Priority Scores</b> Material + Occupancy + Disturbance + Exposure + Maintenance	Priority Algorithm	Management Action	Target Date
8421421	0	001 Rooms throughout property	1	Textured coating	Chrysotile (white)	50 m <sup>2</sup>	3 + 1 + 2 + 2 + 1	9	Manage and re- inspect	08 August 2011
8421421	0	001 Rooms throughout property	2	Floor tiles	Chrysotile (white)	50 m <sup>2</sup>	3 + 1 + 2 + 2 + 1	9	Manage and re- inspect	08 August 2011

Average of Priority scores	Sum of above averages	6
Material algorithm score	From survey report	3
Total Risk Assessment score		<b>9</b>

<b>RECOMMENDATION</b>	Manage and re-inspect
-----------------------	-----------------------

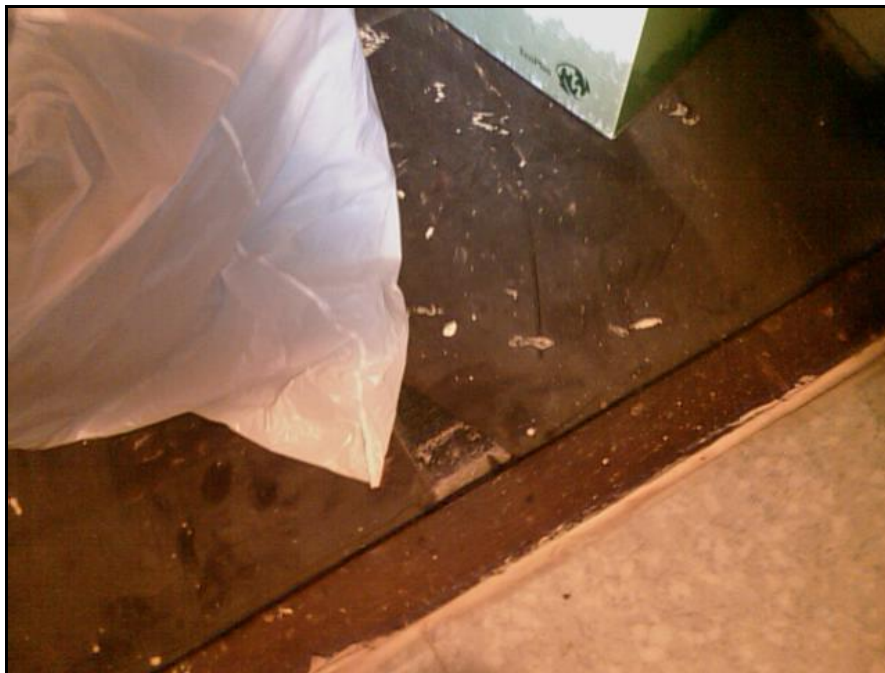
Building	8421421
Floor	Ground Floor
Room/Area	001 - Rooms throughout property
Sample No	2

**Description** Item: Floor tiles throughout property.  
Present below fixed flooring throughout

Score
Product Type	Floor tiles	1
Extent of Damage	Low Damage	1
Surface Treatment	Composite materials containing asbestos, plastics, resins etc.	0
Asbestos Type	Chrysotile (white)	1
Amount	50 m <sup>2</sup>	
Accessibility	Occasional Disturbance	
Algorithm Score		3

Average of Priority scores	Sum of above averages	6
Material algorithm score	From survey report	3
Total Risk Assessment score		<b>9</b>

<b>RECOMMENDATION</b>	Manage and re-inspect
-----------------------	-----------------------
