Report No. 4RS-JP-190316-R664776

**DEMOLITION ASBESTOS SURVEY
FARNBOROUGH COMMUNITY CENTRE - ELLES HALL
OFF OF MEUDEN AVENUE
FARNBOROUGH, HAMPSHIRE, GU14 7LE**

Issue Date: 15th October 2019

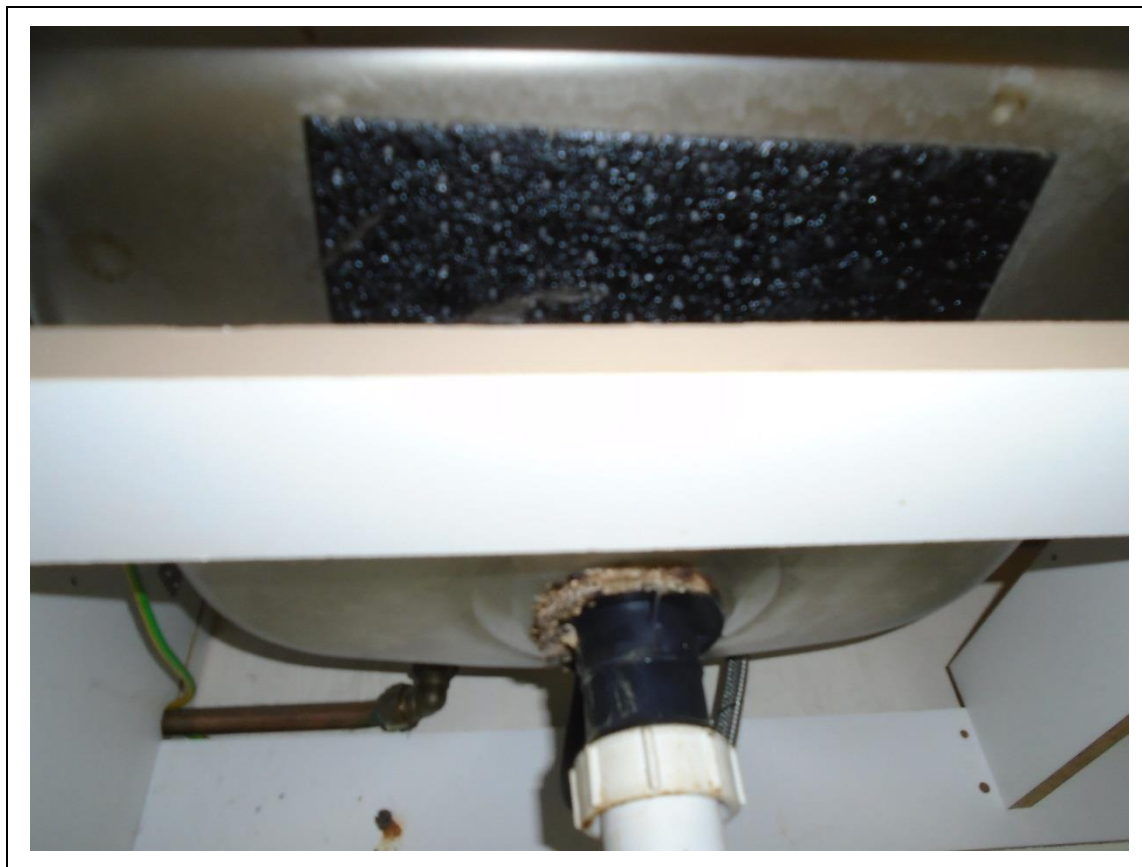
**FIGURE 1: CONFIRMED ASBESTOS IN BITUMEN PAD IN ROOM 1, 1/002 -
DESCRIPTION & RESULT OF ASSESSMENT (SAMPLE REF.
190316/041019/33)**

- Room 1, 1/002
 - Bitumen pad confirmed to contain Chrysotile asbestos, Figure 1 - Material assessment rating: Very low

Sample Number	190316/041019/33
Location	Room 1, 1/002
Material Description	Bitumen pad
Material Comment	Underside of sink
Quantity	<1m ²
Product Type	Composite
Current Condition	Good condition
Surface Treatment	Composite
Asbestos Type	Chrysotile
Material Assessment Rating	Very low
Accessibility	Medium
Further Comment	Not applicable

- 9.1 Just one item of asbestos was identified in the form of a sink pad, as detailed in Figure 1. This should be removed under locally controlled conditions by competent contractor prior to the building being demolished.
