Material Damage Inspection Report

Pendle Borough Council
Wavelengths Leisure Centre
Nelson

November 2019

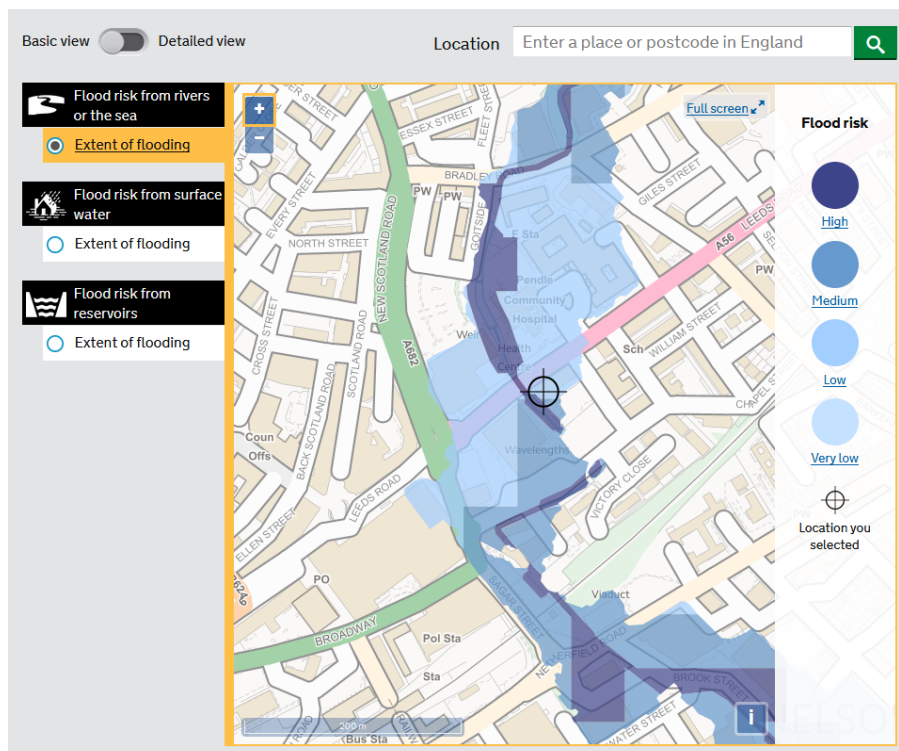
Flood risk from rivers or the sea - Medium risk means that each year this area has a chance of flooding of between 1% and 3.3%. This takes into account the effect of any flood defences in the area. These defences reduce but do not completely stop the chance of flooding as they can be overtopped or fail. This information is taken from the Environment Agency Flood Map.

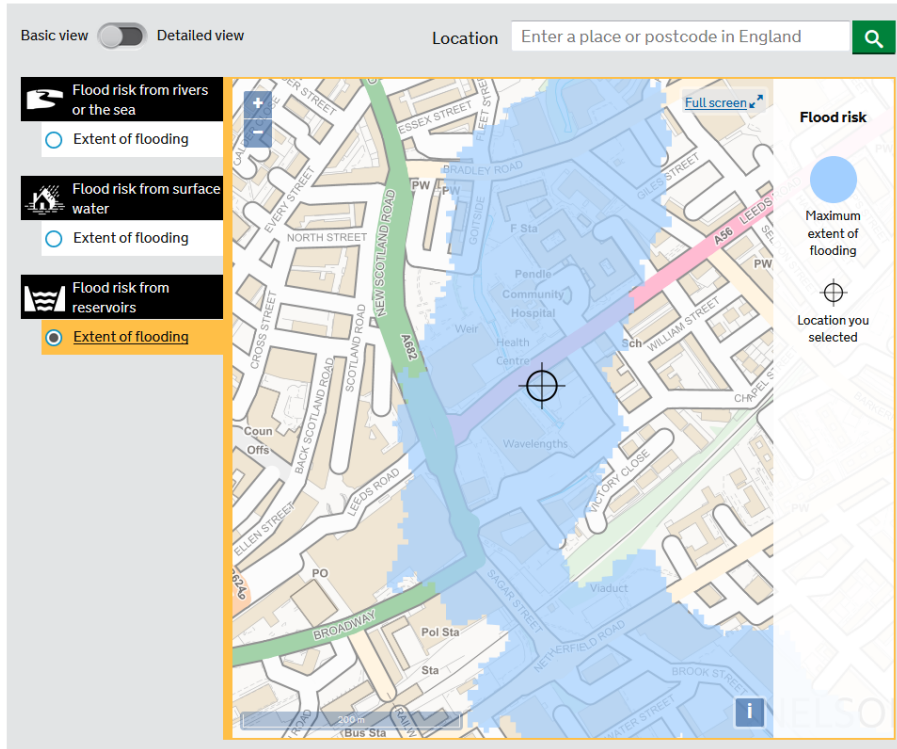
Flood Risk from reservoirs

There is a medium risk of flooding from reservoirs. Barrowford reservoir is to the north of Nelson.

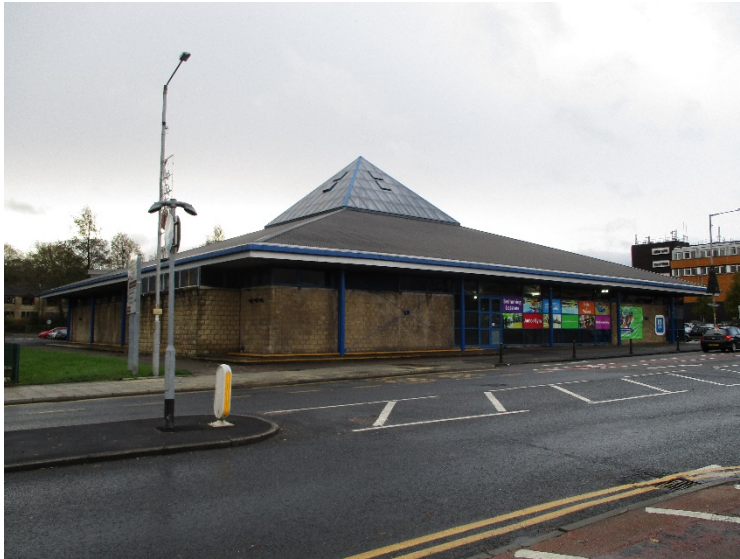
External view of original building

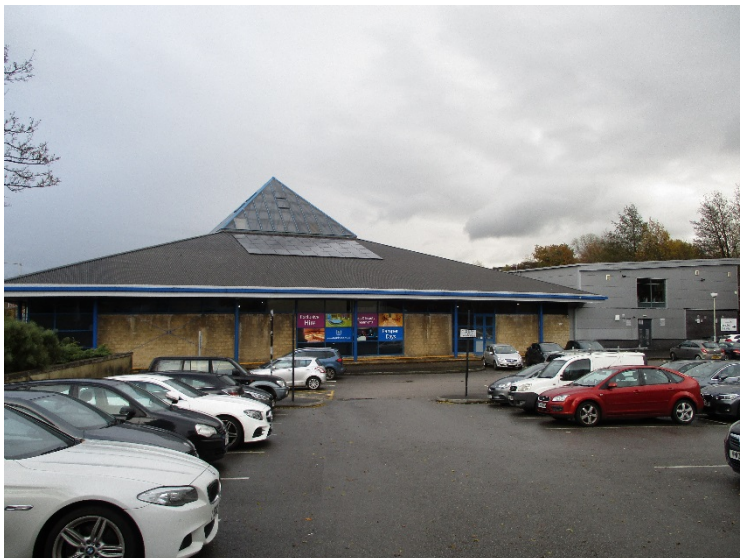
External view of original building

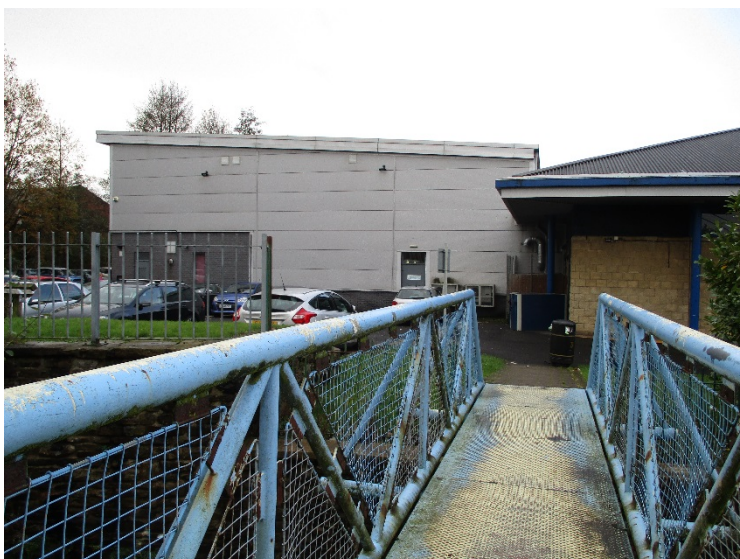
New spa building to the left

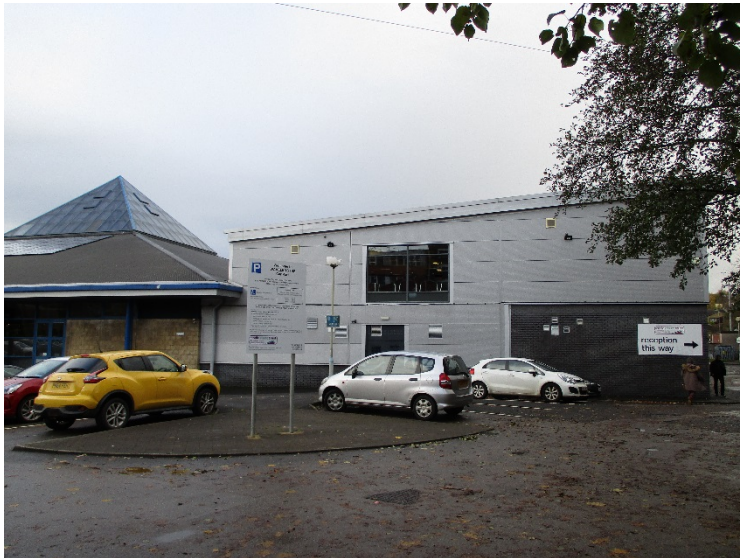
New spa building to the right

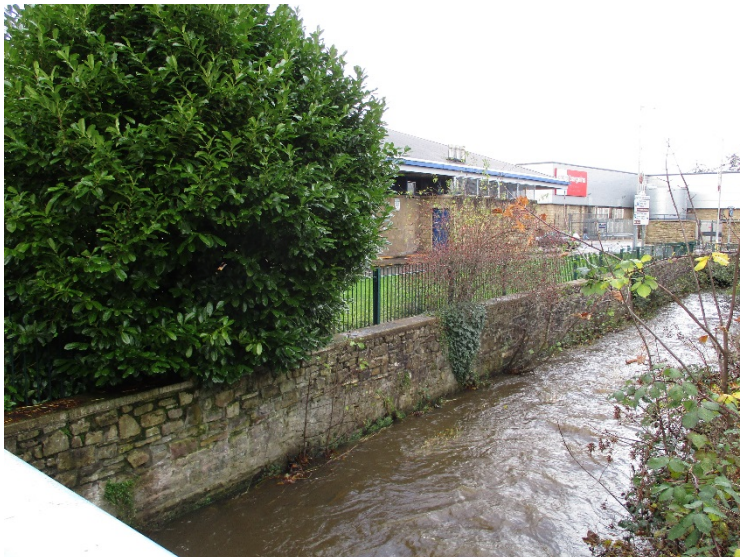
There is a stream adjacent to the site boundary which is at a lower level and no reported flooding incidents. The whole building is however at medium risk of flooding from rivers and from reservoirs according to the Environment Agency Flood Map.

Stream alongside the boundary

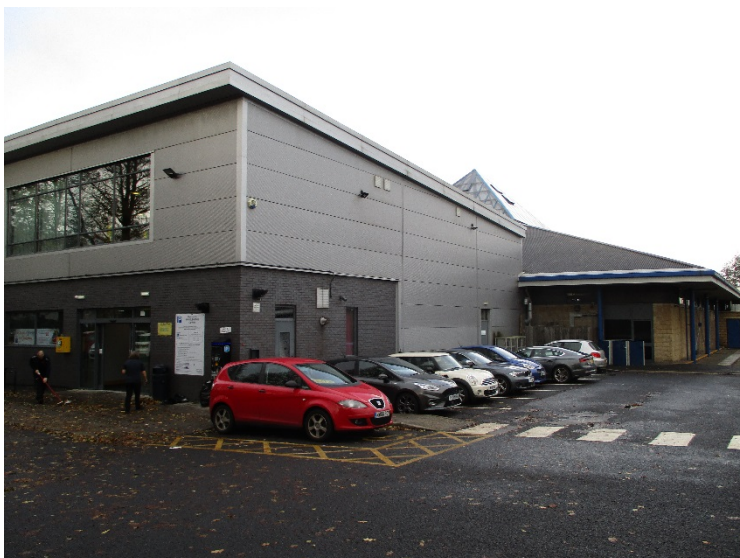
The spa incorporates Kingspan clad/cavity walls with unknown insulation. The roof is a Kingspan clad system (no record available of the insulation).

Spa building
