Condition Survey

P0697 - Parkfield Site (House &
Grounds)

P0697AB - Parkfield House

DATE: 13/04/2022

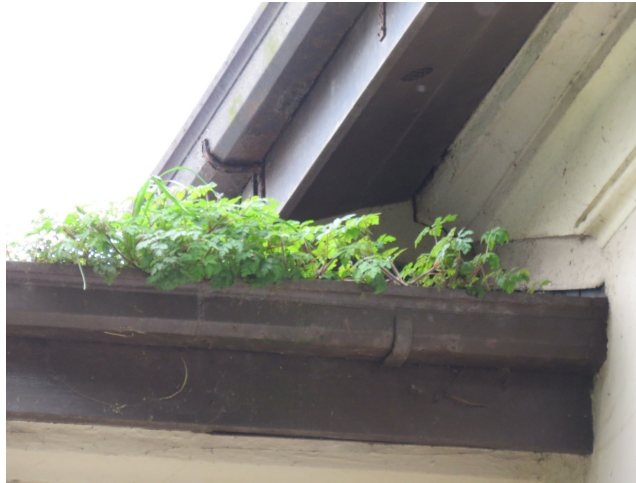
IW00052746

Painted cast-iron and plastic gutters and downpipes - notable amounts of vegetation in gutters.

Identified Work	Floor	Room No	Defect Location	Description	Condition	Repair	P1	P2	P3	P4
W00052746			Remove and clear/flush clear.	Painted cast-iron and plastic gutters and downpipes - notable amounts of vegetation in gutters.	C				2,000

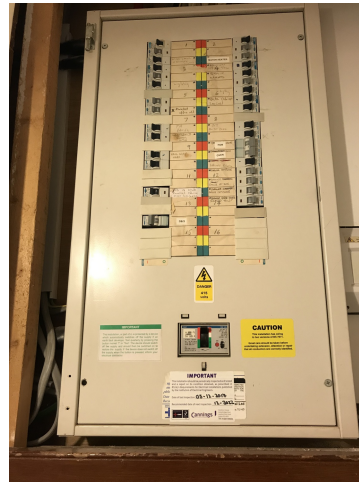
IW00052768

36 Way Hagar TPN D Board on ground floor, 14 Way Hagar SPN in 1st floor Cupboard, 6 Way SPN Legrand in Laundry

Cover missing from Hagar 16W TPN, install replacement

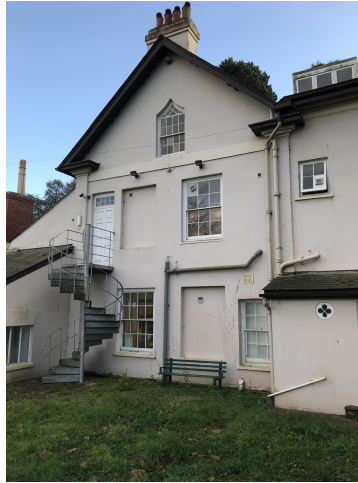
W00052773

High level T halogen floods

Replace with new LED flood lights

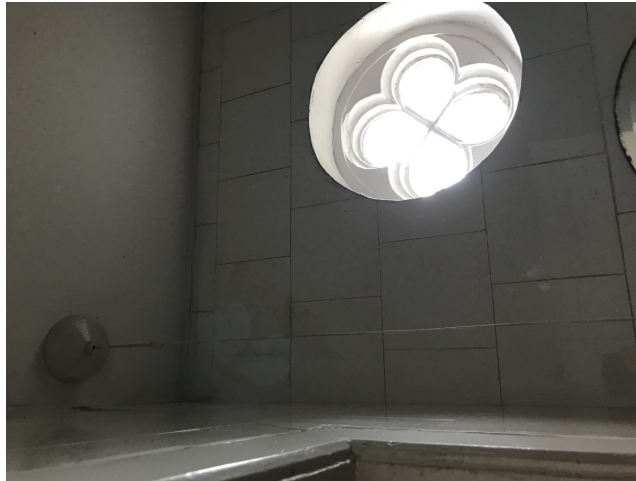
W00052788

Ground floor WC - Damaged pull switch

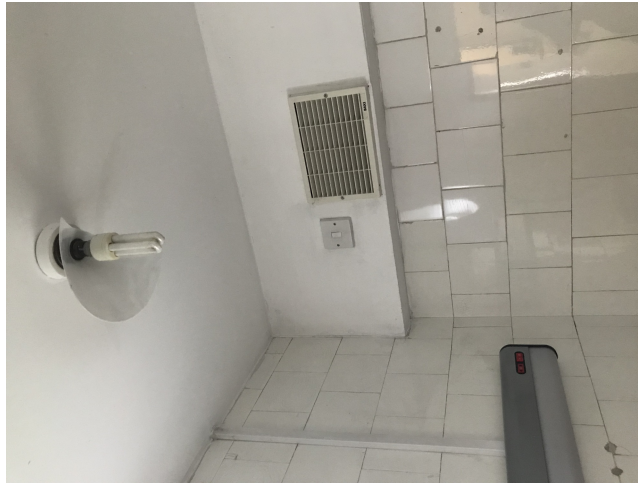
IW00052789

Ground & 1st floor - WC Light broken, Bathroom light not HO batten holder

Replace old batten holders with IP54 bulkheads fittings

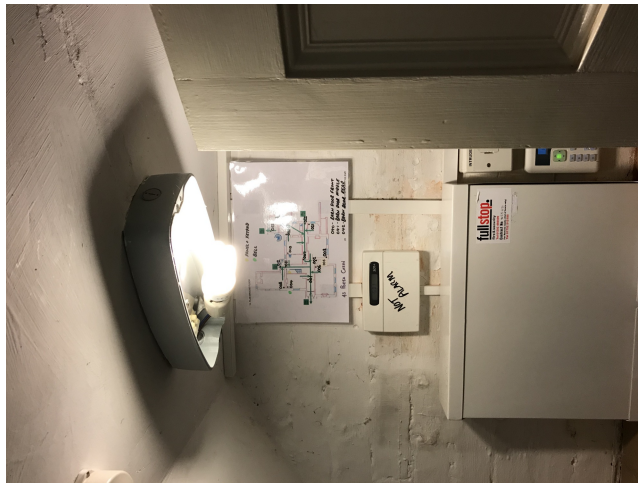
IW00052790

Ground floor Cupboard - Cover missing from light fitting

Replace with new IP54 bulkhead fitting

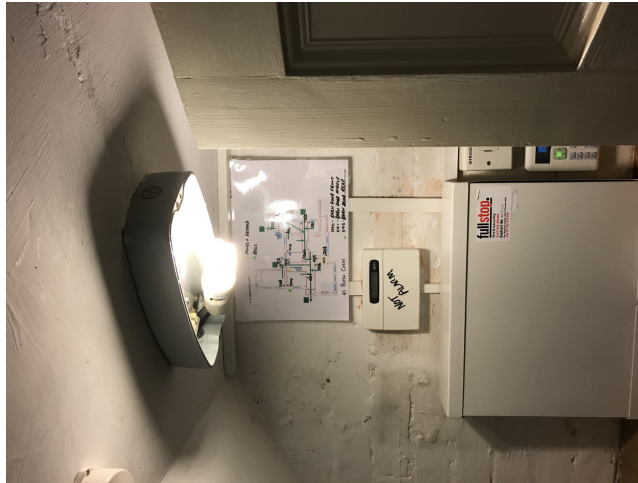
W00052791

Ground floor Cupboard - Damaged light fitting

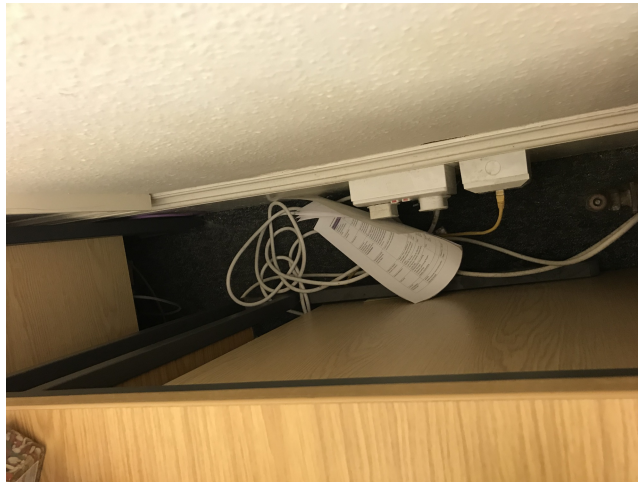
W00052792

Reception office - Extension leads used under desks for IT equipment

Install additional sockets

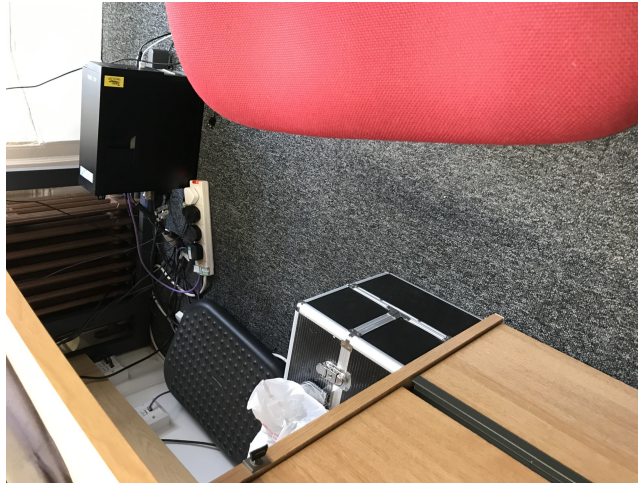
W00052793

Room F4 - Extension leads used under desks for IT equipment

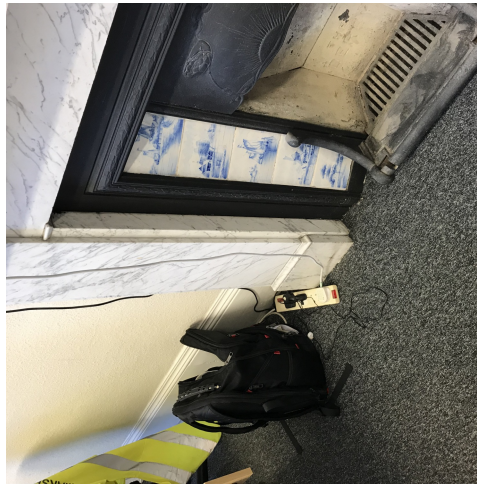
W00052794

Room F5 - Extension leads used under desks for IT equipment

Install additional sockets

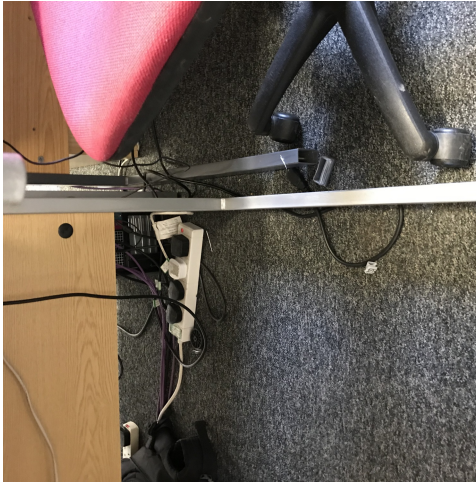
W00052795

Room F2 - Extension leads used under desks for IT equipment

Install additional sockets

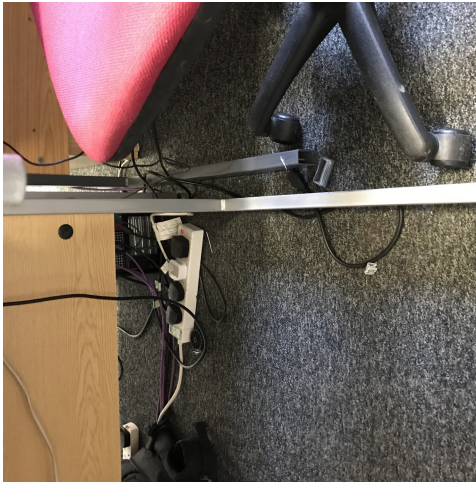
W00052796

Room F3 - Extension leads used under desks for IT equipment

Install additional sockets

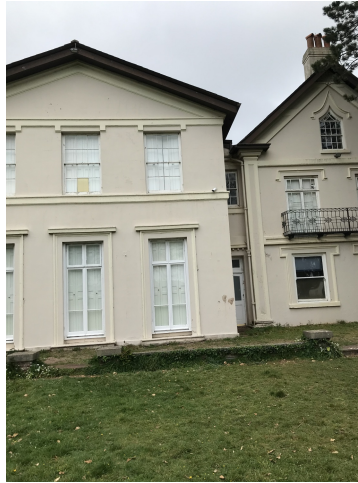
IW00052797

Wall mounted outside - High level Son & TH flood lights

Replace flood lights with LED equivalent

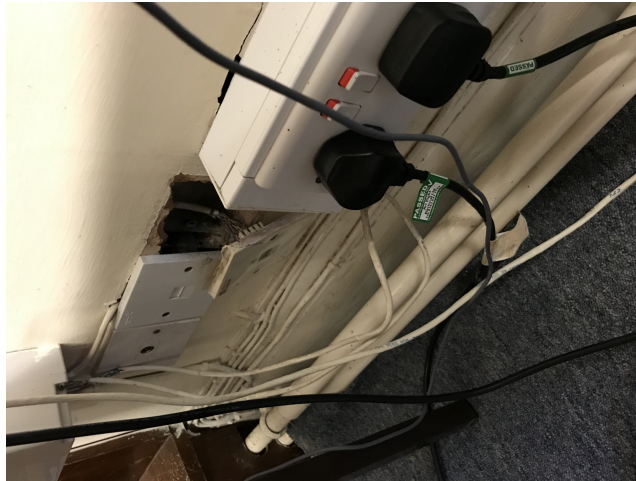
IW00052798

Panelled room - Telephone outlet plate loose

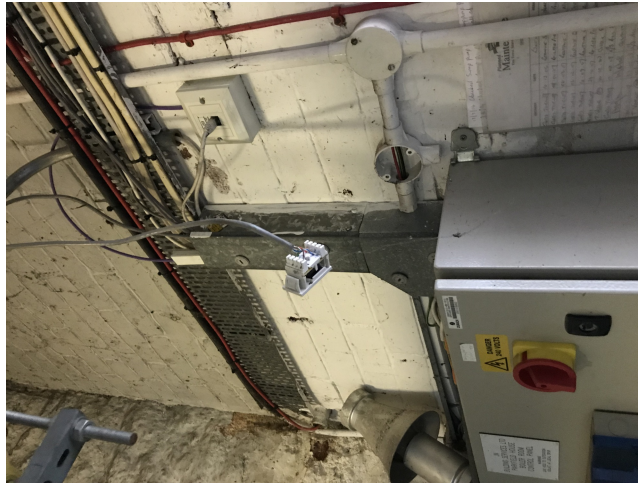
IW00052800

RJ45 outlet hanging loose with bare connections

Install surface single box and RJ45 mounting plate

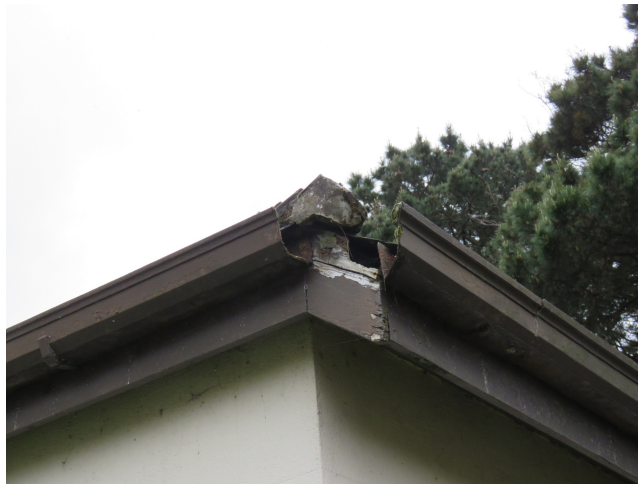
IW00054626

Painted timber fascias and soffits - generally satisfactory with localised areas of rotten timber - nominal sum applied to replace.

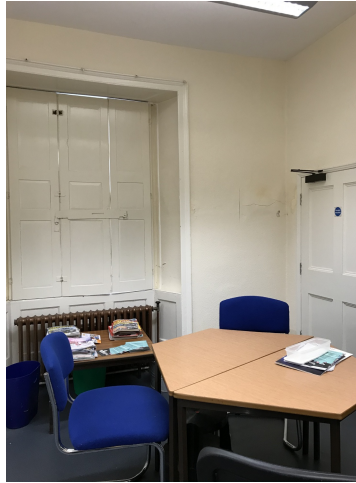
Combination of painted plastered random masonry and lathe and plaster partitions. Generally good to satisfactory with localised areas of plaster defects, presumably linked to historic incidents of water ingress.

IW00054638			Localised areas of peeling paintwork and spalling plaster to be removed/hacked off and replaced with new to match existing. Maintain as part of a cyclical programme of internal redecoration. Nominal sum applied for localised repairs.	Combination of painted plastered random masonry and lathe and plaster partitions. Generally good to satisfactory with localised areas of plaster defects, presumably linked to historic incidents of water ingress.	B				0	
------------	--	--	---	---	---	--	--	--	---	--
