Architectural Services

Asbestos Management

Elms Bank Specialist Arts College – Asbestos Management Plan Review

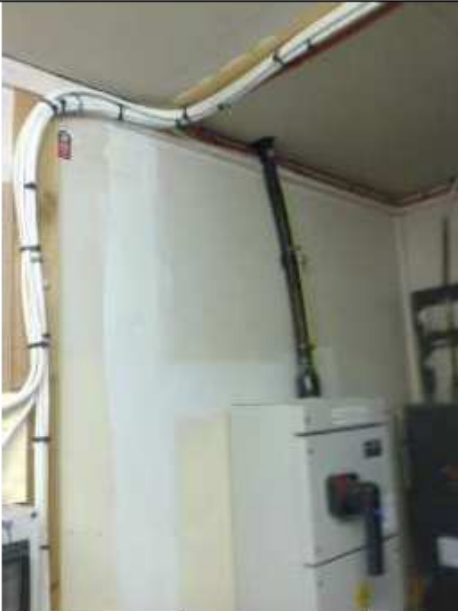
Asb Item ID:	239-AI-001

Item Description:	Insulating board to the walls	
Location:	Main Building G0140/Store (Head Teachers Office)	
Asbestos Fibres:	Amosite	
HSE Notifiable:	Yes	
Extent:	15m2	
Priority Rating:	Green	
Material Risk:	6	
Damage:	Low Damage	
Closure Notice:	No	
Date Issued:		
Date Corrected:		
Recommendation	Monitor and manage in situ

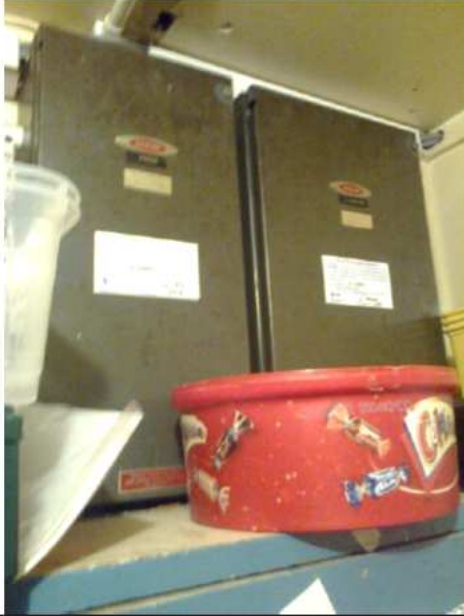
Asb Item ID:	239-AI-003

Item Description:	Internal seals and/ or components to the electrical distribution boxes	
Location:	G0015/ Caretaker's Room Main Building	
Asbestos Fibres:	Crocidolite Presumed	
HSE Notifiable:	Undeterminable	
Extent:	2 no	
Priority Rating:	Green	
Material Risk:	6-12	
Damage:	Undeterminable	
Closure Notice:	No	
Date Issued:		Photo Date: 11/12/2014
Date Corrected:		
Recommendation	Inspect once the services have been isolated. Until then monitor and manage in situ

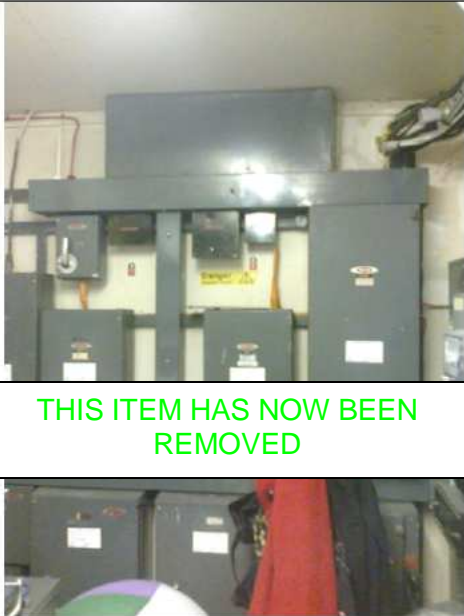
Asb Item ID:	239-AI-004

Item Description:	Internal seals and/ or components to the electrical boxes	
Location:	G0140/ Store Main Building	
Asbestos Fibres:	Crocidolite Presumed	
HSE Notifiable:	Undeterminable	
Extent:	15 no	
Priority Rating:	Green	
Material Risk:	6 - 12	
Damage:	Undeterminable	
Closure Notice:	No	
Date Issued:		Photo Date: 11/12/2014
Date Corrected:		
Recommendation	Item Removed

AI-004: internal seals /components to the electrical boxes.

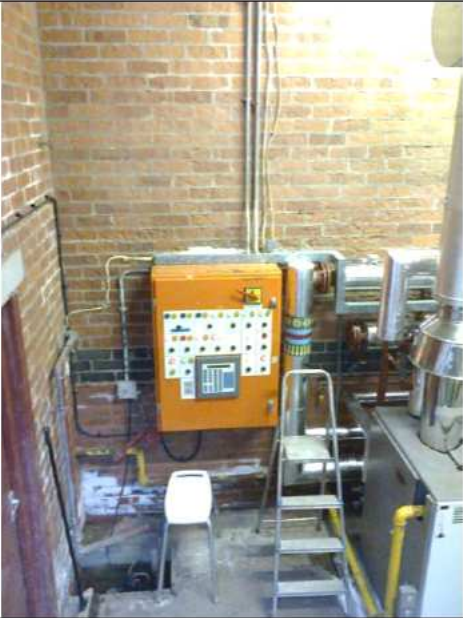
Asb Item ID:	239-AI-006

239-AI-006	Residual Insulation to walls behind electrical boxes and fittings to walls	Medium	Sealed thermal Insulation	Chrysotile Amosite	Basement - G0143 Boiler room	4	9	13	24/06/2018	Monitor and manage in situ	<10m ²
------------	--	--------	---------------------------	--------------------	------------------------------	---	---	----	------------	----------------------------	-------------------

Item Description:	Residual Insulation to walls behind electrical boxes and fittings to walls	
Location:	Basement - G0143 Boiler room	
Asbestos Fibres:	Chrysotile/Amosite	
HSE Notifiable:	Yes	
Extent:	<10m2	
Priority Rating:	Orange	
Material Risk:	9	
Damage:	Medium Damage	
Closure Notice:	No	
Date Issued:		Photo Date: 01/10/2016
Date Corrected:		
Recommendation	Monitor and manage in situ
