Project address:      Museum of Oxford  
Oxford Town Hall  
St Aldgates  
Oxford OX1 1BX

## Pre Construction Information

| Date | 10 November 2018 |

**Works to Museum of Oxford**

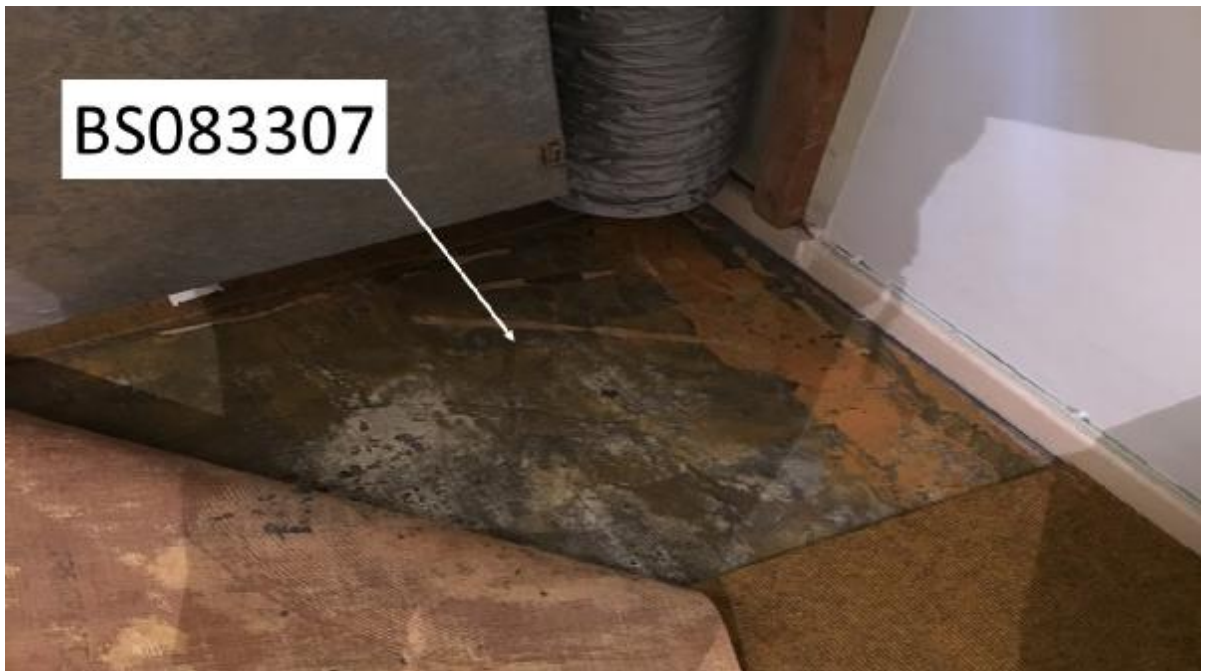
| Product: | Adhesive residue to floor | Damage: | NADIS |

No Action Required

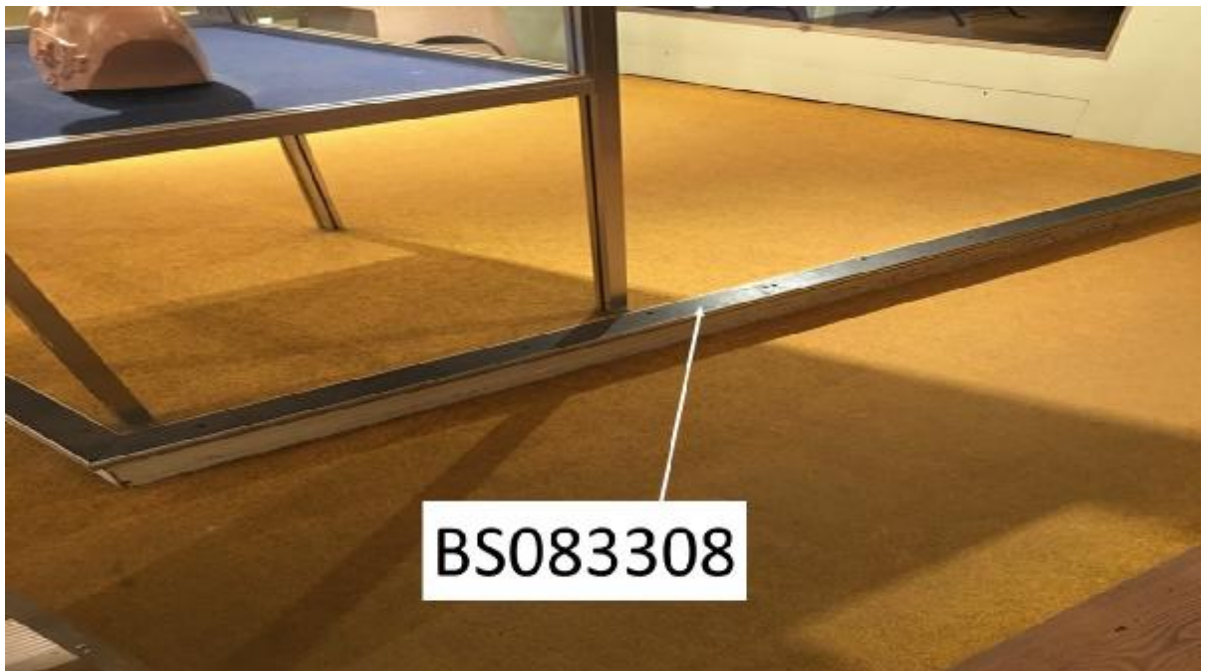
| Product: | Stair nosing | Damage: | Low damage |

No Action Required

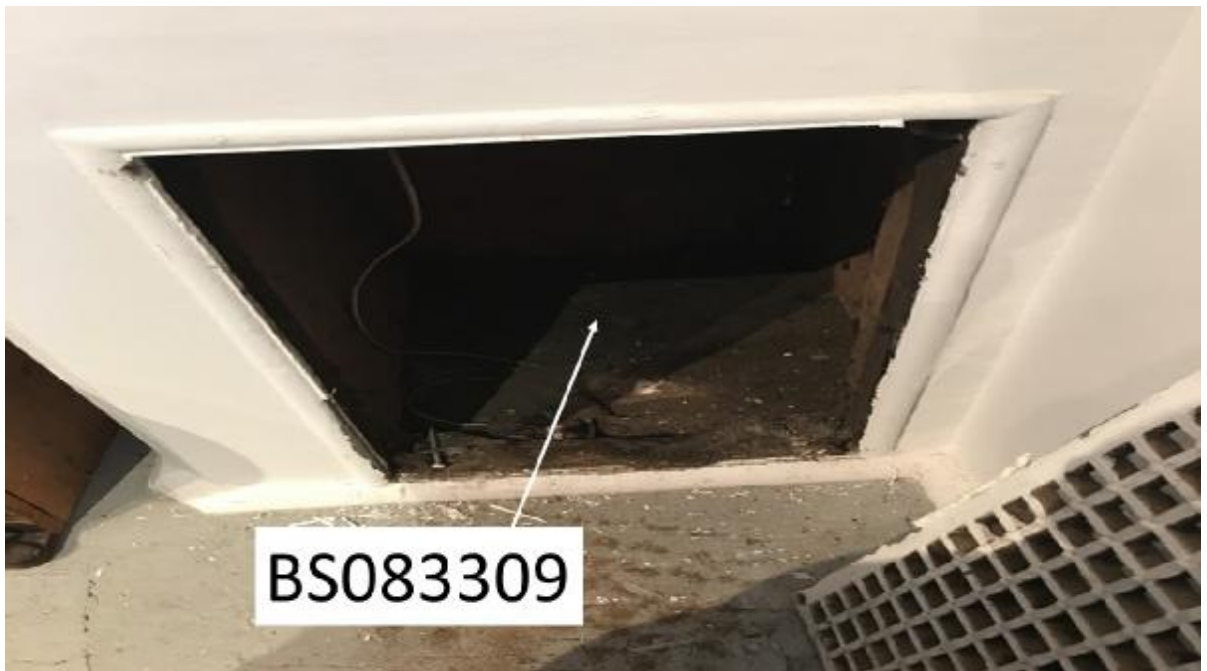
| Product: | Dust sample | Damage: | NADIS |

No Action Required

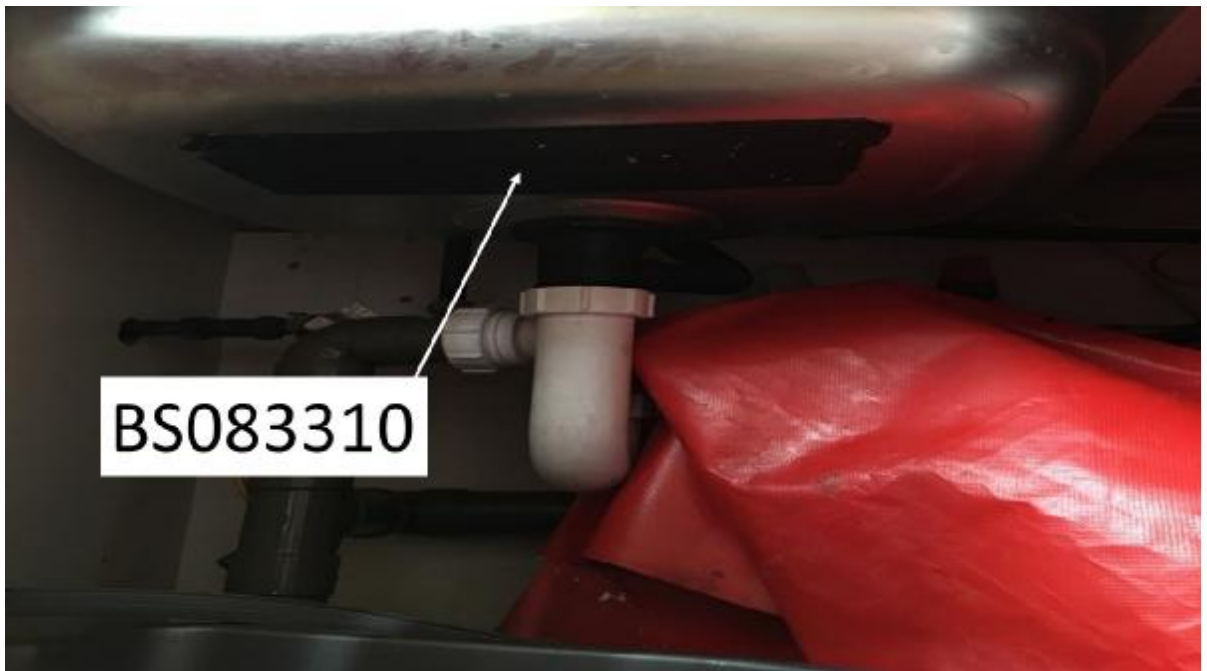
| Product: | Sink Pad | Damage: | NADIS |

No Action Required

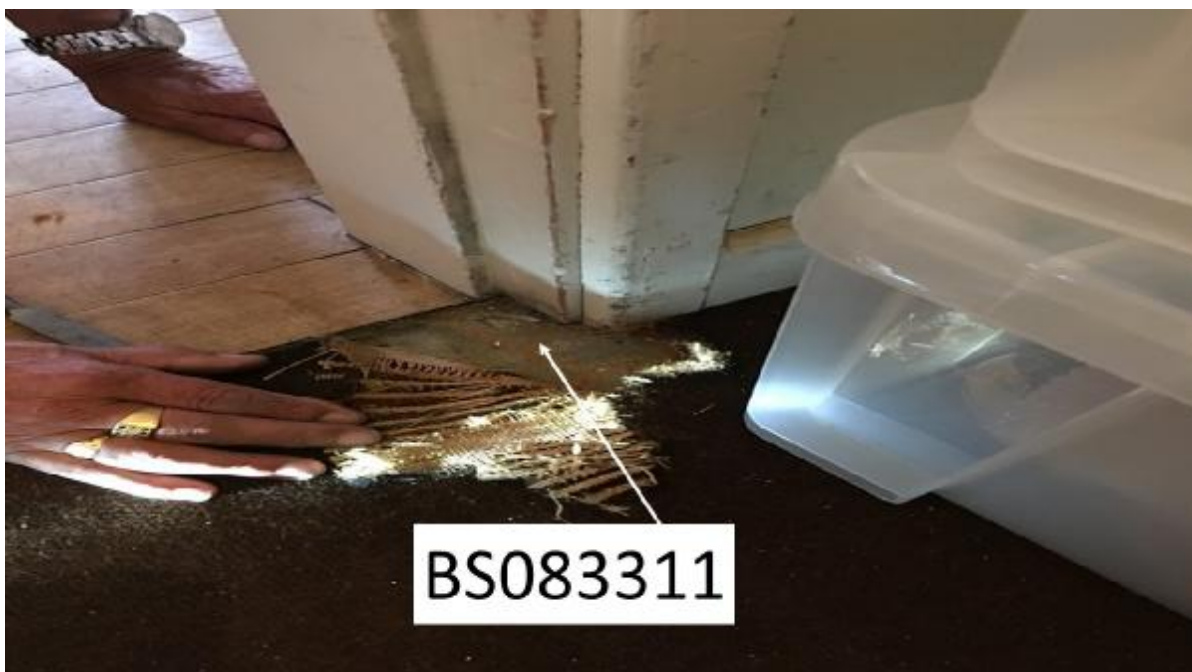
| Product: | Vinyl Flooring | Damage: | NADIS |

No Action Required

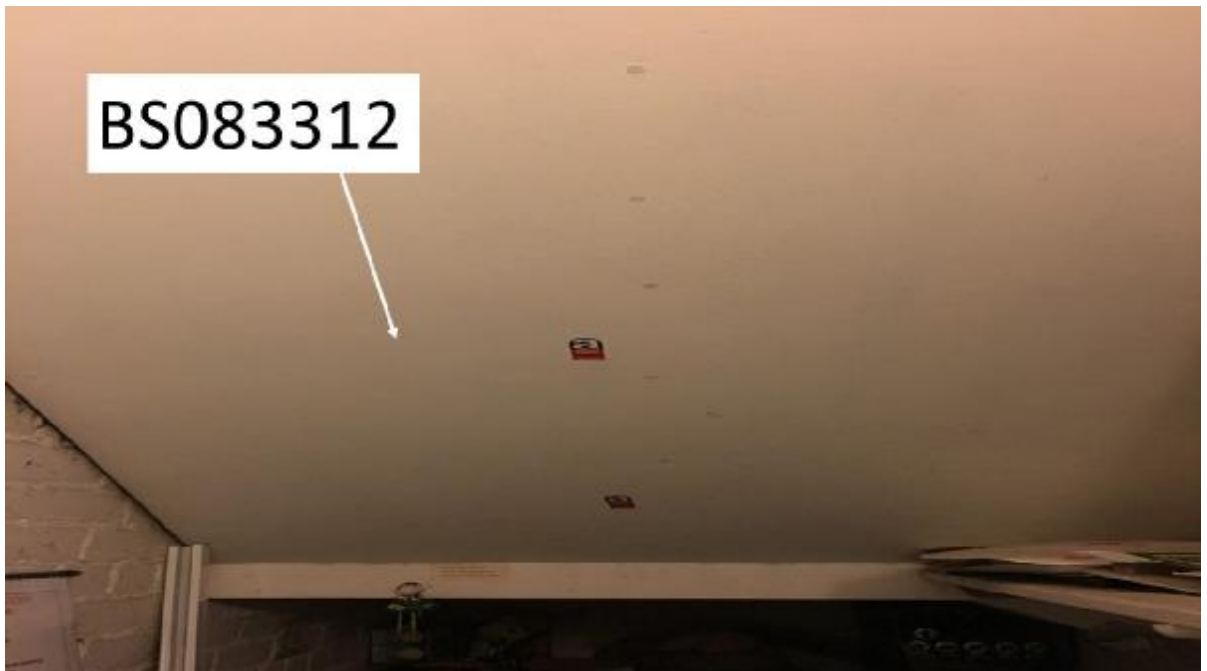
| Product: | Cement Soffit | Damage: | Low damage |

Removal

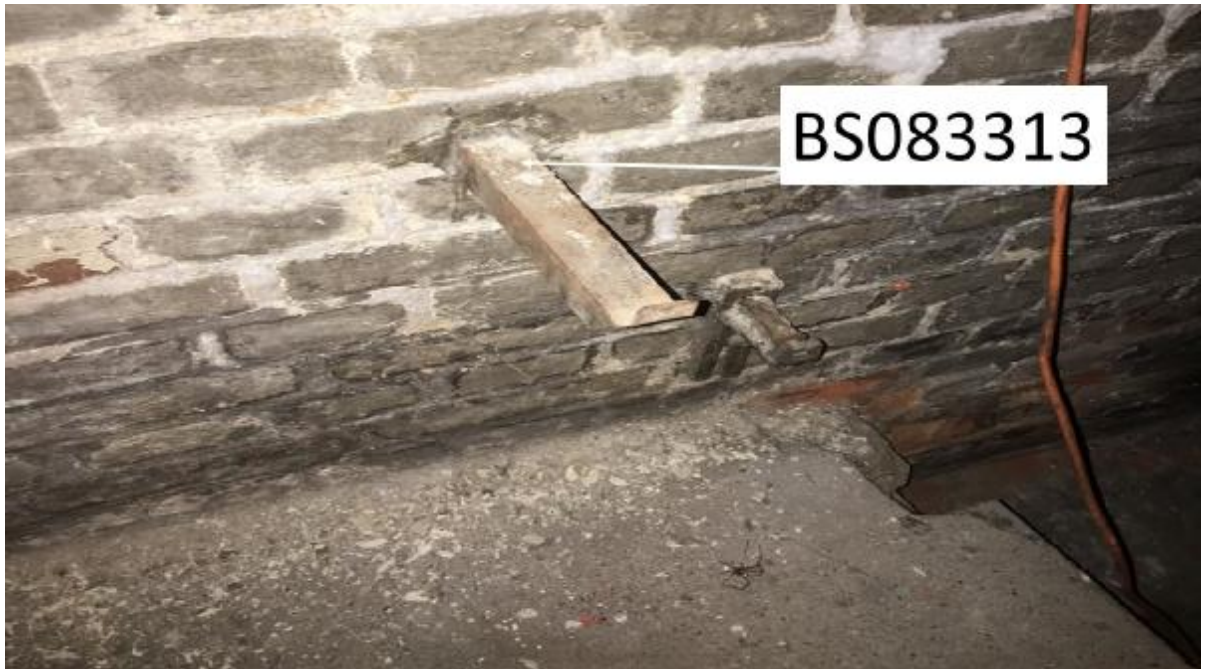
| Product: | Debris | Damage: | NADIS |

No Action Required

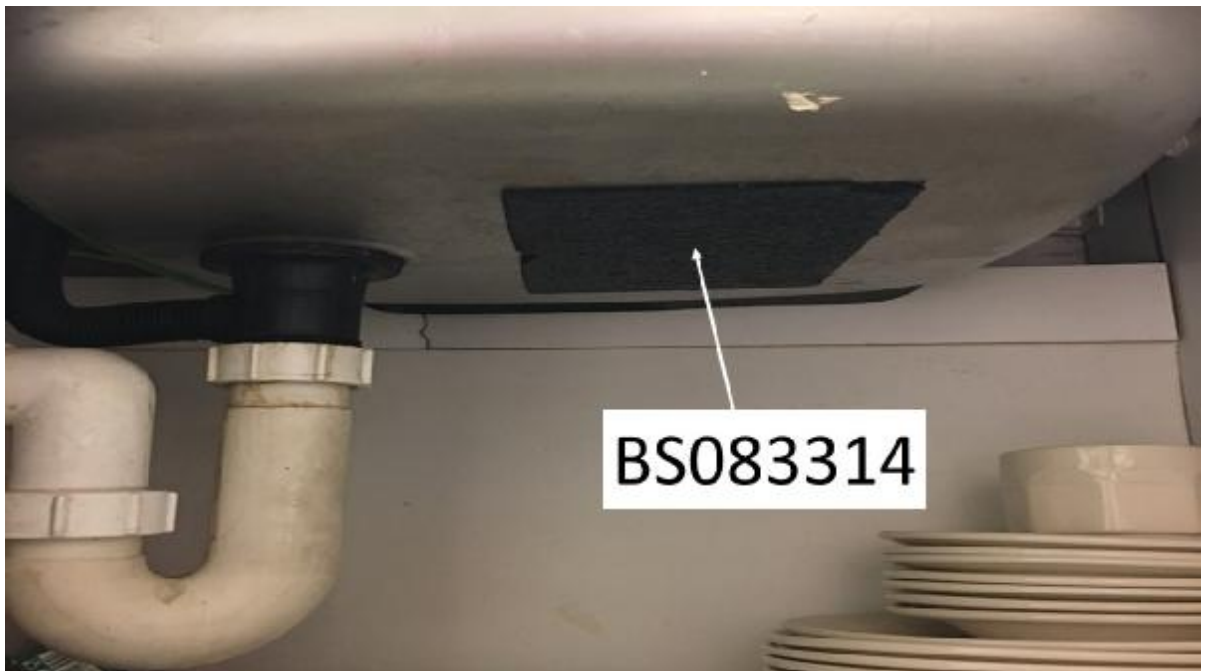
| Product: | Sink Pad | Damage: | NADIS |

No Action Required

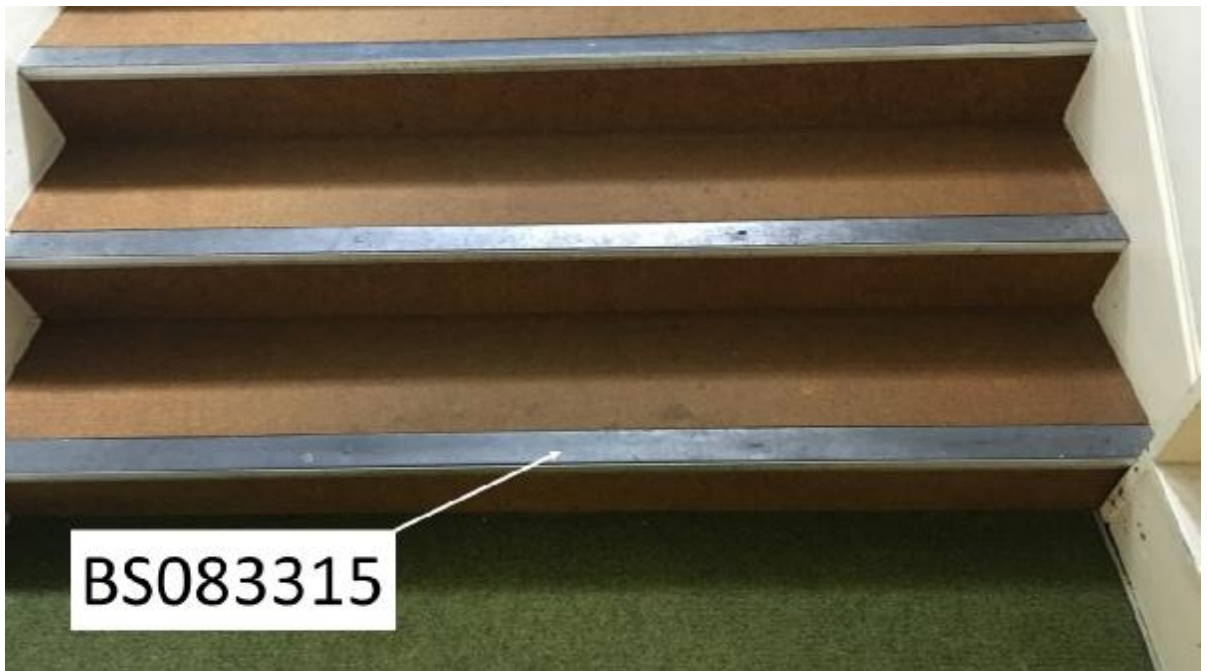
| Product: | Stair nosing | Damage: | NADIS |

No Action Required

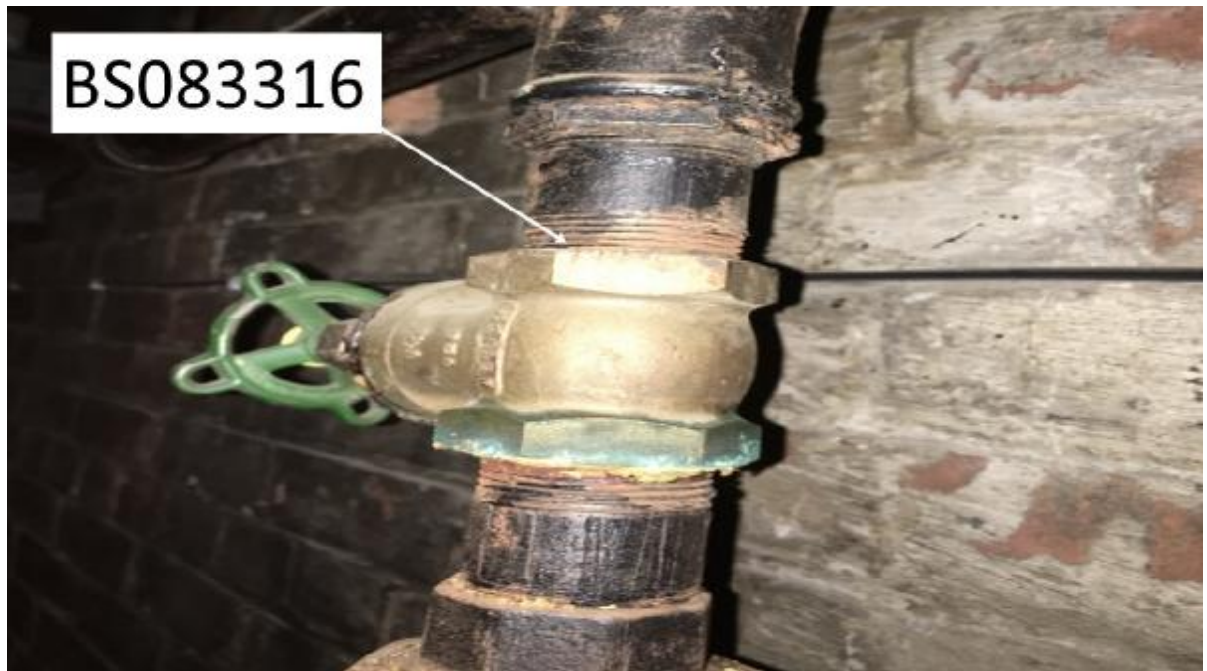
| Product: | Residue to pipe | Damage: | NADIS |

Action: No Action Required

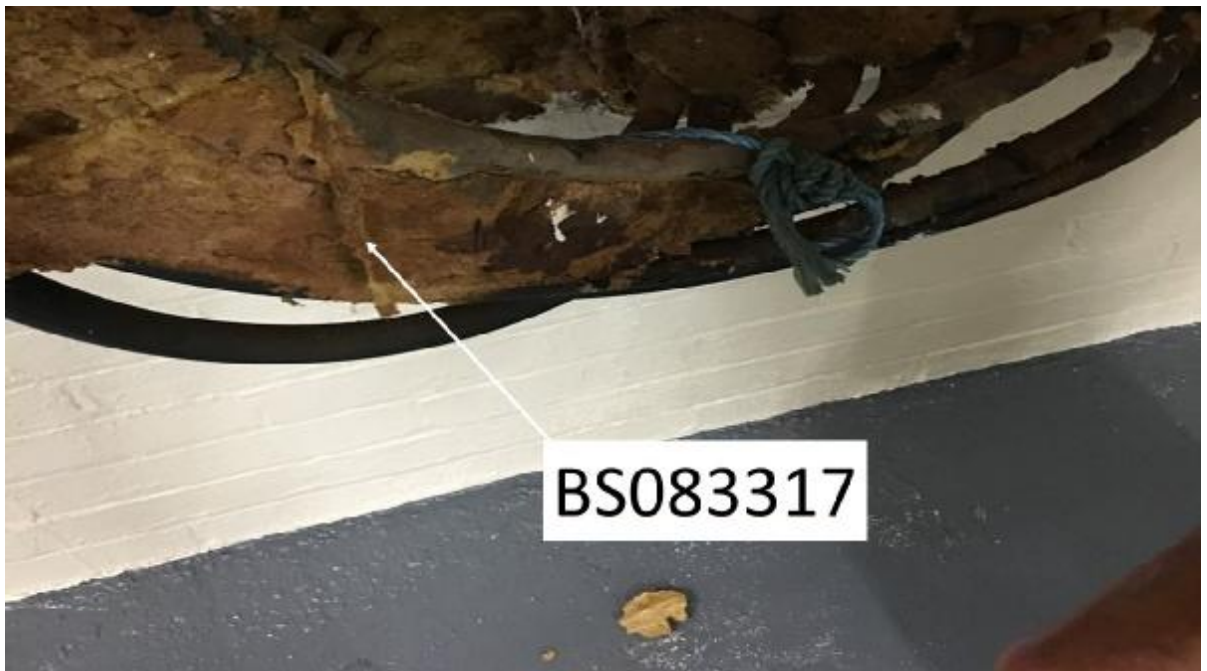
| Product: | String to cables | Damage: | NADIS |

Action: No Action Required

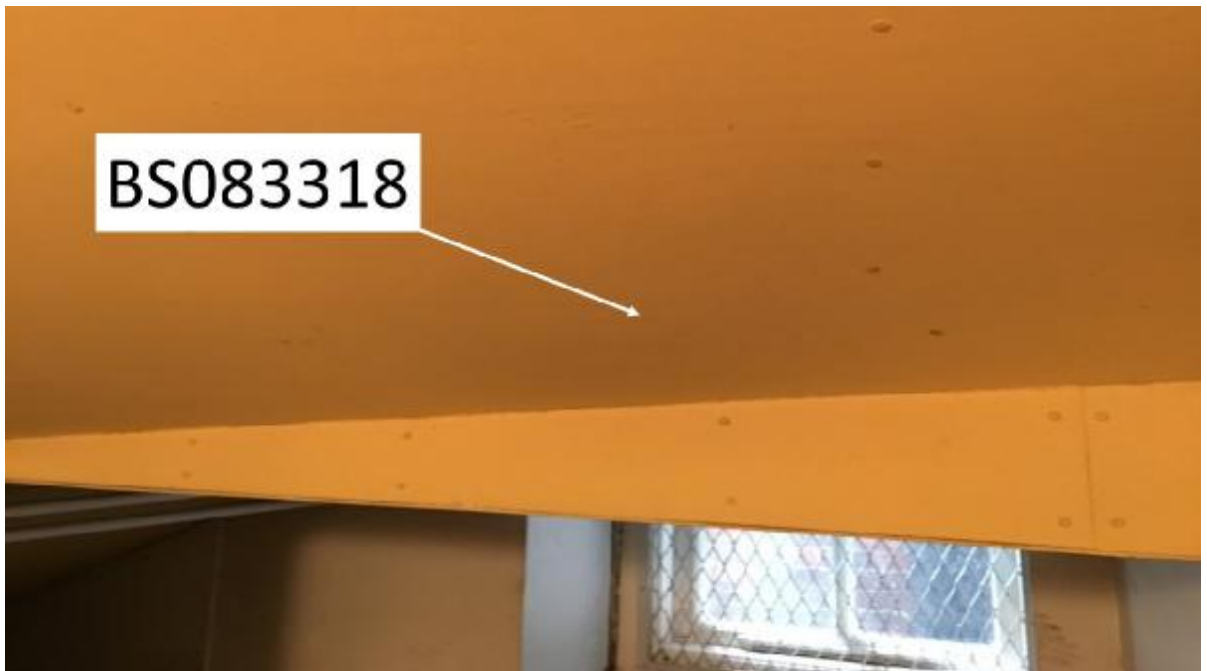
| Product: | Cement Soffit | Damage: | Low damage |

Action: Removal

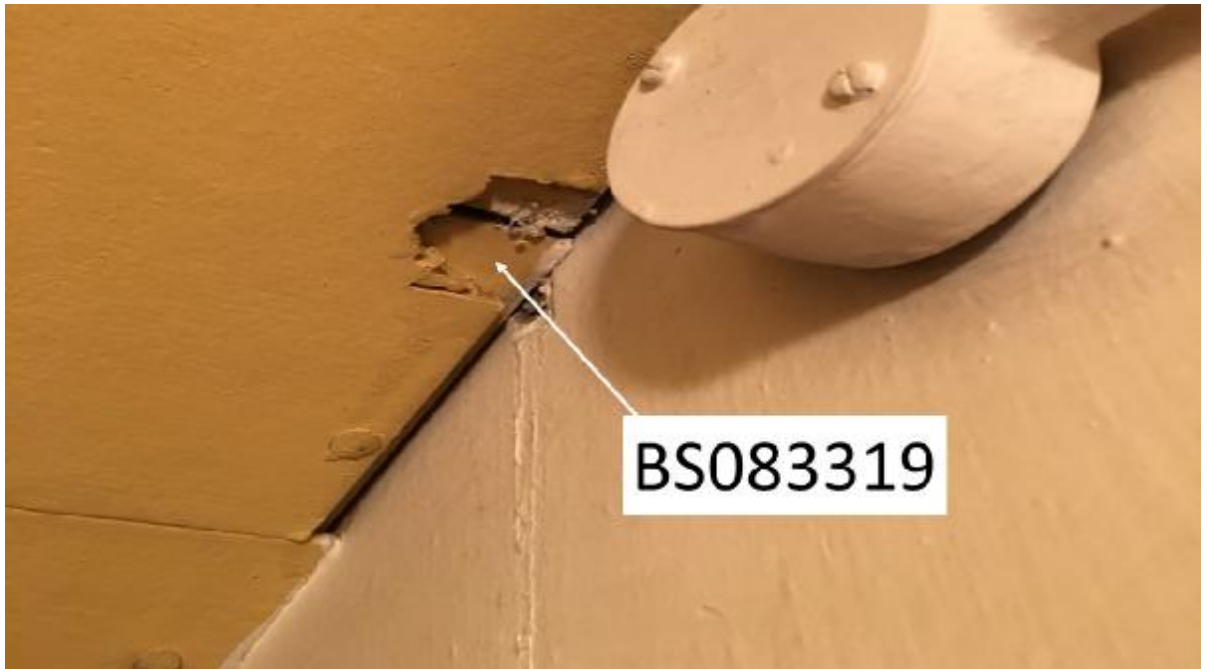
| Product: | Cement Soffit | Damage: | Low damage |

Removal

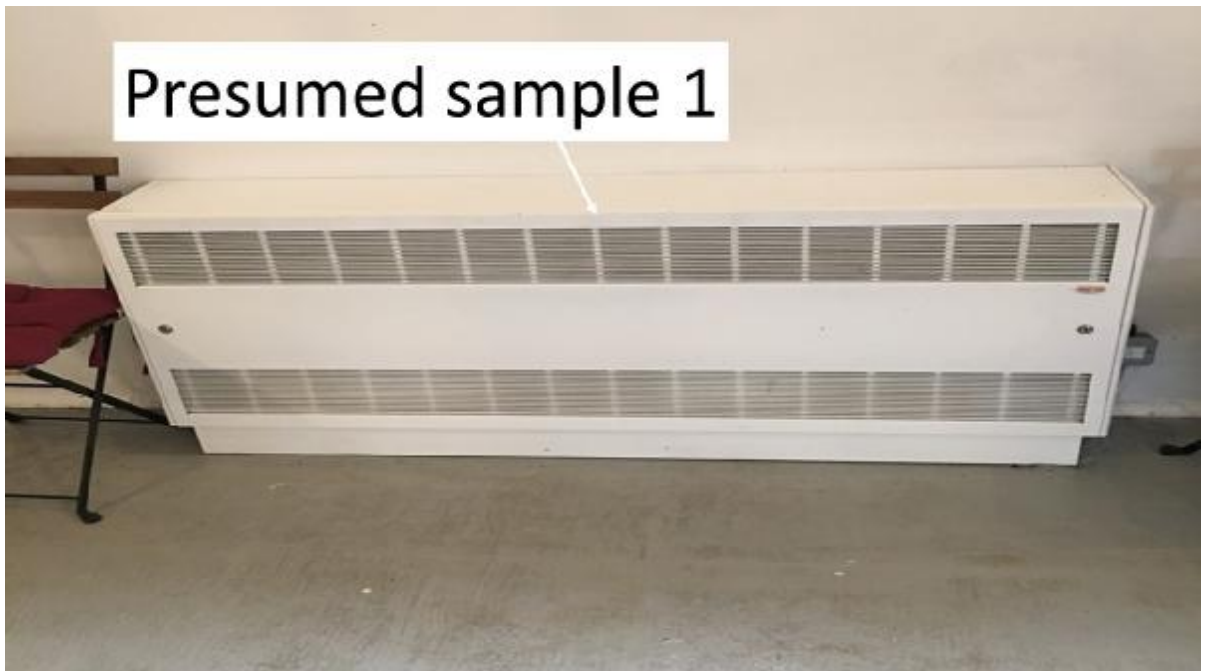
| Product: | Storage heater | Damage: | No visible damage |

Action: To be included in management plan

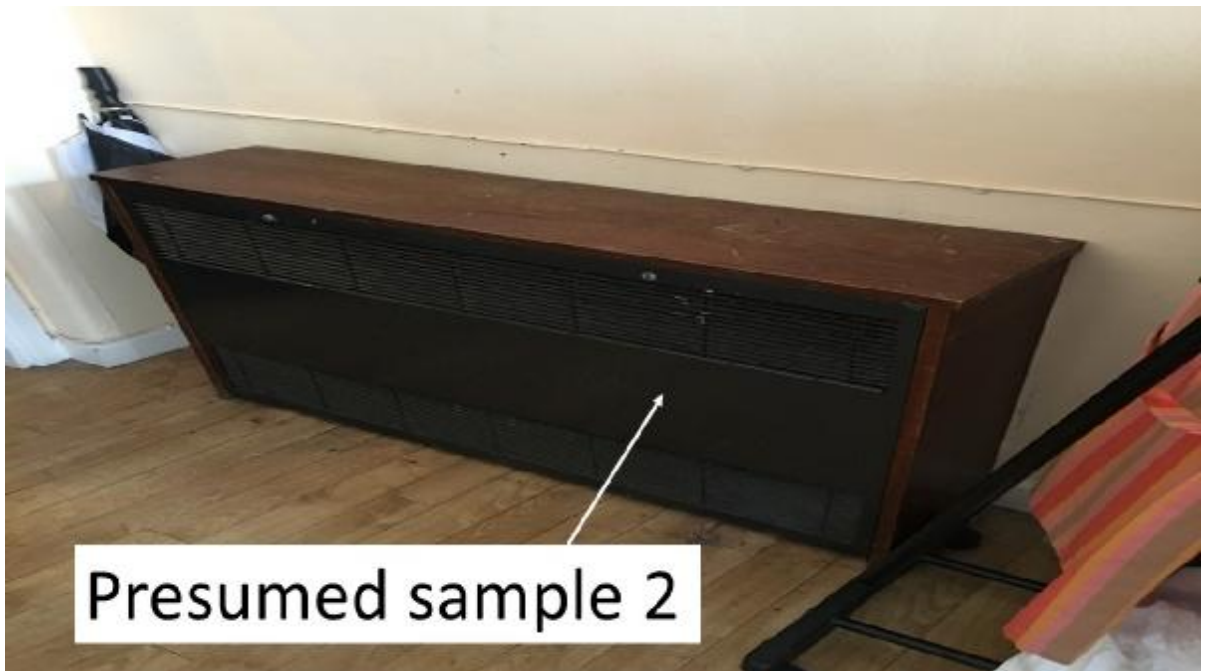
| Product: | Storage heater | Damage: | No visible damage |

Action: To be included in management plan

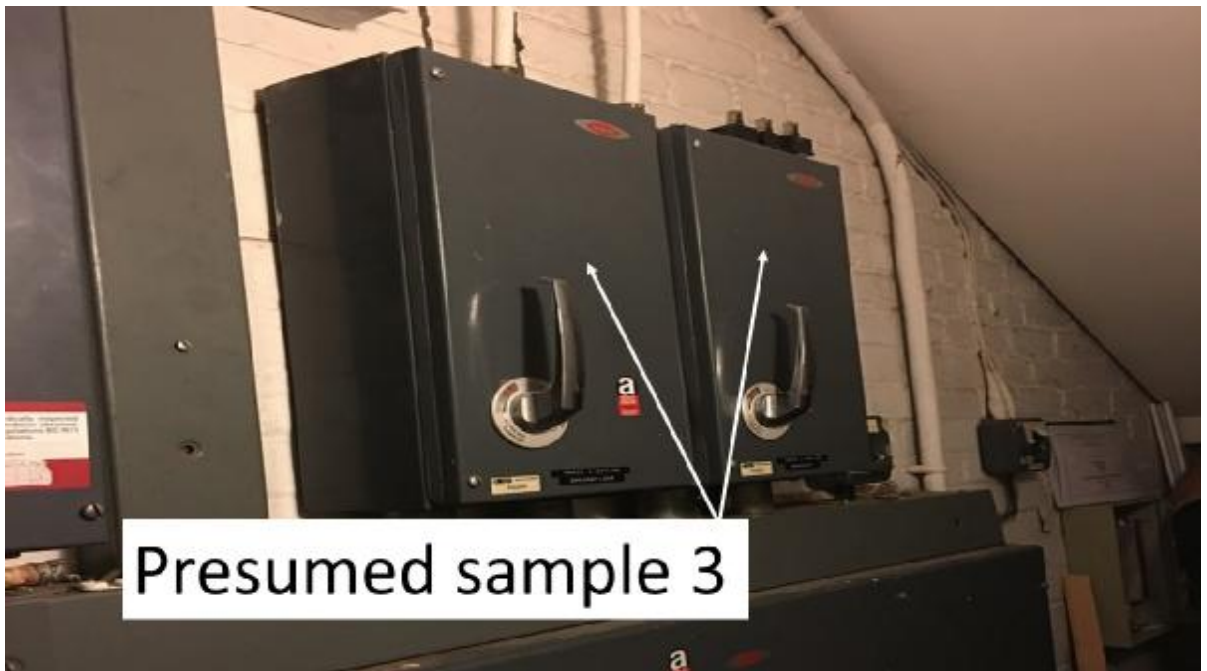
| Product: | Flash guards to switchgear | Damage: | No visible damage |

To be included in management plan

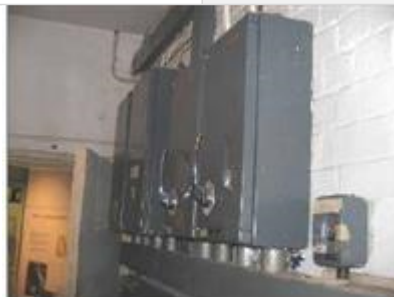
| <b>Location ID</b> | 3B E3 20 98 | <b>Room / Area</b> | Electrical Cupboard |

| <b>Building</b> | Museum | <b>Description</b> | Presume asbestos containing materials within 'MEM' switch boxes |

| <b>Recommendations:</b> | Please apply caution | | | | |

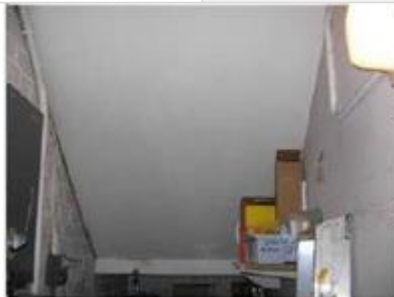
| <b>Location ID</b> | 8E C2 46 6E | <b>Room / Area</b> | Electrical Cupboard |

| <b>Building</b> | Museum | <b>Description</b> | Asbestos insulating board (AIB) panels to ceiling and slope of underside of stairs |

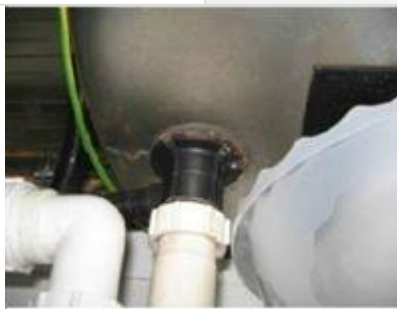
| <b>Location ID</b> | 30 5A 86 0B | <b>Room / Area</b> | Staff Room |

| <b>Building</b> | Museum | <b>Description</b> | Damper pad to base of sink |

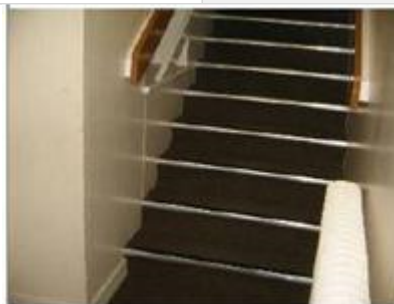
| <b>Location ID</b> | 00 83 3E D8 | <b>Room / Area</b> | Stairs to Ground Floor |

| <b>Building</b> | Museum | <b>Description</b> | Asbestos bonded stair nosing (Black) |

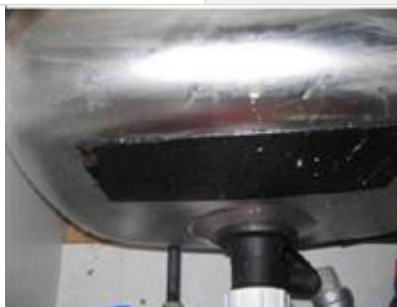
| <b>Location ID</b> | 28 65 BD C8 | <b>Room / Area</b> | Education Lecture Room |

| <b>Building</b> | Museum | <b>Description</b> | Damper pad to base of sink |

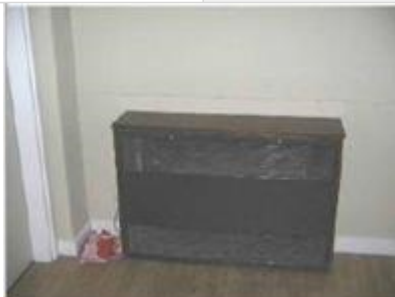
| <b>Location ID</b> | FD C4 3B E8 | <b>Room / Area</b> | Education Lecture Room |

| <b>Building</b> | Museum | <b>Description</b> | Presume asbestos containing materials within wall mounted heater unit |

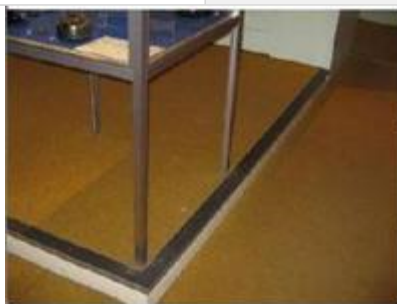
| <b>Location ID</b> | 5E F2 D1 25 | <b>Room / Area</b> | Exhibition Gallery 3 |

| <b>Building</b> | Museum | <b>Description</b> | Asbestos bonded step nosing to perimeter of raised plinth (Black) Modern thermoplastic tiles (Grey) and hardboard below carpet throughout area |
