Pre-Construction Information Pack

Maltmas Farm, Maltmas Drove, Friday Bridge, Wisbech, PE14 0HS

Asbestos Report

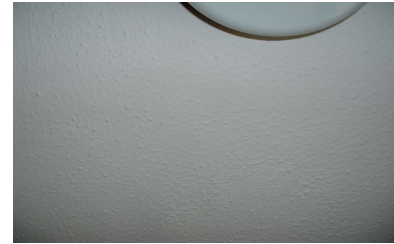
Building 2000602 - Farm Building
Area / 0001 - Unknown
Survey Date 02/12/2021
Survey Programme Original Asbestos Surveys
Surveyor Acorn Analytical Services - Matthew Townsend
Element Ceilings - Structure
Description Ceiling - Artex on ceiling (Material:Artex) Loc: 0001

Risk Assessment	Very Low	3	
------------------------	----------	---	--

Material Assessment	Very Low	3	
----------------------------	----------	---	--

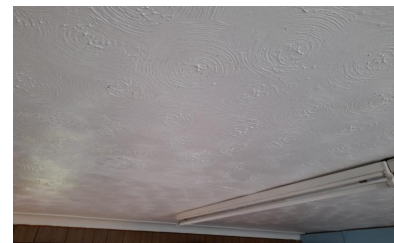
Building 2000602 - Farm Building
Area G / 0003 - Unknown
Survey Date 02/12/2021
Survey Programme Original Asbestos Surveys
Surveyor Acorn Analytical Services - Matthew Townsend
Element Ceilings - Structure
Description Ceiling - Artex on ceiling (Material:Artex) Loc: 0003

Risk Assessment	Very Low	3	
------------------------	----------	---	--

Material Assessment	Very Low	3	
----------------------------	----------	---	--

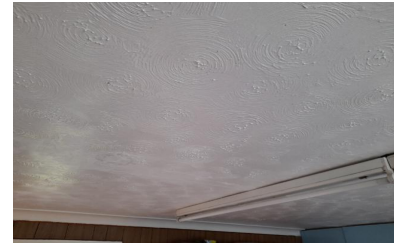
Building 2000602 - Farm Building
Area 1 / 1001 - Unknown
Survey Date 02/12/2021
Survey Programme Original Asbestos Surveys
Surveyor Acorn Analytical Services - Matthew Townsend
Element Ceilings - Structure
Description Ceiling - Artex on ceiling (Material:Artex) Loc: 1001

Risk Assessment	Very Low	3	
------------------------	----------	---	--

Material Assessment	Very Low	3	
----------------------------	----------	---	--

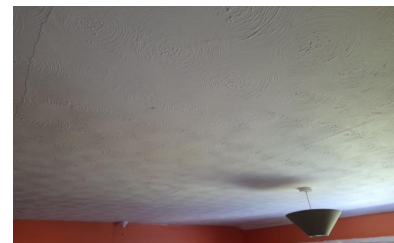
Building 2000602 - Farm Building
Area 1 / 1004 - Unknown
Survey Date 02/12/2021
Survey Programme Original Asbestos Surveys
Surveyor Acorn Analytical Services - Matthew Townsend
Element Ceilings - Structure
Description Ceiling - Artex on ceiling (Material:Artex) Loc: 1004

Risk Assessment	Very Low	3	
------------------------	----------	---	--

Material Assessment	Very Low	3	
----------------------------	----------	---	--

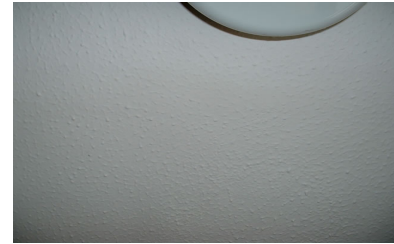
Building 2000602 - Farm Building
Area G / 0002 - Unknown
Survey Date 02/12/2021
Survey Programme Original Asbestos Surveys
Surveyor Acorn Analytical Services - Matthew Townsend
Element Ceilings - Structure
Description Ceiling - Artex on ceiling (Material:Artex) Loc: 0002

Risk Assessment	Very Low	3	
------------------------	----------	---	--

Material Assessment	Very Low	3	
----------------------------	----------	---	--

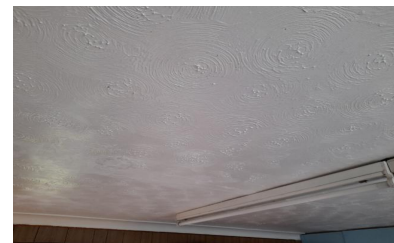
Building 2000602 - Farm Building
Area G / 0004 - Unknown
Survey Date 02/12/2021
Survey Programme Original Asbestos Surveys
Surveyor Acorn Analytical Services - Matthew Townsend
Element Ceilings - Structure
Description Ceiling - Artex on ceiling (Material:Artex) Loc: 0004

Risk Assessment	Very Low	3	
------------------------	----------	---	--

Material Assessment	Very Low	3	
----------------------------	----------	---	--

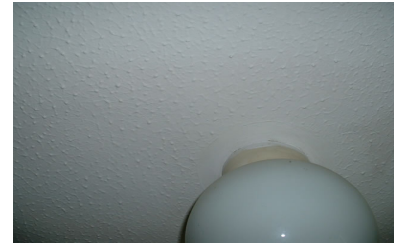
Building 2000602 - Farm Building
Area 1 / 1002 - Unknown
Survey Date 02/12/2021
Survey Programme Original Asbestos Surveys
Surveyor Acorn Analytical Services - Matthew Townsend
Element Ceilings - Structure
Description Ceiling - Artex on ceiling (Material:Artex) Loc: 1002

Risk Assessment	Very Low	3	
------------------------	----------	---	--

Material Assessment	Very Low	3	
----------------------------	----------	---	--

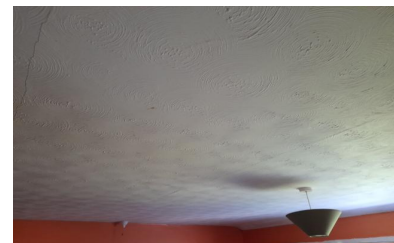
Building 2000602 - Farm Building
Area 1 / 1003 - Unknown
Survey Date 02/12/2021
Survey Programme Original Asbestos Surveys
Surveyor Acorn Analytical Services - Matthew Townsend
Element Ceilings - Structure
Description Ceiling - Artex on ceiling (Material:Artex) Loc: 1003

Risk Assessment	Very Low	3	
------------------------	----------	---	--

Material Assessment	Very Low	3	
----------------------------	----------	---	--

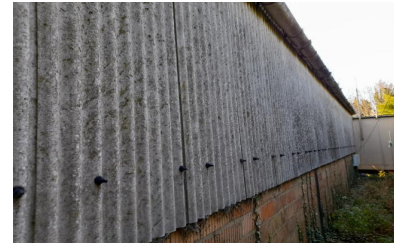
Building 306B2 - Barn 2
Area
Survey Date 02/12/2021
Survey Programme Original Asbestos Surveys
Surveyor Acorn Analytical Services - Matthew Townsend
Element Services (General) - Services (General)
Description Services - Barn 2 - Gutters and downpipes
 (Material:Cement) Loc: 306B2

Risk Assessment	Very Low	4	
------------------------	----------	---	--

Material Assessment	Very Low	4	
----------------------------	----------	---	--

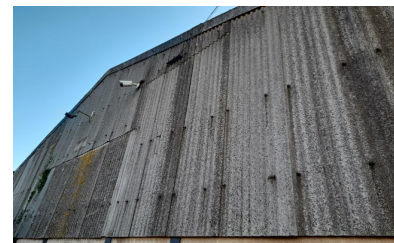
Building 306B1 - Barn 1
Area
Survey Date 02/12/2021
Survey Programme Original Asbestos Surveys
Surveyor Acorn Analytical Services - Matthew Townsend
Element Services (General) - Services (General)
Description Services - Barn 1 - Gutters and downpipes
 (Material:Cement) Loc: 306B1
 Areas of the gutters are flaking causing associated debris to the floor.

Risk Assessment	Low	5	
------------------------	-----	---	--

Material Assessment	Low	5	
----------------------------	-----	---	--

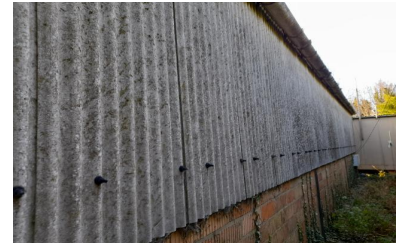
Description Wall and roof - Barn 2 - Wall and roof sheets (Material:Cement) Loc: 306B2
Small areas of damage which is causing associated debris to the floor.

Material Assessment	Low	5	
----------------------------	-----	---	--

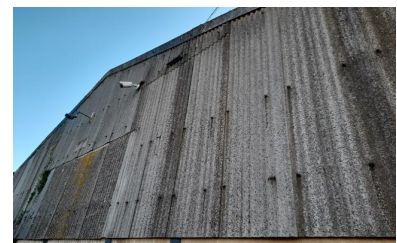
Description Wall and roof - Wall and roof (Material:Cement) Loc: External
Areas of broken cladding sheets and flashings causing associated debris to the floor.

Material Assessment	Low	5	
----------------------------	-----	---	--

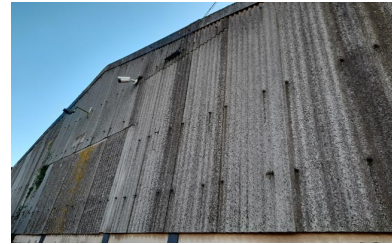
Building Area 306B1 - Barn 1
Survey Date 02/12/2021
Survey Programme Original Asbestos Surveys
Surveyor Acorn Analytical Services - Matthew Townsend
Element Walls (General) - Walls (General)
Description Wall and roof - Barn 1 - Wall and roof sheets (Material:Cement) Loc: 306B1
 Areas of broken cladding sheets and flashings causing associated debris to the floor.

Material Assessment	Low	5
