Asbestos Survey Report

**7 Lunedale UPRN 8421426
Woodcock Drive
Platt Bridge
Wigan
WN2 5NW**

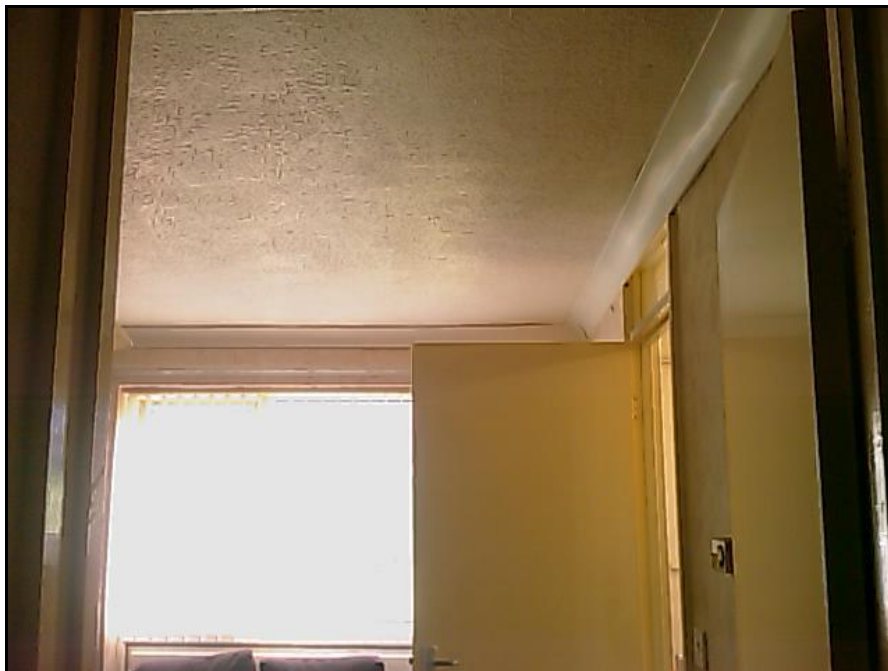
Building	8421426
Floor	Ground Floor
Room/Area	001 - Rooms throughout property
Sample No	1

Description Item: Ceilings throughout property.
Present throughout property

Score
Product Type	Textured coating	1
Extent of Damage	Low Damage	1
Surface Treatment	Composite materials containing asbestos, plastics, resins etc.	0
Asbestos Type	Chrysotile (white)	1
Amount	50m ² each	
Accessibility	Occasional Disturbance	
Algorithm Score		3

Floor	Ground Floor	
Room	001 - Rooms throughout property	
Asbestos Material / Product	Ceilings throughout property Textured coating

Average of Priority scores	Sum of above averages	6
Material algorithm score	From survey report	3
Total Risk Assessment score		9

RECOMMENDATION	Manage and re-inspect
-----------------------	-----------------------

Action	Manage and re-inspect
Target date	08 February 2012

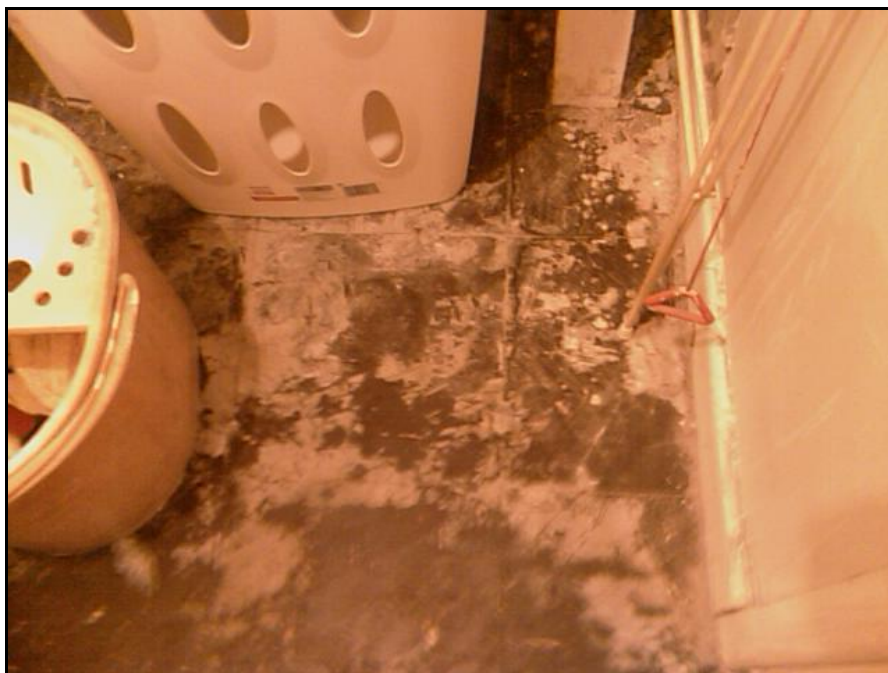
Building	8421426
Floor	Ground Floor
Room/Area	001 - Rooms throughout property
Sample No	2

Description Item: Floor tiles throughout property.
Present below fixed flooring throughout property

Score
Product Type	Floor tiles	1
Extent of Damage	Low Damage	1
Surface Treatment	Composite materials containing asbestos, plastics, resins etc.	0
Asbestos Type	Chrysotile (white)	1
Amount	50m ² each	
Accessibility	Occasional Disturbance	
Algorithm Score		3

Floor	Ground Floor	
Room	001 - Rooms throughout property	
Asbestos Material / Product	Floor tiles throughout property Floor tiles

Average of Priority scores	Sum of above averages	6
Material algorithm score	From survey report	3
Total Risk Assessment score		9

RECOMMENDATION	Manage and re-inspect
-----------------------	-----------------------

Action	Manage and re-inspect
Target date	08 February 2012
