UNDERPASS ANALYSIS

<p>LEEMING ASSOCIATES</p></div><div><p>landscape architecture garden design environmental planning</p><p>43 Cleveland Terrace Darlington DL3 7HD t:01325 481511 f:01325 483082</p></div></div>		
Client		
Allerdale Borough Council		
Project		
Brow Top Enhancements		
Drawing		
Underpass Analysis		
Date	Scale

Aug 2017	NTS	
Drawing Number		
1725.03		
<p>Note:</p> <p>Only figured dimensions to be used.</p> <p>All dimensions and setting out to be checked on site.</p> <p>Refer any query to Leeming Associates.</p>

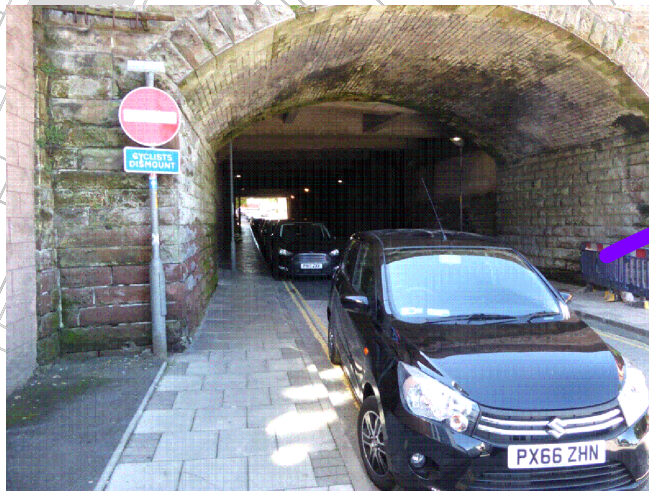
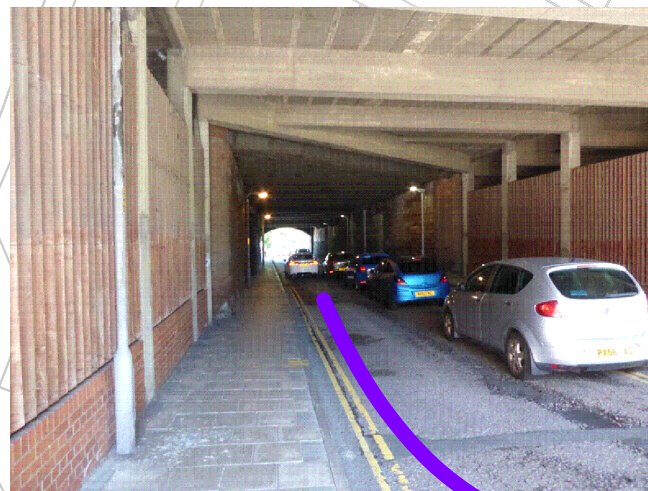
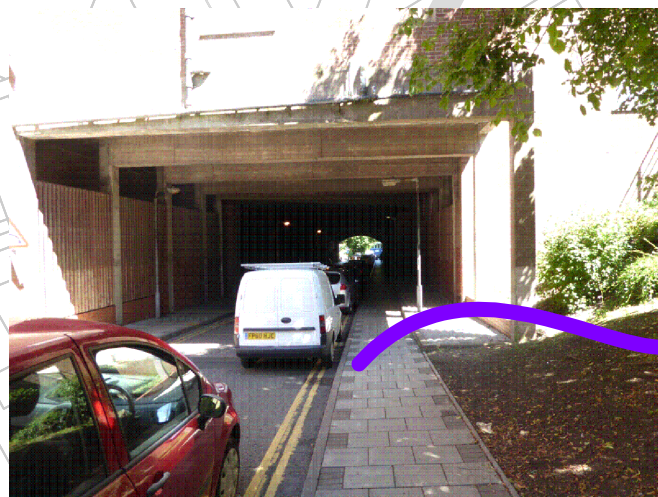
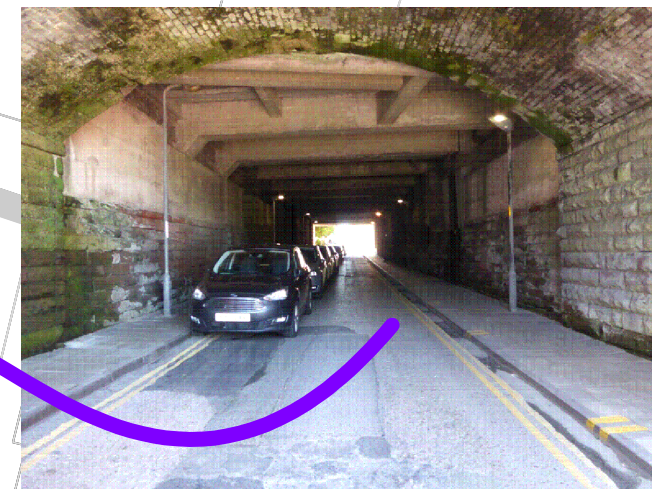
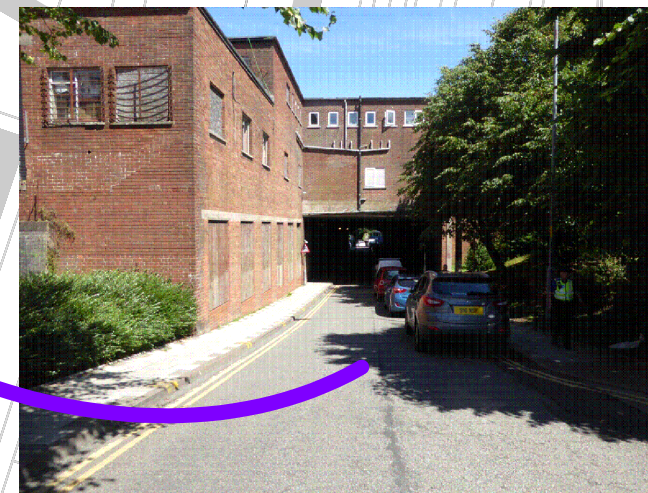
Underpass Analysis

- Busy thoroughfare link with car park and town centre
- Car parking by disabled badge holders on double yellow lines
- Dark, poorly lit and uninviting corridor
- Timber hit-and miss cladding
- Pigeon deterrent netting
- Unsightly building above and at the sides of the underpass at south end
- Attractive trees to the right of the entrance on the south approach
- Narrow footpaths
- Dirty stone and brickwork
