Address	Museum of Oxford, St Aldate's, Oxford, OX1 1DZ		
Site ID	200001115548	Floor	Basement
Location ID	2F D8 15 F3	Room / Area	Auditorium
Building	Museum	Description	No suspect materials observed within area / room

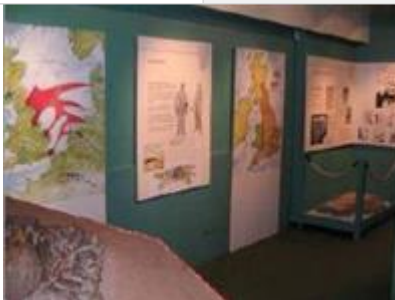
Address	Museum of Oxford, St Aldate's, Oxford, OX1 1DZ		
Site ID	200001115548	Floor	Basement
Location ID	1F A6 52 29	Room / Area	Lower Gallery Area 1
Building	Museum	Description	No suspect materials observed within area / room

Action		Material Assessment Priority Assessment		Combined Risk Score	
Comments:	Area is made up from plasterboard and timber scenery MMM pipe lagging where inspected				
Recommendations:

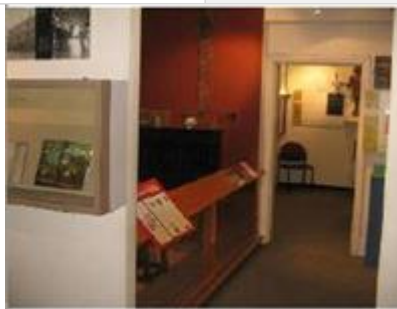
Address	Museum of Oxford, St Aldate's, Oxford, OX1 1DZ		
Site ID	200001115548	Floor	Basement
Location ID	3E D9 08 A2	Room / Area	Lower Gallery Area 3
Building	Museum	Description	No suspect materials observed within area / room

Action		Material Assessment Priority Assessment		Combined Risk Score	
Comments:	Area is made up from plasterboard and timber scenery MMMF pipe lagging where inspected				
Recommendations:

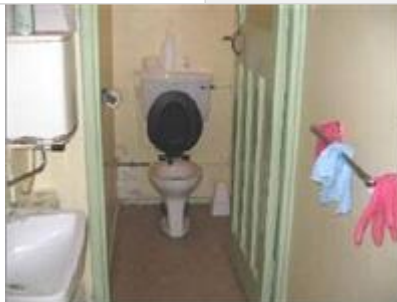
Address	Museum of Oxford, St Aldate's, Oxford, OX1 1DZ		
Site ID	200001115548	Floor	Basement
Location ID	88 49 F7 6C	Room / Area	Male WC
Building	Museum	Description	No suspect materials observed within area / room

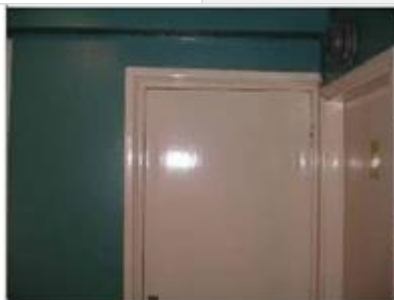
Address	Museum of Oxford, St Aldate's, Oxford, OX1 1DZ		
Site ID	200001115548	Floor	Basement
Location ID	C7 A2 0D C6	Room / Area	Stairs Lobby Area
Building	Museum	Description	Area Accessed - No Asbestos Found

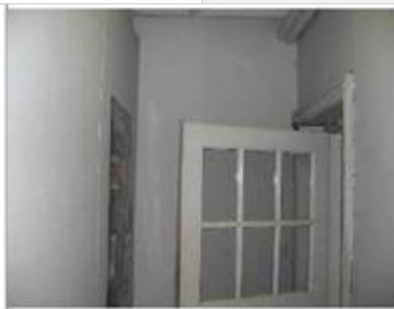
Address	Museum of Oxford, St Aldate's, Oxford, OX1 1DZ		
Site ID	200001115548	Floor	Basement
Location ID	02 3D 58 31	Room / Area	Toilet Corridor
Building	Museum	Description	No suspect materials observed within area / room

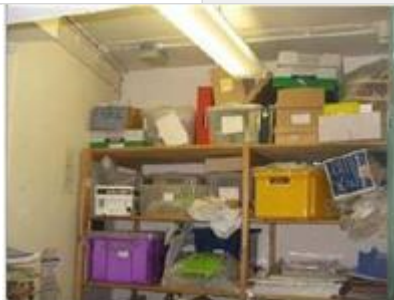
Address	Museum of Oxford, St Aldate's, Oxford, OX1 1DZ		
Site ID	200001115548	Floor	Basement
Location ID	DA 31 94 88	Room / Area	Work Room Store
Building	Museum	Description	No suspect materials observed within area / room

Action		Material Assessment Priority Assessment		Combined Risk Score	
Comments:	Plasterboard rear wall behind racking				
Recommendations:

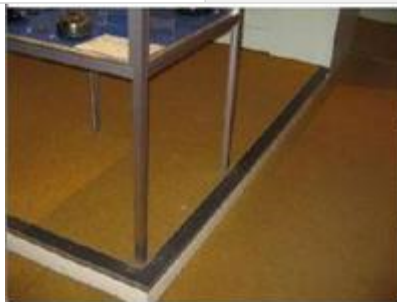
Address	Museum of Oxford, St Aldate's, Oxford, OX1 1DZ		
Site ID	200001115548	Floor	Ground Floor
Location ID	5E F2 D1 25	Room / Area	Exhibition Gallery 3
Building	Museum	Description	Asbestos bonded step nosing to perimeter of raised plinth (Black) Modern thermoplastic tiles (Grey) and hardboard below carpet throughout area

Product Type	1	<u>1</u>	Surface Treatment	0	<u>0</u>
Extent of Damage / Deterioration	Good condition: No visible damage	<u>0</u>	Asbestos Type	1	<u>1</u>

Action		Material Assessment	2	Combined Risk Score	
Comments:	2007 Recommendations have been carried out				
Recommendations:	Continue to manage via periodic review

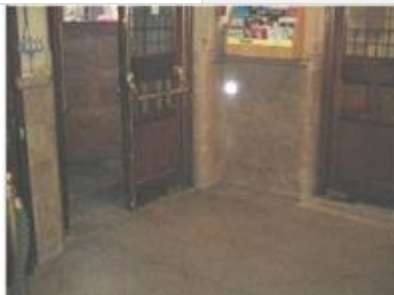
Address	Museum of Oxford, St Aldate's, Oxford, OX1 1DZ		
Site ID	200001115548	Floor	Ground Floor
Location ID	15 31 C5 75	Room / Area	Main Entrance & Foyer
Building	Museum	Description	No suspect materials observed below ceiling

Action		Material Assessment		Combined Risk Score	
Comments:	Part of the ceiling is timber clad				
Recommendations:

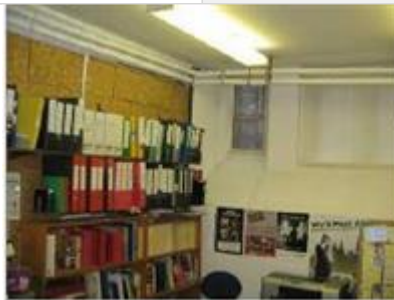
Address	Museum of Oxford, St Aldate's, Oxford, OX1 1DZ		
Site ID	200001115548	Floor	Ground Floor
Location ID	88 C1 69 C3	Room / Area	Museum Office
Building	Museum	Description	No suspect materials observed within area / room
