PRESTON DOWN ROAD,
HOUSING DEVELOPMENT

PHASE 1
DESK STUDY REPORT

TORBAY COUNCIL

Job No. 4756
October 2019

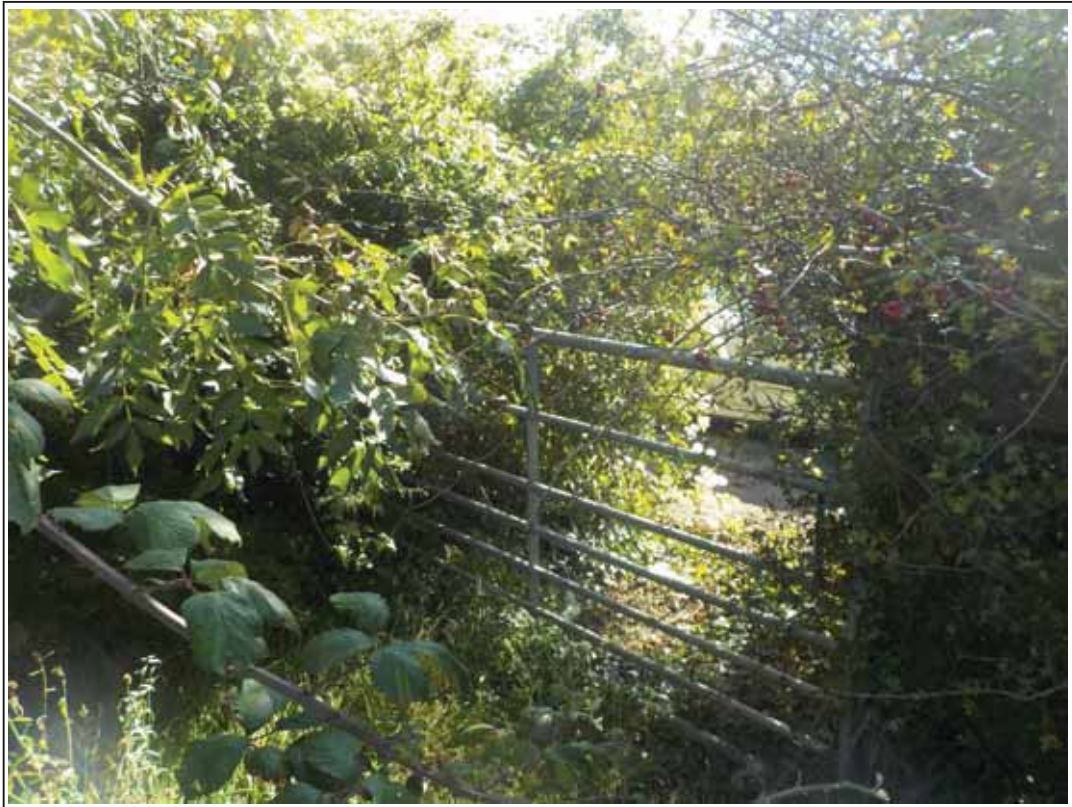
Photograph 1. View from the North Field showing the southeastern gate entrance on to Preston Down Road.

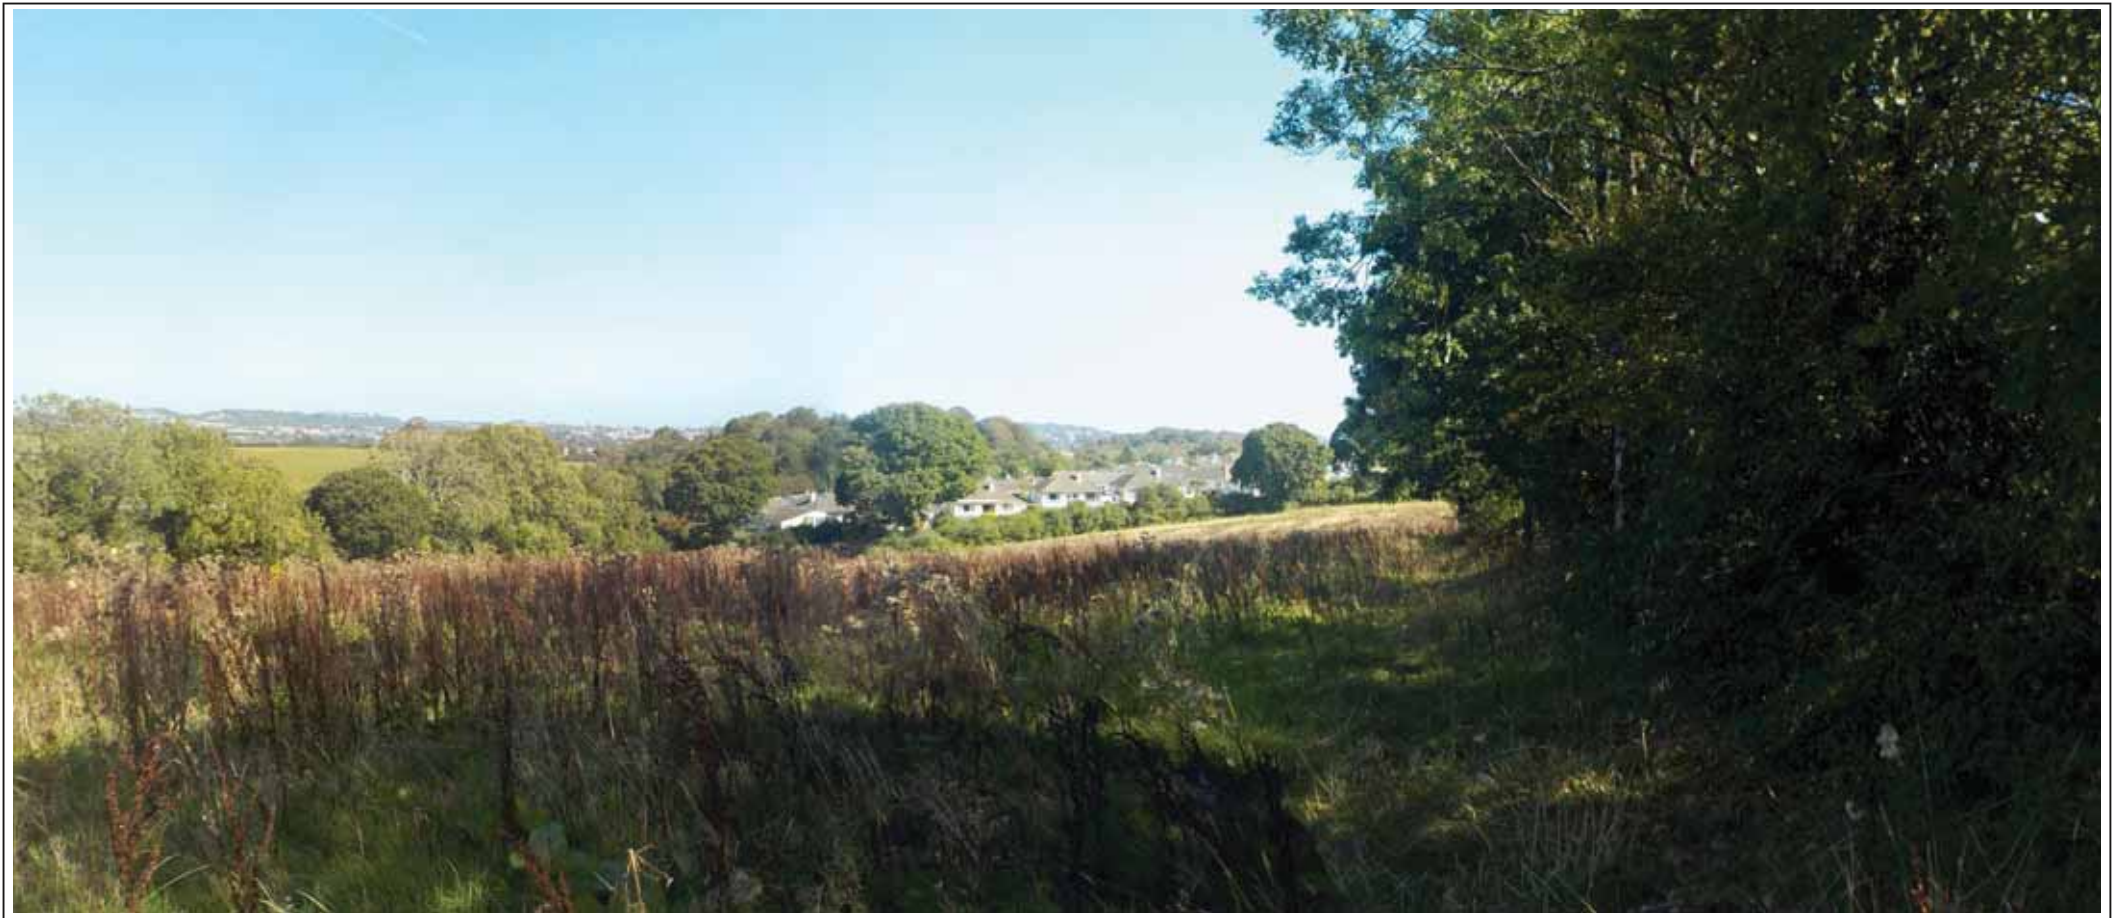
Photograph 3. View looking northeast across the North Field towards the residential housing located along the eastern boundary.
