Historic England

Historic Fibrous Plaster in the UK

Guidance on its Care and Management

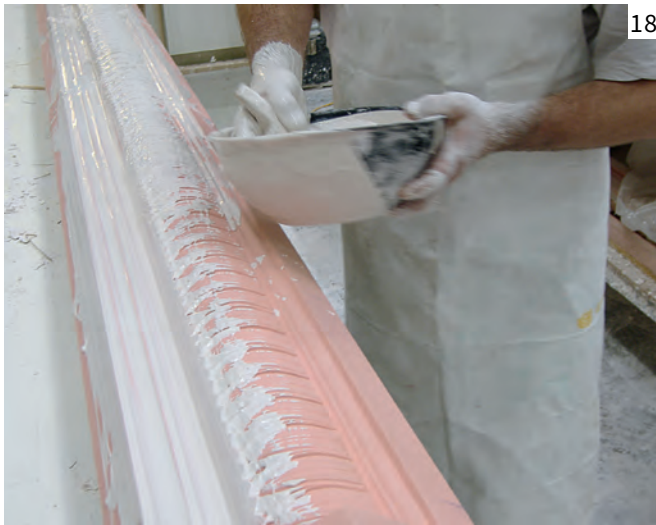
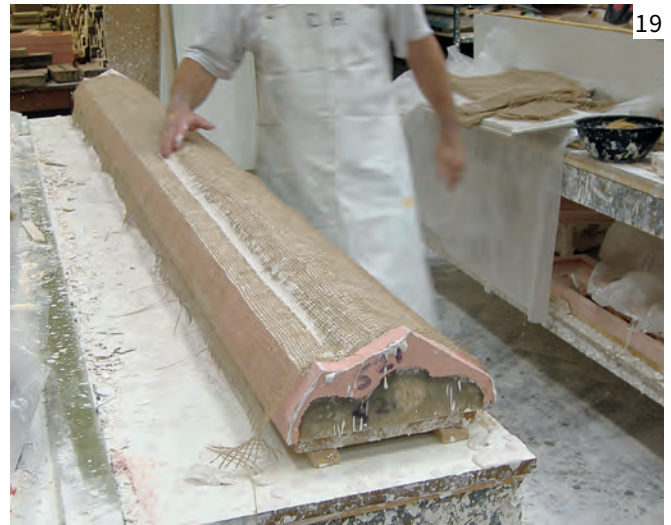
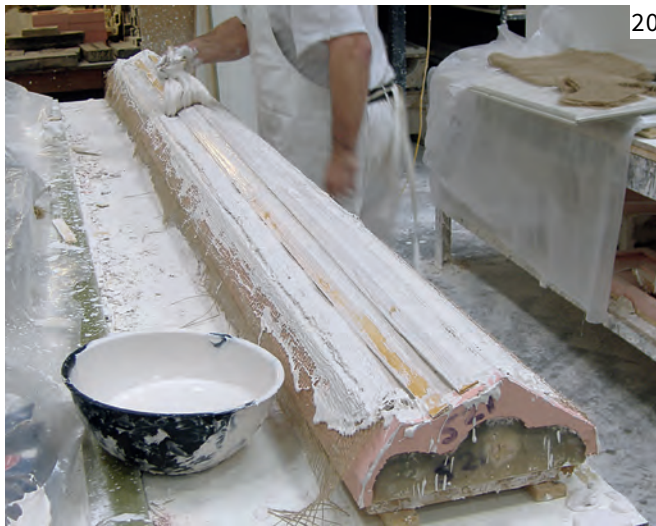
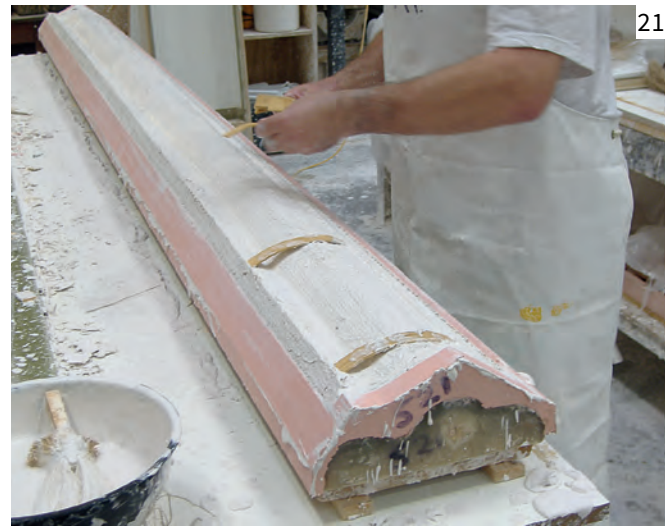
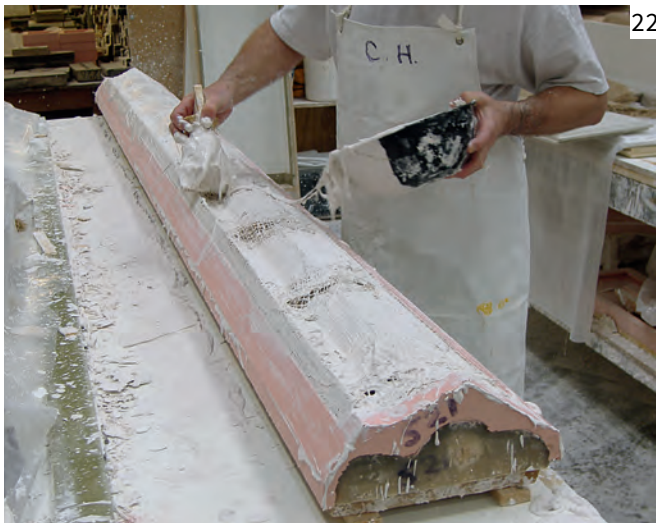
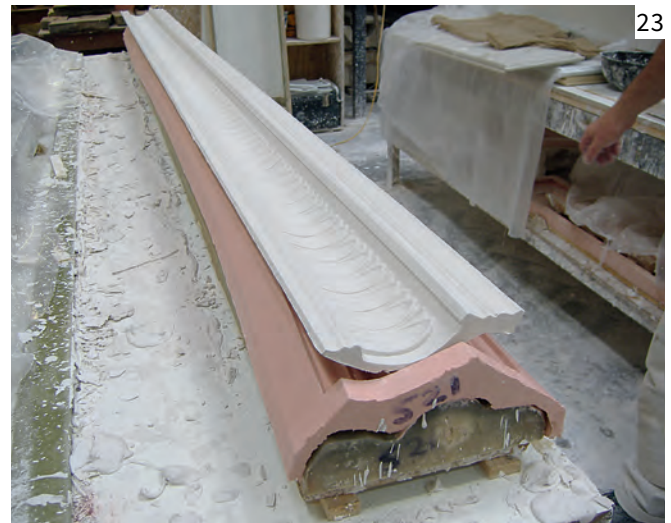
Modern production of traditional fibrous plasterwork moulding, which is slightly different from panel production

18: Brushing on plaster of Paris over a silicon rubber reverse mould.

To make the cast, plaster of Paris is brushed over the mould to form the first coat ('firstings'). This is followed by another coat of plaster ('seconds') gauged with size (animal glue). The first layer of hessian is pressed into the plaster. A second layer of hessian is then laid with more seconds plaster. Timber laths are laid into the seconds plaster as reinforcement and then sealed with more hessian and plaster. The size of the fibrous plaster cast is generally limited to the reach of the plasterer's arm: approximately 2m x 2m for general handling, and safe access to the back of the cast for the installation of fixings.

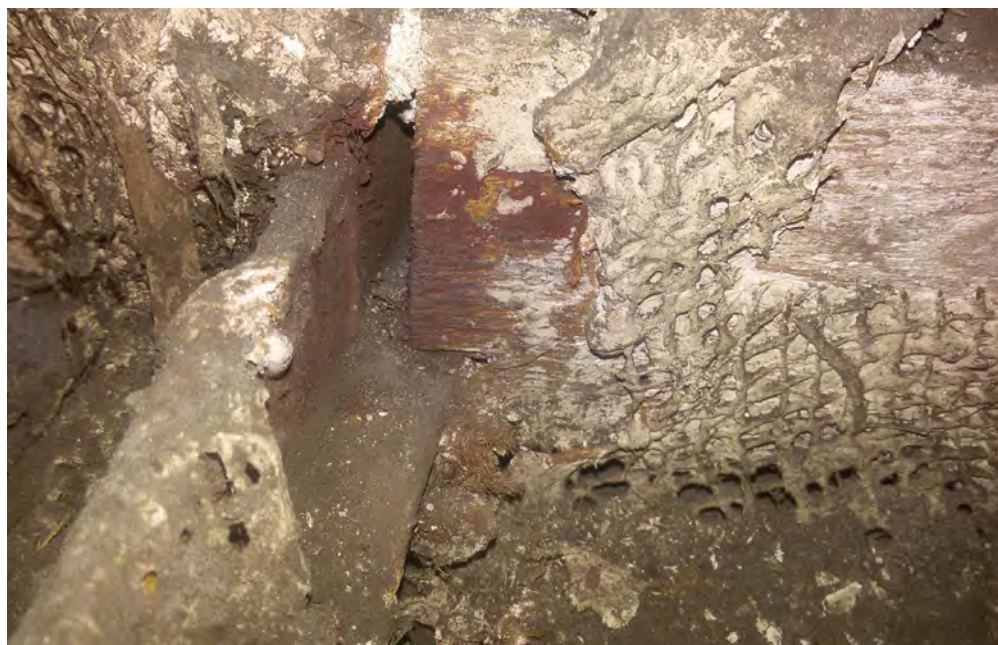
Figure 30: Poor bearing of a timber ceiling joist on a small steel T bar. The hessian has insufficient plaster cover to protect it from degradation. This illustrates how defects can be concentrated.

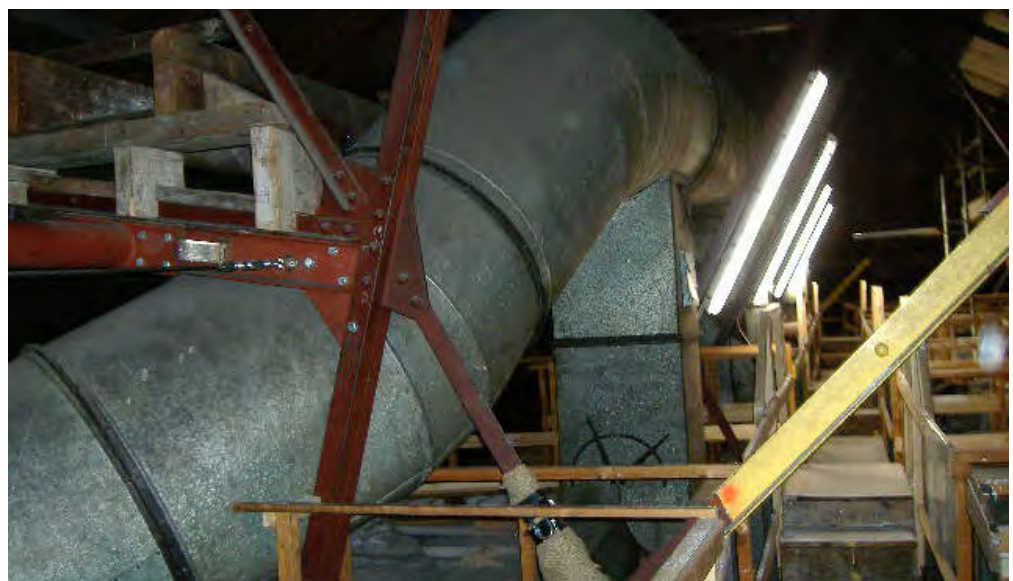
Figure 31: In ceiling voids bulky mechanical plant and boarded walkways (lower right) obscure the fibrous plaster ceiling below and impede its inspection.
