Conservation
Anti-slavery Arch, Paganhill Stroud
for Stroud District Council

SW & NE end elevations Condition

295-SU04 RevA

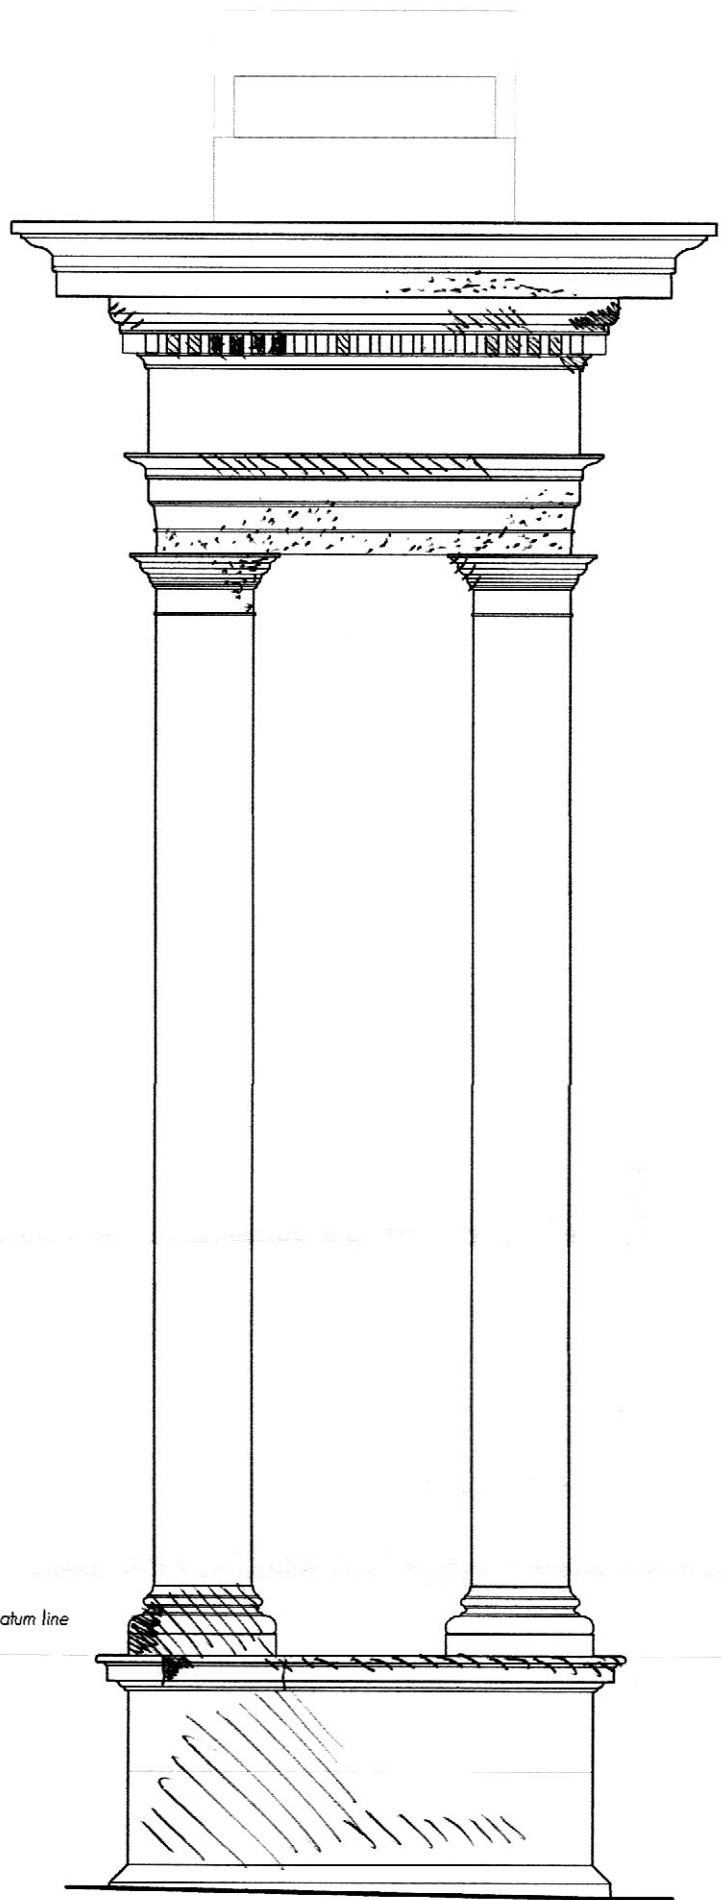
South west elevation (facing gatehouse)

Friable/spalling surface

Friable/eroded surface with loss of section

Completed frost-damaged/lost section	F - Fracture	MR - Mortar repair	EB - Embedded iron
PROPOSED REMEDY	Consolidation with sheltercoat generally (whole block); mortar repair to remove water shedding	Mortar repair to non-weathering surfaces; stone indent to weathering surfaces	Stone indent or stone replacement	Pin/micro-pin	No work if sound Repeat if faulty	No work if stable Drill out and mortar repair if corroding
